DATA REPORT

Water quality and stream invertebrate assessment for the Millstone River, Nanaimo, BC

(Fall 2015)

Prepared by Lorelle Sunduk, Andrew Simpson, Herb Stark, and Andrew Horsfield RMOT 306 – Environmental Monitoring Department of Resource Management and Protection, Vancouver Island University

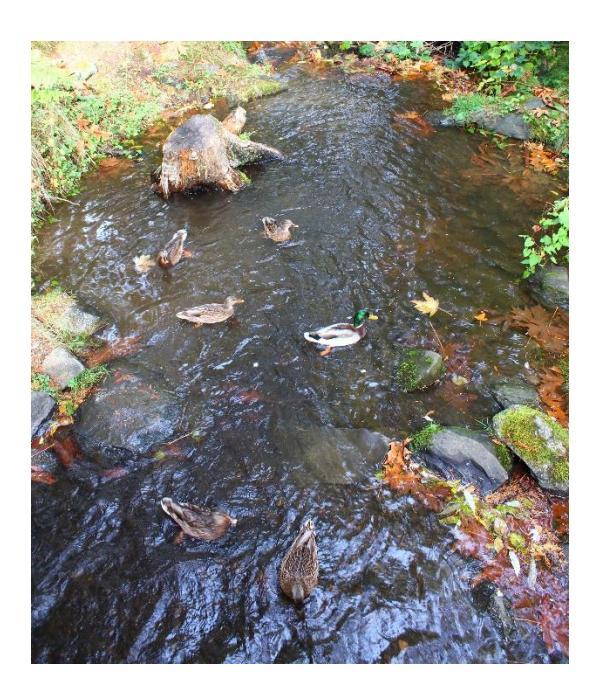
Figure 6: Site 5. Millstone River, looking downstream from the outflow from the duck pond in Bowen Park. October 14, 2015.

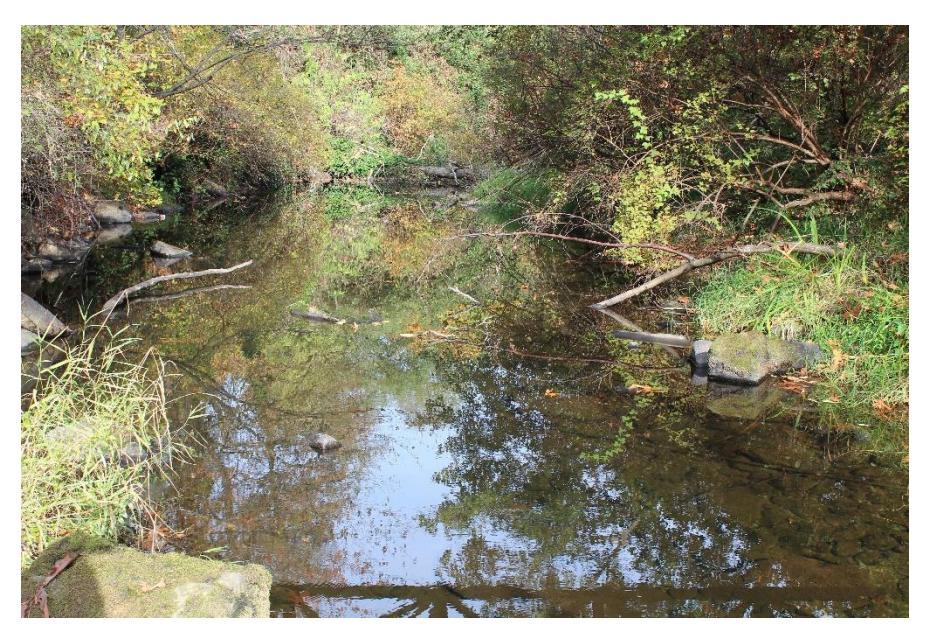
The final site, Site 6 (10 U 0430941 mE 5447091 mN), was located at the end of Barsby Avenue below the bridge (Figure 7). This site consisted of a large glide with several riffle sections. Significant amounts of garbage were also observed in the river at this location. The substrate consisted mostly of boulders.

Figure 7: Site 6. Millstone River under Barsby Avenue bridge, looking upstream. October 14, 2015.

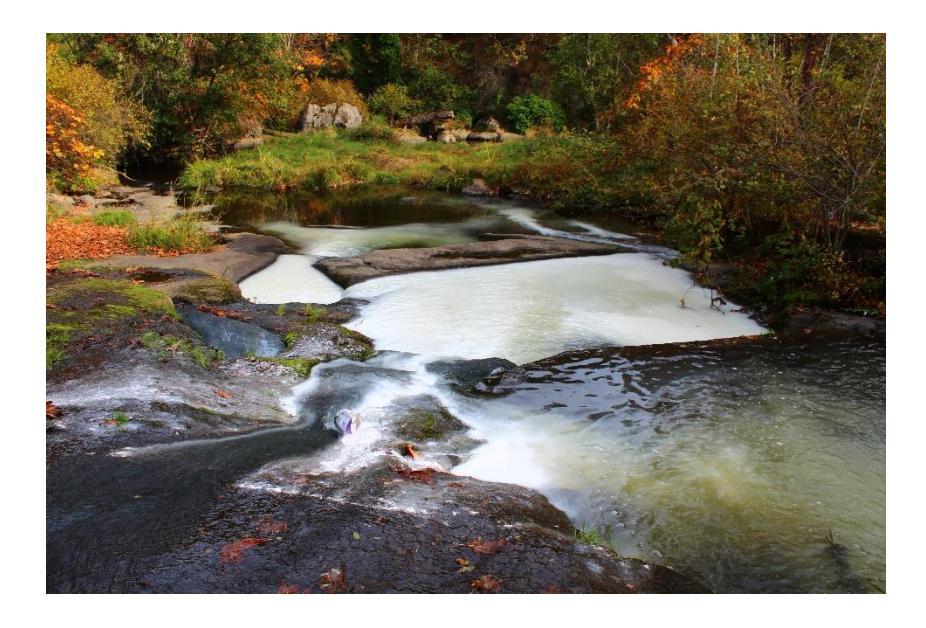
noticed numerous pieces of garbage in the river near the Barsby reach, including a rusty bicycle rim, beer cans, and a can of white acrylic paint which was leaking its contents downstream (see Appendix). Local agriculture operations draw water from Brannen Lake and the Millstone River. In the summer months, the water level in the river can become very low and water temperature increases. The combined effect of these conditions is a reduction in the amount of dissolved oxygen in the river, which can make survival of fish and other aquatic species difficult. The agricultural areas that lie along the Millstone River's path could also be leaching fertilizers and coliforms into the river, posing a threat to the ecosystem (Rolston, 2010).

Figure 8: Paint spill observed at 11:15HR, October 14, 2015, looking downstream at Barsby reach.
