Water Quality and Stream Invertebrate Assessment for the C.W. Young Spawning Channel, Englishman River

Prepared by:
RMOT 306 Environmental Monitoring Students
Sam Sigal,
Brad Wilde,
Brydon Peace &
Shawn Lukas

December 2011

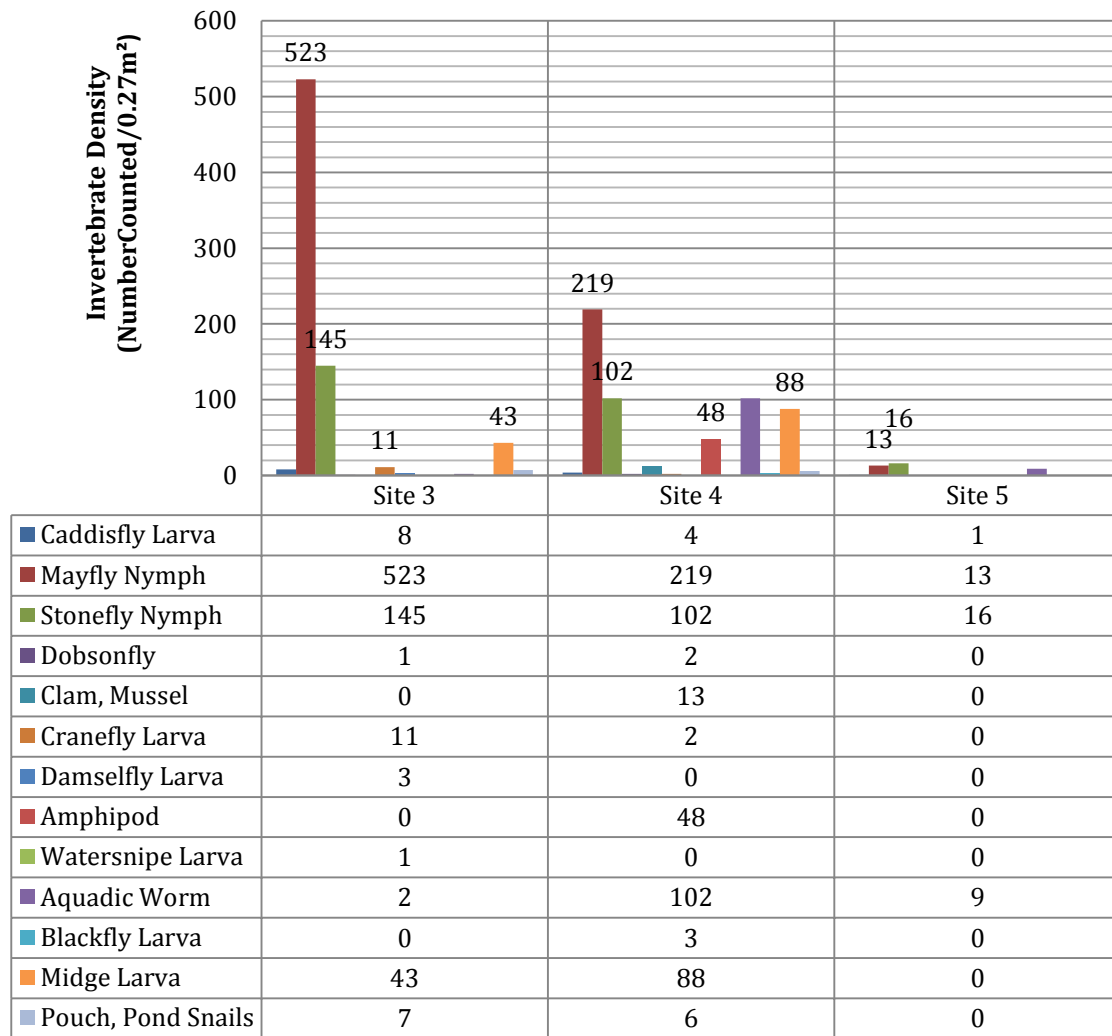
Total Invertebrate Counts

Figure 3. Total invertebrate counts for sites three, four and five during the first sampling event; October 28, 2012.

Highest counts were found at site 3, where 744 organisms were collected that suggest a density of 2565.52/m² (Figure 4). Site 4 had similar numbers but lower at 589 insects that suggested a density of 2031.03/m² (Figure 5). Results from site 5 showed the lowest numbers of invertebrates collected with only 39 that suggested a density of only 134.48/m² (Figure 6).

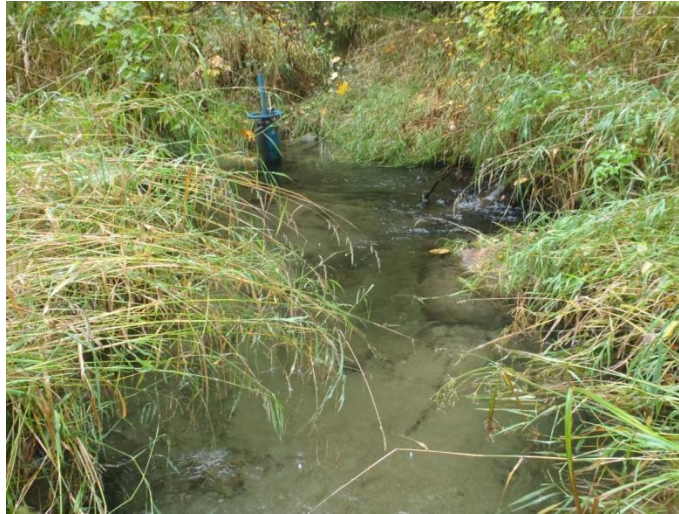
Photo 1: Looking up stream at Site one, taken Oct 21, 2012. This site was one site that ALS samples were taken.

Site1 is located at the headwaters of the channel, approximately 3 meters downstream from where the main waters of the Englishman River feeds water to the channel through the manually controlled flow valve. This valve regulates water flow, ensuring that the water level is consistent at all times of the year. The substrate of site 1 was mostly fines with relatively deep water (approximately 1 meter). Grassy undercut banks were located at this site, making good in stream cover for salmon such as Coho. Photo 1 depicts this site well and can be found in Appendix 1. Access to this site was available down a steep grassy slope, caution was required.

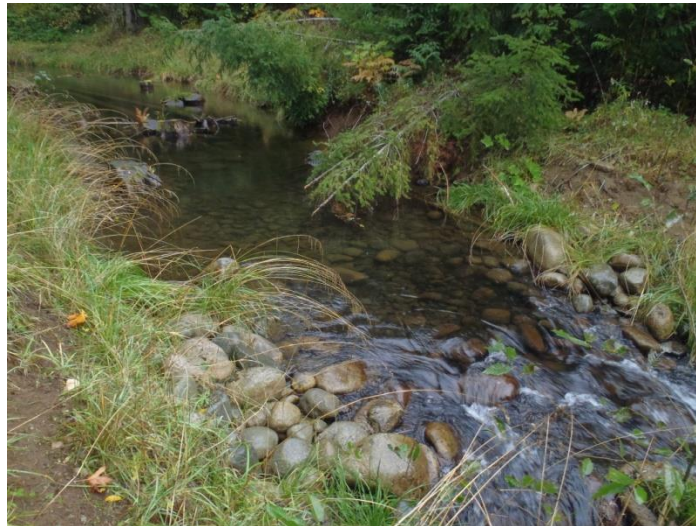
Photo 2: Looking upstream at Site 2 taken on Oct 21, 2012, this site 20 meters downstream from a culvert and road crossing.

Site 2 is located approximately 1250 meters downstream from site 1 (Boss et al., 2011). This site can be accessed from a culvert that goes under the road, and is roughly 25 yards down the stream. The easily accessible site has large woody debris, medium depth water (approximately 2 feet), with substrate represented by mostly cobble. The water velocity was relatively slow moving water. A photo of this site can be seen in Appendix 1.

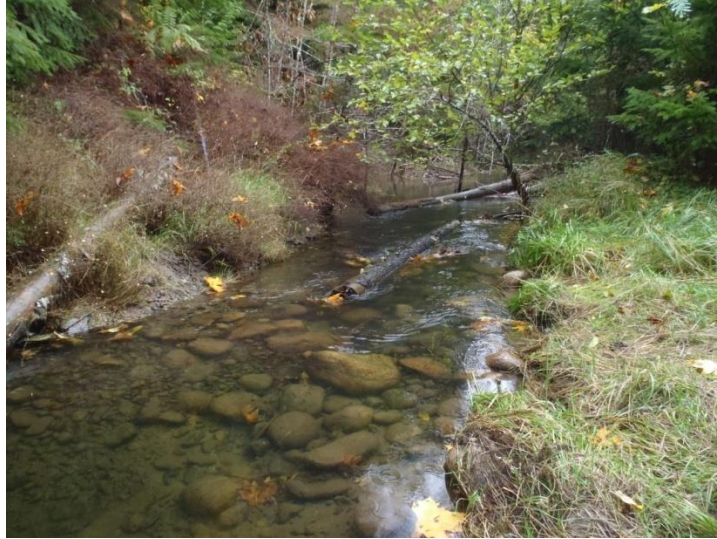
Photo 3: Looking downstream at site 3, taken Oct 21, 2012. This site was one of the sites ALS and stream Invertebrates where taken.

Site 3 is located approximately 2925 meters downstream from site 1, and access to this location is only available by parking along the road a short distance away and walking to the site. Stumps and woody debris has been piled up along the road to deter any vehicle access, a narrow walking path give access to the site approximately 75 meters. The water depth located at site 3 (approximately 2 feet) flowed over a good mixture of gravel and cobble substrate (Appendix 2). Deep pools are situated above and below this site, and ample shade and canopy cover is provided by large coniferous and deciduous trees along the stream. Invertebrate sampling was conducted at this site because of substrate composition, depth of water, and overall site condition.

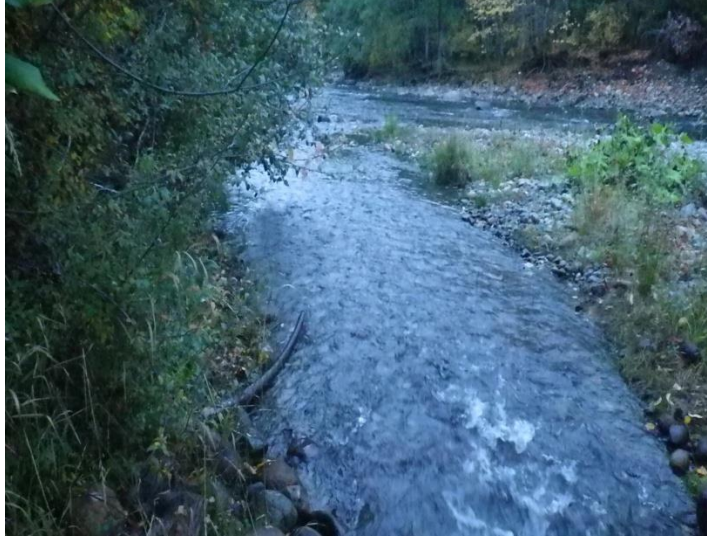
Photo 5: Looking down stream at site 5, where the side channel flows back into the Englishman River.
ALS and Invertebrate samples were taken at this site. Taken on Oct 21, 2012

Site 5 is located at the confluence of the side channel and Englishman River. It is approximately 4100 meters downstream from site 1 (Boss et al., 2011). All water samples and invertebrate samples were taken within an area of direct influence of the main waters of the Englishman River to gain comparison results between the river and the side channel. The substrate characteristics were a boulder cobble blend with fast flowing water. Due to the high velocity basic hydrology measurements were conducted in the outflow of the side channel (Photo 5), and not done within the Englishman River. This site is susceptible to erosion based on the fast moving water and the flashiness of the river. Table 1 gives a complete and concise view of each sites safety, habitat, and coordinates.
