**Water Quality and Stream Invertebrate Assessment for the C.W. Young Channel,  
Englishman River, BC  
(Fall, 2015)**

Students of Vancouver Island University

RMOT 306 (Environmental Monitoring)

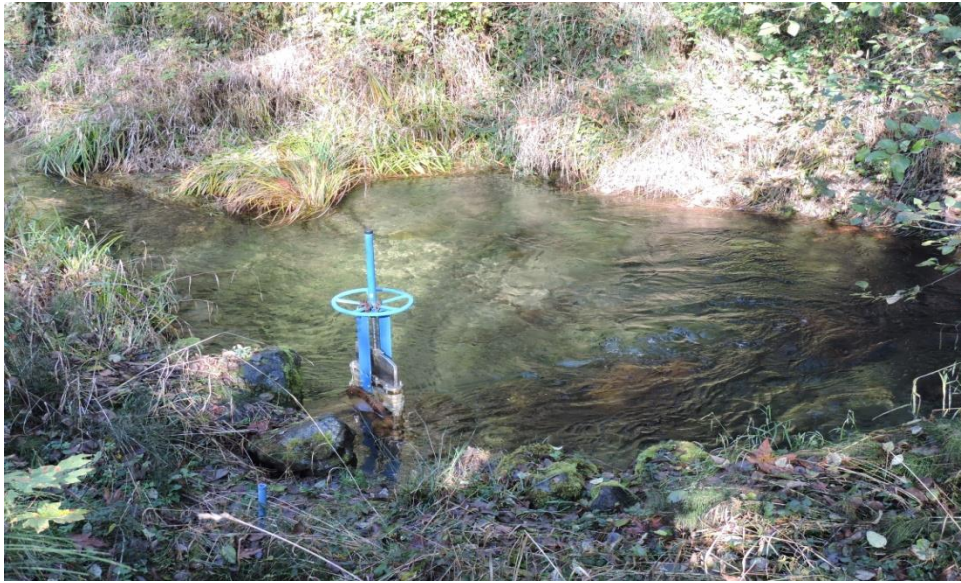
Site 1- Picture of pipe and control valve for flow located at the top end of the side channel. Picture taken on November 18, 2015.

Site 1 is located upstream of the side channel near the metal inlet pipe, which allows water to be discharged from the Englishman River into the side channel (Appendix 2). The metal pipe is >50 metres long and can be adjusted to increase or decrease flow. There is a second metal pipe located upstream from the main valve pipe, with a metal screen located <5 metres downstream from the pipe. A steep bank >10 metres runs southerly along site 1, followed by a gravel path/road and >20 metres of vegetation, which divides the Englishman River and side channel. Water quality parameters were taken 1 metre downstream from the metal inlet pipe during both sampling periods.

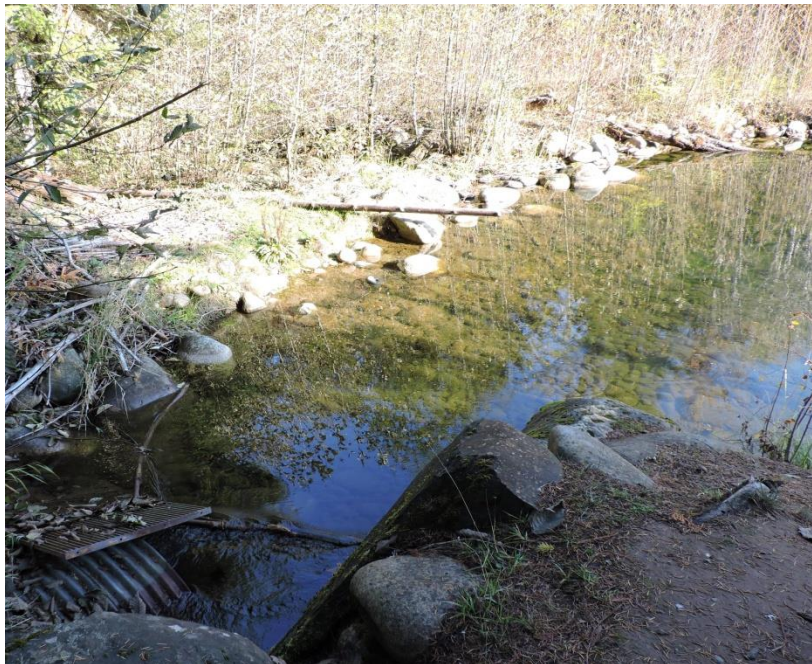
Site 2 - Picture of South side of site 2 showing culvert running under main gravel road. Picture taken on November 18, 2015.

Site 2 is located north of the main road/path that runs through the park and along most of the side channel (Appendix 2). The north side of the road was chosen sampling due to the culvert that runs under the road and discharges to the north. The metal culvert is >1 metre in diameter

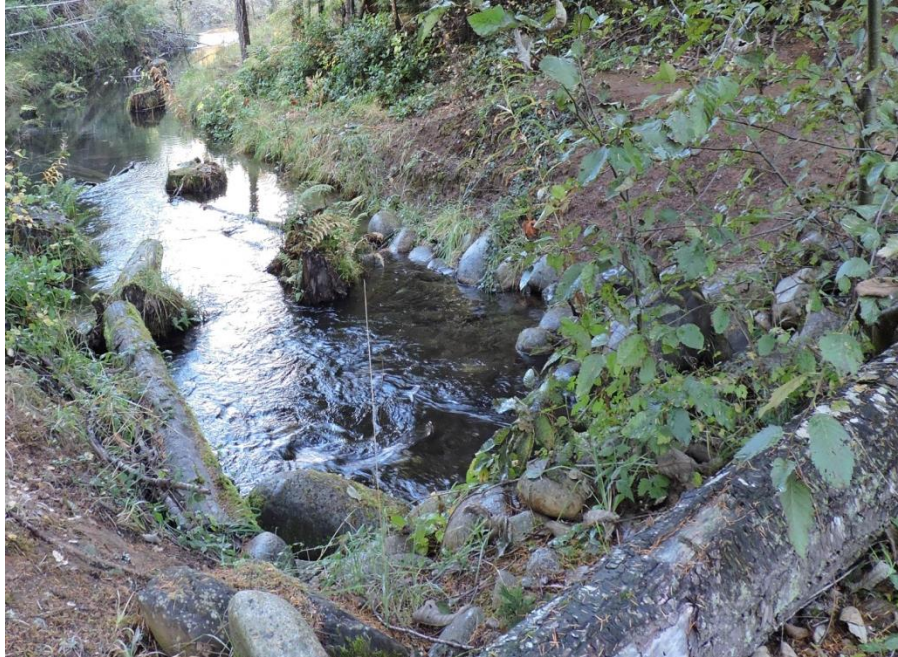
Site 2- Picture of North side of culvert running under main gravel road where site 2 is located. Picture taken on November 18, 2015.

and >5 metres in length (Appendix 2). Water quality and velocity parameters were taken 3 metres downstream of the metal culvert; with velocity calculations calculated over 5 metres. Site 2 has a high concentration of large boulders with large woody debris (LWD). Dense vegetation is located along the west and east banks of site two with steep banks >2 metres on both sides. Three wooden salmon ponding boxes installed by the fish hatchery and used for pink salmon (*Onchorhynchus gorbuscha*) are situated downstream from site 2 (Appendix 2).

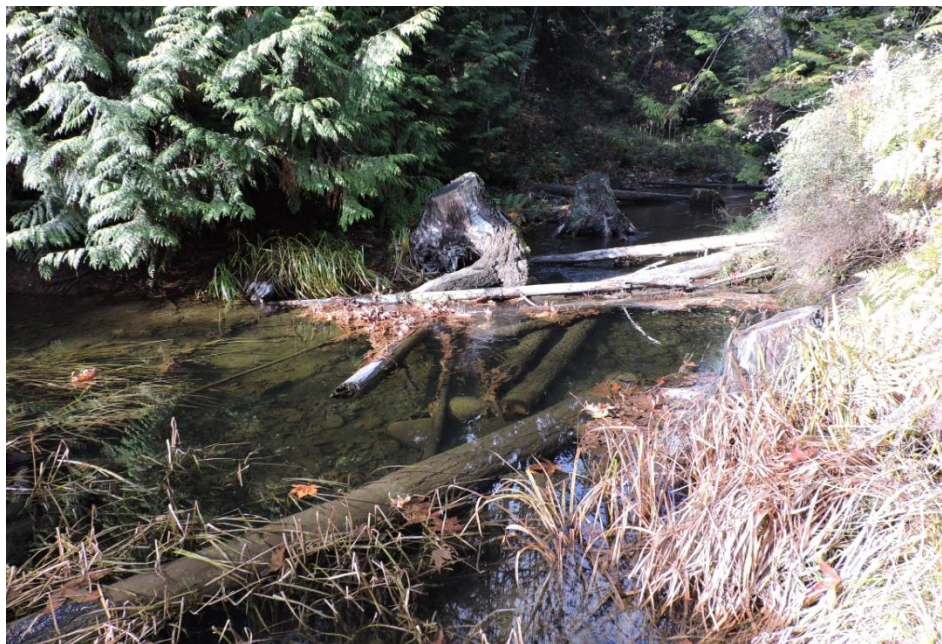
Site 3- Picture of site 3 located 30 metres north of the main gravel road. Site 3 is located just beyond the LWD crossing the side channel. Picture taken November 18, 2015.

Site 3 is located >20 metres south of the main road/path and has a large abundance of LWD with presence of small gravel substrate (Appendix 2). The side channel runs south while taking a westerly turn at site 3. The southern portion of the site has dense vegetation, while the northern side contains grassy vegetation surrounded by dense vegetation. There is a path that runs from the main gravel road to site 3, which becomes more apparent with site visitation. Water quality, velocity, and invertebrate sampling were taken 2 metres downstream from the LWD pictured in appendix 2.

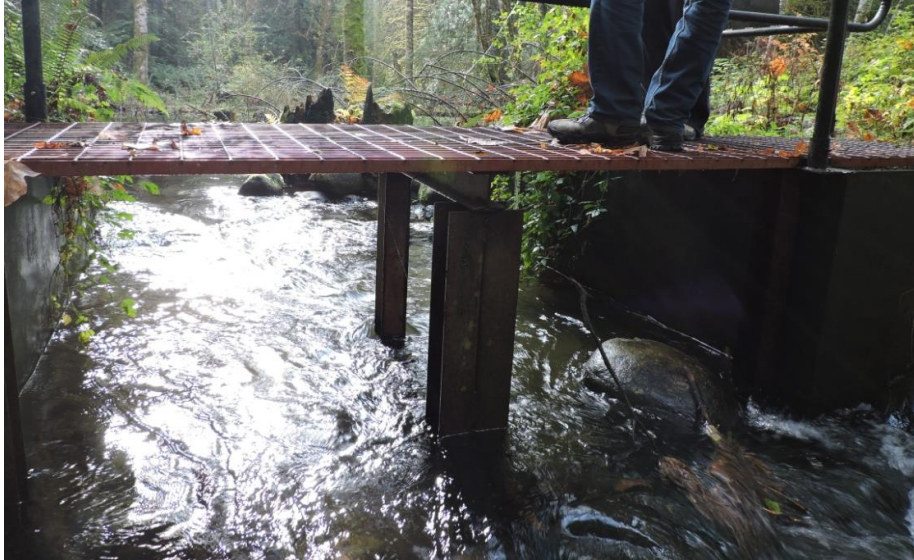
Site 4- Picture of Site 4 located south of the main gravel road. Picture showing metal bridge used to access multiple leisure trails. Picture taken November 18, 2015

Site 4 is located near the lower section of the side channel just above a metal bridge/grate and is surrounded by dense vegetation between the Englishmen River located >20 metres south-east (Appendix 2). The metal bridge is >2 metres long and narrows below a wide pool section of the side channel. The site is surrounded by various sizes of substrate, including large boulders, fines and LWD. The bridge located <3 metres below site 3 connects a walking path to the main road/path, which is a high traffic area connecting the main gravel road to several walking paths. There is a steep bank <2 metres along either side of the site, which produces light vegetation including low brush and ferns. Water quality, and invertebrates sampling were taken 1 metre above the metal bridge/ grate as pictured in appendix 2.

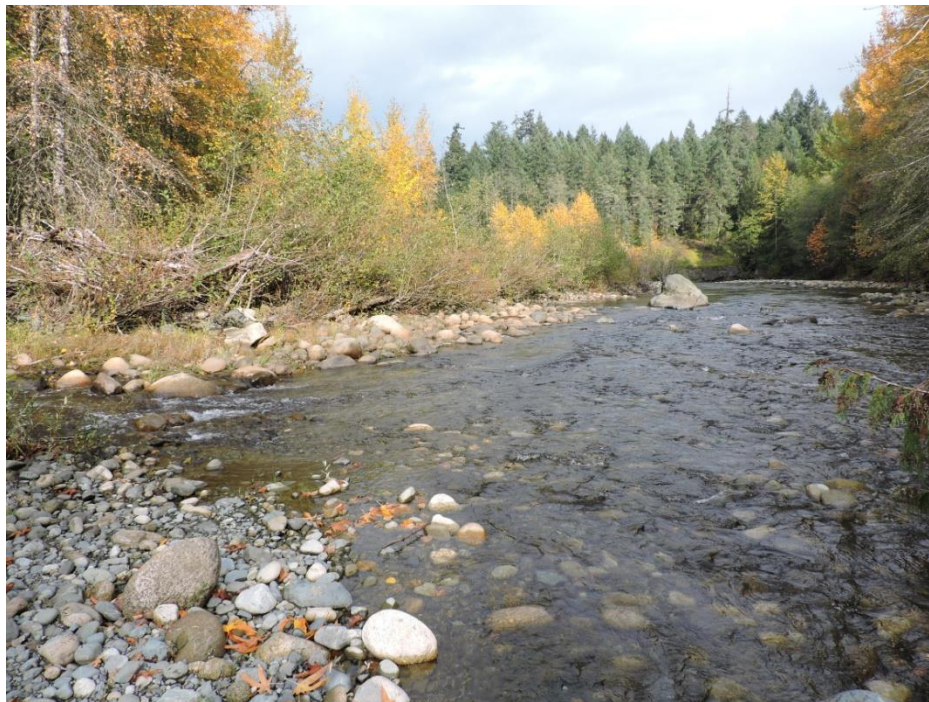
Site 5- Picture of discharge of Side Channel meeting Englishman River. Picture taken November 18, 2015

Site 5 is located at the discharge point of the side channel into the Englishman River (Appendix 2). The area has a high abundance of small to medium size substrate, with presence of LWD scattered throughout the area adjacent to the site. Site 5 is located on the northern shore of the Englishman River, which acts as a drainage point for the side channel, which were <2 metres at the initial site visit. The Englishman River was >5 metres wide, with moderate to low flow and <0.5 metres deep at the side channel. There is a large abundance of LWD located along the side channel between sites 4 and 5 along with rough terrain and a long section of undercut along steep sections of rock where chum salmon were observed (Appendix 2). There was dense vegetation on the northern side of the Englishman River at side channel drainage point. This site is important to test as this is the only drainage point from the side channel into the Englishman River. Water quality parameters were taken 3 metres beyond the discharge point of the side channel.

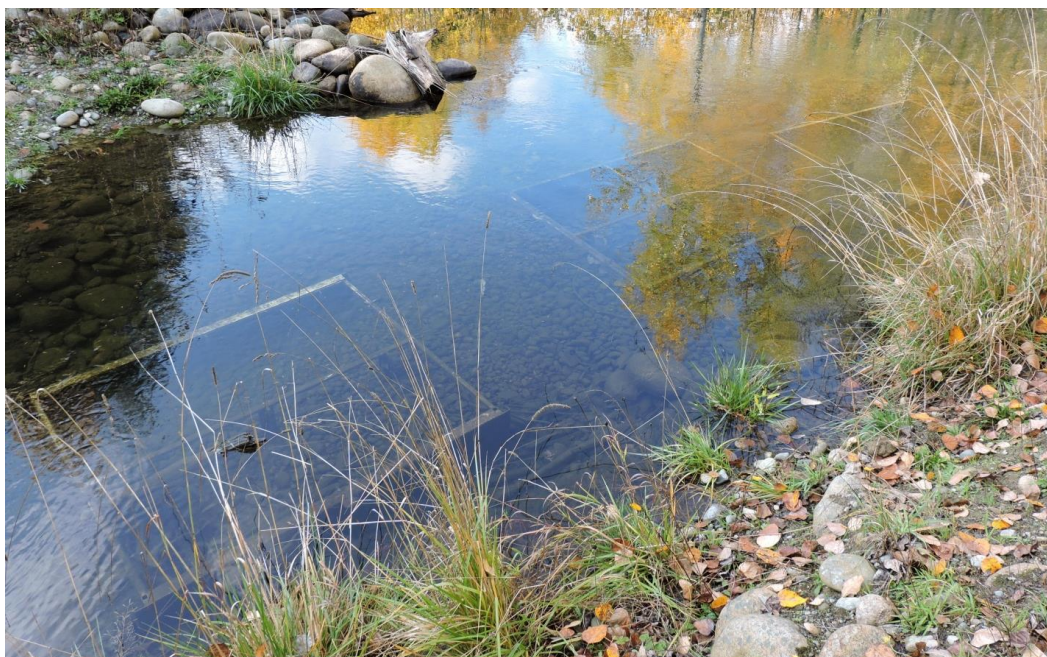
Picture of egg rearing structures downstream of site 2. Picture taken November 18, 2015
