Cottle Creek Water Quality, Microbiology and Stream Invertebrate Assessment, 2016

RMOT 306

Vancouver Island University

December 12, 2016

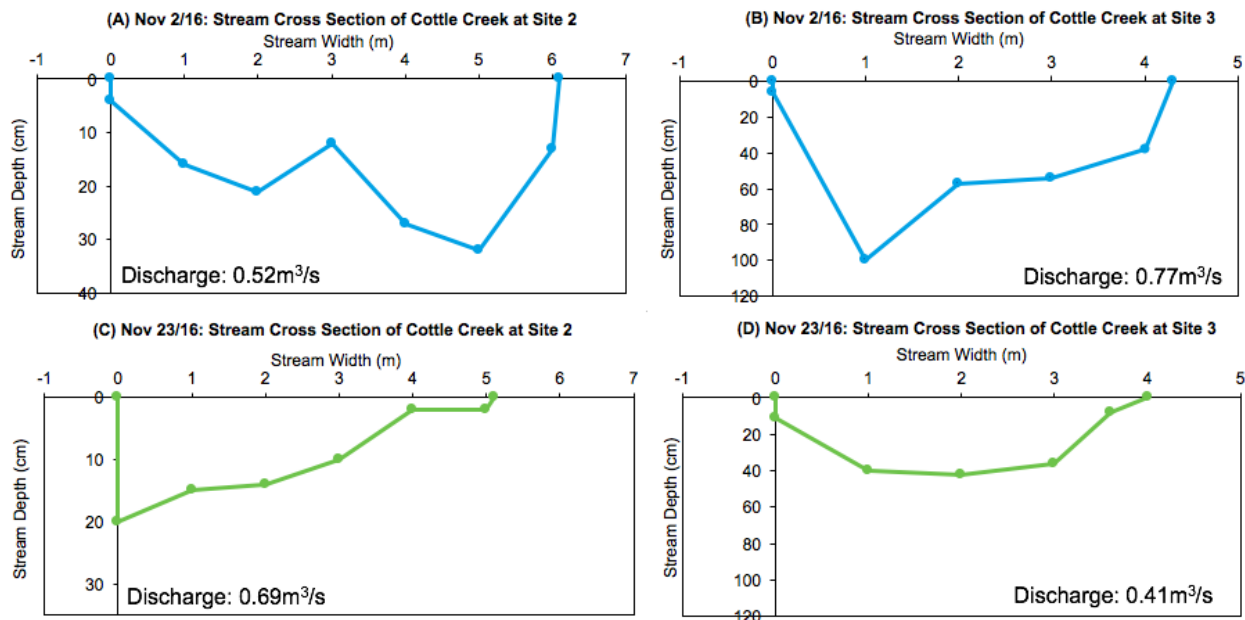
Figure 2: Stream cross sections and discharge of Cottle Creek measured during both sampling events (November 2nd and 23rd, 2016) at sites 2 and 3. Blue lines indicate measurements for sample event 1, and green lines indicate measurements for sample event 2. (A) Shows the stream cross section at site 2 for sample event 1. (B) Shows the stream cross section at site 3 for sample event 1. (C) Shows the stream cross section at site 2 for sample event 2. (D) Shows the stream cross section at site 3 for sample event 2.

Hydrological measurements were taken at sites 2 and 3 during both sampling events on November 2 and 23, 2016 (for methods see Section 4.3). The results obtained from our assessment are summarized in Table 4 and Figure 2. Site 2 showed an increase in discharge from sample event 1 to sample event 2 (figure 2A & C). Site 3 showed a decrease in discharge from sample event 1 to sample event 2 (figure 2B & D). Sample event 1 was predicted to have the highest discharge values due to the heavy amount of rain that Nanaimo had received on November 2, 2016. Site 3 followed this prediction with a discharge of $0.77 \text{ m}^3/\text{s}$ during sample event 1, and a lower discharge of $0.41 \text{ m}^3/\text{s}$ during sample event 2. Site 2 did not follow this prediction as it showed a discharge of $0.52 \text{ m}^3/\text{s}$ during sample event 1, and a higher discharge of $0.69 \text{ m}^3/\text{s}$. Some possible

causes of the increase may have been due to precipitation lag time of the watershed following the November 2nd heavy rainfall event. A hydrograph of the site over the month of November would have been required to further investigate the possibility of this speculation. Other possible causes of the discharge increase may have been a result of higher drainage of Cottle Lake into Cottle Creek during sample event 2, or sampling errors during data collection in the field (i.e. measuring velocity at stream surface rather than subsurface). It should also be noted that all discharge values observed during our 2016 Cottle Creek assessment were much higher than the discharge values reported in the 2015 assessment. This was due to higher precipitation received in November 2016 versus November 2015. Nanaimo, BC had a total rainfall of 111.1 mm in November 2015, and a total rainfall of 205.3 mm in November 2016 (Environment Canada, 2016). Average discharge of Cottle Creek at site 2 was 0.010 m³/s in 2015, and 0.65 m³/s this year. Average discharge at site 3 was 0.0007 m³/s in 2015, and 0.55 m³/s this year (VIU, 2015). Overall, it can be concluded that Cottle Creek is a small stream with relatively low discharge rates, even under high precipitation conditions.

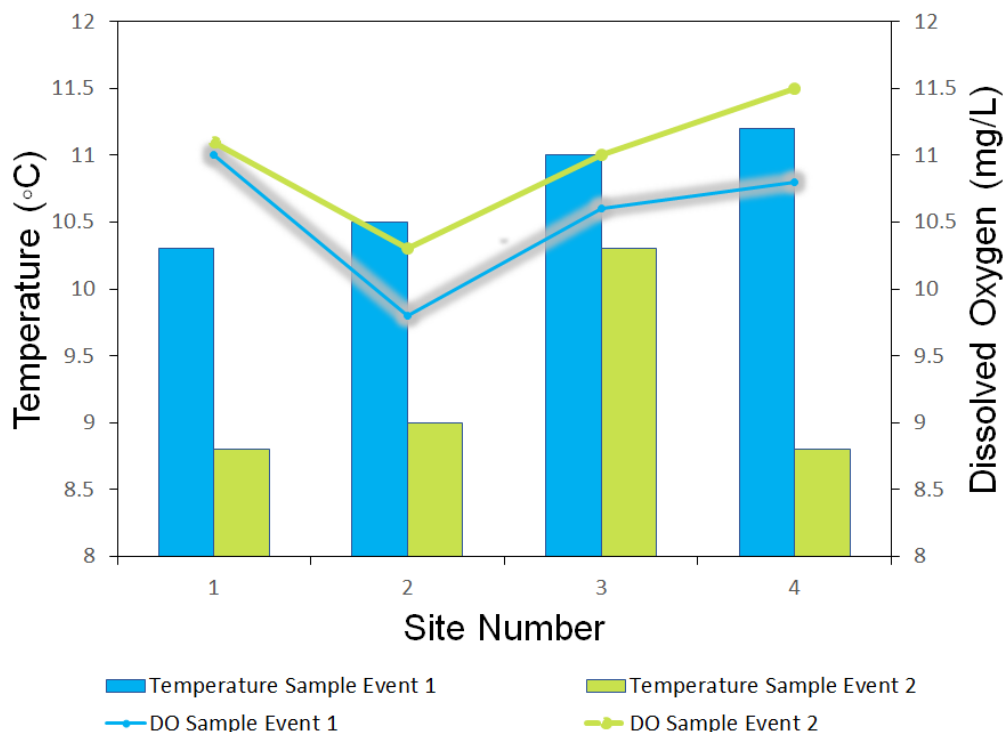
Figure 3: Temperature and dissolved oxygen levels for Sample Event 1 (November 2, 2016) and Sample Event 2 (November 23, 2016) for Cottle Creek, located in Nanaimo, B.C.

Temperature is shown in relation to dissolved oxygen in Figure 3 to better reflect the correlation between the two parameters and for trend analysis. Temperature was measured in degree Celsius (°C) and dissolved oxygen (DO) in mg/L. As the temperature of water increases, gas solubility decreases (Shaw *et al.*, 2004). Therefore, as the water in Cottle Creek heats up, the less dissolved oxygen gas molecules the water can hold.

This expected trend was found when analyzing and comparing the parameters between each sample event. The first sampling event (Nov 2nd, 2016) had resulting higher temperatures and lower levels of DO when compared to the second sampling event (Nov 23rd, 2016), which had lower temperature levels and high levels of DO.

Temperatures ranged from 10.3-11.2°C (9.8-11.0 mg/L for DO) during the first sampling event and 8.8-10.0°C (10.3-11.5 mg/L for DO) during the second sampling event (see Appendix A). Per the *Guidelines for Interpreting Water Quality Data* (Ministry of Water, Land, and Air Protection, 1998), the criteria for supporting all aquatic fish and invertebrates, DO levels must be a minimum of 9 mg/L. DO levels during both events were sufficient to support aquatic life with no detrimental effects.

Levels of DO and % saturation were lowest at site 2 during both events due to the site being the output for Cottle Lake (see Appendix A). The oxygenic photosynthetic organisms in and surrounding Cottle Lake utilized the DO during primary production, therefore slightly depleting levels in outflowing waters. Water temperatures were higher

at site 3 during both events due to the site being relatively open. The dominant riparian trees at site 3 were deciduous alders that had lost most of their foliage, allowing for an open canopy and increased light penetration.

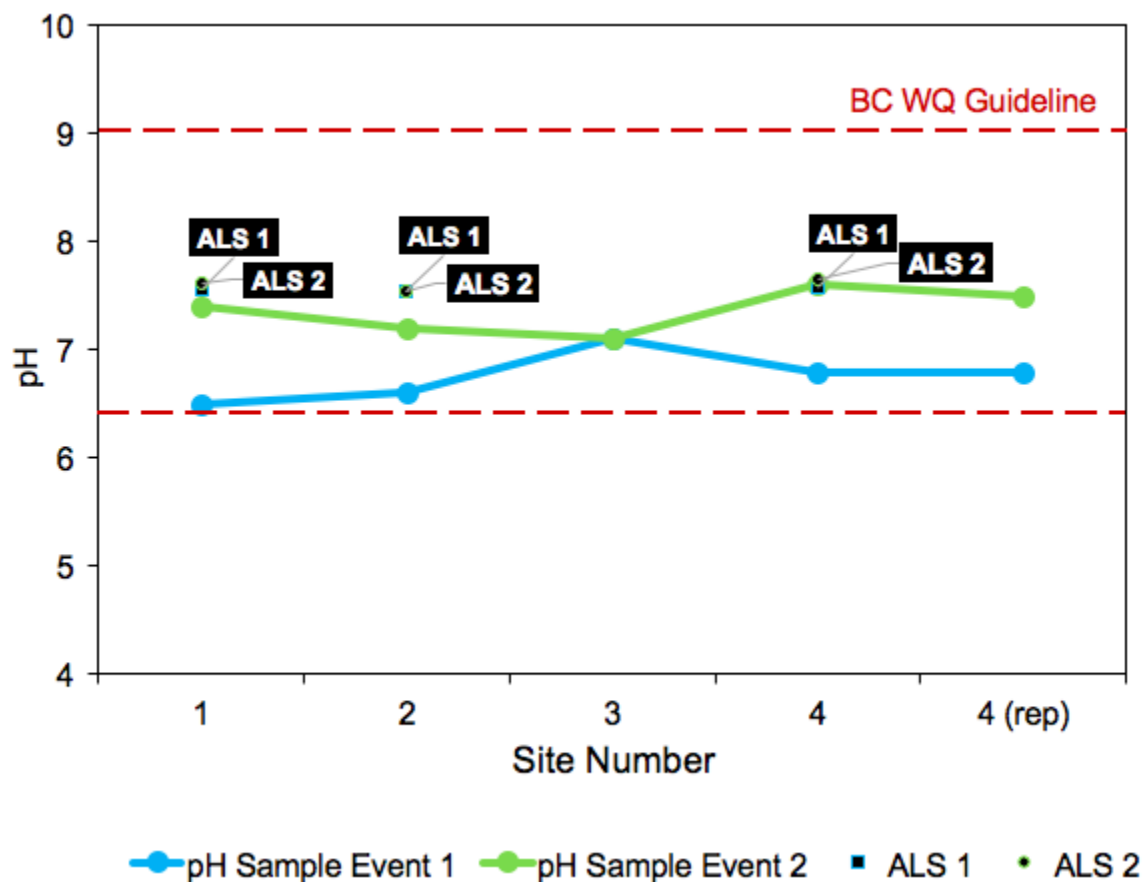
Figure 4: Change in pH moving downstream of Cottle Creek from site 1 to site 4. The blue line indicates pH levels obtained from sample event 1 (November 2nd, 2016), and the green line indicates pH levels obtained from sample event 2 (November 23rd, 2016). Site 4 (rep) indicates the results obtained from a replicate sample of site 4 for quality control. Black boxes indicate the pH results obtained from ALS. Dashed red lines indicate the range for the BC water quality guideline.

This is an important parameter to consider when conducting an environmental monitoring program as it has a large influence on many biological reactions, and the potential toxicity of some metals (Shaw et al., 2004). From our VIU lab analysis for sample event 1, site 1 had a pH of 6.5 and site 4 had a pH of 6.8. For sample event 2, site 1 had a pH of 7.1 and site 4 had a pH of 7.6 (figure 4). There is some concern in the accuracy of our VIU results as there is a large deviation from the reported ALS pH

values. This may have been a result of sampling error, or a faulty probe in the pH meter that was used for our measurements. Overall, there was a subtle increase in pH downstream from our VIU and ALS results during both sampling events. Although there were some differences between the VIU and ALS pH levels, all measurements fell within the BC water quality guideline (Ministry of Environment, LandData BC, and Geographic Data BC, 1998). Therefore, based on current conditions, acidification of Cottle Creek is not a concern.

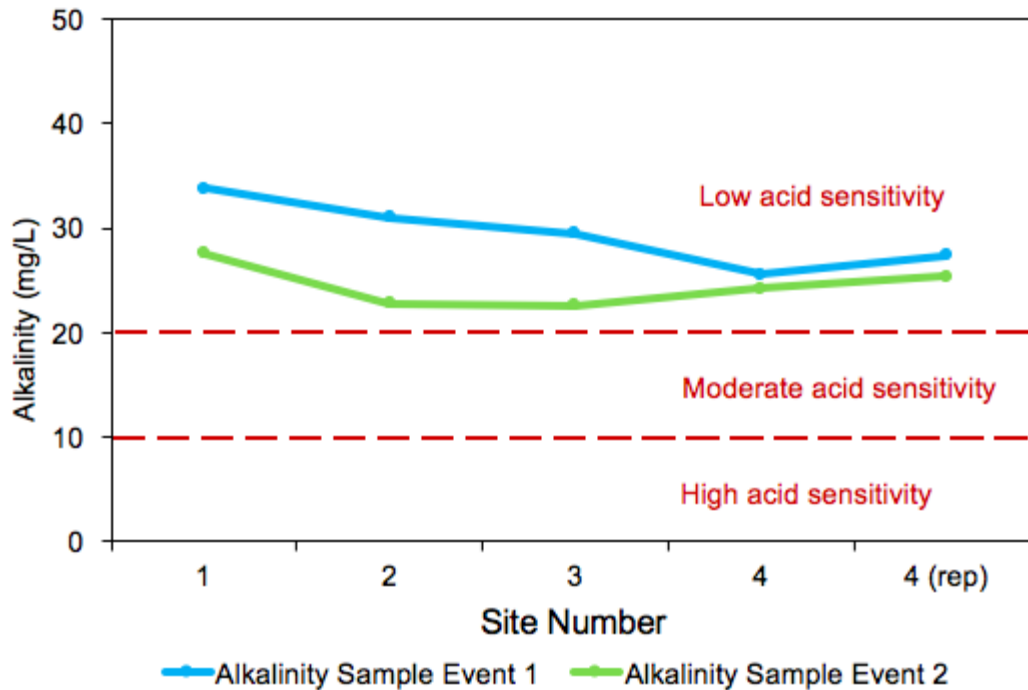
Figure 5: Change in alkalinity moving downstream of Cottle Creek from site 1 to site 4. The blue line indicates alkalinity in mg/L obtained from sample event 1 (November 2nd, 2016), and the green line indicates alkalinity obtained from sample event 2 (November 23rd, 2016). Site 4 (rep) indicates the results obtained from a replicate sample of site 4 for quality control. Dashed red lines indicate the BC water quality guideline for low, moderate, and high sensitivity to acidification.

Alkalinity is a measure of the acid neutralizing capacity of a solution. It measures the concentration of carbonates (HCO_3^- and CO_3^{2-}) present in the solution. Higher concentrations of carbonates in a sample mean there will also be a higher alkalinity. It is an important water quality parameter to consider as it directly has an influence on the pH of the water (Shaw et al., 2004). From our VIU analysis for sample event 1, site 1 had an alkalinity value of 33.8 mg/L and site 4 had an average value of 26.5 mg/L (average of site 4 and site 4 rep. results). For sample event 2, site 1 had an alkalinity value of 27.6 mg/L and site 4 had an average value of 24.8 mg/L (figure 5). Overall, these results show a decreasing trend downstream. This may possibly be related to the high amount of surface runoff being received at site 1. Surface runoff causes erosion of the stream bank sediments, which may be rich in carbonate ions (Shaw et al., 2004). This would explain the higher alkalinity upstream at site 1. The decrease downstream may have been a result of dilution effects. The BC water quality guideline divides alkalinity into 3 categories: low, moderate, and high sensitivity to acidification (figure 5) (Ministry of Environment et al., 1998). All alkalinity results for Cottle Creek fall into the category of low acid sensitivity; meaning it has a high capacity to neutralize acids. Together, the pH and alkalinity results allow for the further conclusion that acidification of Cottle Creek is not currently a concern.

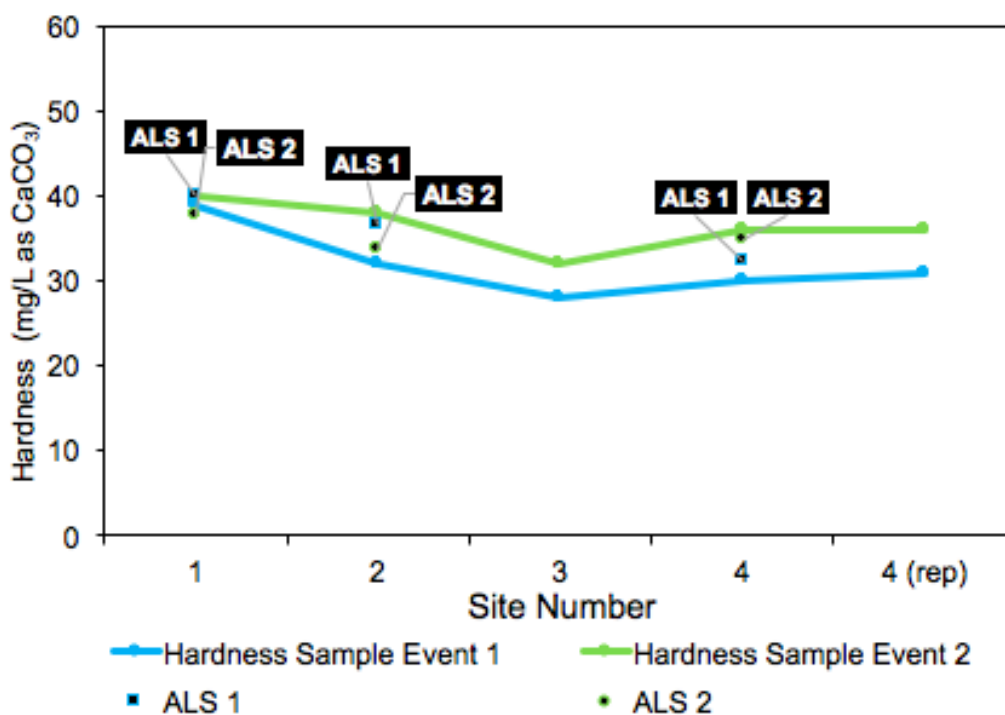
Figure 6: Change in hardness moving downstream of Cottle Creek from site 1 to site 4. The blue line indicates hardness obtained from sample event 1 (November 2nd, 2016), and the green line indicates hardness obtained from sample event 2 (November 23rd, 2016). Site 4 (rep) indicates the results obtained from a replicate sample of site 4 for quality control. Black boxes indicate the hardness results obtained from ALS.

hardness levels. From our VIU analysis for sample event 1, site 1 had a hardness value of 39 mg/L as CaCO_3 and site 4 had a value of 30 mg/L as CaCO_3 . For sample event 2, site 1 had a hardness value of 40 mg/L as CaCO_3 and site 4 had a value of 36 mg/L as CaCO_3 (figure 6). Since hardness and alkalinity are theoretically correlated, a similar decreasing trend downstream was observed. The higher hardness concentration at site 1 during both sampling events may also be a result of the high surface runoff and erosion being received there. The VIU lab analysis results for hardness were similar to the ALS results received from our water samples, indicating that our hardness results were accurate. All hardness results were well below 60 mg/L as CaCO_3 , meaning that Cottle Creek drains soft water from the watershed.

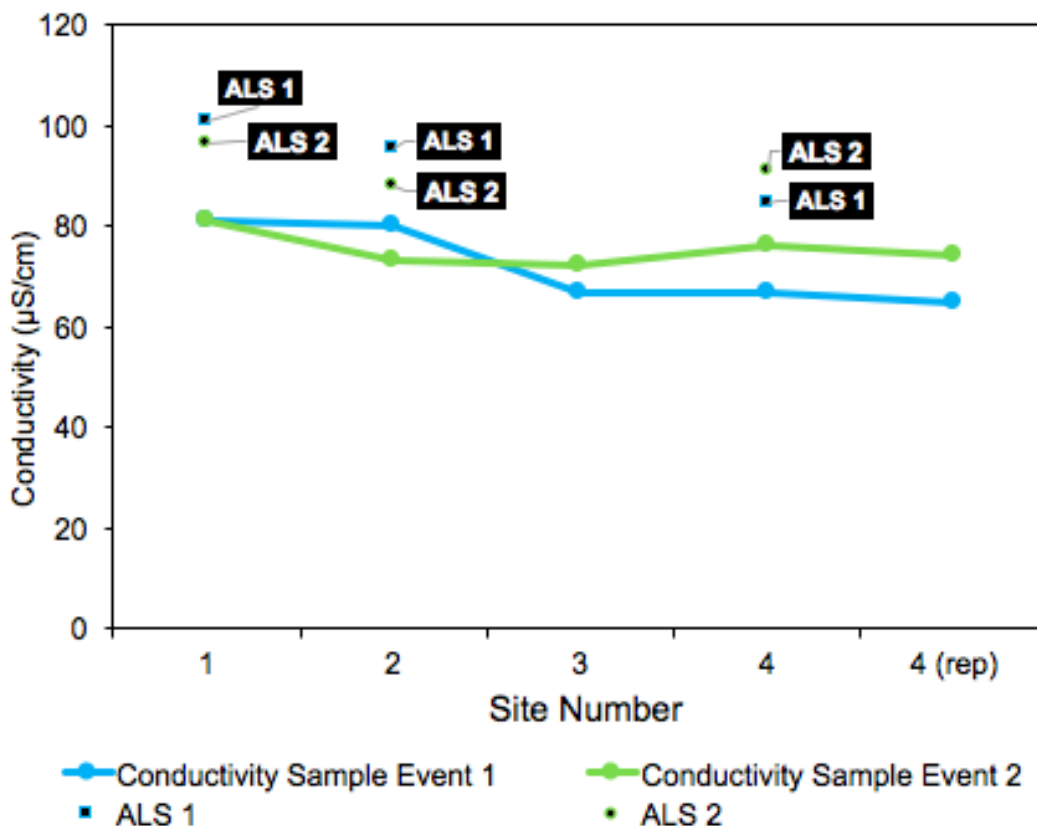
Figure 7: Change in conductivity moving downstream of Cottle Creek from site 1 to site 4. The blue line indicates conductivity obtained from sample event 1 (November 2nd, 2016), and the green line indicates conductivity obtained from sample event 2 (November 23rd, 2016). Site 4 (rep) indicates the results obtained from a replicate sample of site 4 for quality control. Black boxes indicate the conductivity results obtained from ALS.

Conductivity is a measure of the amount of electricity that can be conducted within a solution. It is directly correlated with hardness because a higher concentration of dissolved ions causes an increased ability for water to conduct electricity (Shaw et al., 2004). There is no specific BC water quality guideline for conductivity as it can vary greatly depending on the ions present in the water (Ministry of Environment et al., 1998). However, it is also very valuable for identifying potential pollution sources from any industrial or residential effluents. From our VIU analysis for sample event 1, site 1 had a conductivity value of 81 $\mu\text{S}/\text{cm}$ and site 4 had an average value of 66 $\mu\text{S}/\text{cm}$ (average of site 4 and site 4 (rep) results). For sample event 2, site 1 had a conductivity value of 81 $\mu\text{S}/\text{cm}$ and site 4 had an average conductivity of 75 $\mu\text{S}/\text{cm}$ (figure 7). Since conductivity, hardness, and alkalinity are all theoretically correlated, the same decreasing trend downstream was also observed for conductivity. Again, the higher values at site 1 during both sampling events may have been caused by the increased surface runoff seen at the site. The VIU lab analysis results somewhat deviated from the ALS conductivity results, which may indicate reduced accuracy during our in lab measurements. Reduced accuracy of our conductivity measurements may possibly be caused by sampling errors in the lab (i.e. contamination with deionized water, or other group's samples), a weak conductivity probe, or different sample locations when bottles were filled in the field. Overall, the conductivity results remain as expected for typical coastal BC streams ($<150 \mu\text{S}/\text{cm}$). Therefore, effluent pollution in Cottle Creek is not a concern.

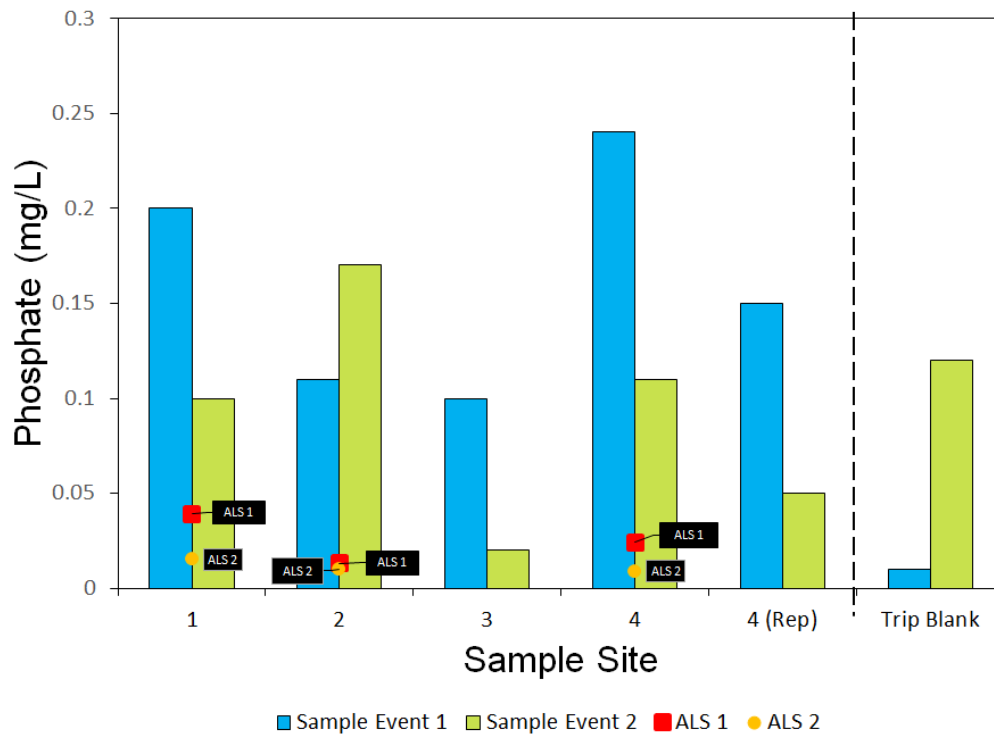
Figure 8: Comparison of phosphate levels from VIU and ALS laboratories for Sample Event 1 (November 2, 2016) and Sample Event 2 (November 23, 2016) for Cottle Creek, located in Nanaimo, B.C.

Although it is not spring turnover, fall also represents a time when nutrients would be mixing and spread throughout the water column. The results from the VIU lab analysis shows levels way higher than the guidelines, and in the case of ALS, they are either too high or right on the cusp. This would indicate a trophic state from mesotrophic – eutrophic (Ministry of Water, Land, and Air Protection, 1998). High results of phosphate in the water are most likely due to anthropogenic inputs entering the system from the surrounding watershed. Phosphates are found in fertilizers and sewage runoff. The Cottle Creek sites run through urban neighborhoods and are impacted from agricultural and industrial inputs.

The results from the ALS lab were lower than those from VIU. The reason may be due to the high volume of students using the equipment at VIU, leaving room for possible vial contamination. This is evident in the trip blank in sampling event 2, as levels of phosphate were detected in a blank sample of distilled water. ALS is a private, analytical lab that most likely has stricter adherence to sanitization between sample analysis.

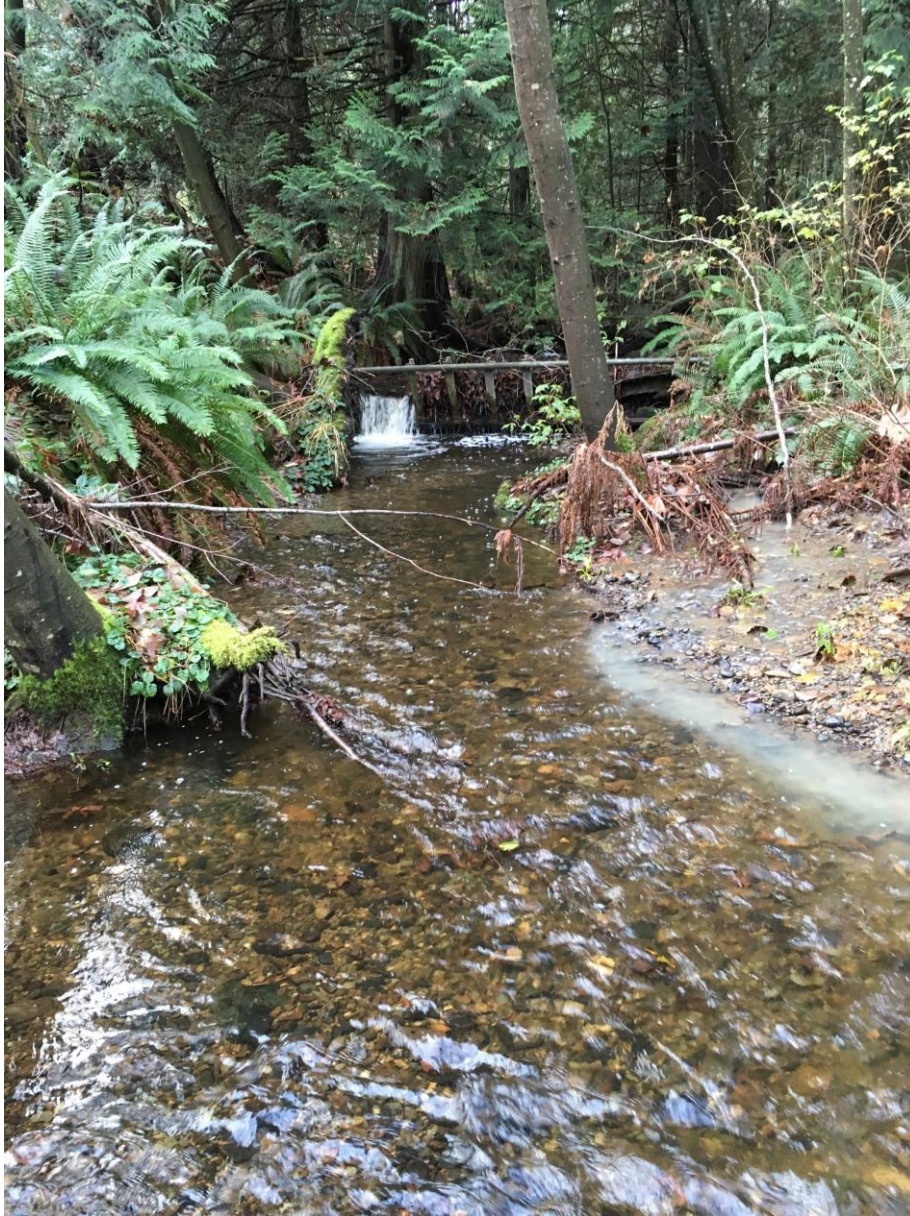
Figure A-1: Photo taken November 23rd, 2016 at Site 1 (Landalt Rd.) looking upstream.

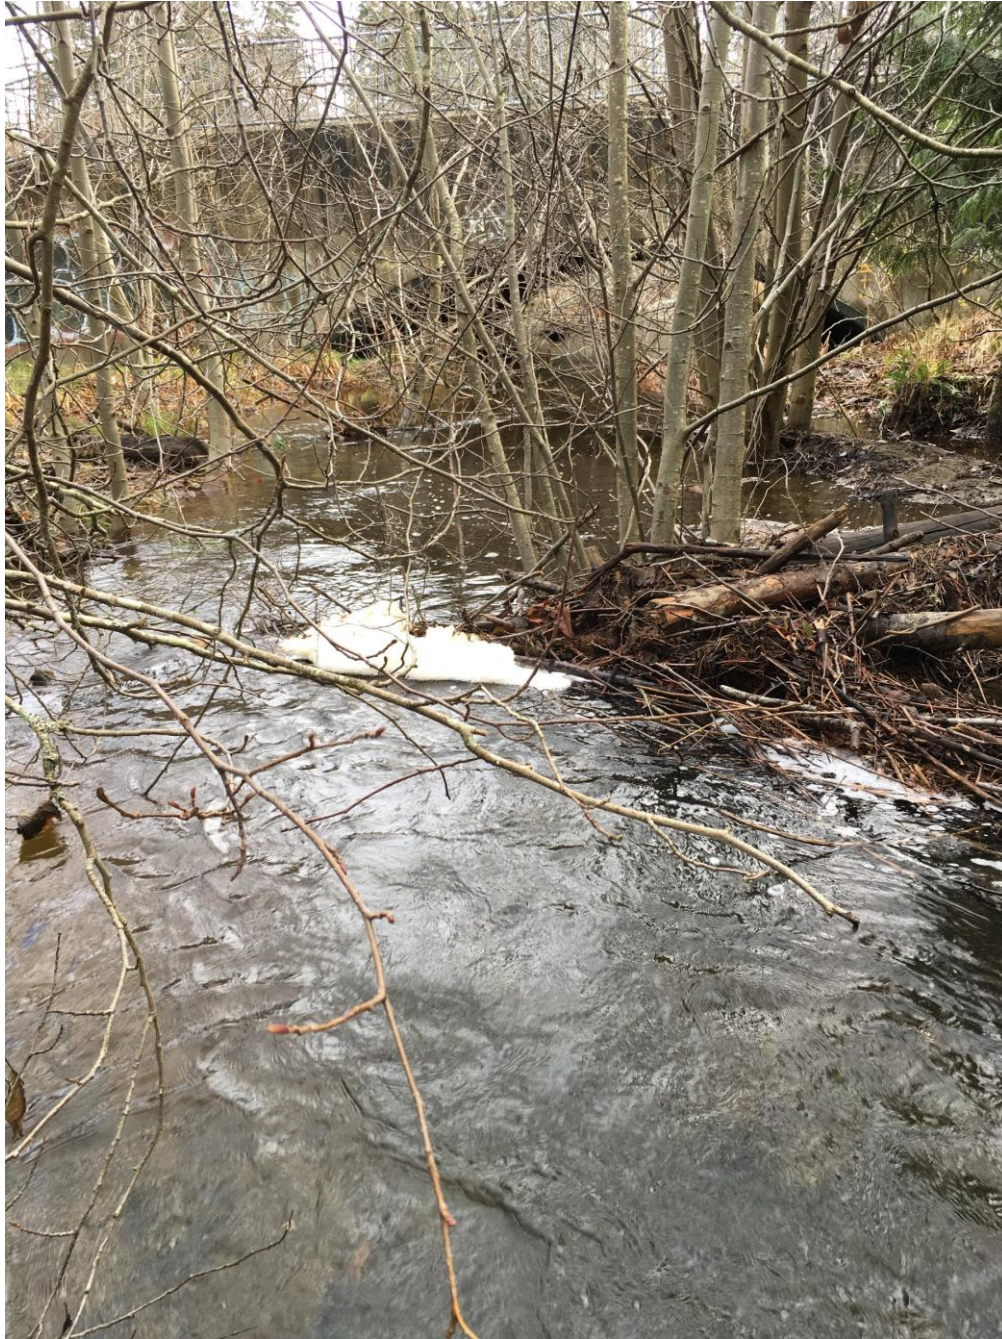
Figure A-3: Photo taken November 23rd, 2016 at Site 3 (Nottingham Dr.) looking downstream.

and the location that sampling happened at was right after a foot bridge along the hiking trail. The banks were relatively flat but sloped on one side and populated by Douglas fir, red cedar, sword ferns, salal and salmonberry bushes. The stream bed was composed of large and small rocks with a bit of gravel in some places. This site provided information on the conditions of the discharge area from the lake. Site 3 is located at Nottingham Drive where Cottle Creek flows under a small bridge. A lot of rapid residential development has occurred in this area recently, including the construction of a playground directly beside the creek. The banks were flat, populated by grasses, blackberries and some large alder and maple trees. The ground was very saturated and muddy at this site compared to the other three, as was the stream bed, which was very deep mud with some gravel areas. Sampling here provided data on new potential environmental risks present from recent construction.

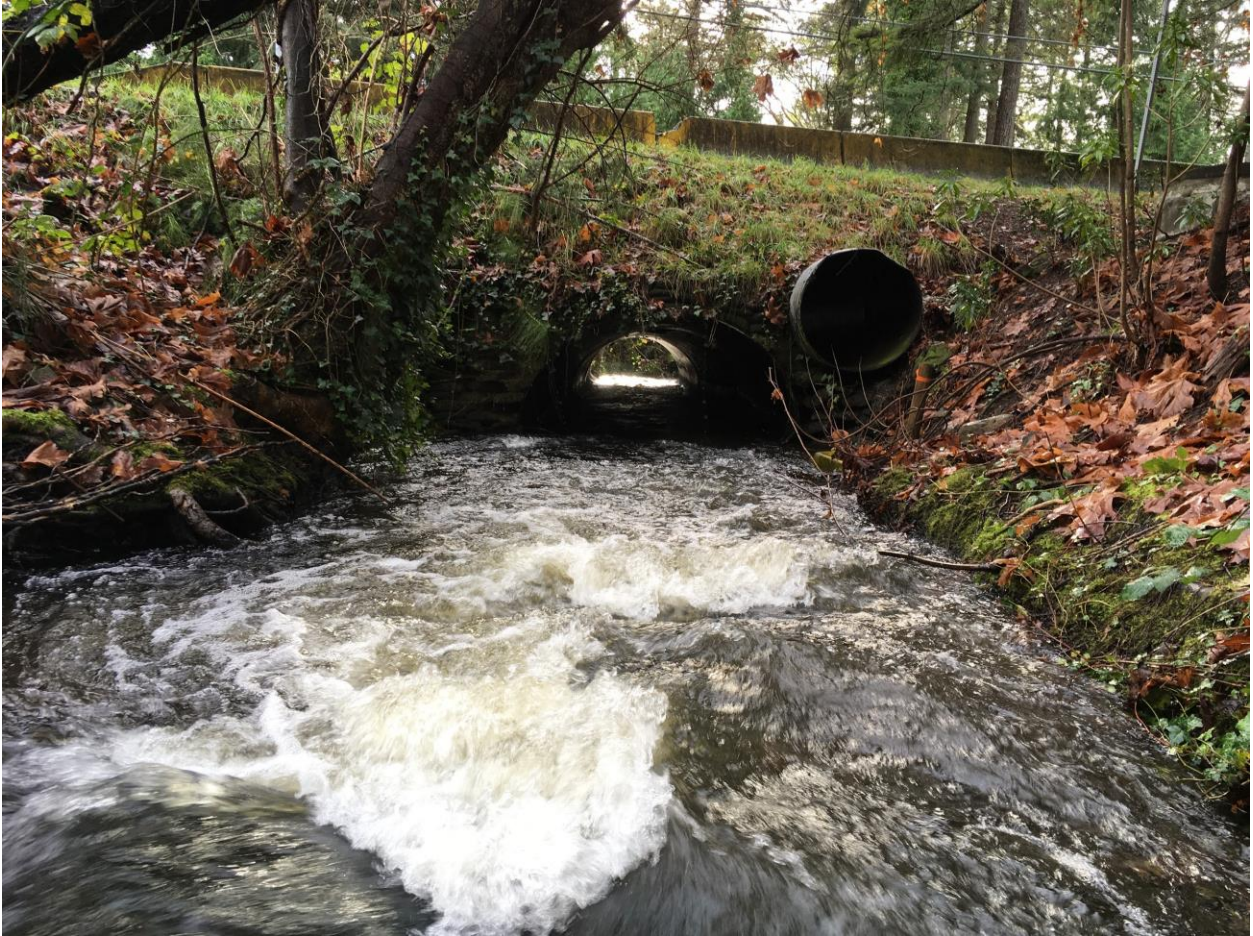
Figure A-4: Photo taken November 23rd, 2016 at Site 4 (Stephenson Point Rd.) looking downstream.

Site 4 was the furthest downstream sampling station, located where Cottle Creek flows beneath Stephenson Point Road. This site had medium sloped banks populated by Douglas fir, red cedar, sword ferns and salal. The stream bed was mostly slippery large rocks with some smaller rocks. This site provided important information on the environmental conditions of Cottle Creek as it flowed into the coastal marine ecosystem of Departure Bay.
