# Water Quality and Stream Invertebrate Assessment of the C. W. Young Channel, Englishman River, B.C. (Fall 2016)

**Report prepared by:** Undergraduate Students of Environmental Monitoring (RMOT 306)  
Vancouver Island University  
900 Fifth Street, Nanaimo, B.C. Canada V9R 5S5

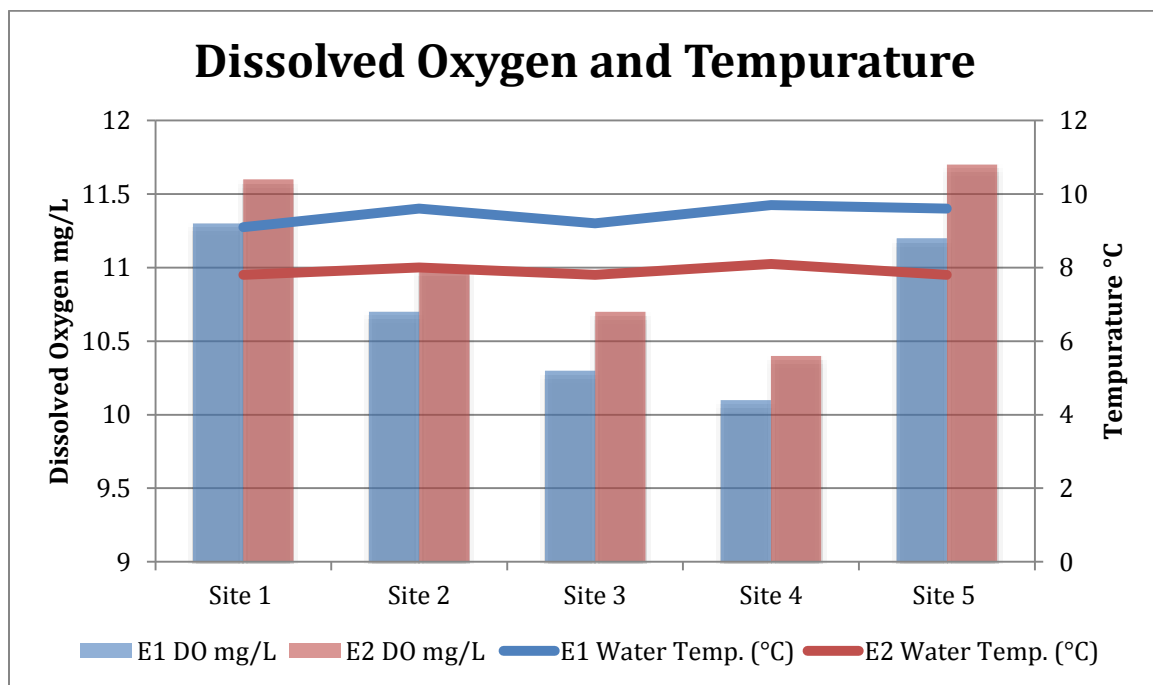
Figure 4. Dissolved oxygen and water temperature during sampling event 1 October 31, 2016 (blue) and sampling event 2 November 21, 2016 (red).

For both sampling events, the dissolved oxygen was highest at site 1, near the beginning of the C.W. Young Channel and site 5 at the output of the C.W. Young Channel into the Englishman River (figure 4). The increase concentration in dissolved oxygen at these sites is not only due to the associated lower water temperatures but also likely attributed to the oxygenating effects of flow and riffles at these sites. There is an

observable 1.5 °C temperature difference between the two events and is suspected due to the lower ambient air temperature at the time of the second event. The middle reaches of the channel, between sites 2 and 3, were observed to have an average 0.2 °C increase in water temperature. There is an average decreased 0.92 mg/L of dissolved oxygen in the middle reaches of the channel. The increase in water temperature at these locations is likely due to the shallower depth of the waters in the mid-reaches and the decreased dissolved oxygen also observed would be expected with this.

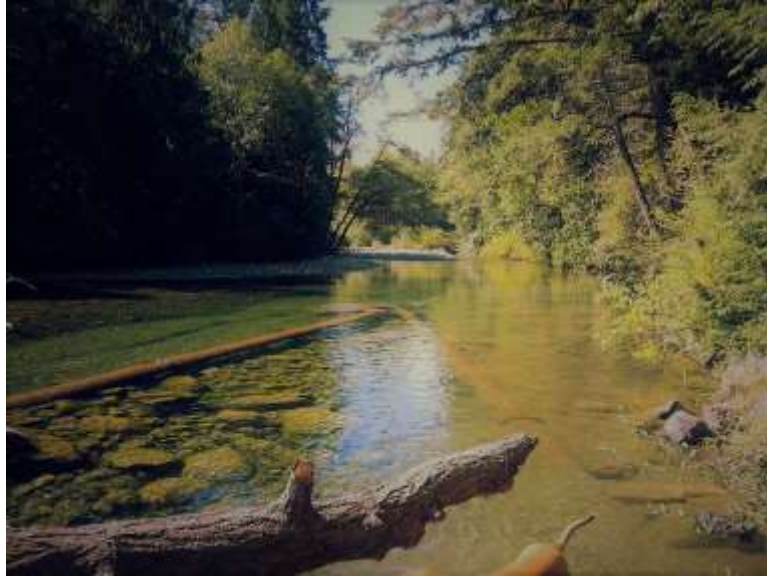
**Photograph 1.1.** Englishman River main stem and the water intake pipes for the C.W. Young Channel, approximately 300 m upstream from Site 1. Photograph by Tamara Stauffert, August 2016.

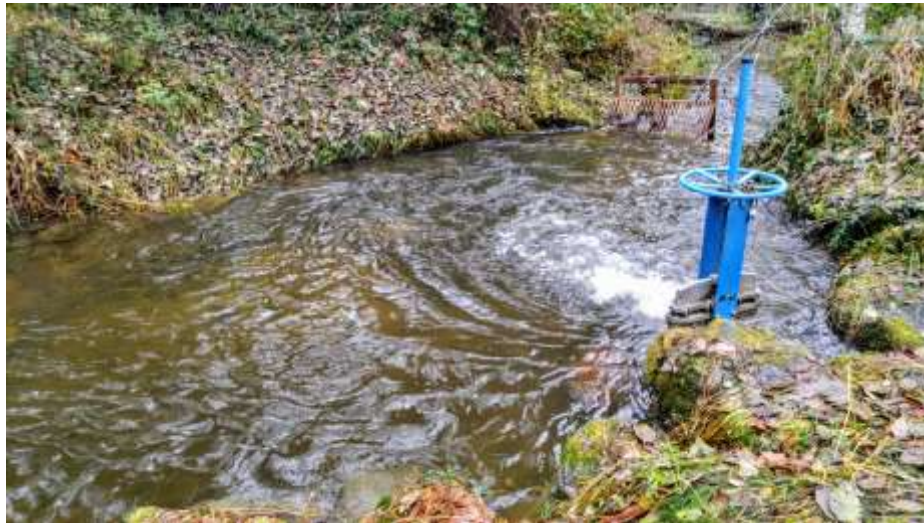
**Photograph 1.2.** Site 1 looking downstream on the C.W. Young Channel and at one of two blue manual water flow control valves located here and a debris screen placed mid-channel. From the water flow control valve in the photo, the second valve is located upstream approximately 15 m. *Oncorhynchus* Keta *O. kisutch* were observed swimming here. Photo by Tamara Stauffert, 31 October 2016.

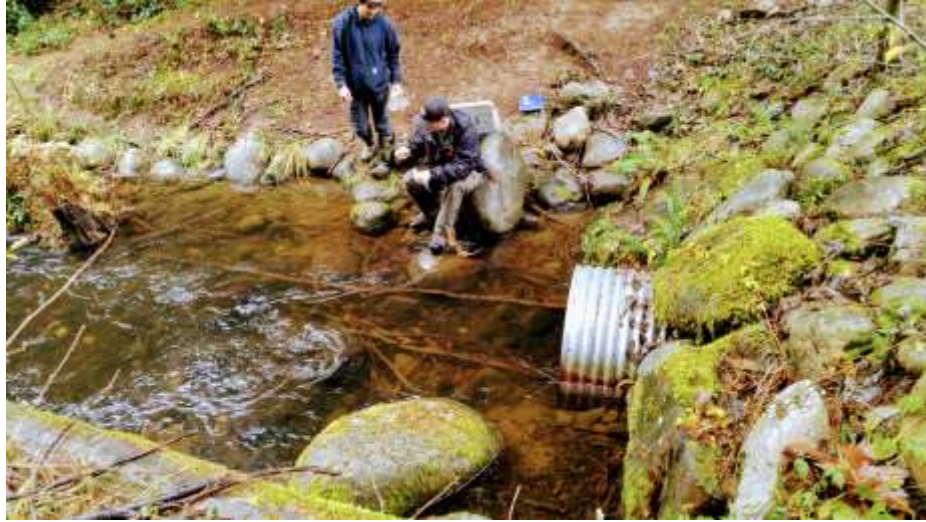
**Photograph 1.3.** Site 2 and looking northeast across the C.W. Young Channel which is flowing from the culvert and meanders into a wetland area. Mark Walkosky obtaining water samples for analyses. An unknown species of salmon was observed swimming in the culvert. Photo by Tamara Stauffert, 31 October 2016.

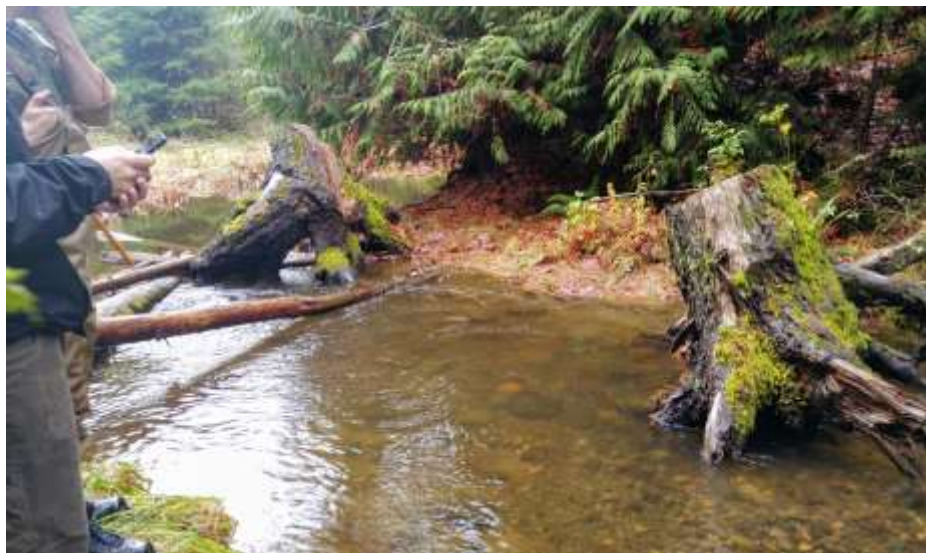
**Photograph 1.4.** Site 3 looking northwest across the C.W. Young Channel, fairly low/moderate water flow and a high percentage of silty substrate with mixed cobble midstream. Photo by Tamara Stauffert, 31 October 2016.

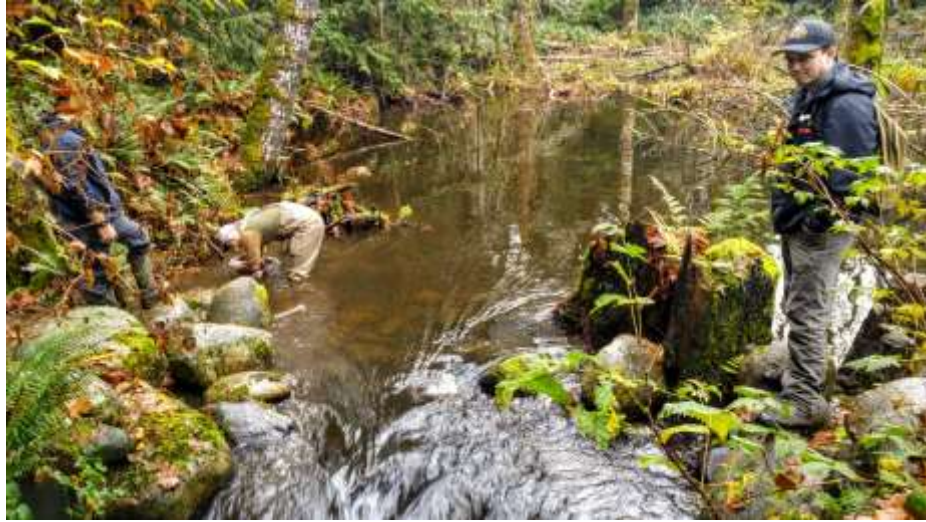
**Photograph 1.5.** Site 4 looking upstream into a pond on the C.W. Young Channel. Dylan MacGregor is sampling stream invertebrates following water sampling and hydrology measurements by Tristan Montjoy, Tamara Stauffert, and Mark Walkosky. Photo by Tamara Stauffert, 31 October 2016.

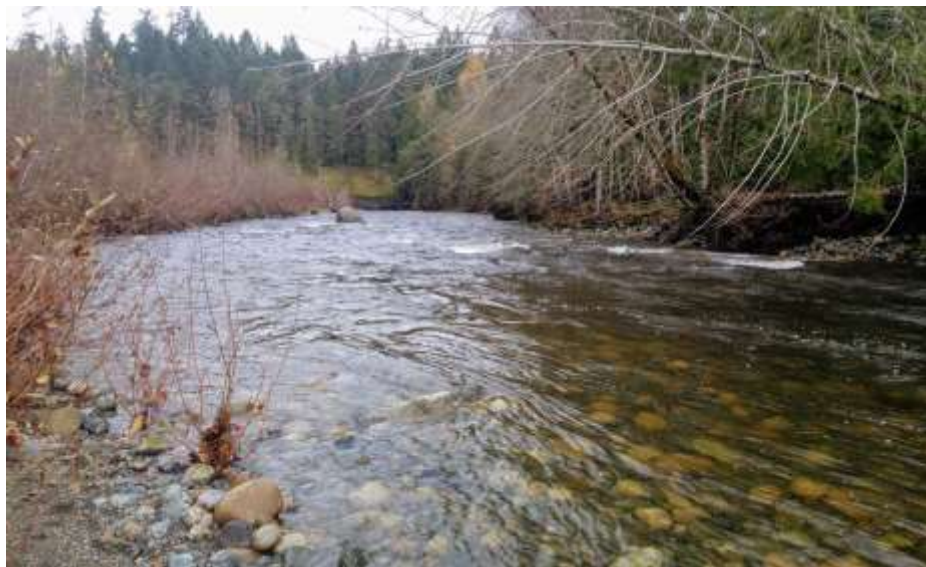
**Photograph 1.6.** Site 5 looking downstream from the input of the C.W. Young Channel into the Englishman River. Several decaying salmon carcasses were observed on the stream banks. Photo by Tamara Stauffert, 31 October 2016.

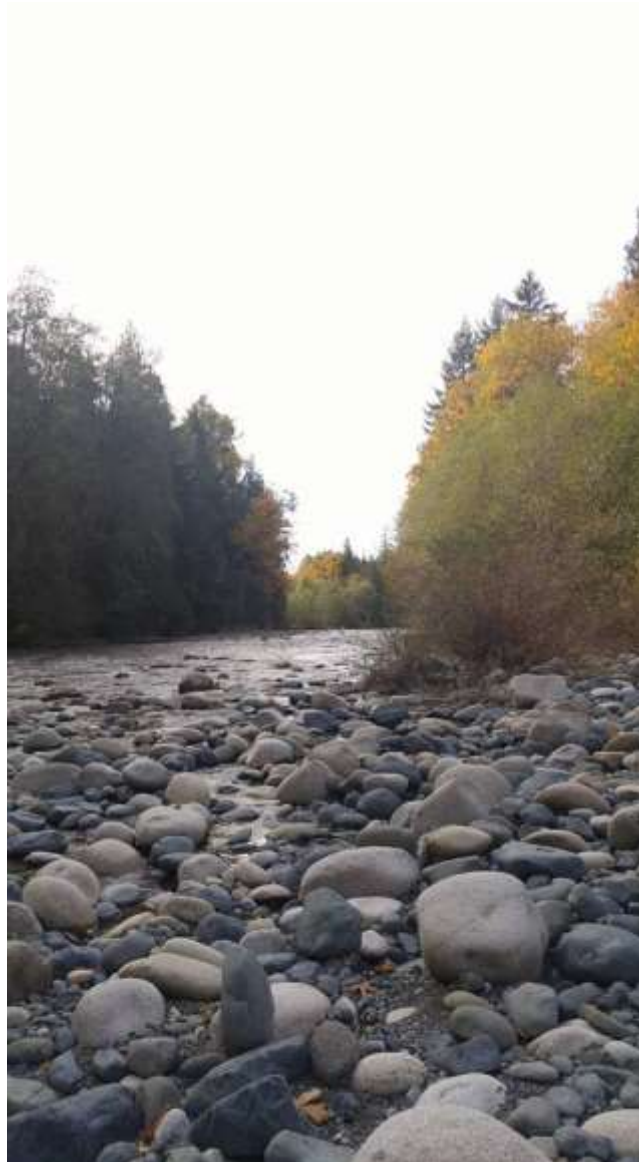
**Photograph 1.12.** Looking upstream along the northbank of the Englishman River, approximately 800 m from the service road entrance. Note the large cobble and boulders

indicative of high flow events. Photo By Tamara Stauffert, 31 Oct, 2016.

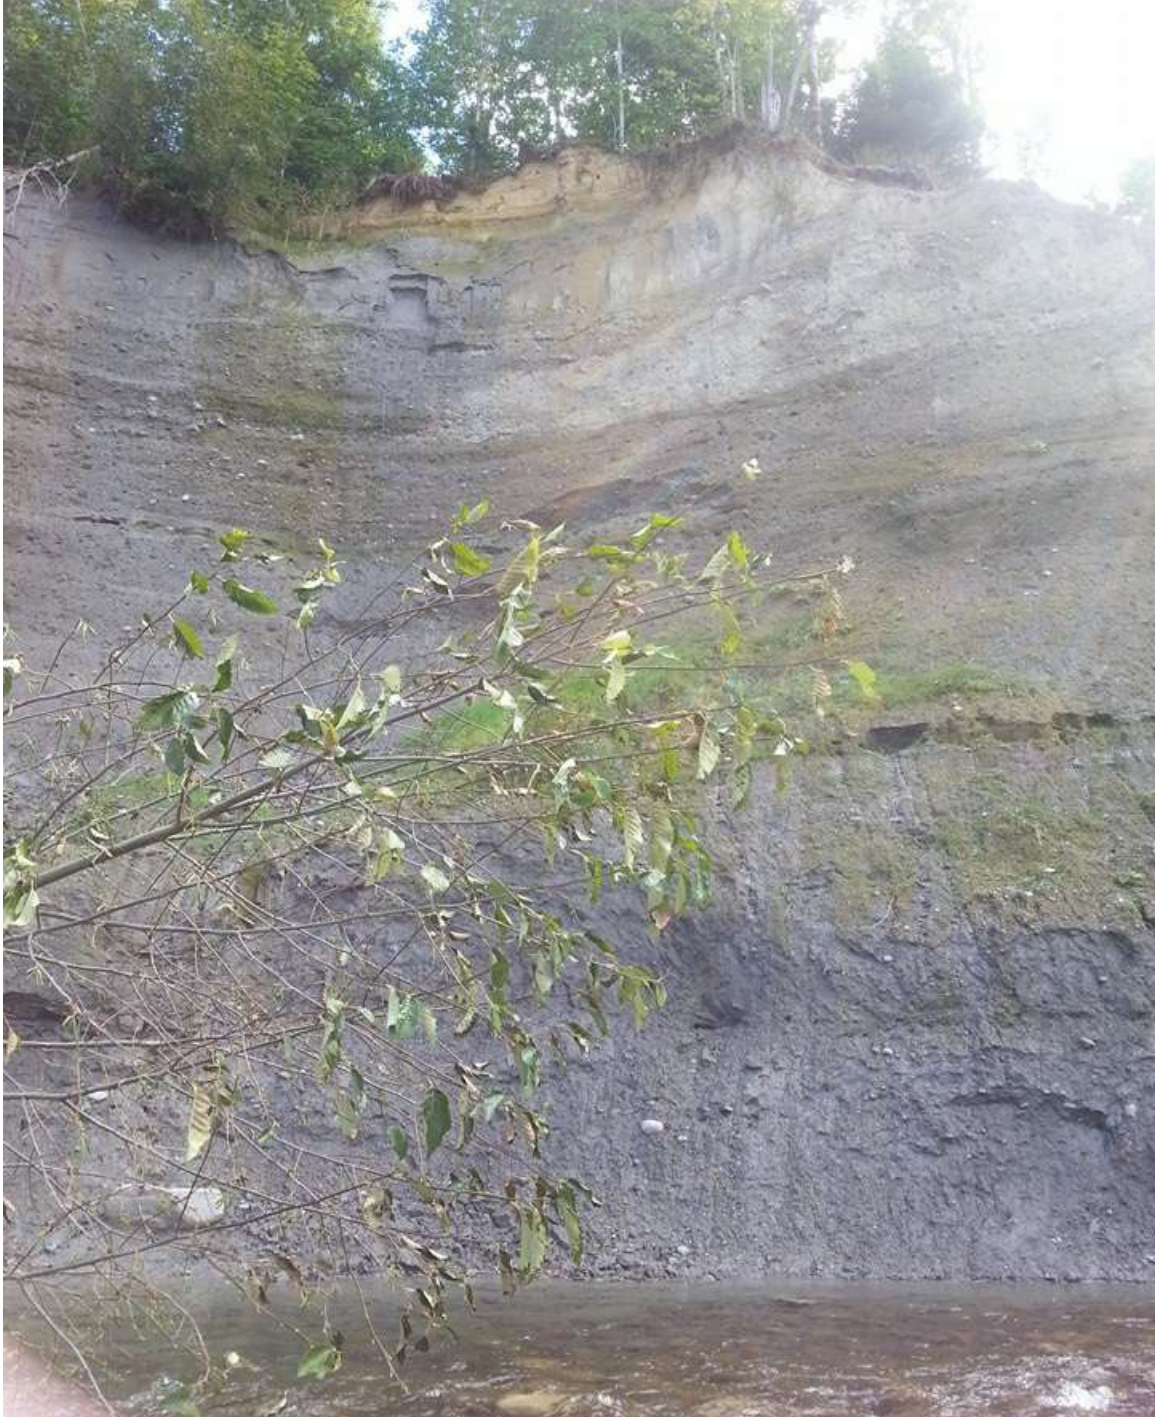
**Photograph 1.14.** The Clay Banks located on the southbank of the Englishman River approximately 1.5 km upstream from the outlet of the C.W. Young Channel into the Englishman River. This is a concern for erosion and silt deposition into the Englishman River. Photo by Tamara Stauffert, 31, Oct 2016.
