**Water Quality and Stream Invertebrate Assessment for Beck Creek, Nanaimo, BC**

**(Fall, 2017)**

Submitted by: Students of Vancouver Island University

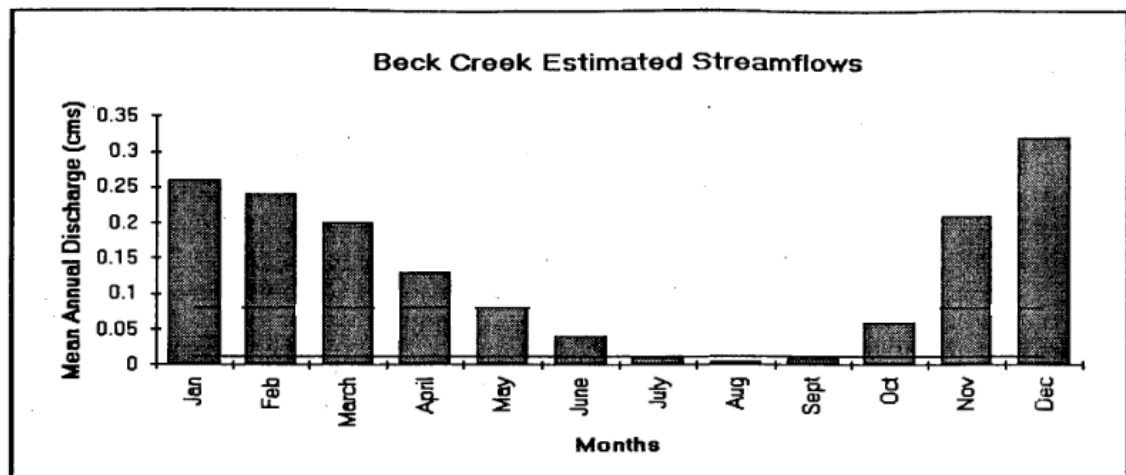
**Figure 3:** Mean Annual Discharge for Beck Creek (Cook & Baldwin 1994)

Beck Creek's estimated streamflow in the summer months has been reported to be minimal (Figure 4). Due to a lack of streamflow and relative distance to residential and agricultural development, eutrophication of the creek is a concern. Another factor in eutrophication is nutrient enrichment from adjacent agricultural lands surrounding Beck Lake, which supply the main flow to Beck Creek. The creek flows through urban and semi-urban areas
