Cottle Creek Environmental Assessment Final Report

2017

**Submitted to:
Eric Demers
RMOT 306
December 15, 2017**

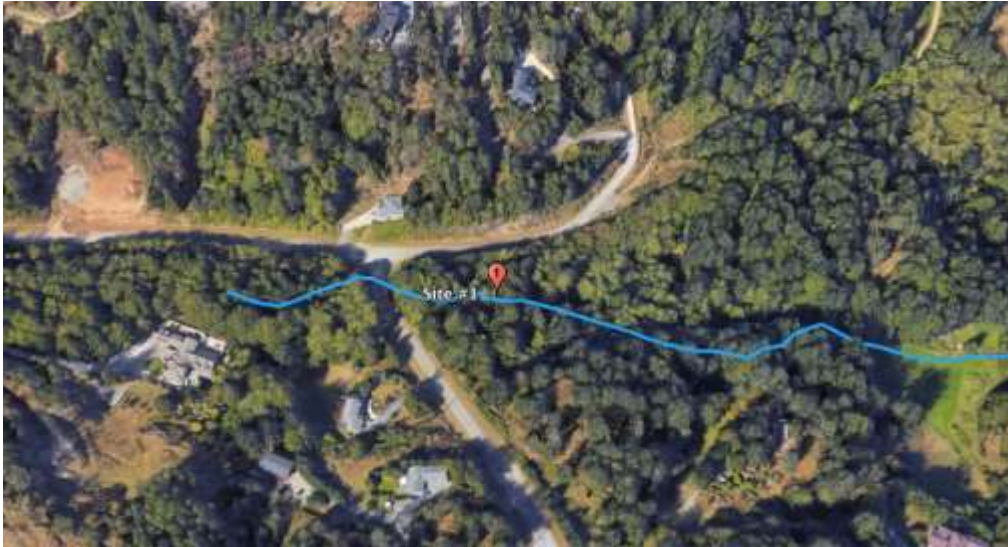
Figure 3: Site #1 (Google Earth 2017)

Site #1 (UTM 10 U 0428025 m E; 5452201 m N) (Figure 3) is located downstream of Landalt Rd and runs parallel with Arrowsmith Rd. This site is located upstream of Cottle Lake and displays a variety of different flow characteristics which are representative of the rest of the creek. Additionally, the area around the site is relatively flat and easy to walk around which proved beneficial while sampling. However, to access this site, it is required to walk down a steep gully from Arrowsmith Rd followed by climbing over 2 m high wire fence and requires caution to avoid any risk of injury. Vegetation in this site primarily consists of young Western Red Cedar, Sword Fern and some Deer Fern. Substrate composition consists of roughly 60% gravel and 40% cobble.

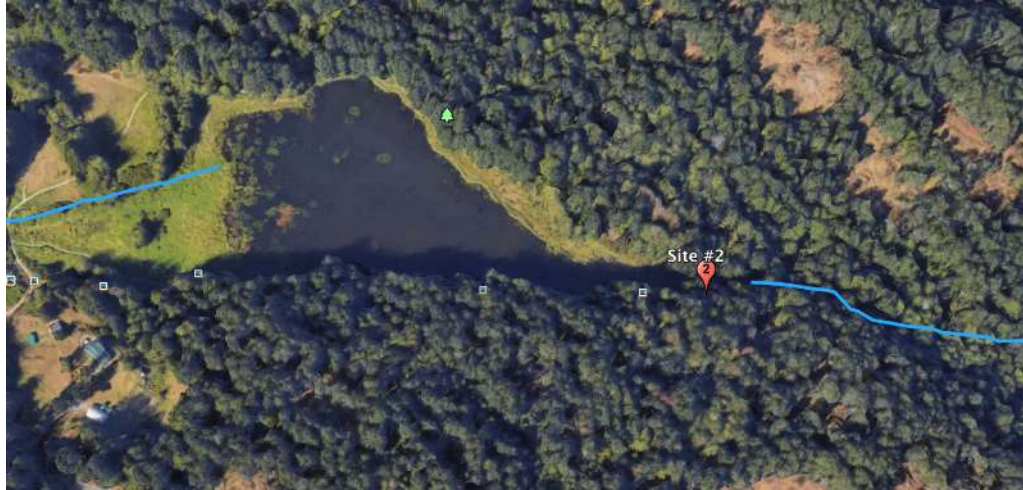
Figure 4: Site #2 (Google Earth 2017).

Site #2 (UTM 10 U 0428587 m E; 545262 m N) (Figure 4) is located at the east end of Cottle Lake where the lake drains downstream towards Departure Bay. The site is located approximately 10 m from the main trail bridge and was selected as it has characteristics which are representative of the other three sites. Furthermore, this site is easy to access from the main lake trail, although a 10-minute walk is required from the main parking lot. Site 2 consists of approximately 40% cobble, 60% gravel. Vegetation consists of sword fern, deer fern, bracken fern, Pacific willow (*Salix lucida*), cedar, skunk cabbage (*Symplocarpus foetidus*), and red huckleberry.

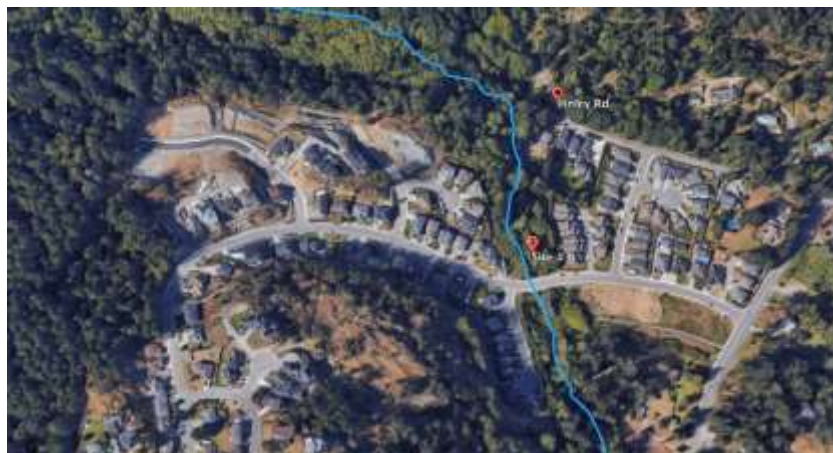
Figure 5: Site #3 (Google Earth 2017).

Site #3 (UTM 10 U 0430184 m E; 5452037 m N) (Figure 5) is located approximately 20 m north of the upstream side of Nottingham Dr. This site is easily accessible and has little to no risks associated with it. There is a variety of different flow characteristics within this area of the creek. Substrate composition consists of 80% fine silt and 20% cobble. Vegetation within the site includes Red Alder, Skunk Cabbage and a variety of grasses.

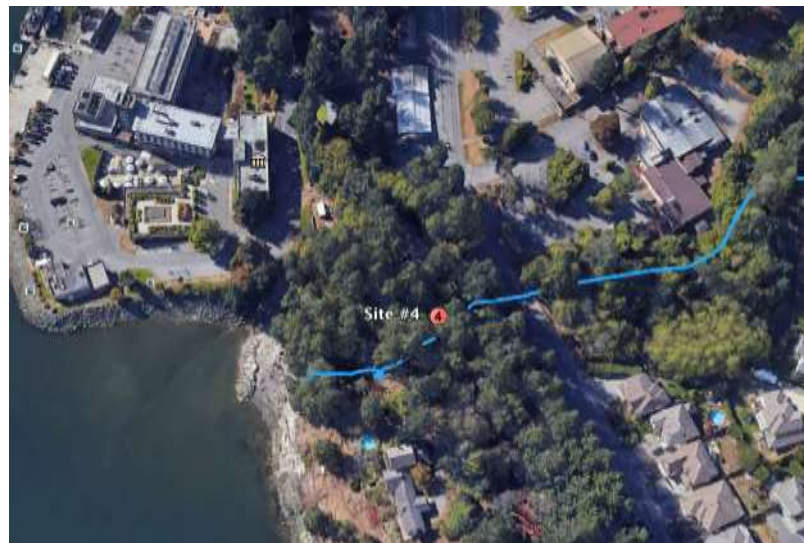
Figure 6: Site #4 (Google Earth 2017).

Site #4 (UTM 10 U 0430573 m E; 5451345 m N) (Figure 6) is Located approximately 20 m south off Stephenson Point Rd on the downstream side of where the road intersects the creek. This site is the furthest downstream site to be assessed and is located very close to where the system discharges into Departure Bay. This site displays a variety of stream characteristics such as pools, riffles, and small waterfalls. Substrate composition consists of 80% boulder, 20% cobble and contained some large chunks of concrete left behind by past construction. Site vegetation comprised of a variety of ferns, Oregon Grape (*Mahonia aquifolium*), Red Huckleberry, Red Cedar and Arbutus.
