# **DATA REPORT**

## **Water Quality and Stream Invertebrate Assessment for the C.W. Young Channel, Englishman River, BC (Fall 2017)**

Students of Vancouver Island University

15 December 2017

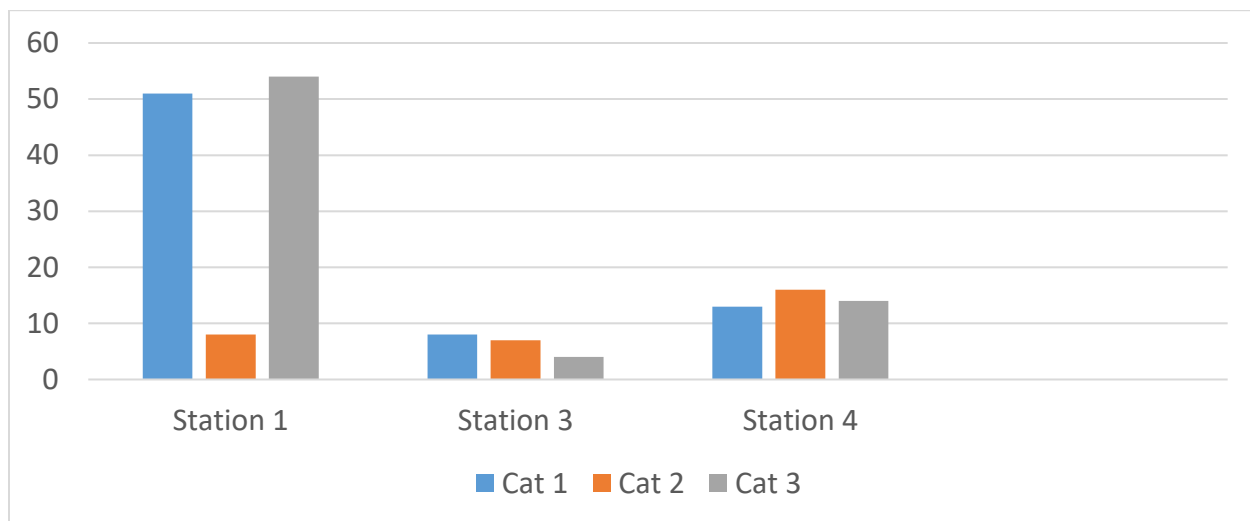
The average site rating for sites 1, 3, and 4 was calculated at 3.08, which is stated as acceptable to good on the assessment rating rubric. The Shannon-Wiener Index was averaged at 0.848 from the sites sampled, showing a positive diversity index. The overall sampling of benthic macroinvertebrates showed an average rating consistent with past years' data. The channel water quality indicated by stream invertebrates is between acceptable and good according to the site assessment rating and Shannon-Weiner Index calculations. All three categories were found at each station showing that pollution intolerant invertebrates can and are living within the C. W. channel that is connected to the Englishman River. Below I have included a graph showing the presence and abundance of invertebrates in category 1,2, & 3 at each site.

**Figure 12.** Shannon-Weiner Diversity Index 2017C.W. Channel Englishman River  
Table 1, 2, & 3 is presenting the results of our findings per station. The calculations per station are also included in the appendix for reference.

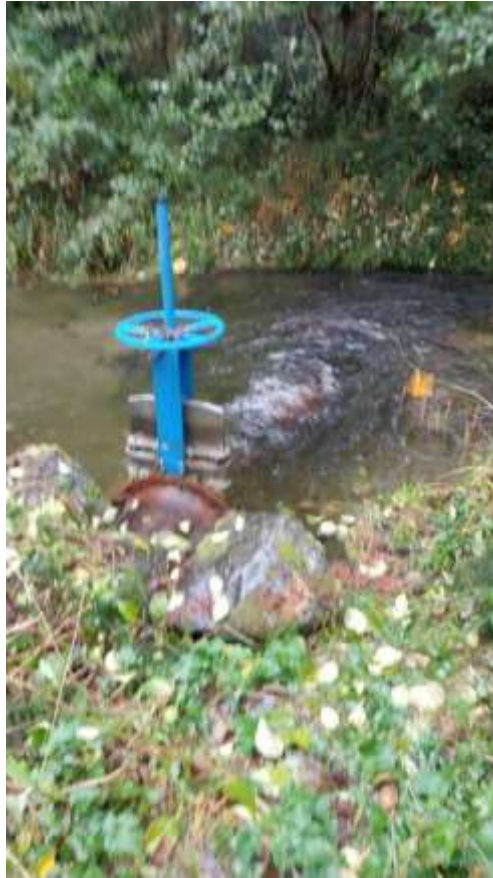
Site #1 is a pool habitat which receives outflow from the Englishman River through a metal effluent release pipe connected to a blue, metal valve. Beneath about 2 m of water, the substrate is estimated to be 60% large boulders on top on 40% fines like silt and sand. Nestled within a moist mixed forest habitat, site #1 has a 25% canopy cover composed of Bigleaf Maple (*Acer macrophyllum*) and Red Alder (*Alnus rubra*) (Hawkes et al., 2008). Surrounding site #1 in the riparian areas on both sides of the channel are Salmonberry (*Rubus spectabilis*) and Himalayan Blackberry (*Rubus discolor*) bushes, as well as Reed Canarygrass (*Phalaris arundinacea*) and Common Horsetail (*Equisetum arvense*) in the understory. The steep trail down to the site was muddy and slippery during all three visits.

**Figure A1.** Site #1, located in the C.W. Young Channel. Facing mid-stream.  
Note the outflow pipe and valve.

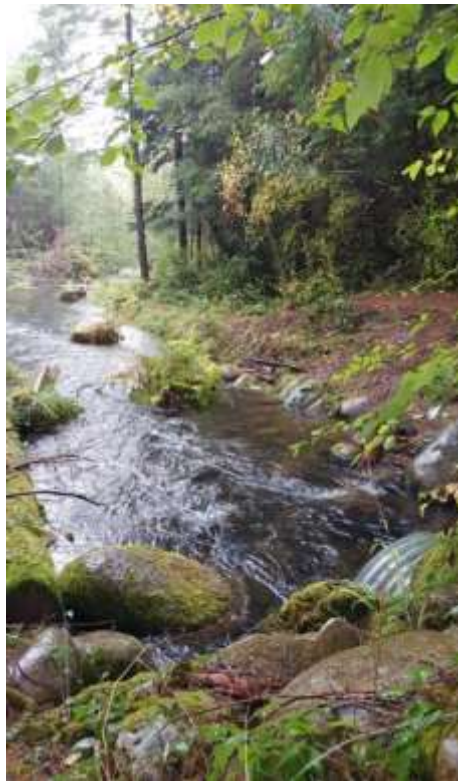
At the cross section of a moist mixed forest and a “mesic second growth coniferous forest,” site #2 is a glide habitat where water enters from a culvert (Hawkes et al., 2008). The majority (60%) of the substrate consists of cobble, while the rest (40%) is evenly distributed between boulders, gravel, and fines. This site has a 20% canopy cover split equally between Douglas-fir (*Pseudotsuga menziesii*) and Bigleaf Maple trees. The diverse riparian area contains Sword Ferns (*Polystichum munitum*), Oceanspray (*Holodiscus discolor*), Salal (*Gaultheria shallon*), Trailing Blackberry (*Rubus ursinus*), and various species of grass.

**Figure A2.** Site #2, located along the C.W. Young Channel.  
Facing downstream and showing the culvert

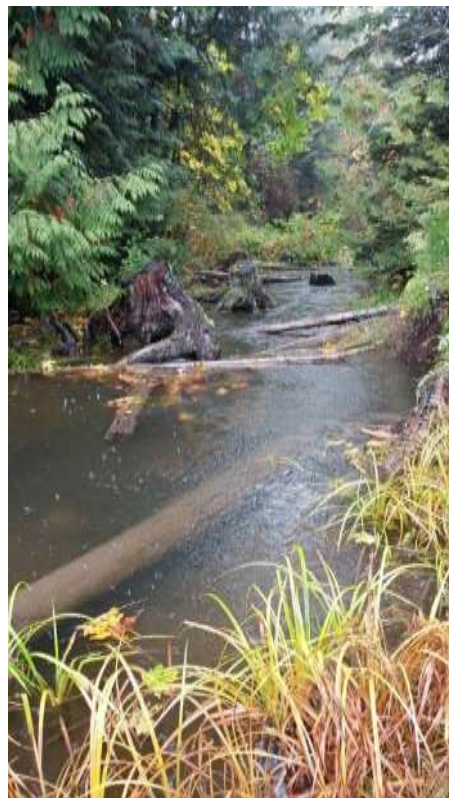
Various large woody debris including four stumps and several fallen trees are scattered in this habitat. A scarce 15% canopy is covered by Douglas-fir, Western Red Cedar (*Thuja plicata*), Red Alder, and Bigleaf Maple trees (Hawkes et al., 2008). Bordering this rich habitat is a large patch of Nootka Rose (*Rosa nutkana*), and Canada Thistle (*Cirsium arvense*), as well as Salmonberry and Common Snowberry (*Symphoricarpos albus*) bushes, and Bracken Ferns (*Pteridium aquilinum*). Also spotted at this site was a Great Blue Heron (*Ardea herodias fannini*), a blue-listed species and a treasured member of the Englishman River Conservation Area (Hawkes et al., 2008).

**Figure A3.** Site #3, located along the C.W. Young Channel.  
Facing downstream and showing the large woody debris.

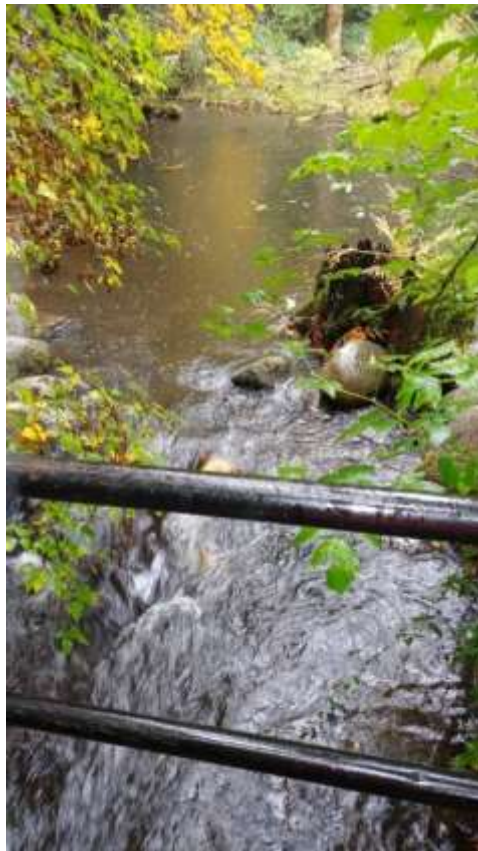
At site #4, a pool habitat drops off into a rapid riffle due to a moderate gradient. Site #4 is heavily shaded by a 50% canopy cover of large Red Alder, Bigleaf Maple, and Douglas-fir trees. Beneath the water is a perimeter of 40% boulders, filled in with 50% cobble substrate on top of 10% fines. Three stumps also dot this habitat and collect leaves from the shedding autumn canopy. Neighbouring this site, and the trail, are many tall Salmonberry shrubs, a few Thimbleberry (*Rubus parviflorus*) bushes, as well as Sword and Bracken Ferns (Hawkes et al., 2008).

**Figure A4.** Site #4, located along the C.W. Young Channel.  
Facing upstream and showing the bars of the metal walking bridge.

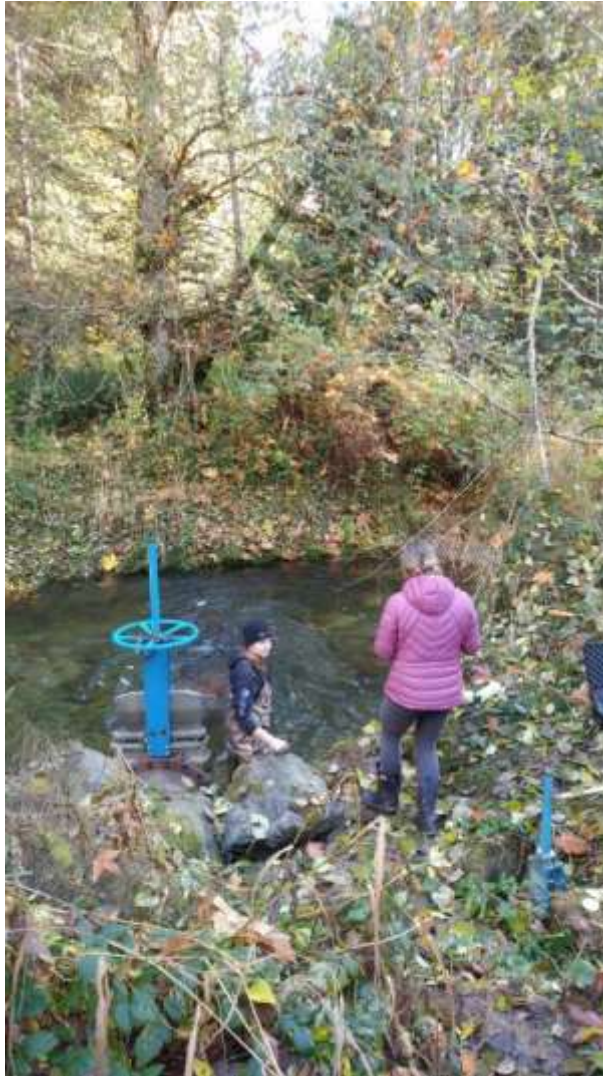
**Figure B1.** Site #1, located at the entrance to the C.W. Young Channel. Facing mid-stream.  
Note the outflow pipe and valve.

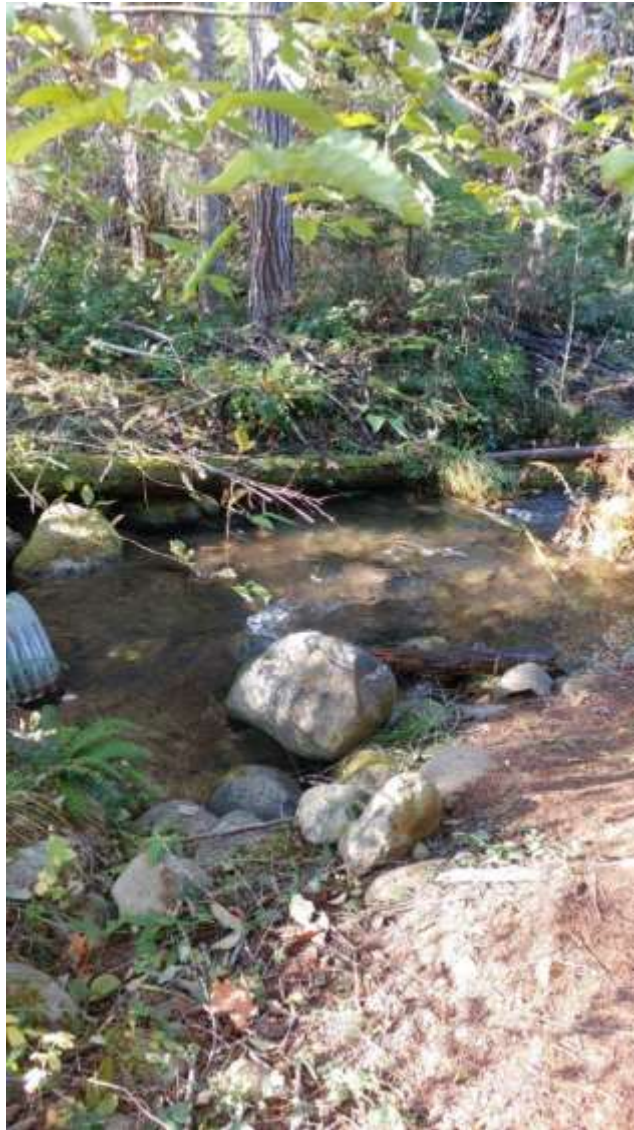
**Figure B2.** Site #2, located along the C.W. Young Channel.  
Facing downstream and showing the culvert.

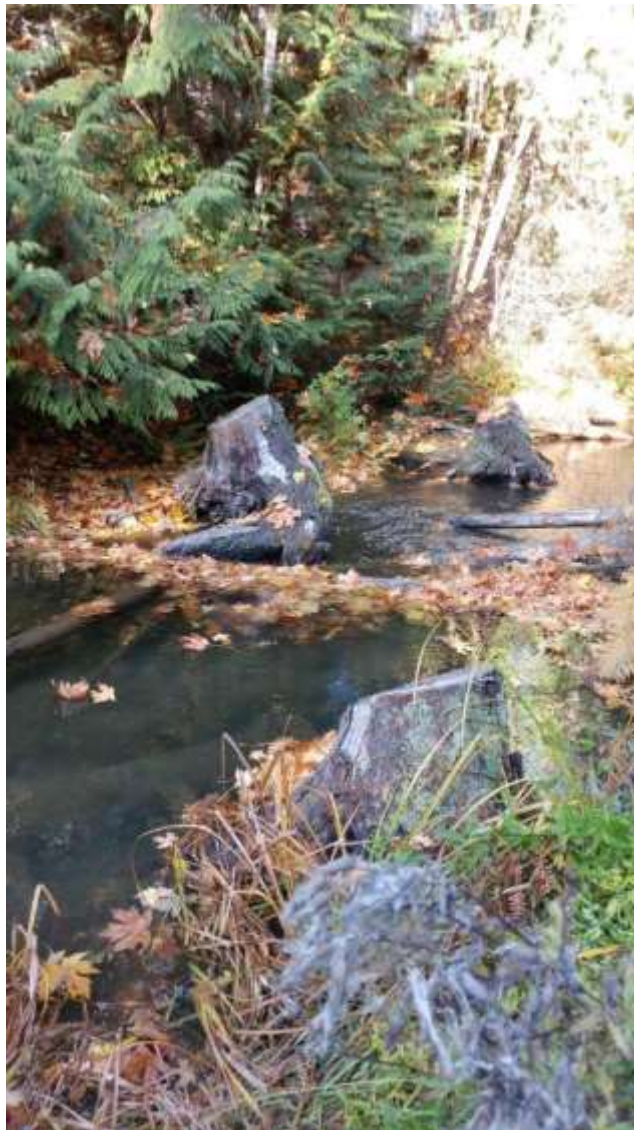
**Figure B3.** Site #3, located along the C.W. Young Channel.  
Facing downstream and showing the large woody debris.

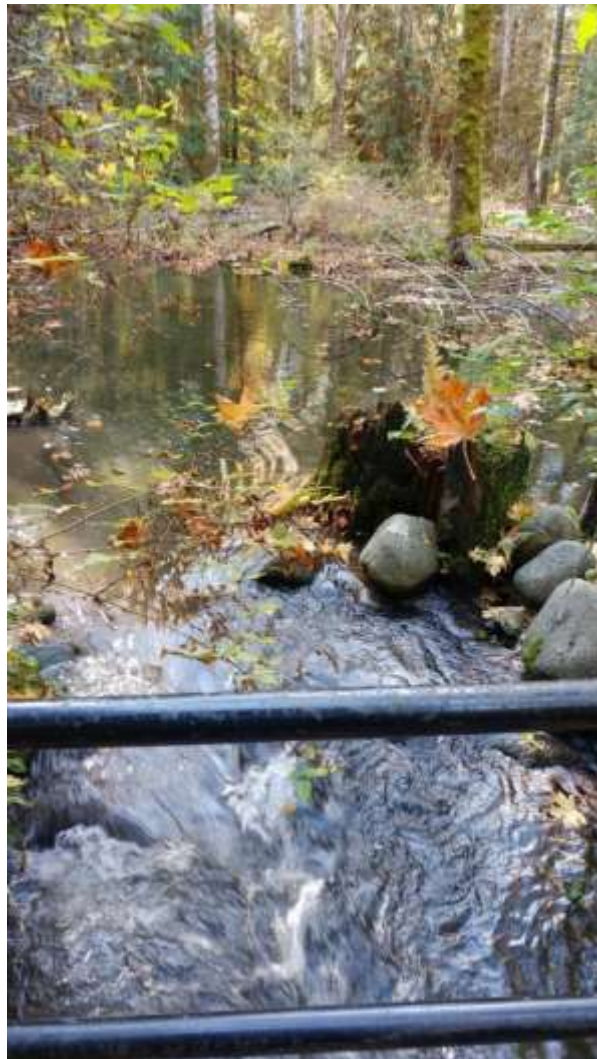
**Figure B4.** Site #4, located along the C.W. Young Channel. Facing upstream and showing the bars of the metal walking bridge.

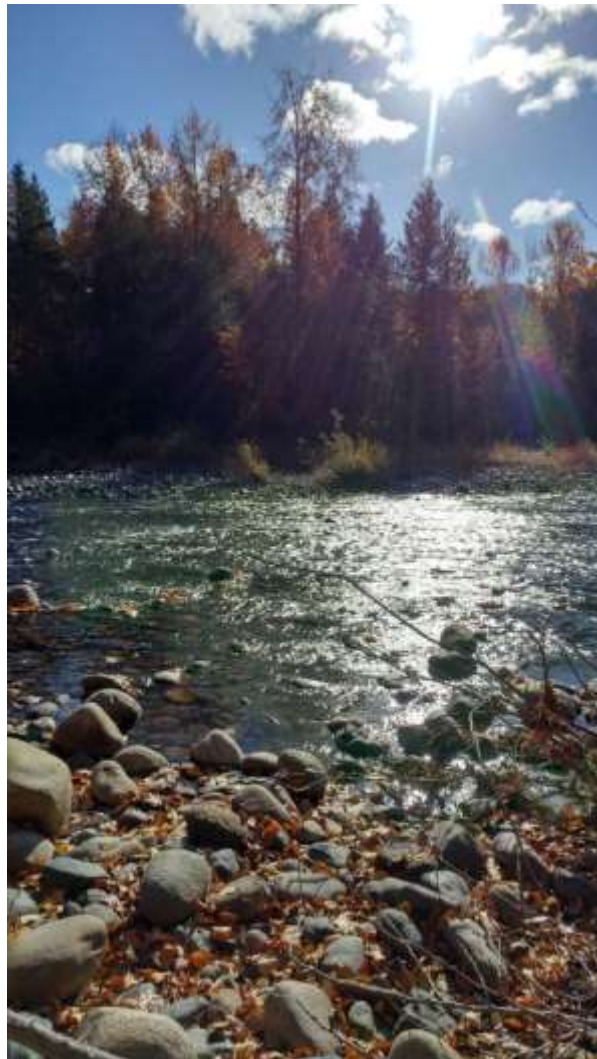
Site #5 differs from the previous sites as it is a riverine flat habitat where the C.W. Young Channel reconnects to the main stem of the Englishman River (Hawkes et al., 2008). Visual habitat characteristics of site #5 could not be gathered during the initial site assessment. However, according to a project conducted by VIU Environmental Monitoring Students (2014), site #5 is clear of any canopy coverage; however, Bigleaf Maple, Red Alder, and Sitka Willow (*Salix sitchensis*) trees frame the area. The substrate here is predominantly (75%) cobble, with the rest comprising a mixture of boulders and fines. These features were confirmed to be accurate during sampling session #1.

**Figure B5.** Site #5, located at the downstream union of the C.W. Young Channel and the Englishman River. Facing mid-stream. Note the relatively low water level.

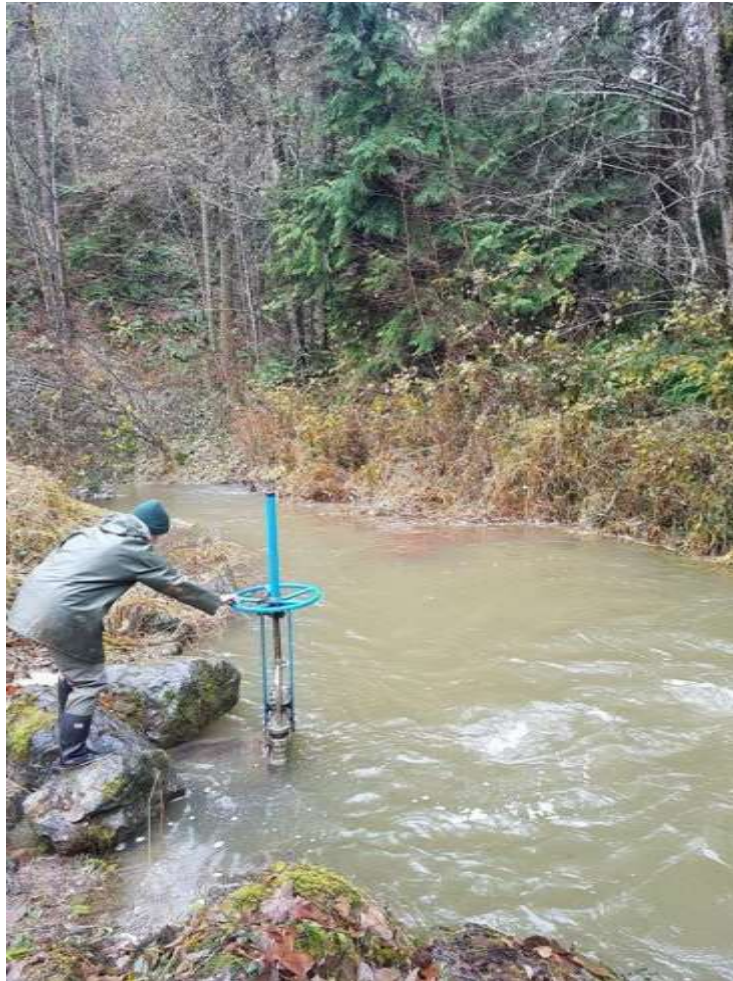
**Figure C1.** Site #1, located at the entrance to the C.W. Young Channel. Facing upstream. Note the outflow pipe and valve and increased water level.

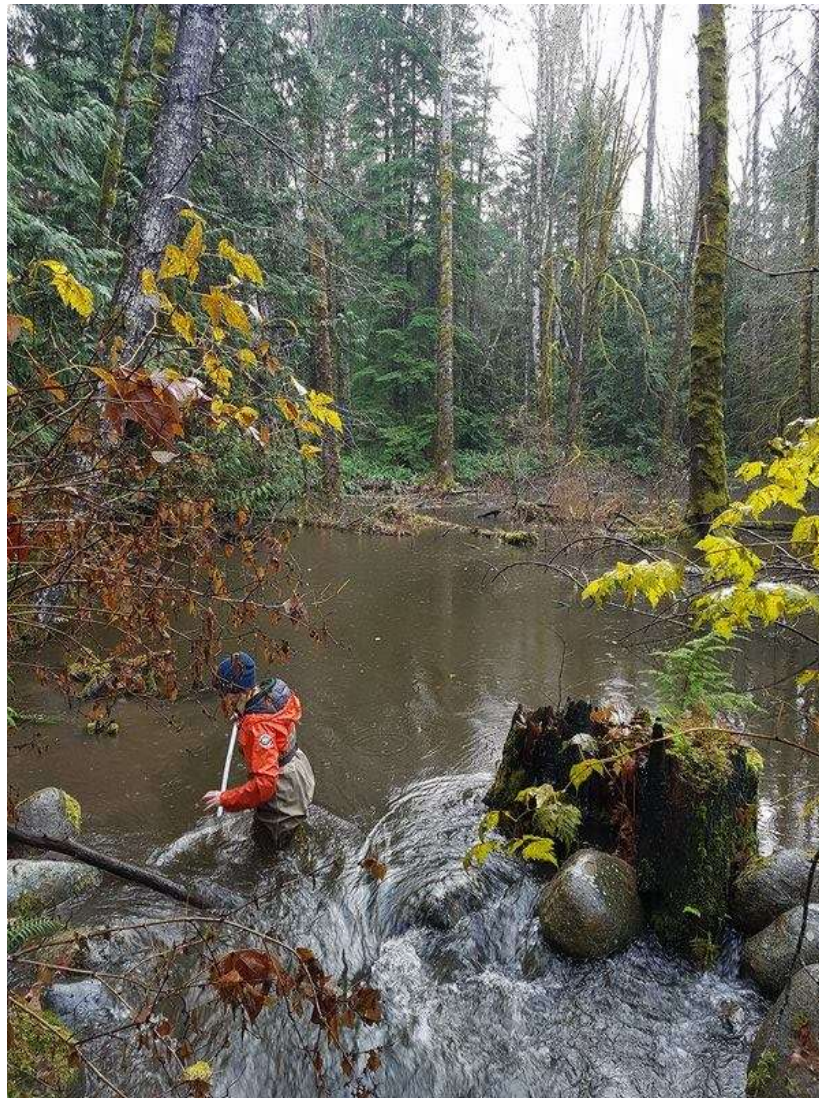
**Figure C4.** Site #4, located along the C.W. Young Channel.  
Facing upstream.

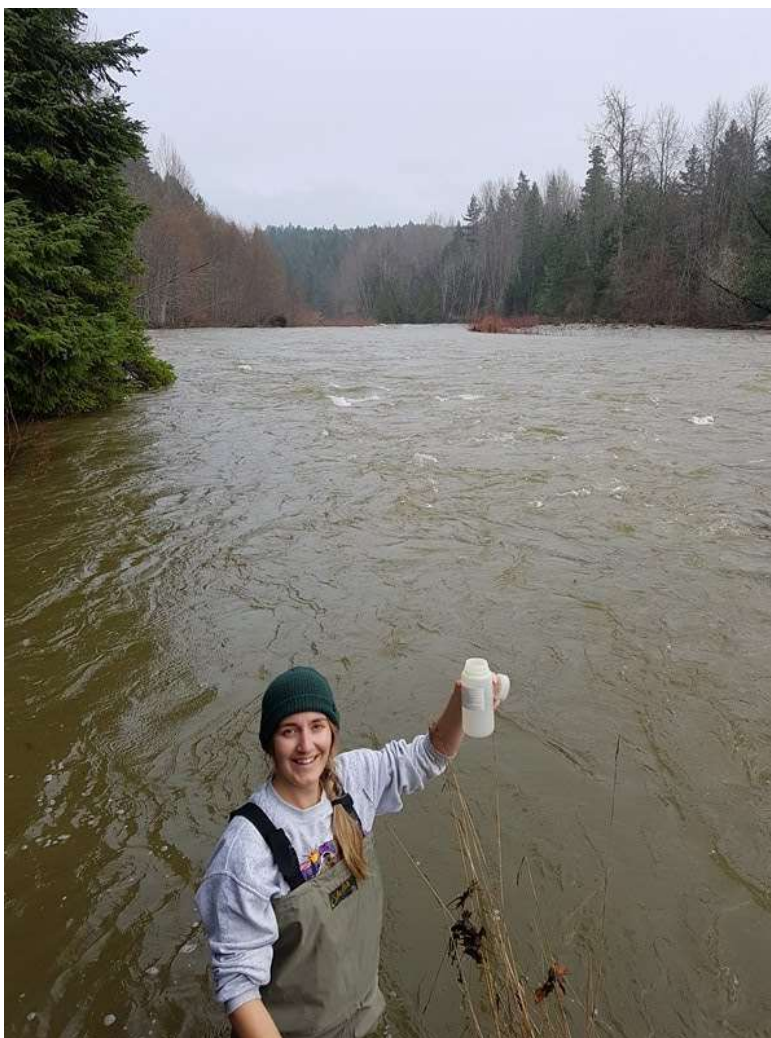
**Figure C5.** Site #5, located at the downstream union of the C.W. Young Channel and the Englishman River. Facing downstream. Note the drastic increase in water level and reduced clarity compared to Figure B5.
