**Water Quality and Invertebrate Analysis of
Millstone River in Nanaimo, B.C.**

Course number: RMOT 306

Date: December 15, 2017

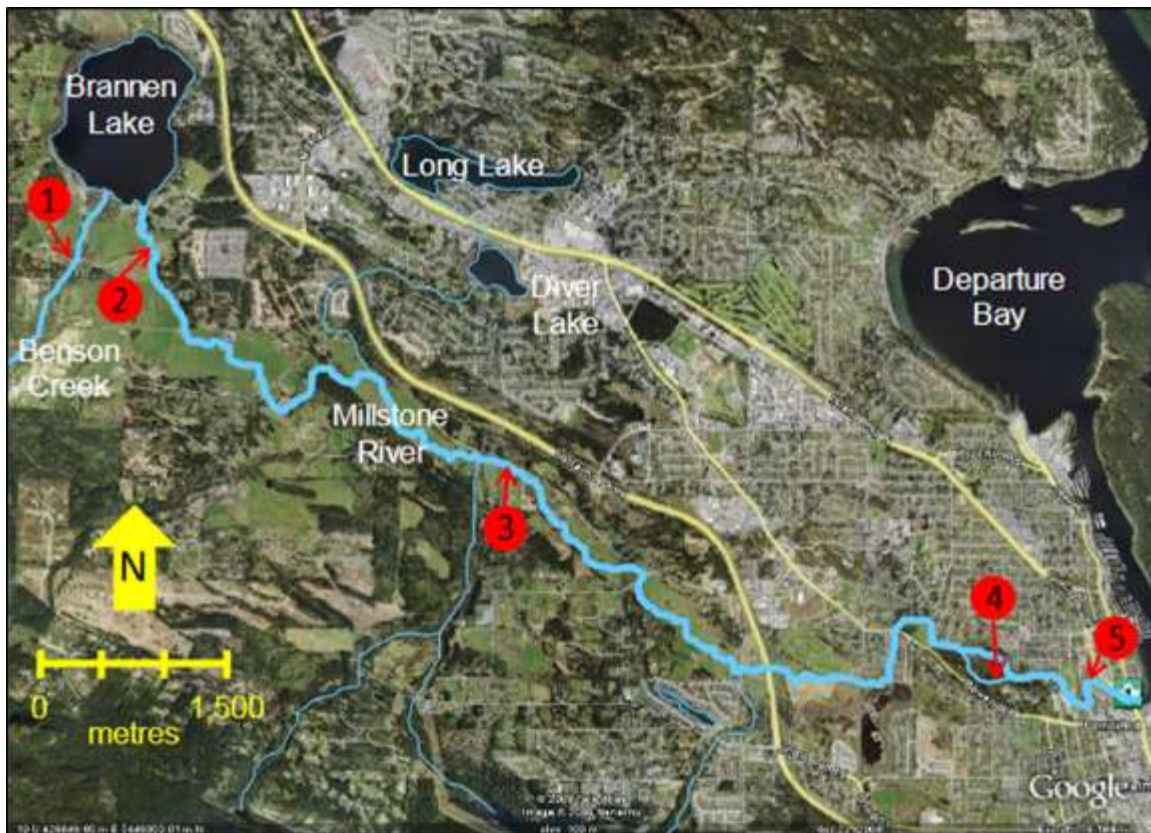
Figure 3. Locations of the water quality stations in the Millstone River, (Demers, 2016).

The sampling area was distributed between Benson Creek and the lower section of the Millstone River covering an approximate 14 kilometer stretch of water. The general distribution is as follows: sample sites (1, 2) are located in the upper part of the system, sample site (3) is in the central section, and sites (4, 5) are near the lower reaches of the river where the water discharges into the Georgia Basin at the Nanaimo Harbour (Figure 3). Pictures of each sample location taken during the October 30th site visit on are displayed in the Appendix (A2).

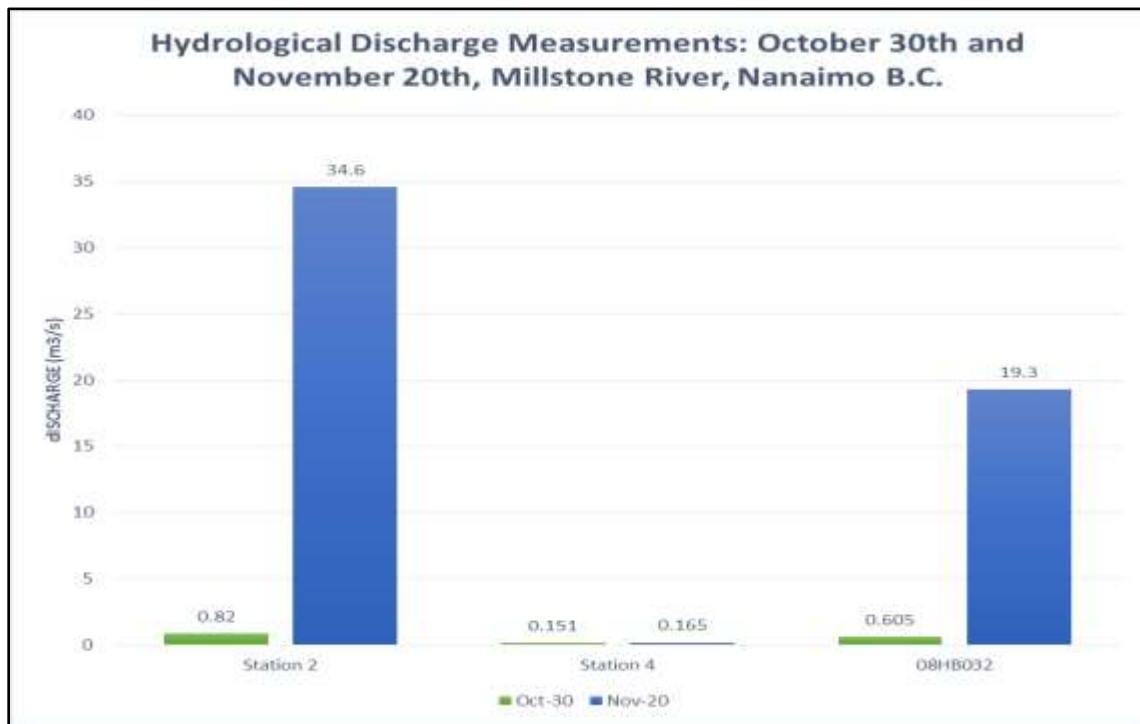
Figure 5. The October 30th and November 20th discharge measurements recorded from sample stations 2, 4 and the Millstone Hydrological Station 08HB032.

The discharge at station 2 on November 20th was calculated to 29.4 m³/s, albeit imprecise nonetheless it shows the extreme variation between the two sampling days. The Millstone Hydrological station (08HB032) measured a discharge of 19.3 m³/s thus confirming the general trend observed upstream observed in Figure 5. The rate of discharge observed at site 4 between the 2 sampling days shows very little variation.

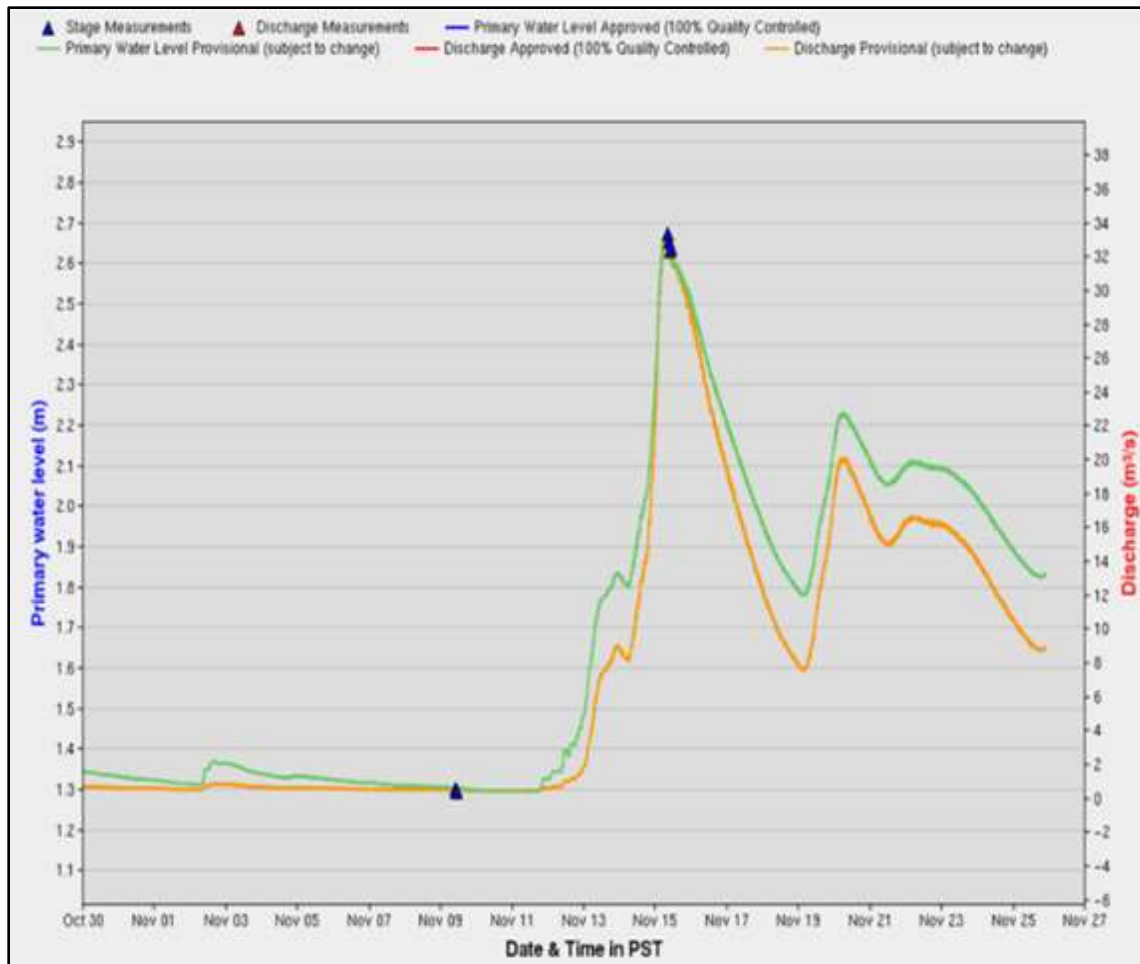
Figure 6. October 30th and November 20th discharge measurements recorded from sample stations 2, 4 and the Millstone Hydrological Station 08HB032.

The discharge data collected between October 30th and November 27 from the Millstone Hydrological Station (08HB032) is displayed below (Figure 6). Two spikes occur on November 15th and November 20th further validating the results observed in the field. It's interesting to note that the November 15th the discharge exceeded our imprecise measurements taken November 20th.

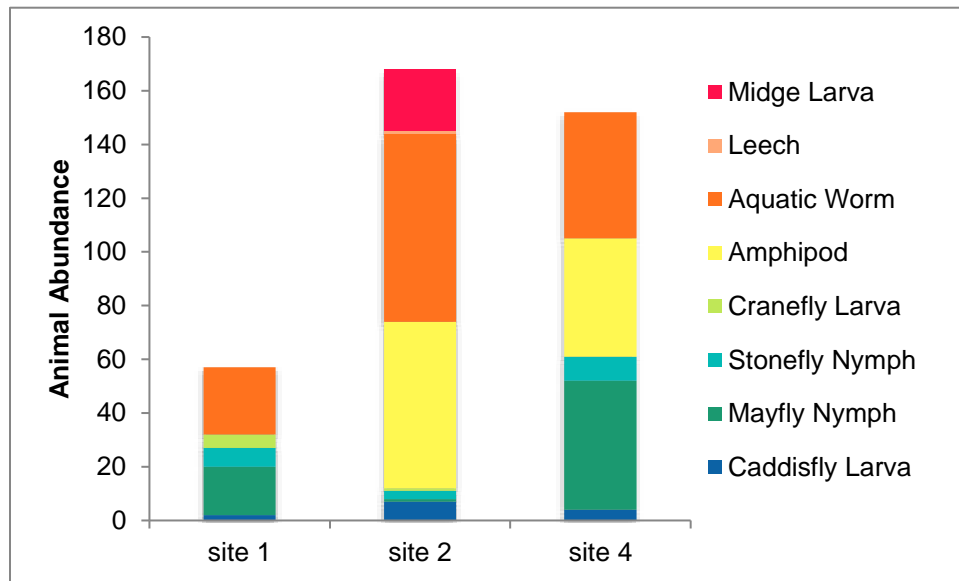
Figure 16. Animal abundance observed at sites 1, 2, and 4. The greatest abundance of invertebrates is observed at site 2. Cooler colours (blue and green) denote pollution intolerant species, whereas warmer colours (yellow, orange and red) represent pollution tolerant species. The greatest amount of pollution-tolerant species were found at site 2. The greatest amount of pollution-intolerant species were found at site 4.

A total of 377 invertebrates were collected between all three sites on October 30, 2017. Of that, 13 different taxa were identified. The highest abundance of total invertebrates was collected at site 2 with 168. Below that was site 4 with 152, and the

lowest was found at site 1 with 57. The predominant taxa for sites 1, and 2 was aquatic worm (oligochaete), and mayfly nymph for site 4 (A5). Aquatic worms are classified as category 3 pollution tolerant as they can adapt to more challenging environmental conditions. The mayfly nymph is classified as category 1 pollution intolerant and their presence generally indicates clean, clear water (Tacogna & Munro, 1995).

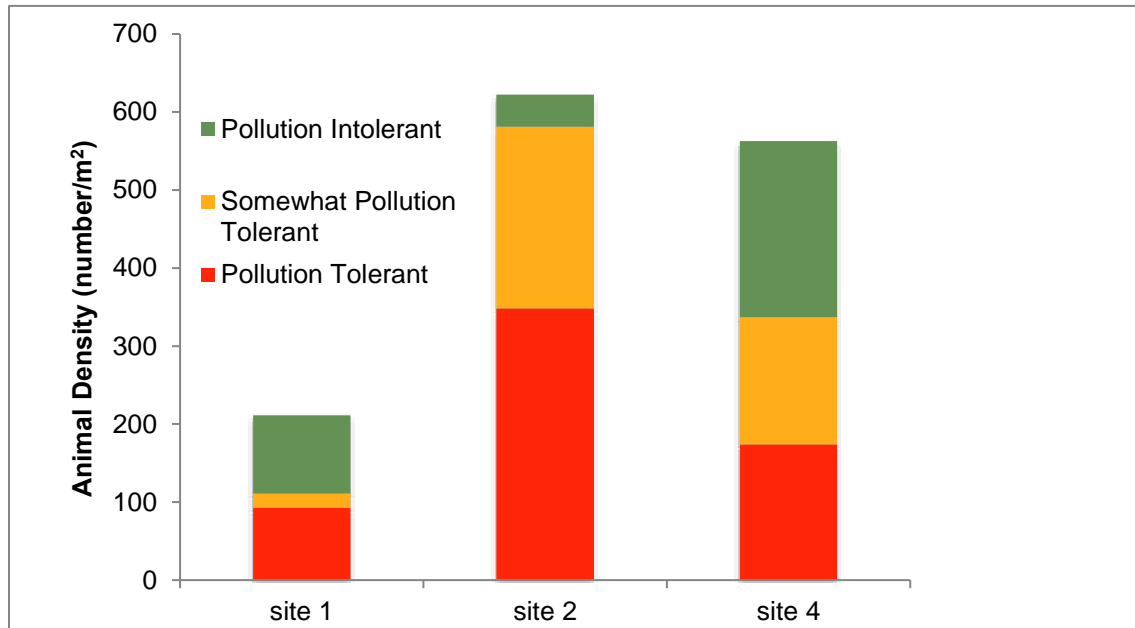
Figure 17. Invertebrate density collected on October 30, 2017, identifying pollution intolerant, somewhat pollution tolerant, and pollution tolerant animals found at sites 1, 2, and 4. The greatest density was found at site 2 with a total of 622/m², yet the greatest pollution tolerant, and the fewest pollution intolerant was also observed at site 2.

The greatest overall invertebrate density was collected at site 2 with a total of 622/m². A density of 563/m² was observed at site 4, and a density of 211/m² was found at site 1. The greatest total density was observed at site 2, yet the least amount of pollution

intolerant species and the greatest amount of pollution tolerant species were observed at site 2 (Figure 17).
