WATER QUALITY AND INVERTEBRATE MONITORING OF BECK CREEK, NANAIMO BC

Fall 2018

Dr. Eric Demers, Vancouver Island University

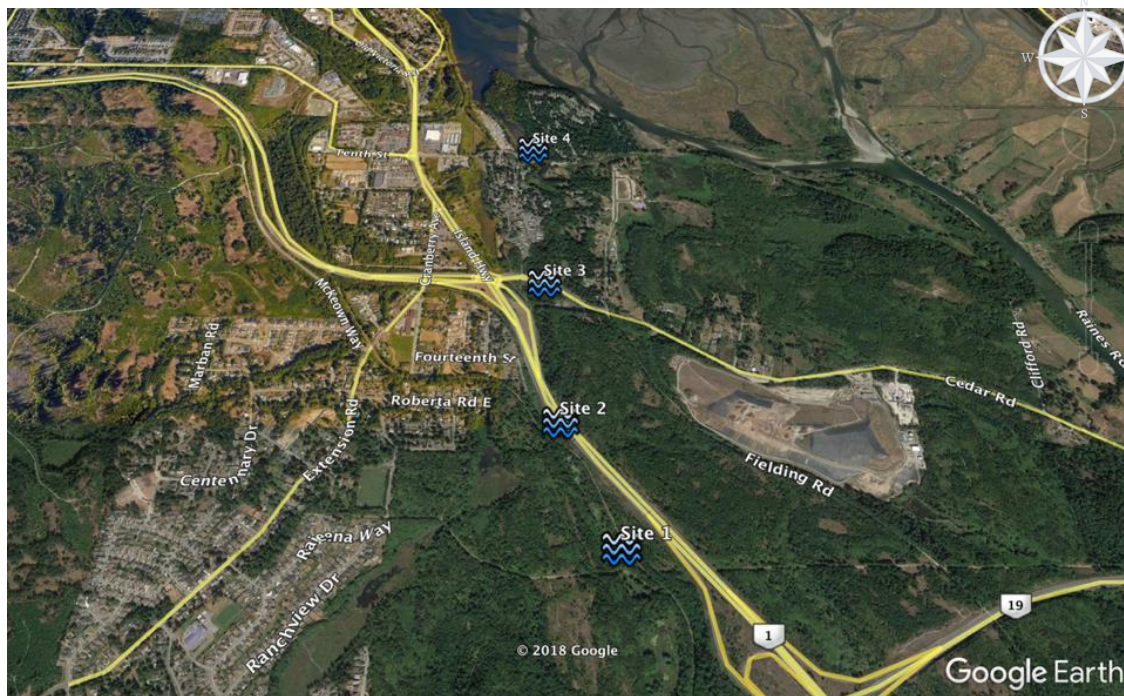
Figure 4: Predetermined site locations for the Beck Creek environmental assessment.

Site 1 is situated furthest upstream from the ocean, and slightly downstream of a beaver pond, at the approximate UTM coordinates 10U, 433603 E, 5440523 N (BC Albers). This site, along with the others, are used for this report in order for it to be compared to past reports. The water was moving relatively slowly in this reach, on either side of the culvert. Water depth was difficult to determine as the water was quite dark but was estimated at 30 cm deep. Depth of the water was expected to rise owing to the start of the rainy season. Above the culvert is a dirt road which seems to be accessible by vehicle, if needed. Access to the site is quite straightforward and is an

Site 2 can be found around 500 m downstream of site 1, approximate UTM coordinates 10U, 433409 E, 5440990 N. This particular site has been used in the past along with the others, for research purposes. Using it for this report will continue its relevancy to the assessments.

Site 3 is positioned across the highway from sites 1 and 2, around UTM coordinates 10U, 433346 E, 5441612 N. The water flow coming from the culvert here is quite rapid, but only approximately 10 cm deep before running into a large pool where depth is unknown. The water is retained in the pool by a large semicircle of cobble, which stops the water from overflowing downstream and creating an environmental hazard and/or disaster. Less than 10 m downstream of this cobble, a riffle is situated. This area acted as a good location for invertebrate sampling for

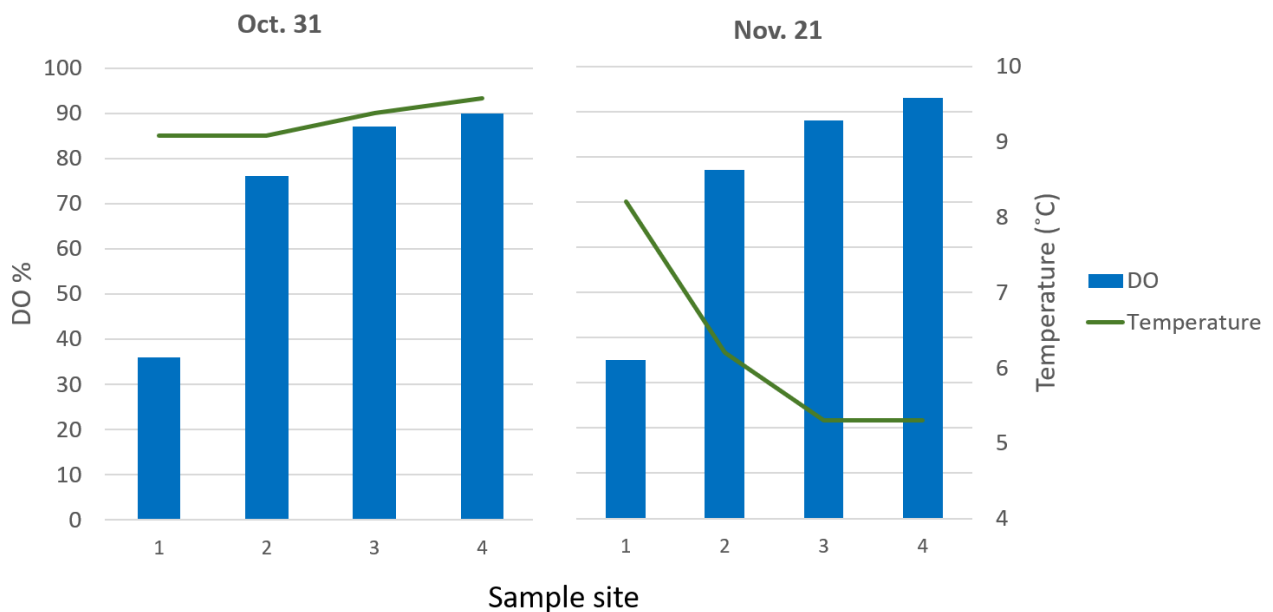
Figure 6: Temperature and dissolved oxygen (percent saturation) during both sampling events.

Field measurements were obtained during both sampling events at all sites for temperature and dissolved oxygen (DO) and are represented in Figure 6. The dissolved oxygen values were found to be ever increasing when comparing findings from Site 1 heading downstream towards Site 4 and the exiting of Beck Creek into the Nanaimo Estuary during both sampling events. A lowest value of 3.3 mg/L and highest of 9.4 mg/L where both found at Site 1 and 4 respectively during our second sampling event. It was found that when considering all sites, the average sample

mean was 6.8 mg/L ($s \pm 2.3$) during the initial sampling, with a slight increase to 7.3 mg/L ($s \pm 2.8$) in the following. These findings are congruent with the slow movement of poorly oxygenated water from eutrophic Beck Lake at the upstream sites, with increasing gradient resulting in oxygenation of the lower ones, resulting in higher DO from atmospheric diffusion and features such as riffles.

Although flow rates (refer to section 4.1) were similar during both events due to the fact that there was little in the way of meaningful rainfalls, the temperature of the water was found to have decreased between events with an average temperature of 9.3° ($s \pm 0.2$) on October 31st to 6.3° ($s \pm 1.4$) on November 21st, owing to a significant change in air temperatures prior to the second sampling event. Given these findings, although not exclusive of other influences, both field parameters showed a correlation between them as should be expected. The dissolved

oxygen increased as the water temperature declined, and in their sum, were found to be within a good range to support aquatic life (BCMWLAP, 1997).

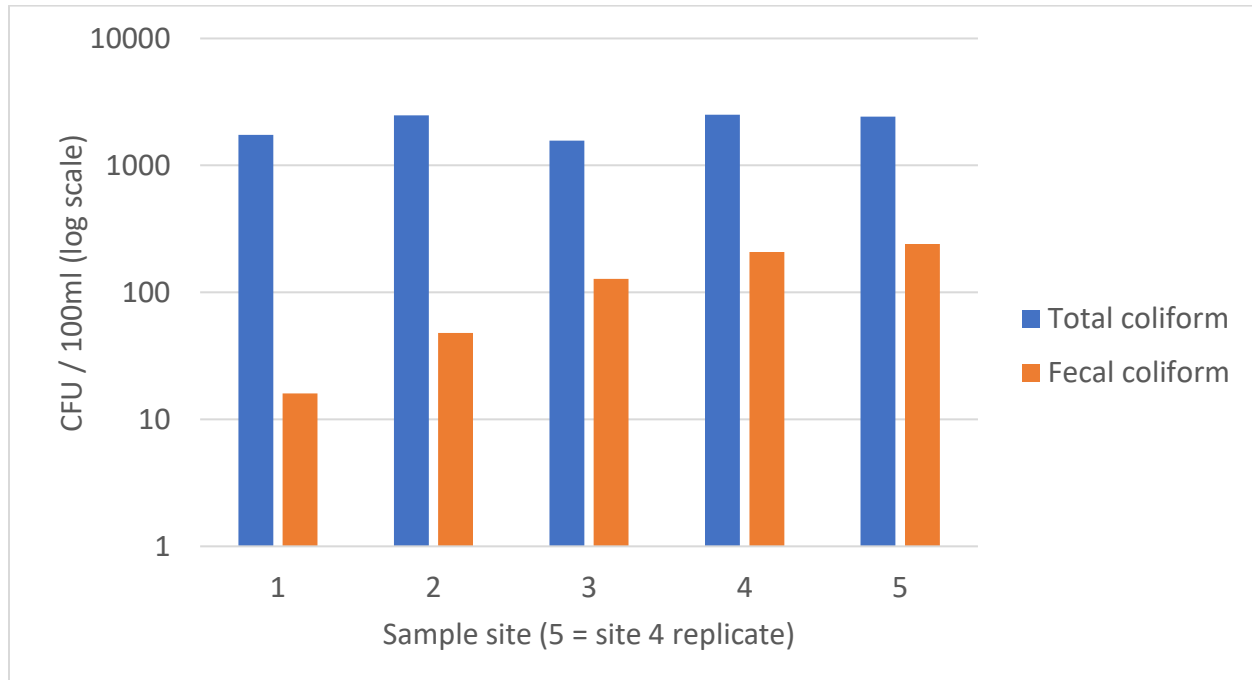
Figure 12: Total and fecal coliform counts for all sample sites, including Site 4 replicate (labelled as site 5 on graph). Note semi-log scale used.

After incubation, we enumerated the colonies grown on the membranes. This method results in bacterial colonies of three colors: red, blue, and clear and/pink, shaped like small circles. The red colonies found on our membrane indicate coliform was found but does not express it is *E. coli*, while blue colonies specify the presence/abundance of *E. coli* within the water sample. Each dot is counted as one colony, and results reported as colony forming units/100 mL (CFU/100 ml). Coliform plate images can be found in the appendix of this report, and result represented below in Figure 12.

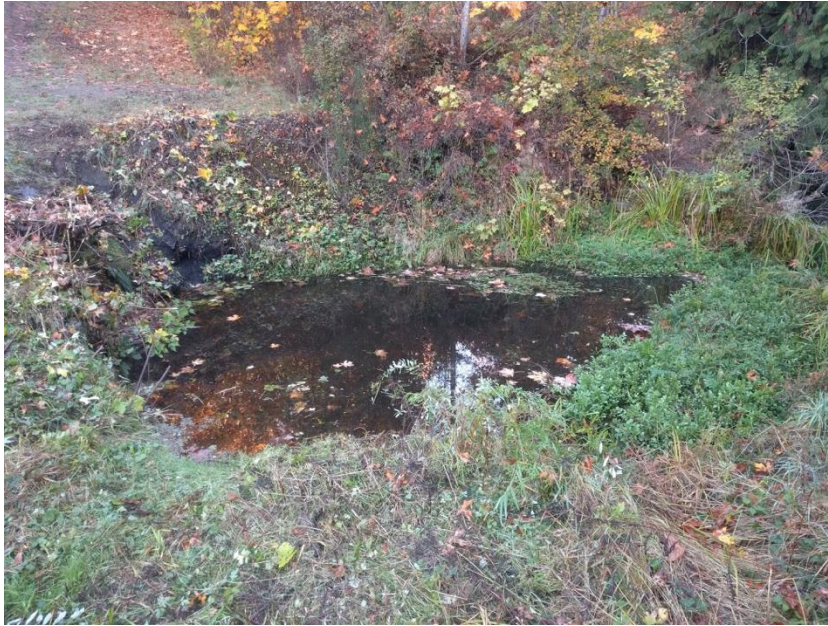
Figure 18: Downstream of culvert at Site 1.

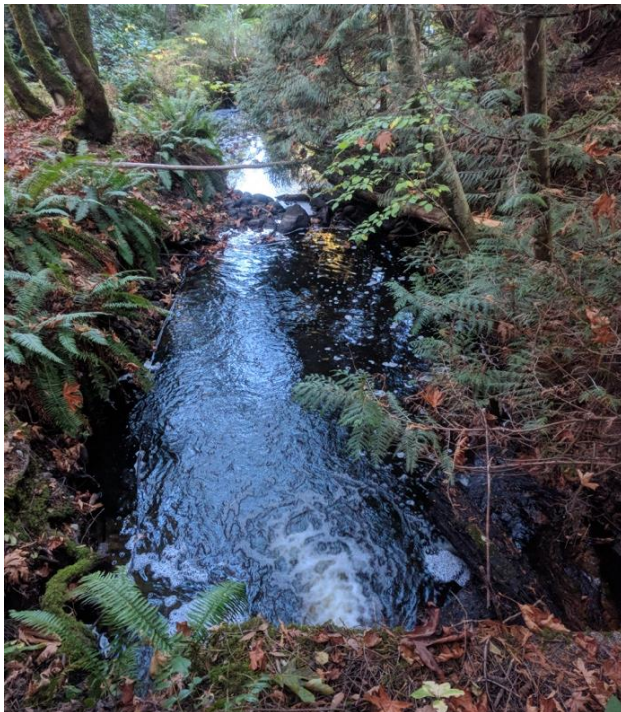
Figure 19: Downstream of culvert at Site 2.

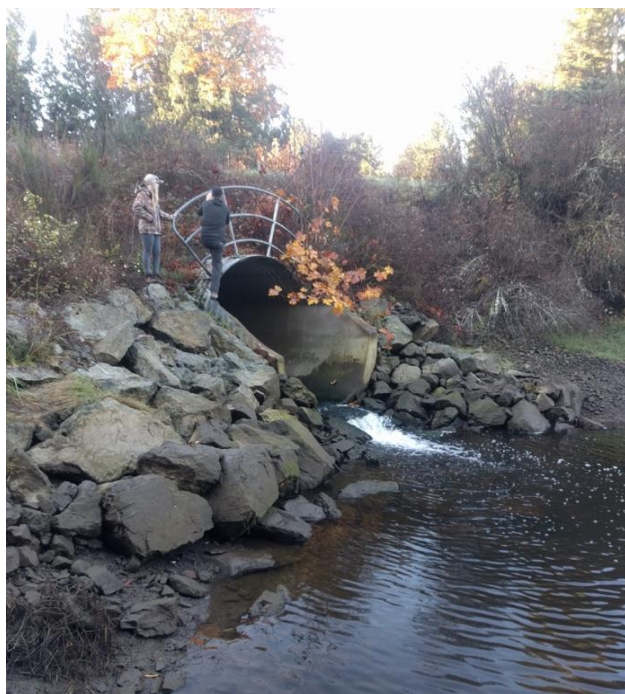
Figure 21: Downstream end of culvert at Site 4 (tidewater).
