Cottle Creek Final Assessment 2018

Final Draft Submitted by:
Jenna Odynsky, Karlee Hall and Kayla Zielke

RMOT 306
Vancouver Island University
December 11, 2018

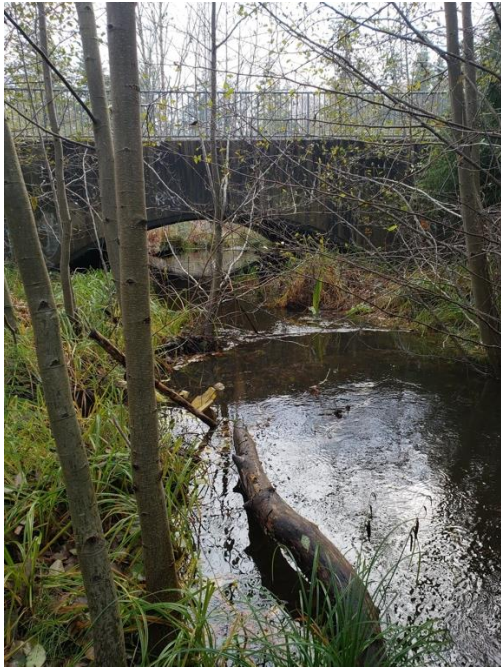
Site 3: Lower Cottle at Nottingham Drive.

Site 3 runs underneath a bridge on Nottingham Drive, in a residential area. Surrounding the creek are houses and a busy roadway. This site has small amounts of large woody debris and little canopy cover, mostly consisting of red alder. Its substrate composition is cobble, gravel and fines. It is possible that chemicals and other toxic substances may be leaching into the stream via residential lawns and the roadway.

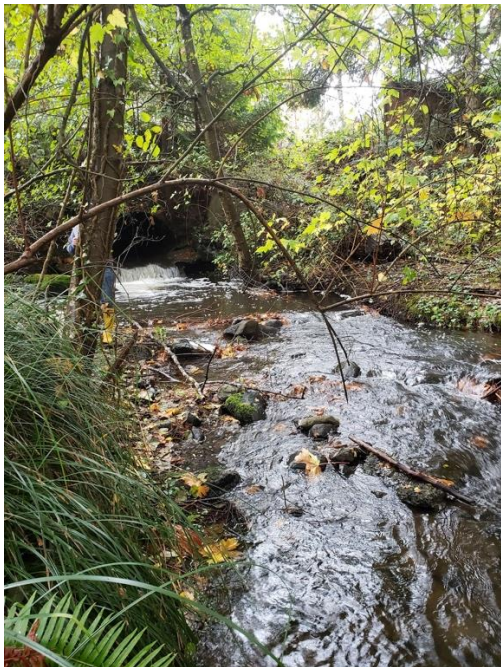
Site 4: Lower Cottle at Stephenson Point Road.

Site 4 lies south of Stephenson Point Road. We chose to conduct our sampling just south of the road, approximately 3 m from the culvert. This area of the creek has a steep gradient and there were even a few waterfalls further downstream. Like many of the other sites, site 4 is also surrounded by busy roads and residential houses. Substrate composition at site 4 consisted of cobble and large boulders and the area had good canopy cover providing shade by western red cedars and big leaf maples.

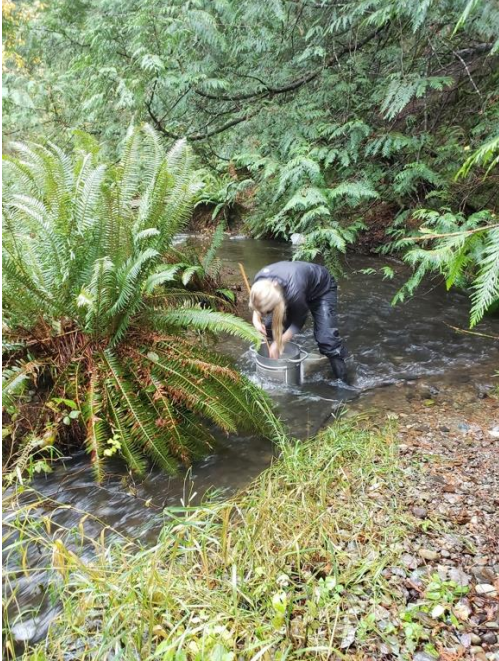
Site 2: Lower Cottle Tributary at East end of Cottle Lake.

Site 2 is located at the eastern end of Cottle Lake, where the start of Lower Cottle Creek originates. This site is located in the protected area of Linley Valley and has well developed trails for easy public access. There is a bridge that crosses the beginning of Lower Cottle Creek that links the two trails around Cottle Lake together. There is a buildup of large woody debris at the outlet of the lake that forms a natural dam, which controls the amount of water entering the stream. There is also thick vegetation of salmonberry, sword fern and grasses that surrounds the area and provide stability to the banks as well as offer riparian cover for fish and wildlife. Since this site is

located in a public park, human impacts may be a concern due to high amounts of visitors. At the boundary of the park there is a small recreational farm elevated above the stream/ lake which could be a threat due to pollution, bacteria and fecal matter leaking into the groundwater and leaching into the water system. The substrate composition consists mainly of gravel and fines.

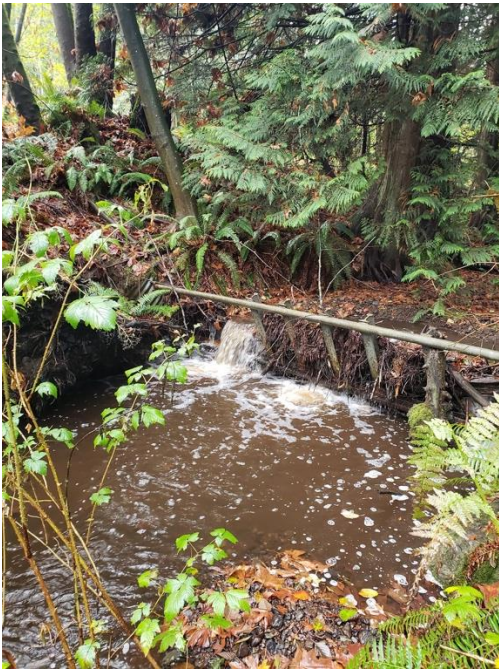
Site 1: Metal structure in the upper Cottle tributary at Arrowsmith Road.

Site 1 is situated between Landalt and Arrowsmith Road on the west side of the intersection. This side was chosen because it was easier to access, minimizing safety hazards. At site 1, a culvert directs water downstream, towards Cottle Lake. This area of the creek lays between Arrowsmith Road in the north and residential houses in the south. It is possible that run off from the road, as well as the yards (i.e., fertilizers) may be leaching down into the stream. There is a manmade metal and wooden dam-like structure across the creek, that is slowing the flow down. Miscellaneous items were found littering the creek and surrounding area, including a tire and a pile of black plastic fencing material. The creek is surrounded by dense riparian coverage consisting of mainly red alder and big leaf maple and there is lots of large woody debris. The substrate composition consists mainly of cobble, gravel and fines.
