# **Millstone River Monitoring Project**

December 14, 2018

## **Executive Summary**

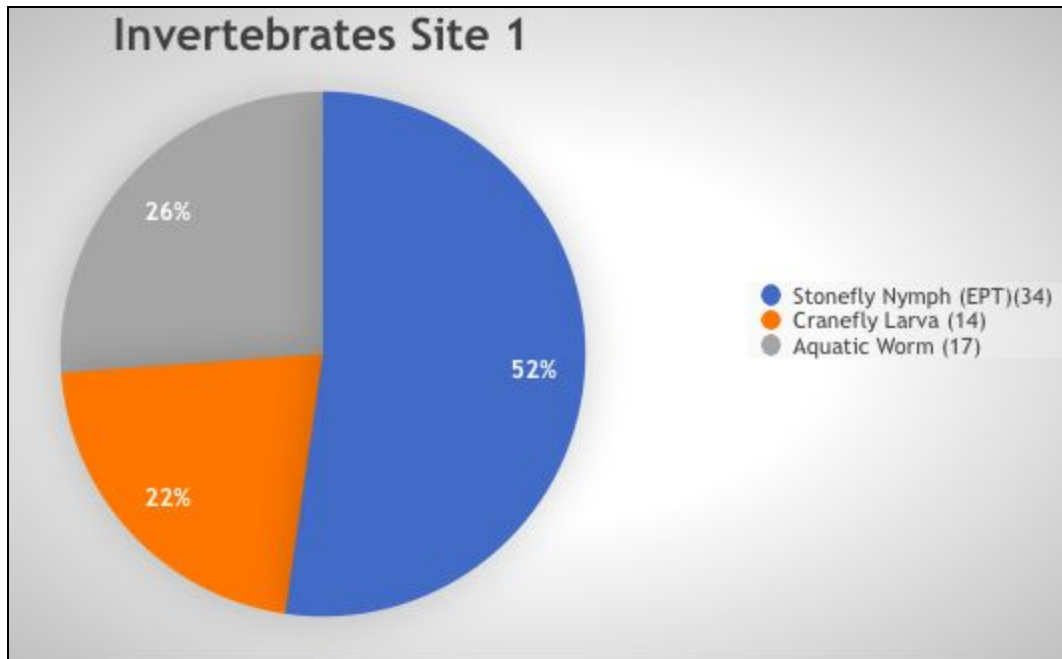
As stated previously in the methods section, invertebrate sampling was conducted three times each at three different sites for a total of nine samples. The sampling was done at site 1 (Benson Creek at Biggs Road.), site 2 (Millstone River at Biggs Road), and site 4 (downstream outlet of the Bowen Park duck pond). The invertebrate sampling at site 1 resulted in the collection of 34 Stonefly Nymphs, 17 Aquatic Worms, and 14 Crane fly Larva (figure 10). Site 1 had 34 invertebrates which were pollution intolerant, 14 that were somewhat pollution tolerant, and 19 that were pollution tolerant. A total of 7 taxa were counted for this site. This site had a high percentage of EPT species at 52%, which can be indicative of lower pollution levels. The Pollution Tolerance Index was 13 (Marginal), the EPT Index was 2 (Marginal), and the EPT to Total Ratio Index and the Predominant Taxon Ratio Index were both 0.523 (Acceptable). The invertebrate density per total area sampled was 722.2 per square metre. This site received an assessment rating of 2.5, which was also the highest of all of our sites and carries a classification of marginal to acceptable. The Shannon-Weiner diversity index score for site 1 was 0.929. Site 1 probably experiences lower pollution levels because it is a quieter agricultural area and receives less traffic, coupled with less pollution from runoff than our site near downtown Nanaimo would get.

Figure 10: Invertebrates Counts for Site 1

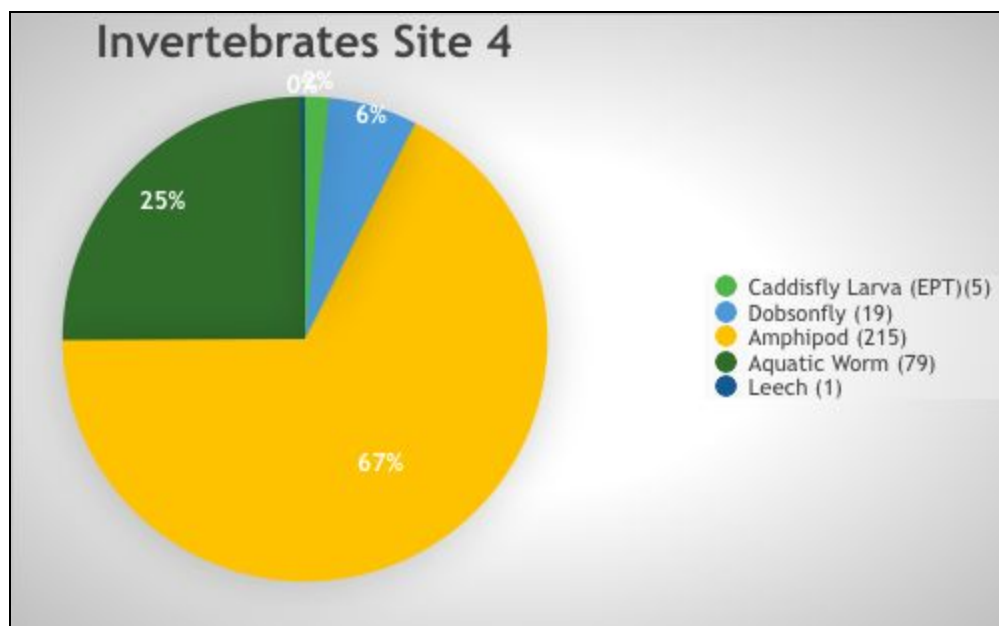
The final site which received invertebrate sampling was site 4, which also scored the lowest rating of the three sites. We counted 215 Amphipods, 79 Aquatic Worms, 19 Dobsonflies, 5 Caddisfly Larvae, and 1 Leech (figure 12). We counted 24 pollution intolerant invertebrates, 215 that were somewhat pollution tolerant, and 80 which were pollution tolerant. There were a total of 10 taxa counted at this site. The Invertebrate Density per Total Area Sampled was 3544.44 per square metre. This site had a large percentage of worm and Amphipod species, while EPT species only constituted 2% of the invertebrates collected. The Pollution Tolerance Index was 18 (Acceptable), the EPT Index was 1 (Poor), the EPT to Total Ratio Index was 0.015 (Poor), and the Predominant Taxon Ratio Index was 0.67 (Marginal). Site 4 received an assessment rating of 1.75, which translates to poor bordering on marginal. The Shannon-Weiner

Diversity Index score for site 4 was 0.616. This could be indicative of higher pollution levels, which is consistent with the high conductivity observed at this site.

Figure 12: Invertebrate Counts for Site 4

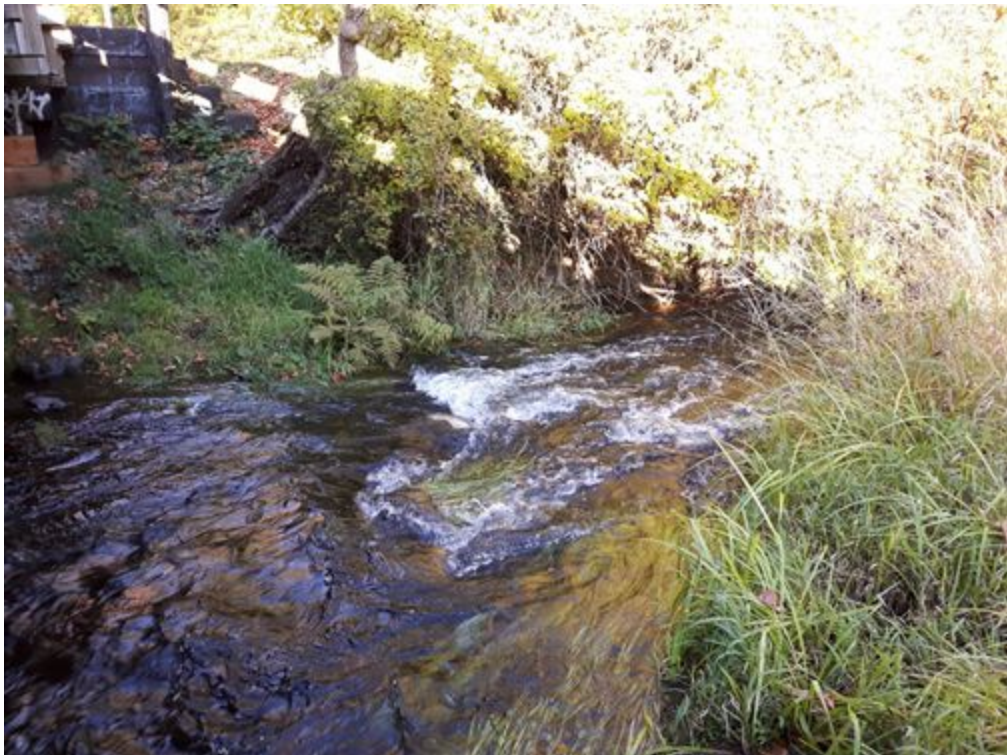
Photo 9: View from the right bank showing increase in flow velocity downstream of the Durnin Rd bridge at Site 3.
