Water Quality, Microbiology, and Invertebrate Analysis for the
Beck Creek in Nanaimo, British Columbia

Proposal Submitted By:
RMOT 306 Environmental Monitoring Students
(Katelyn Cooper, Brad Farrow, Kitina Munroe)

Submitted to:
Dr. Eric Demers at Vancouver Island University
December 13, 2019

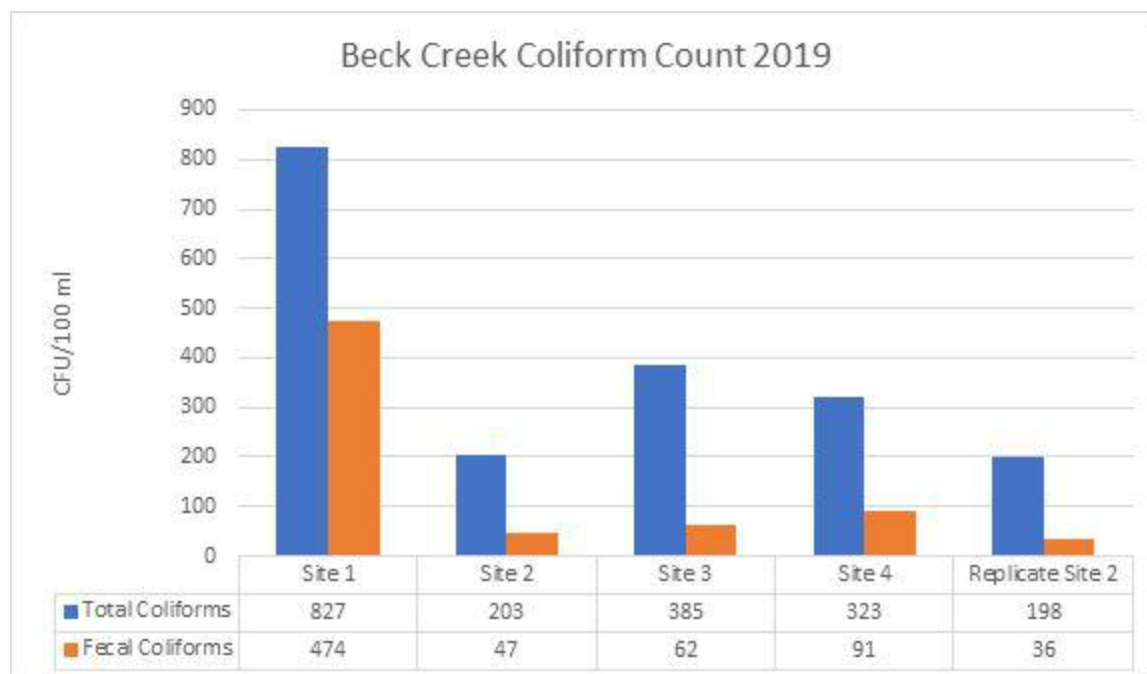
Figure 14: Total and fecal coliform counts taken during first sampling stint on October 30, 2019.

After water samples were analyzed at VIU lab, the number of fecal (*E. coli*) and non-fecal coliforms grown in petri dishes was recorded. Colours of the colonies formed included red, blue, and clear but only the red and blue. Images of the coliform plates can be found in the appendix. The blue coliforms indicate the presence of fecal coliform (*E. coli*) and red coliforms indicate the presence of non-fecal coliforms. Blue colonies counted from Site 1 and red colonies from Sites 1, 3, and 4 were counted by choosing 10 random squares due to the high amount of fecal (*E. coli*) and non-fecal coliforms. The average count per square for each individual dish was multiplied by the filtered area (908 mm^2) over the area of each square (9 mm^2). Calculations of fecal (*E. coli*) and non-fecal coliforms can be found in Figure 3. For the rest of the plate counts, the number of fecal (*E. coli*) and non-fecal coliforms was determined by counting each individual red or blue dot.

Results from 2017 and 2018 vary from the results indicated below. In 2017, the highest amount of fecal (*E. coli*) coliforms was found at Site 3 and the highest amount of fecal (*E. coli*) coliforms in 2018 was at Site 4 replicate sample. In 2019, the highest amount of fecal (*E. coli*) coliforms was also found at Site 4. This beaver dam and stagnant water around and at this location may be a reason for the buildup of fecal (*E. coli*) coliforms. According to the *Guidelines for Interpreting Water Quality Data*

(BCMWLAP 1997), water from Beck Creek should not be consumed without treatment and Site 1 could be used for general irrigation.

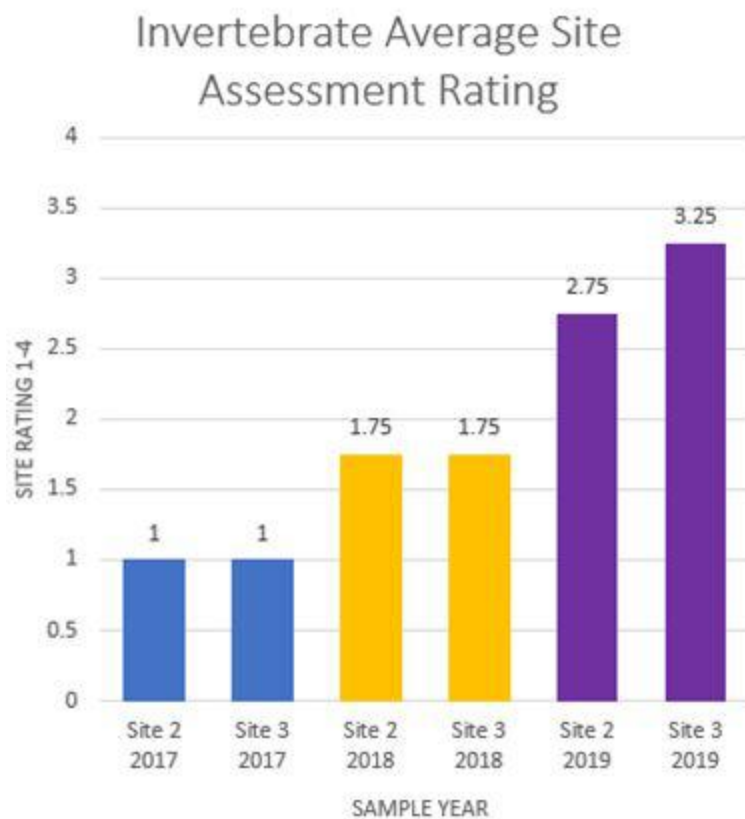
Figure 16: Comparison of Invertebrate Average Site Assessment for 2017-2019

Lastly, it was important to get an overall comparison of the invertebrates collected and analyzed from the VIU students in 2017 and 2018 to understand how the 2019 monitoring projects reflects previous data. A bar graph was created to illustrate the comparison of the Invertebrate Survey average site ratings for all 3 years (See Figure 17). In 2017 for both sites 2 and 3 gave an average site rating of 1 which is ranked in the poor site rating category. In 2018 for both sites 2 and 3 gave an average site rating of 1.75 which is in poor to marginal site assessment category. For this year (2019) we calculated site 2 at 2.75 in the marginal to acceptable category and site 3 at 3.25 in the acceptable to good site assessment category. In the graph you can see the trend of the site assessment ratings increasing each year. This is an indicator that water quality

parameters are reflecting the increase in overall health of the stream by the presence of pollution intolerant species in abundance. Invertebrate sampling supplements water quality parameters well, because without good water quality we would not have good site assessment ratings or good Shannon Wiener Index ratings (Taccogna and Munro 1995).. Invertebrates play an important role in the stream ecosystem, they are part of the food chain and supply many organisms and aquatic life with food. Invertebrates also help clean the streams by consuming algae, fungi, bacteria and break down leaf liter to provide food for other species (Taccogna and Munro 1995).

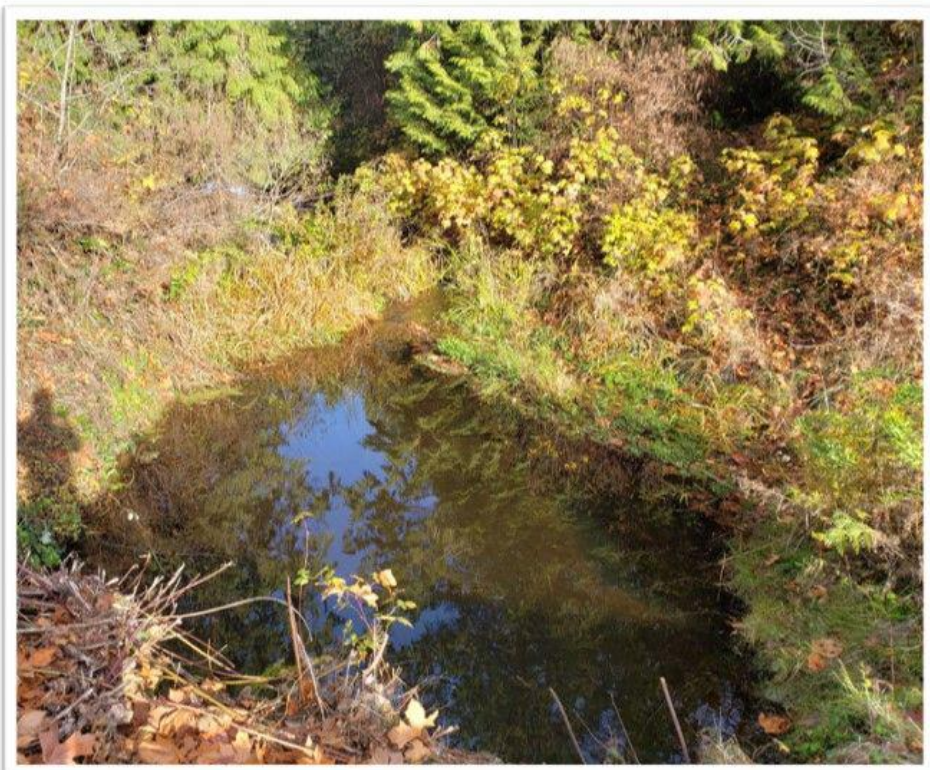
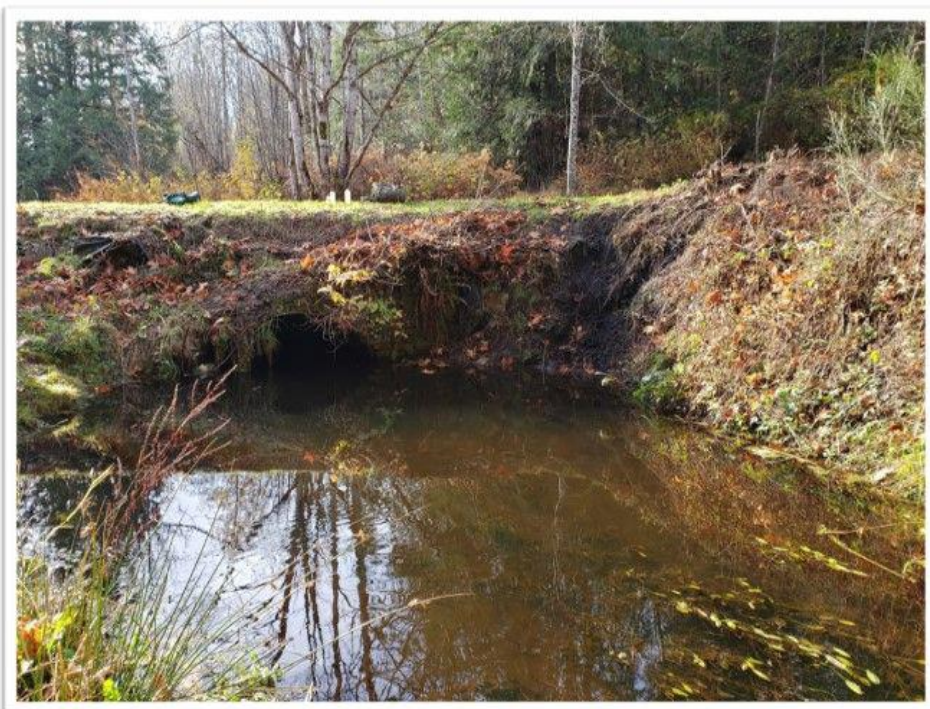
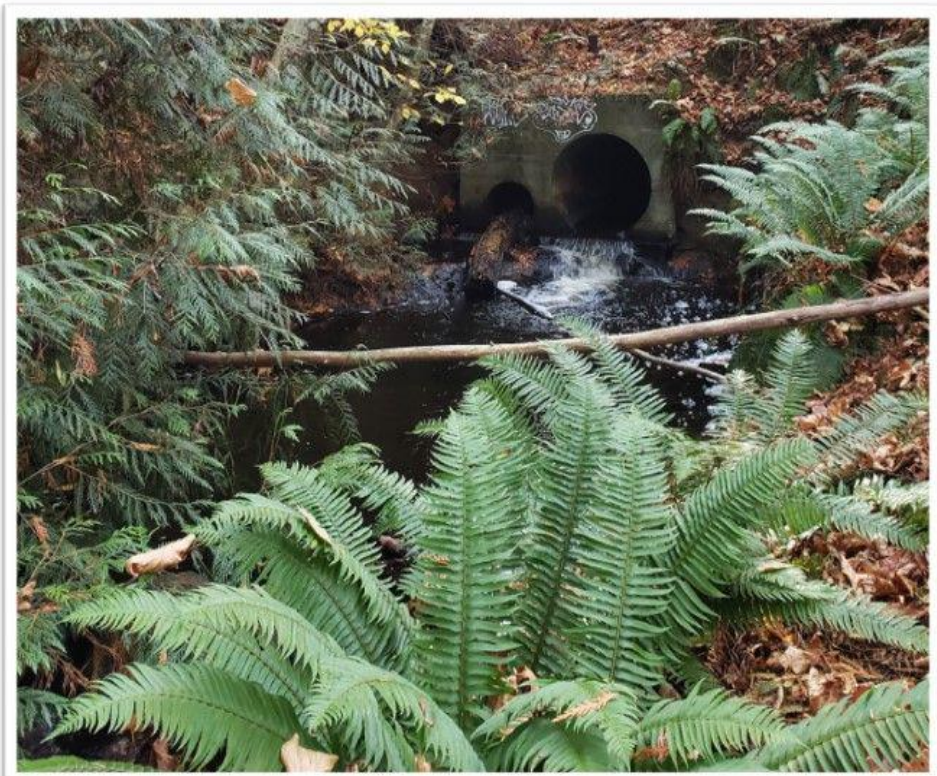
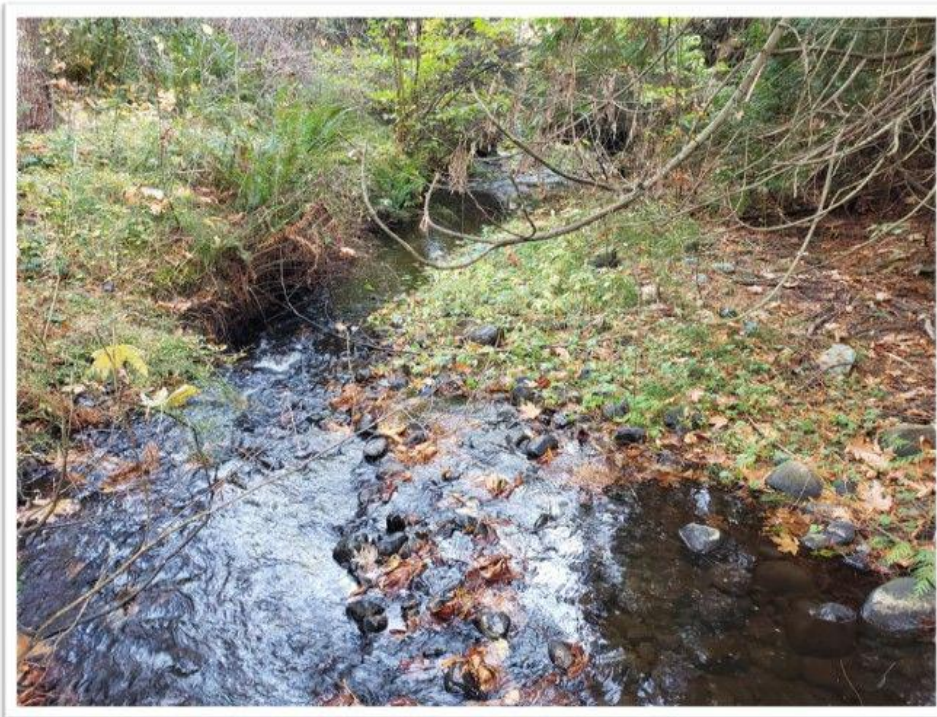
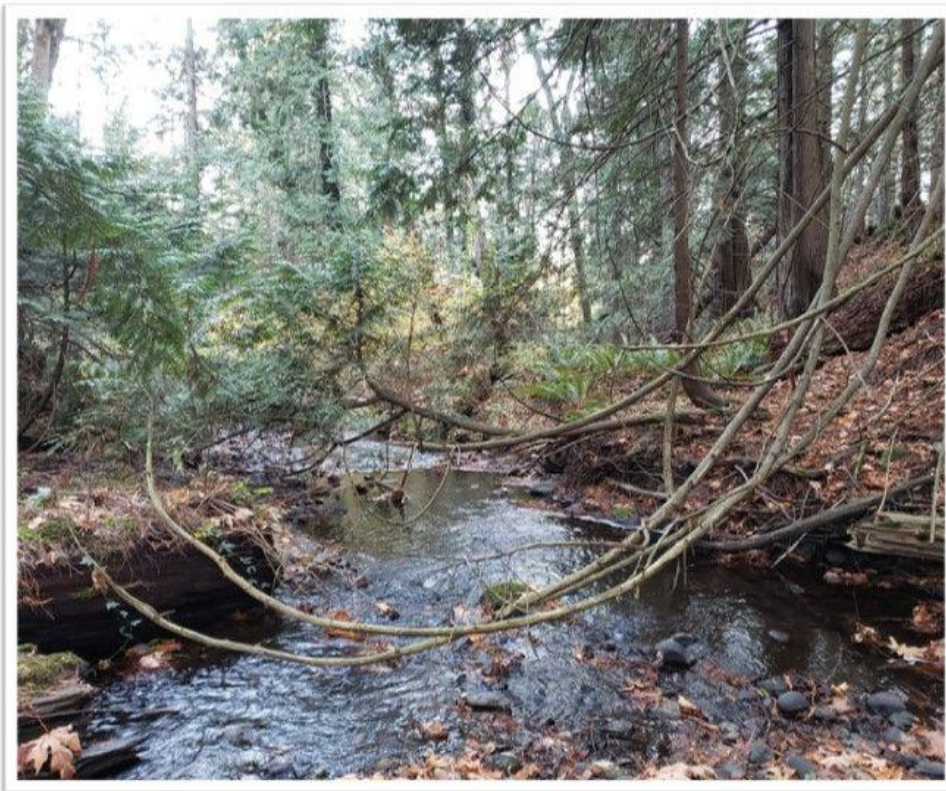
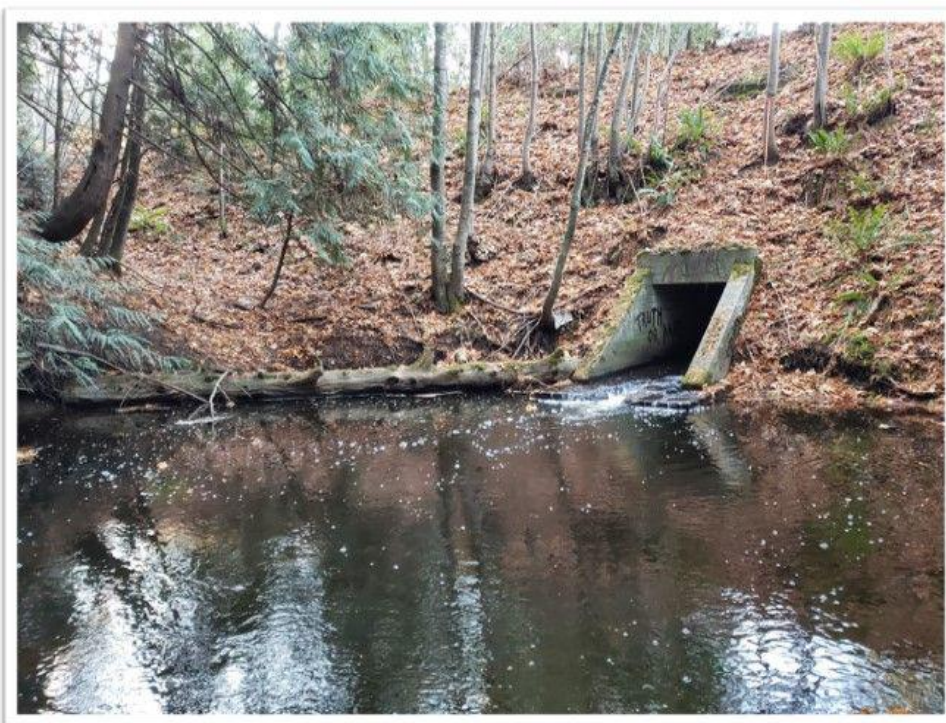
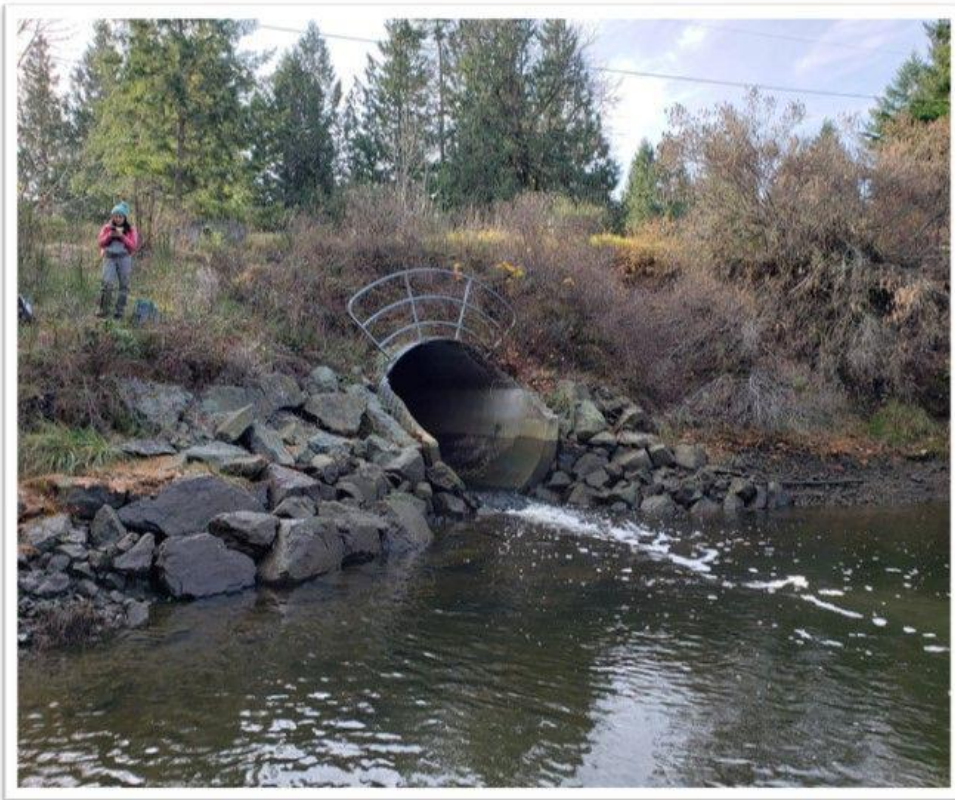
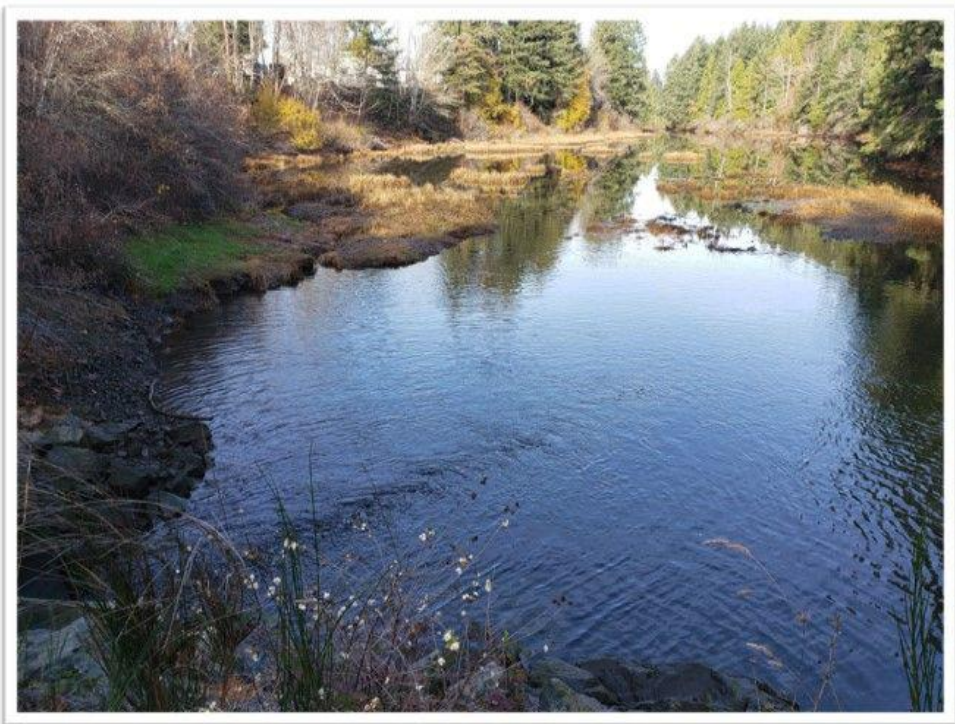
Tab
Photograph of sites 1-4	A
VIU Field Measurements and Lab Analyses	B
ALS Laboratories Results	B
Coliform Plates Sites 1-4 with Replicate from Site 2	C
Invertebrate Comparison 2017-2019	D
Invertebrate Survey Field Data Sheet Site 2 and 3	D

Starting furthest upstream, Site 1 is located at UTM 10U 433603 E, 5440523 N. Situated downstream of a culvert and gravel road, the monitoring site is open to almost full sun. Riparian vegetation consists of mainly grasses and bushes, located on steep slopes on either side of the water's edge. The flow was observed to be slow-moving, but water depth could not be ascertained on the initial visit as water visibility was obscured below approximately 30 cm of depth. Substrate was also unobserved but estimated to be an even mix of gravel and fine substrate with some woody debris (de Leplante et al. 2018).
