# **Water Quality Assessment of the C.W. Young Channel of the Englishman River, Parksville, British Columbia**

AJ Johnston,  
Steve Egan,  
Madison Benton,  
Curtis Ripmeester

Dr. Eric Demers, Vancouver Island University December 13, 2019

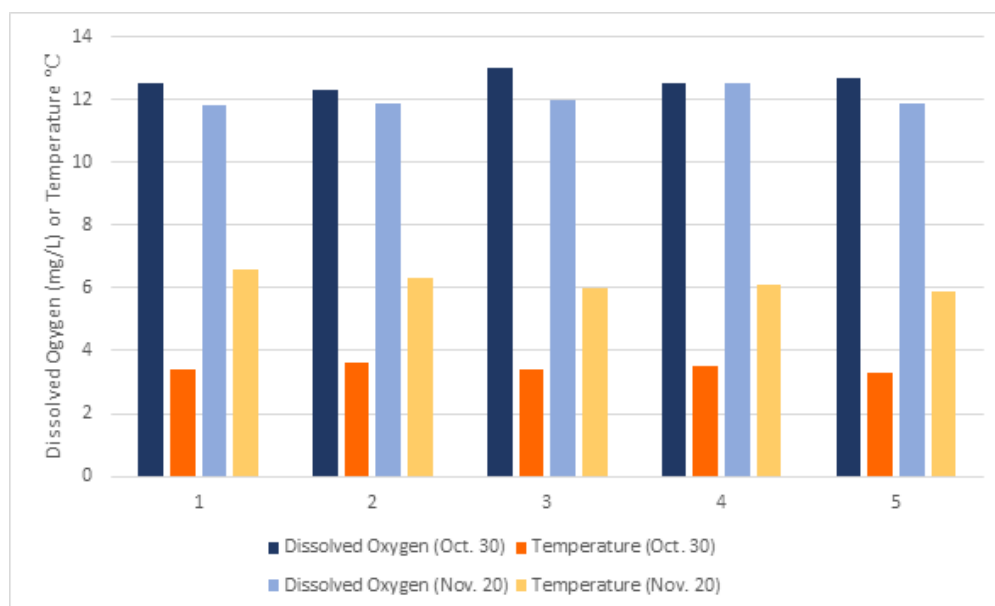
**Figure 3:** Dissolved oxygen and water temperature comparison between Oct. 30 and Nov. 20

The results of the dissolved oxygen and water temperature measurements aligned with expectations. The water was an average 3.5°C on October 30th when sampling occurred. Along with these cool water temperatures, high dissolved oxygen levels were measured. All five sites resulted in greater than 12 mg/L of dissolved oxygen. These cool water temperatures are due to several days of clear skies and cool air temperatures prior to October 30th. The air temperature while sampling occurred on October 30th was 4°C. The second sampling event, on November 20th, saw slightly higher water temperatures and slightly lower dissolved oxygen levels. The water temperature was about 2°C higher on November 20th than October 30th with an average of 6°C. The dissolved oxygen measurements averaged just less than 12 mg/L which is slightly lower than on October 30th. These results were expected as a significant rain event on November 17th and warmer air temperatures brought up the water temperature. The air temperature when sampling occurred on November 20th was 8°C.

Dissolved oxygen is very closely related to water temperature. As water temperature decreases, water is more capable of holding oxygen in a dissolved form. This means that a decrease in water temperature will result in an increase in the amount of dissolved oxygen present. Appropriate levels of dissolved oxygen are necessary for aquatic species to survive. These appropriate levels are outlined in the Guidelines for Interpreting Water Quality Data (Resource Inventory Committee 1998). Both of the sample events water temperature results were several degrees below the maximum temperature guidelines for all salmonid activities. The maximum average weekly water temperature for salmonid spawning is 8-10°C. The dissolved oxygen levels measured in the C.W. Young Channel were significantly above the minimum level

required for aquatic life. The minimum mean monthly level of dissolved oxygen for fish in all life stages other than buried embryo or alevin is 8 mg/L. The lowest level of dissolved oxygen that was measured between the two sample dates was 11.9 mg/L. With excellent water temperature and dissolved oxygen levels, the C.W. Young Channel provides excellent habitat for salmonids and other aquatic species.

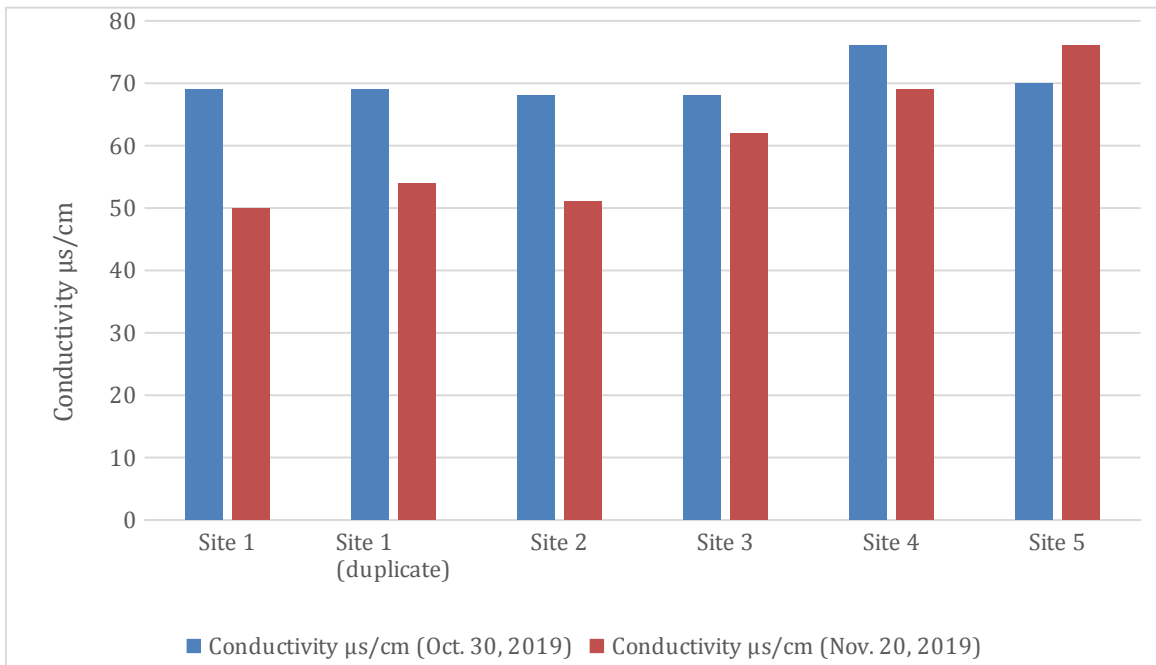
Conductivity refers to water's ability to pass electrical currents through it. As water passes through a watershed it collects positively and negatively charged ions as it comes in contact with the substrate. The more ions that are present in the water, the more capable it is to pass electrical currents through it. Conductivity is measured in micro siemens per centimeter ( $\mu\text{S}/\text{cm}$ ). Coastal waters in British Columbia typically have conductivity levels of 100  $\mu\text{S}/\text{cm}$  or less. The results from conductivity testing on water samples from the C.W. Young Channel align with these suspected levels. The average conductivity level from the first sample event was 70  $\mu\text{S}/\text{cm}$  and the average from the second event was 62  $\mu\text{S}/\text{cm}$ . The second sampling event saw slightly lower conductivity levels at all of the sites except site 5 was slightly higher than the first sampling event (figure 5). These results were expected as the second sampling event took place during a high flow event causing the ions in the water to be more dilute than during a low flow event. Conductivity is a useful water quality parameter to measure as it can identify sources of pollution in water. Many sources of pollution cause a significant increase in the level of ions in water and this can be displayed in increased conductivity levels. There is not a water quality guideline for conductivity, but the results align well with previous years data (Demers 2016). Many years of similar conductivity results points to the fact that this is a healthy and consistent stream.

**Figure 5:** Conductivity results from sample event one and two

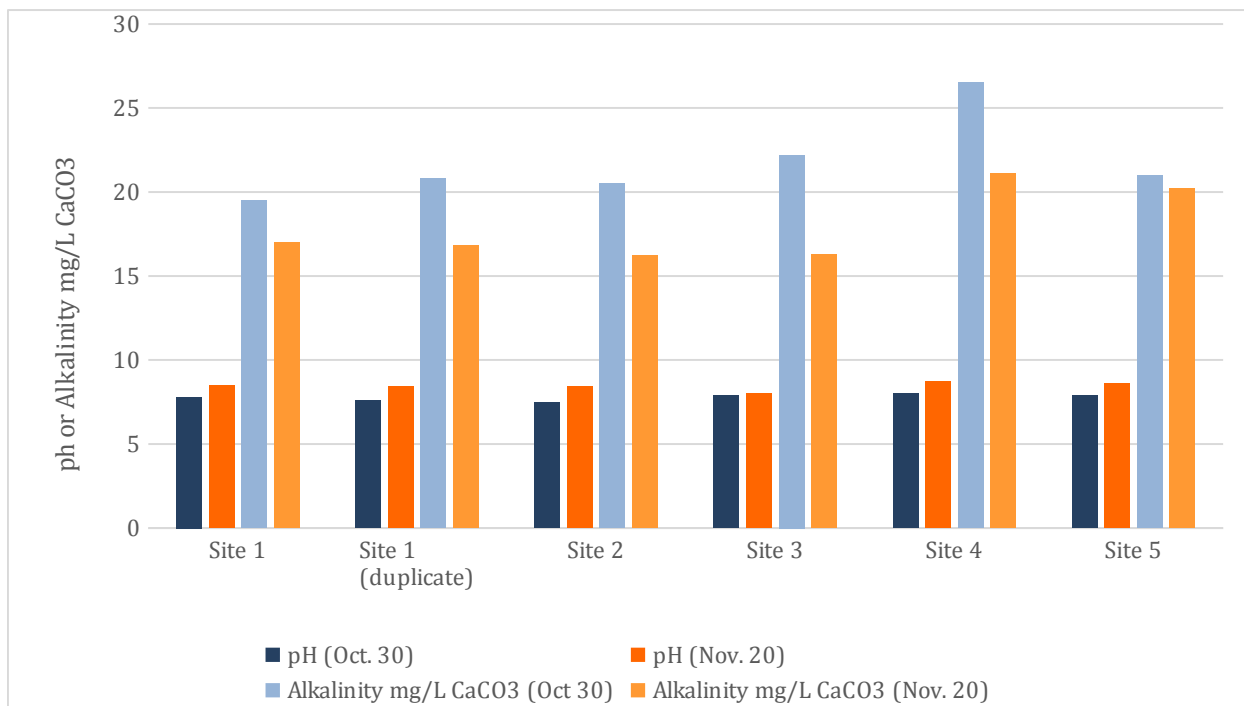
pH refers to the concentration of hydrogen ions in a substance. Substances with high levels of hydrogen ions are considered basic and have a pH between 7 and 14. pH values of 7 or under are considered acidic. All pH levels between the two sample days ranged from 7.5 to 8.7 (figure 6). All sample results fell within the pH guideline of 6.5-9 for aquatic life (Resource Inventory Committee 1998). Coastal streams typically have low pH levels of 5.5 to 6.5 meaning the C.W. Young Channel displayed high a pH for a coastal watershed. pH levels were slightly higher in samples taken on the second sample event than the first. These results are comparable to previous years data although they are slightly higher than average (Demers 2016).

concentrations is more capable of neutralizing acids. Water with an alkalinity of 10 mg/L or less is considered sensitive and is common in coastal areas. An alkalinity of 10-20 mg/L is considered moderate sensitivity and greater than 20 mg/L is considered low sensitivity. Test results from the C.W. Young Channel conclude that this water has moderate to low sensitivity with values ranging from 16.2-26.5 mg/L (figure 6). The first sample event saw higher alkalinity values with an average of 21.75 mg/L between the sites. The average between the five sample sites was 17.93 mg/L on the second sample event. These results accurately represent the high flow event on November 20 with more dilute ion concentrations.

**Figure 6:** pH and Alkalinity results from sample event one and two

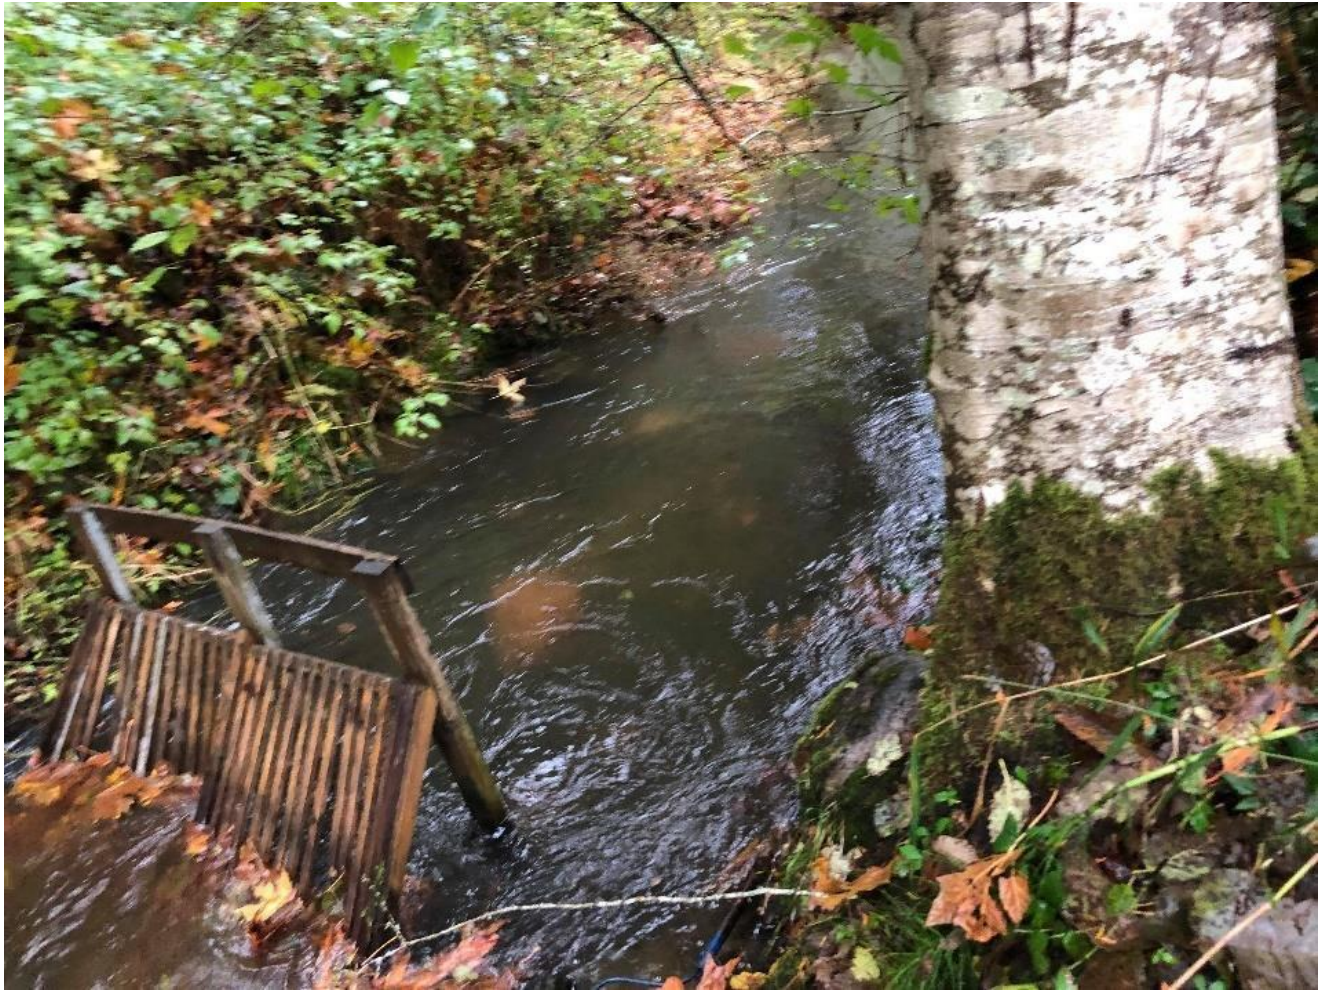
**Figure A1:** Site #1, Located in the C.W. Young Channel

The first site is located at the beginning of the C.W. Young channel (UTM 10 U 0405267mE 5459846mN). Site #1 contains the outflow pipe for the channel, the outflow pipe creates a deep pool, because of this the sampling took place 5 meters down from the outflow pipe. The substrate at this location consists of (80%) course gravel and (20%) slit. The gradient downstream of the outflow pipe is  $<1^\circ$ . The canopy coverage was ( $<10\%$ ) and contains Red Alder (*Alnus rubra*) and Big Leaf Maple (*Acer marcophyllum*), the riparian zone consisted of the same tree species but includes numerous grasses and shrubs. The entrance into this site is steep and slippery, caution will be taken when entering and exiting the site.

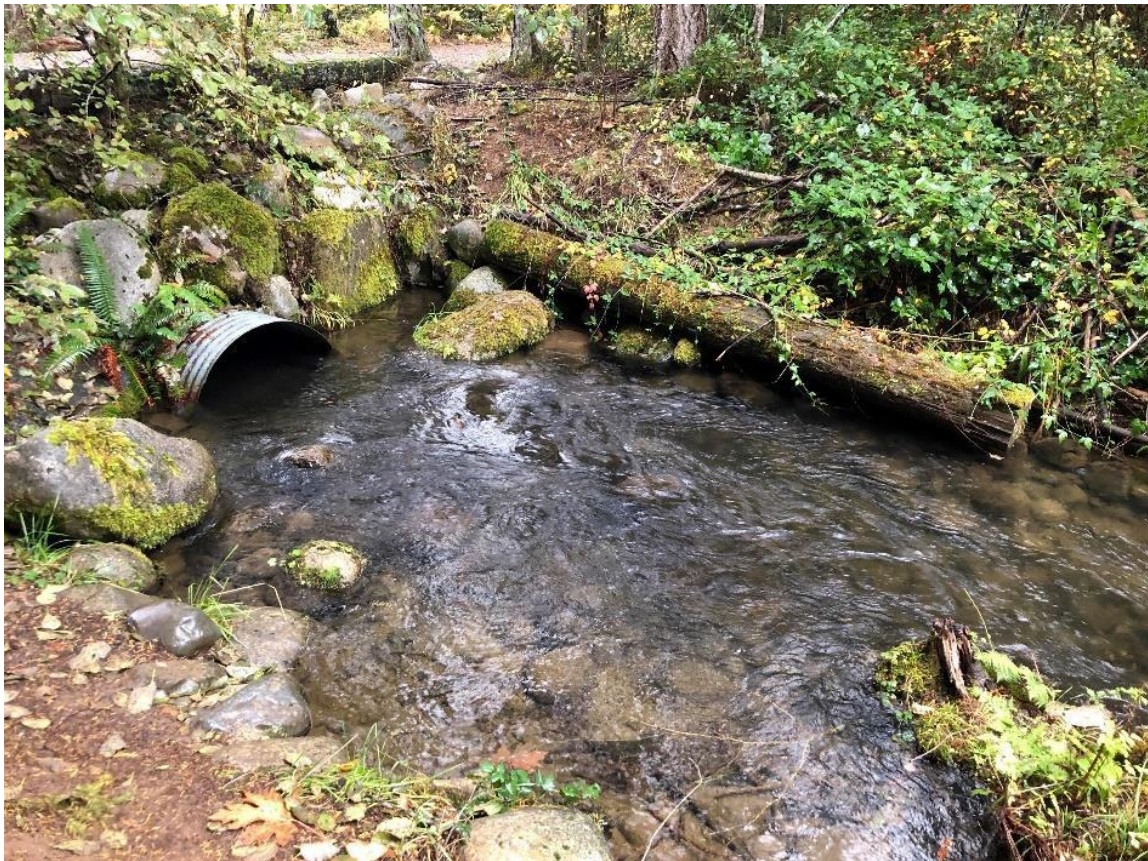
**Figure A2:** Site #2, Located in the C.W. Young Channel

Site #2 is located (UTM 10 U 0406143mE 5459962mN) where the access road crosses the channel and is 1250m downstream of site #1. The sampling station is 3 meters downstream of the metal culvert which runs under the access road. The gradient of this site is comparable to site #1 but the water has more flow at this location and could be considered a riffle. However, the substrate of this location is quite different and consists of course gravel (60%), cobble (20%), boulders (10%) and large woody debris (10%). The canopy cover is ( $<30\%$ ) and is comprised of Douglas firs (*Pseudotsuya menziesii*) and Western Red Cedars (*Thuja plicata*), the riparian zone consists mostly of salal (*Gaultheria shallon*).

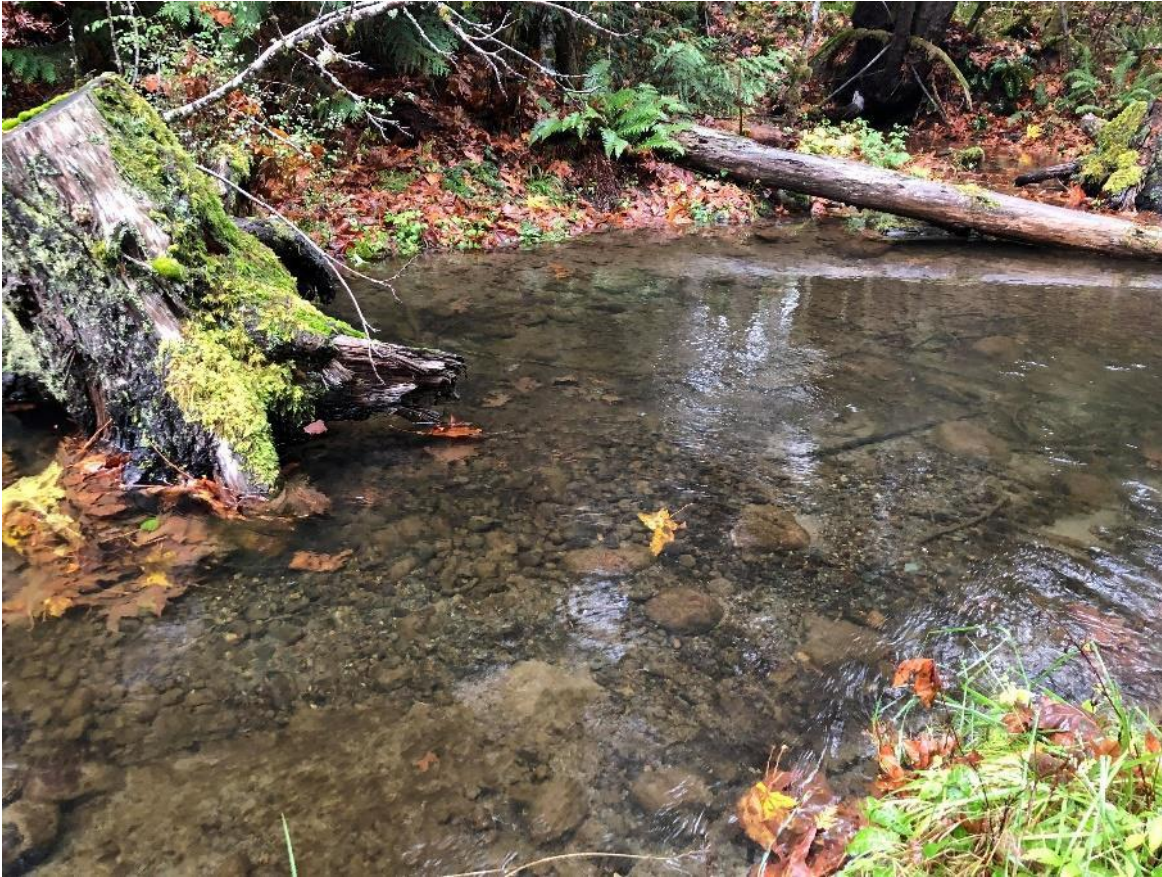
**Figure A3:** Site #3, Located in the C.W. Young Channel

The third site (UTM 10U 0407089mE 5460663mN) is located 2900m downstream of site #1 and is found ~ 50m west of the access road. The sample station is 3 meters downstream of the bend in the channel. The gradient of site #3 is low and resulting in slow water flow. The canopy is limited to ( $<10\%$ ) and is comprised of Big Leaf Maples and Western Red Cedars. There is a

large open meadow that consumes most of the riparian zone which consists of various grasses, downstream of the bend the riparian switches to salal and other shrubs. The sample station substrate consisted of coarse gravel (30%), cobble (30%), large woody debris (20%), and fines/silt (20%). The large meadow could be susceptible to flooding in high water conditions, therefore, accessibility could be more difficult for the crew.

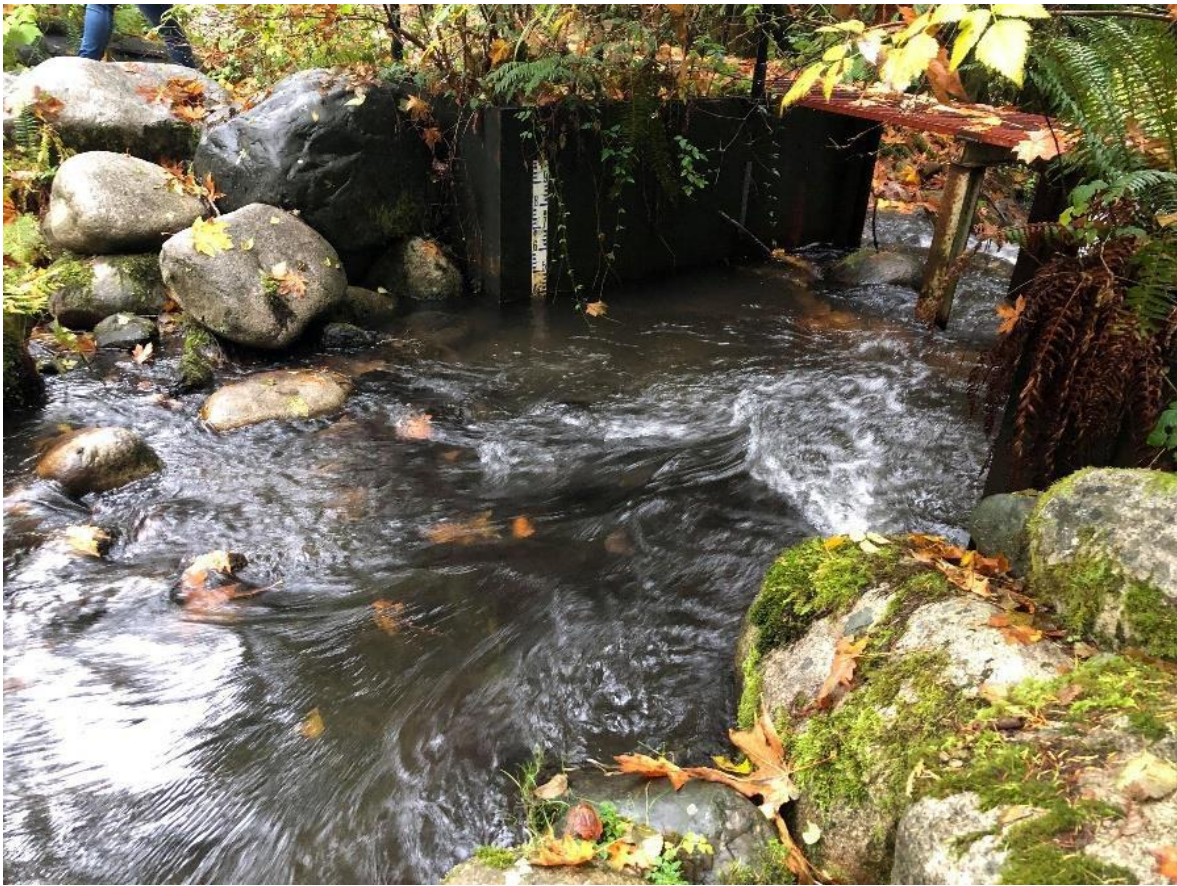
**Figure A4:** Site #4, Located in the C.W. Young Channel

Site #4 (UTM 10U 0407495mE 5461056mN) is located 3800m downstream of site #1. The site is unique from the rest as it has a metal footbridge in it, this footbridge has a water level measurement on the side and is used to monitor water level in channel. The metal footbridge creates a drop resulting in a cascade and isn't suitable for sampling, therefore, the sample station will be 5 meters downstream of the bridge. The canopy covered is (~40%) consisting of Douglas firs and Maple trees. The sample station substrate is mostly large cobble (50%), coarse gravel (20%), Boulders (20%) and fines/silt (10%). The surrounding riparian zone has sword ferns, salal, and salmonberry shrubs. There is a large pool located upstream of the bridge, if the water level was to increase it could make sampling this site more difficult.

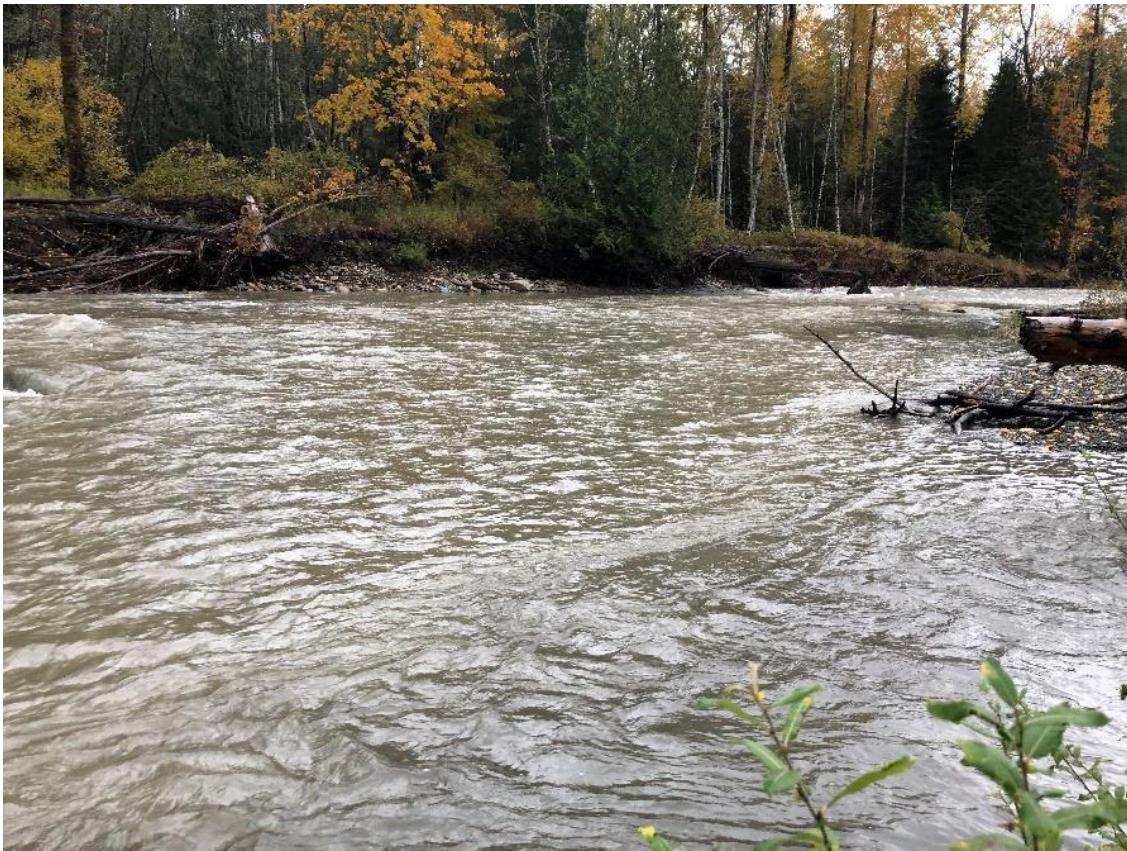
**Figure A5:** Site #5, Located in the Englishman River

The last sample station site #5 is located on the Englishmen River and is downstream of the outflow of the channel. Site #5 (UTM 10U 0407805mE 5461177mN) has no canopy coverage as the confluence of the channel and river is very open. The riparian zone is dominated by willow. The Englishmen substrate is very different from the C.W. Young channel and consists of cobble (80%), boulders (5%), and coarse gravel (15%).
