**Water Quality and Stream Invertebrate  
Assessment for the Millstone River, Nanaimo, BC  
(Fall 2019)**

RMOT 306 - Environmental Monitoring  
Dr. Eric Demers, Vancouver Island University

December 13, 2019

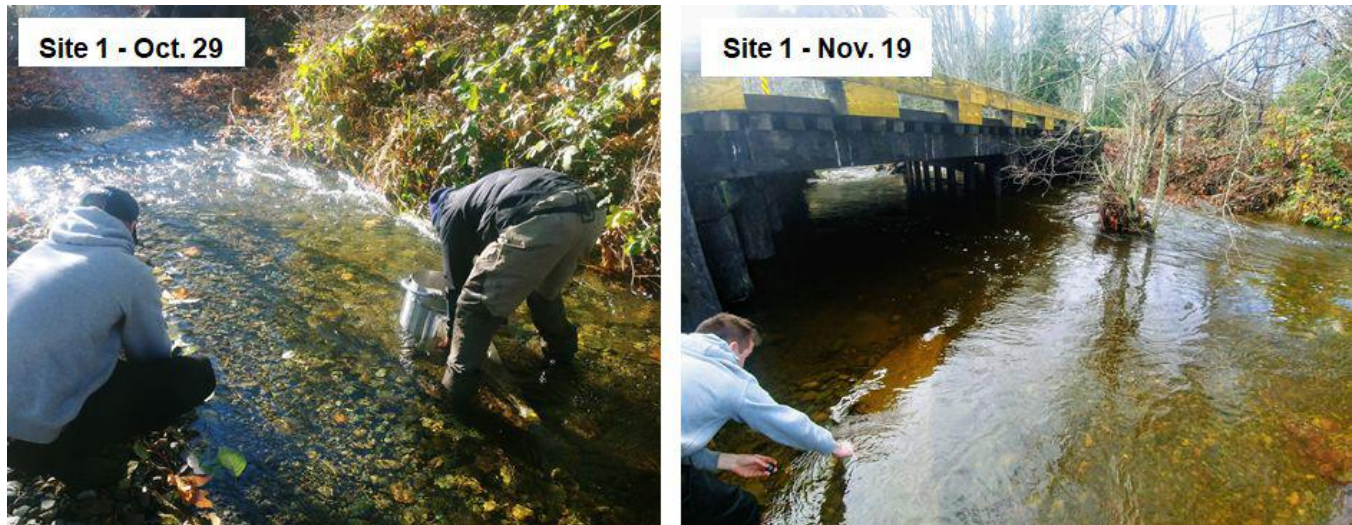
**Figure 2.** Sampling site 1 - Benson Creek at Biggs Road.

Site #1 (Figure 2) is located on the Benson Creek, which flows into Brannen Lake from the southwest. Access to the sampling site is from the bridge where Biggs road crosses the creek, and the safest route of access is to hike down southwest from the bridge to the rocky embankment running along the creek. Due to Benson creek passing through agricultural lands, it is possible that nutrient levels, such as phosphorus and nitrogen, may be higher than normal due to runoff from fertilizer and manure. There is little riparian vegetation along the bank within the low-lying floodplain where the sampling site is located due to frequent flooding. The substrate mainly consists of bare sands (~10%), gravel (50%), and cobbles (~40%) at the sampling site; however there are also large amounts of organic material (leaves and plant matter) providing potential habitat and food sources for invertebrates. The canopy is composed dominantly of alder and big leaf maple, which provides patches of cover for the creek. This

is important as trees help maintain the integrity of the river bank, preventing erosion during high flows observed in the second sampling event (Nov. 19 2019).

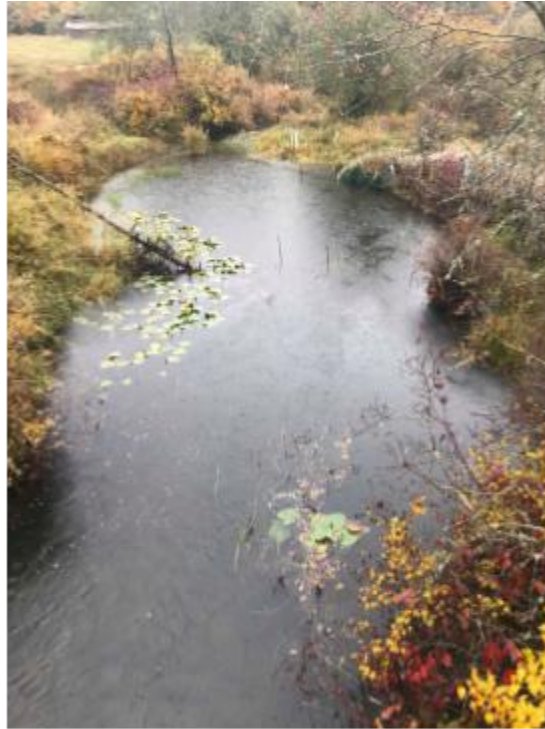
**Figure 3.** Sampling site 2 - Millstone River at Biggs Road

Site #2 (Figure 3) is located at the initial stage at which the Millstone River exits Brannen Lake and crosses below Biggs Road. The safest point of access at this sampling location is off of the Northeast corner of the bridge crossing and down a grassy embankment. Potential hazards correspond to prolonged exposure of the site to rainfall, causing the bank to potentially become loose or eroded. The site is heavily vegetated, with heavy shrub and tree cover approximately 5 metres upstream, and the site itself is resided mainly by grasses and shrubs. Due to the slow/moderate flow of the river at this site, the substrate was mainly composed of sediment with a sparse covering of gravel (~30%), coarse rock (~20%) and organic material (~50%).

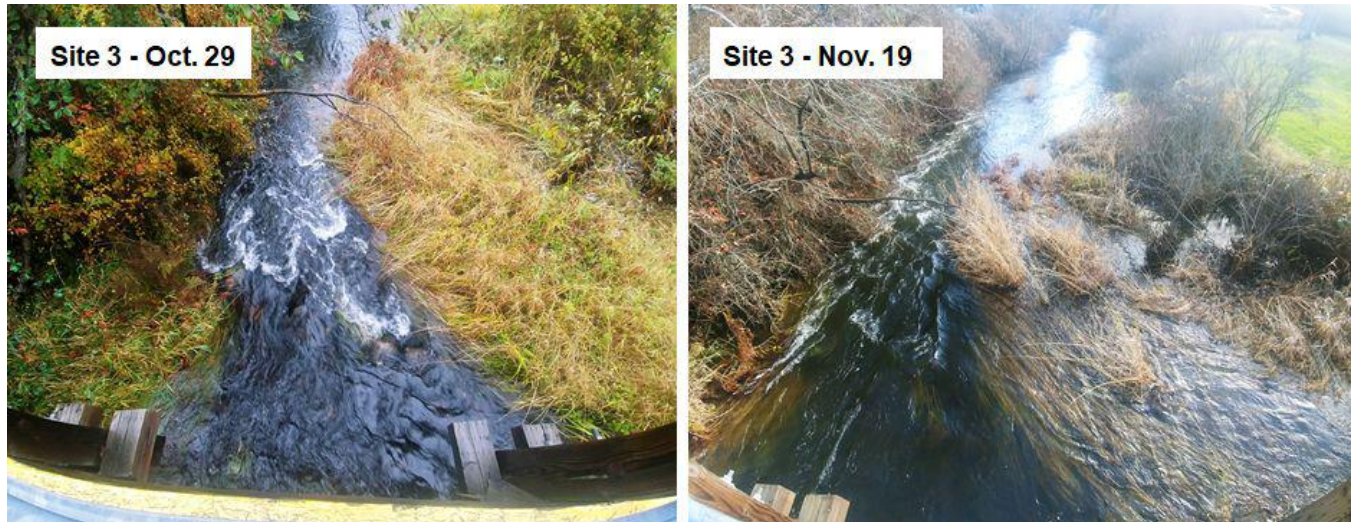
**Figure 4.** Sampling site 3 - Millstone River at the corner of Maxey and Durnin Road.

Site #3 (Figure 4) is located at the junction of Maxey Road and Durnin Road. Access to the sampling site was gained by traversing down a gravel path off of the Southwest side of the bridge. Similar to Site #2, the river bank is heavily vegetated with shrub and tree cover along the river bank. The substrate is mainly composed of fines/silt (~40%) and organic material (~40%) with a small portion of gavel/rock present (~20%). Potential concern associated with this site is in the case of water levels rising due to increased rainfall, which would cause erosion and flooding of the small gravel bar where sampling would occur from.

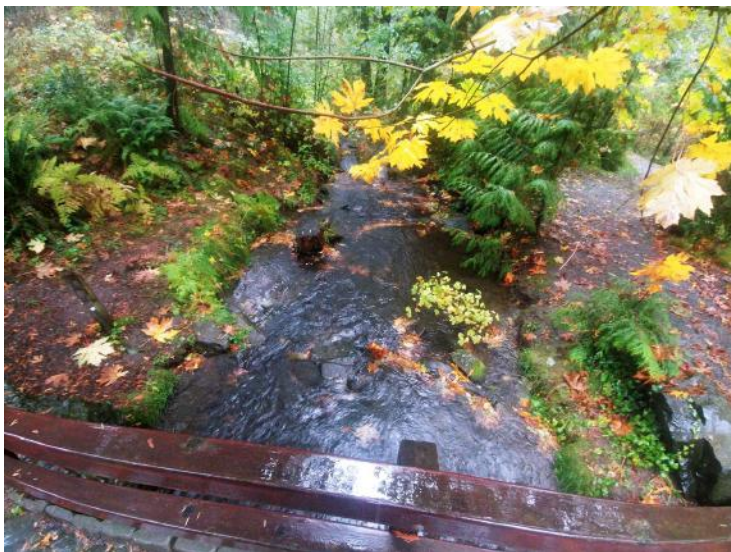
**Figure 5.** Site 4 - Millstone River side channel at Bowen Park

Site #4 (Figure 5) is located in Bowen Park, at the downstream outlet of the duck pond in the side channel. Due to the heavy presence of water fowl directly upstream from the sampling station, it would be assumed that the water sampled may contain significant microbial activity due to feces and organic material produced and disturbed flowing into the outlet. There is little to no hazard associated with accessing this site, where the only potential for concern is loose footing on the surrounding bank and rock when entering the stream. The substrate is mainly composed of large rock (~60%), leaf litter (~20%) and fine sand/silt (~20%).
