**WATER QUALITY, MICROBIOLOGY, AND INVERTEBRATE  
SAMPLING IN RICHARDS CREEK, CROFTON, BC**

RMOT 306 - Environmental Monitoring

December 13, 2019

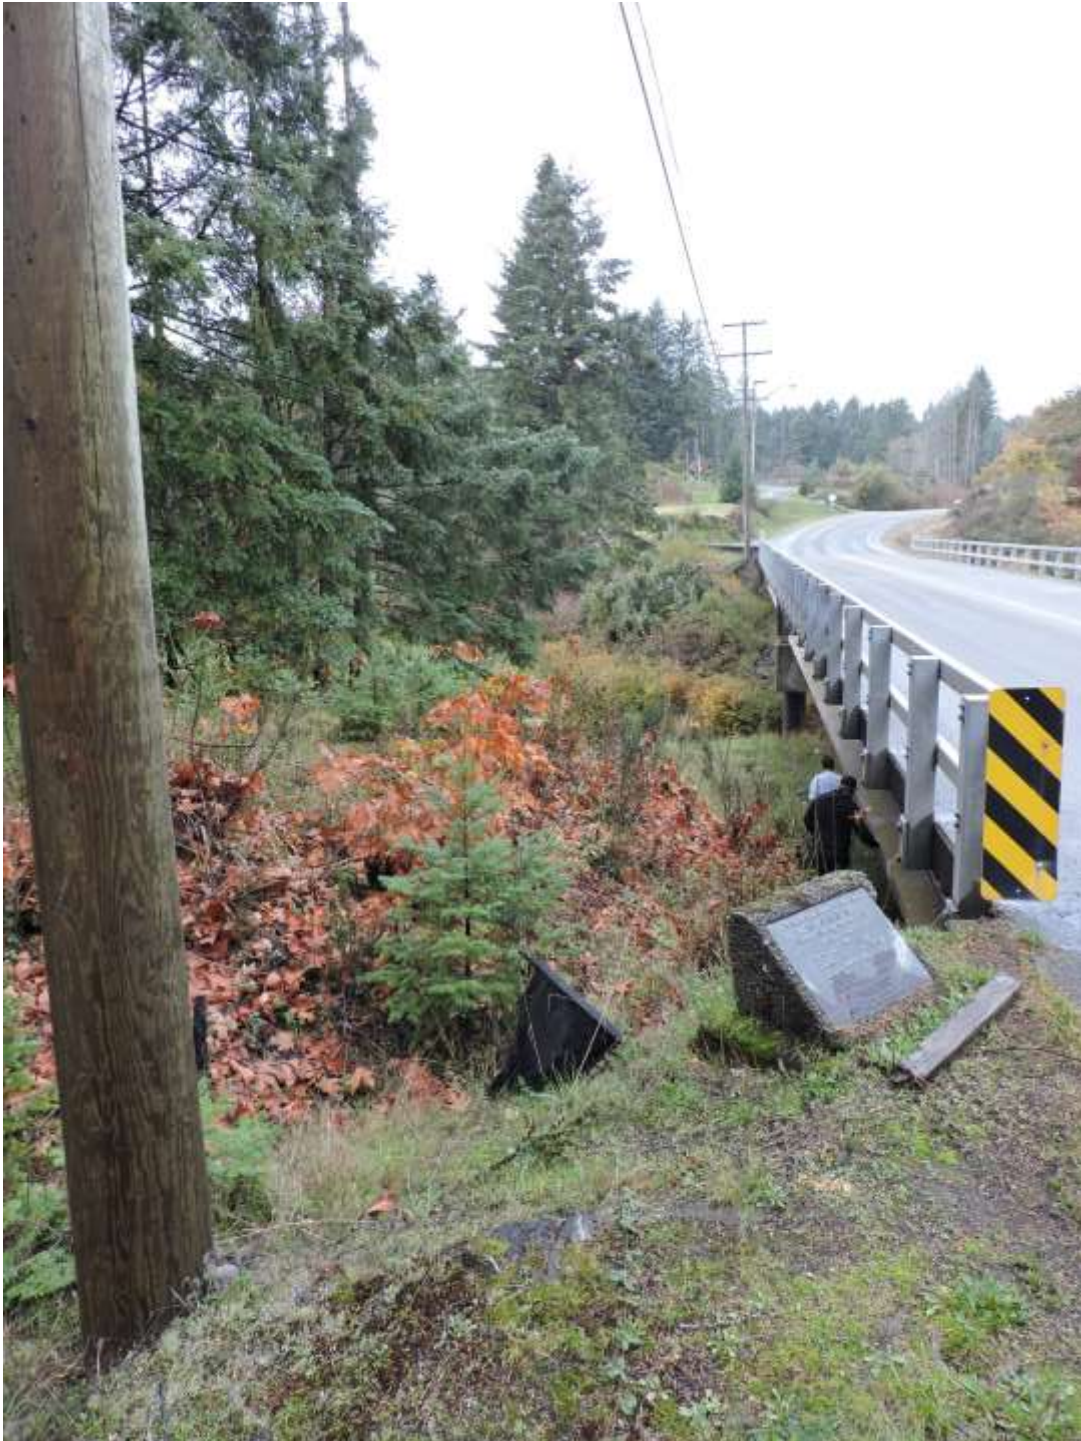
Photo # 1

SITE #	DATE	DESCRIPTION
4	Oct 16 <sup>th</sup> 2019	Richards Creek via Herd Rd Bridge shows uneven terrain and vegetation for access and egress

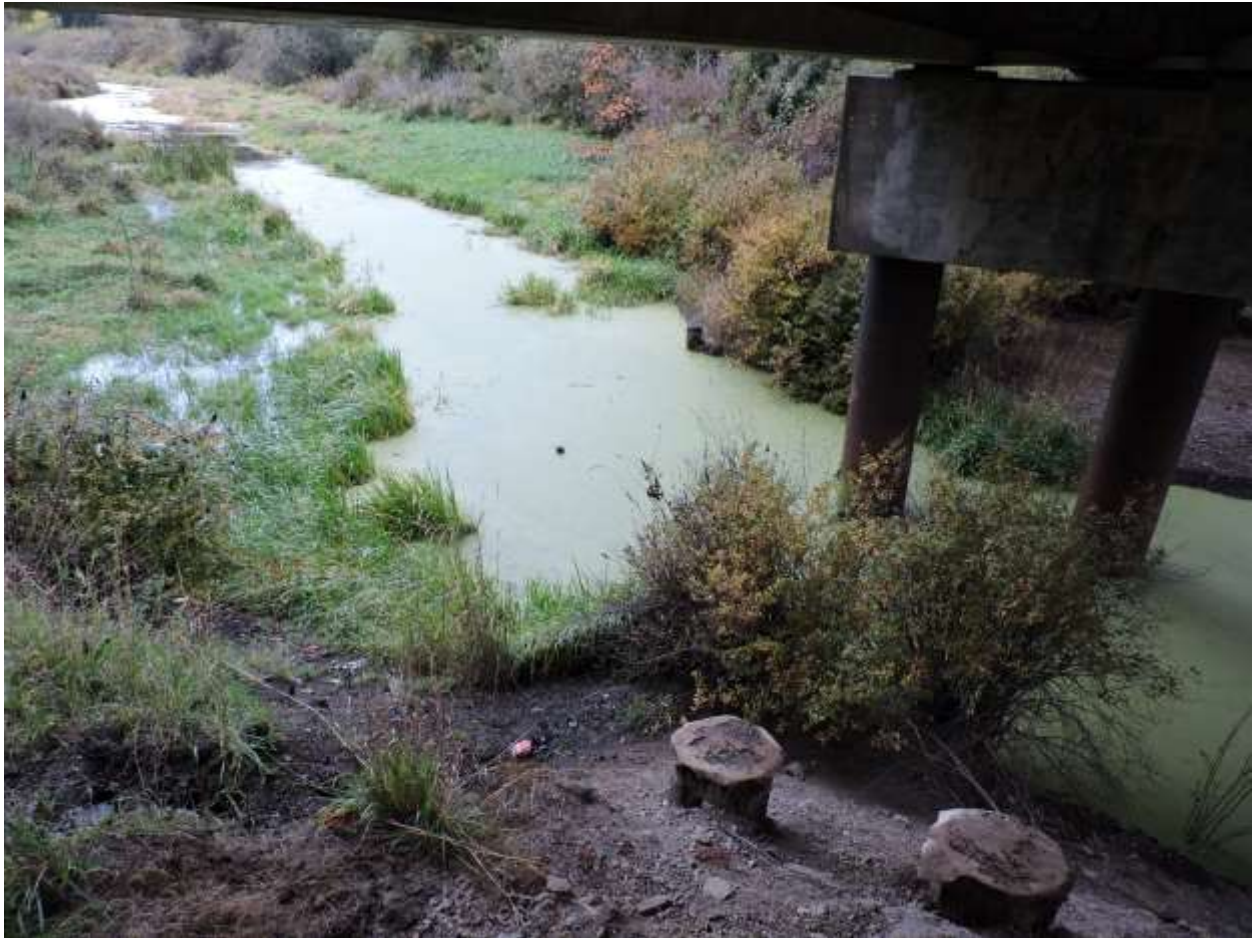
Photo # 2

SITE #	DATE	DESCRIPTION
4	Oct 16 <sup>th</sup> 2019	Green slow-moving/pooling water with insteam vegetation

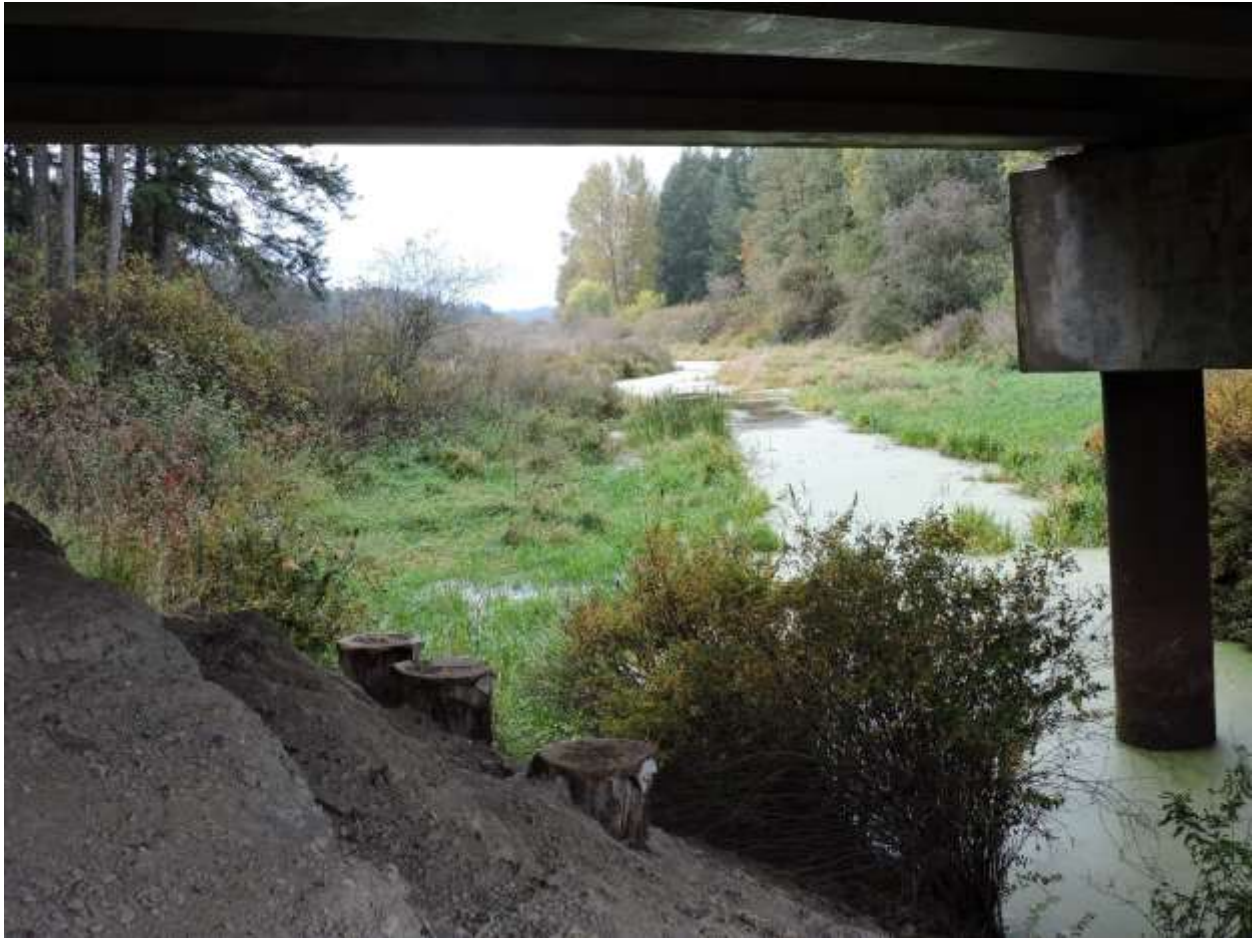
Photo # 3

SITE #	DATE	DESCRIPTION
4	Oct 16 <sup>th</sup> 2019	Steep embankment gravel area under Herd Rd bridge

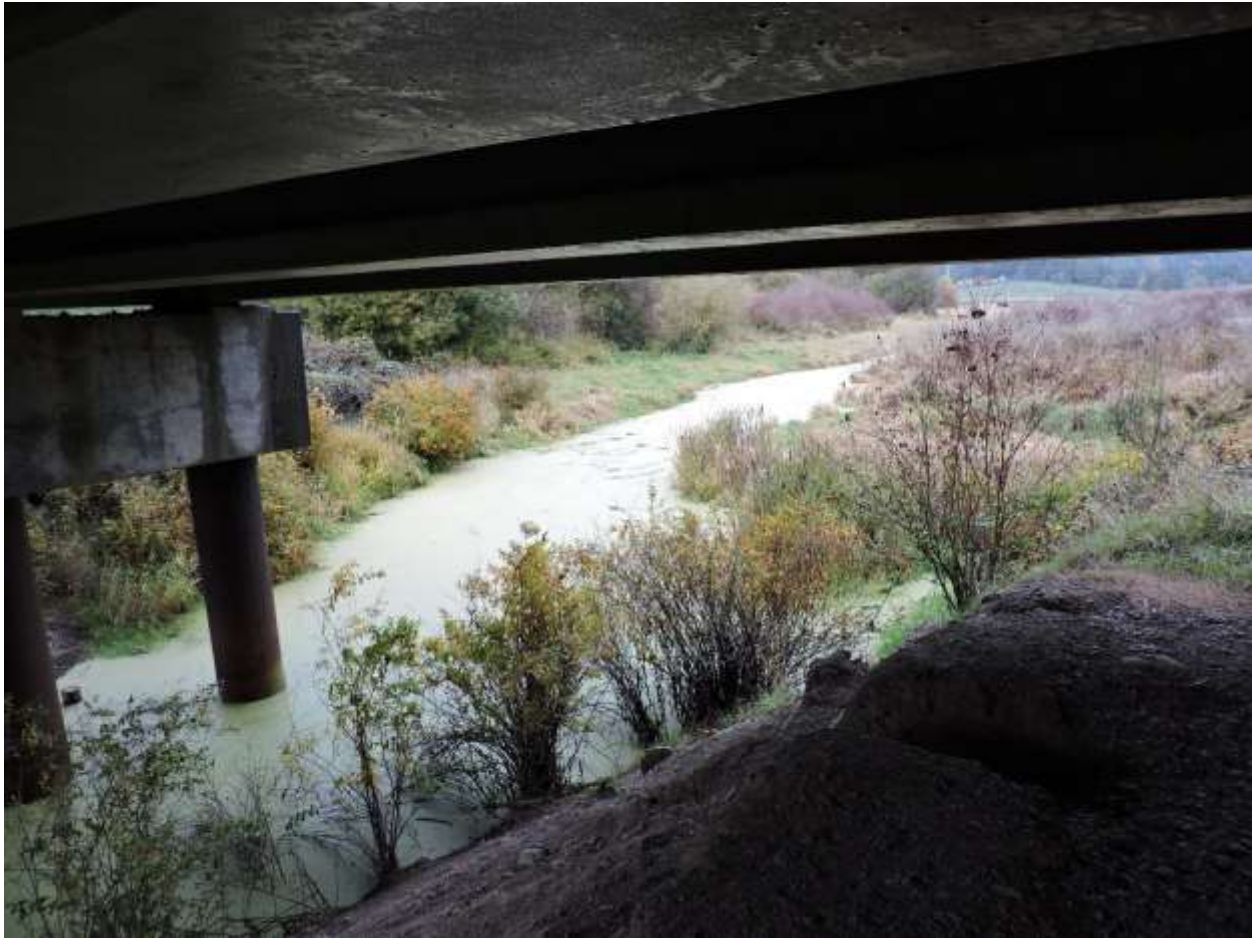
Photo # 4

SITE #	DATE	DESCRIPTION
4	Oct 16 <sup>th</sup> 2019	View from under Herd Rd bridge looking upstream – evidence of waterfowl visible in algae markings

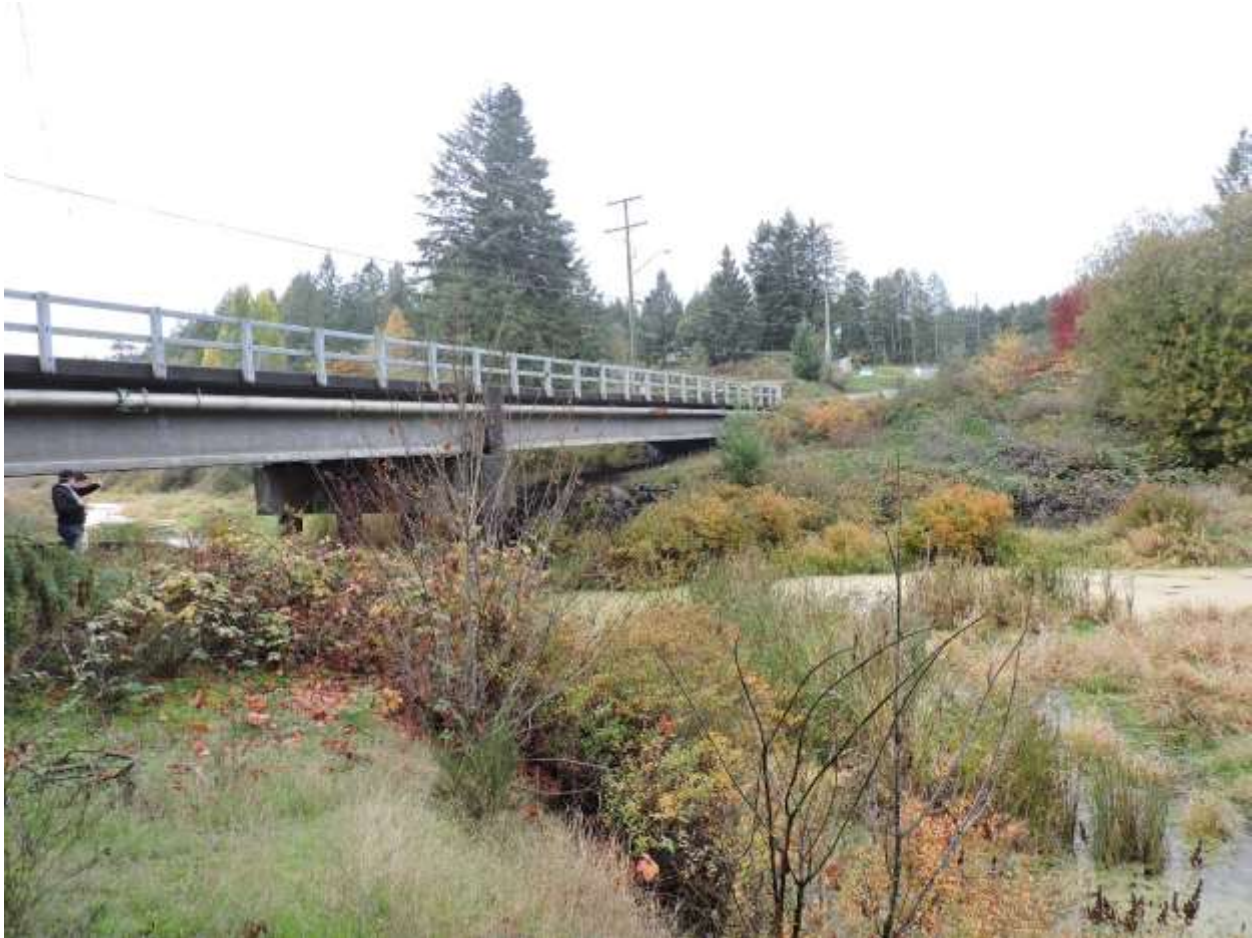
Photo # 5

SITE #	DATE	DESCRIPTION
4	Oct 16 <sup>th</sup> 2019	Uneven terrain covered with vegetation on far-side of creek versus gradual access on near-side of creek

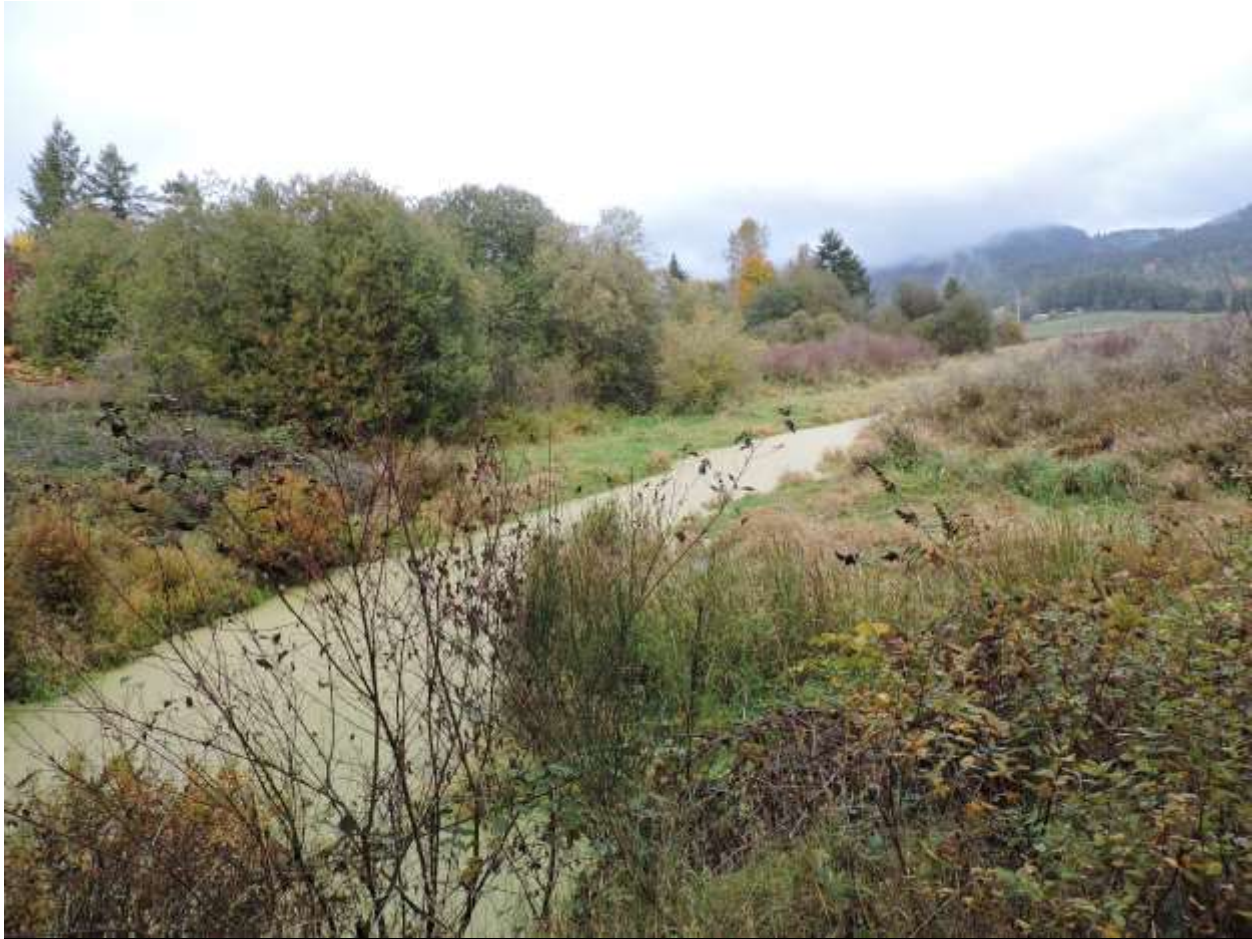
Photo # 6

SITE #	DATE	DESCRIPTION
4	Oct 16 <sup>th</sup> 2019	View of Richard Creek from Herd Rd bridge showing green water surrounded by marsh type vegetation with virtually zero canopy cover

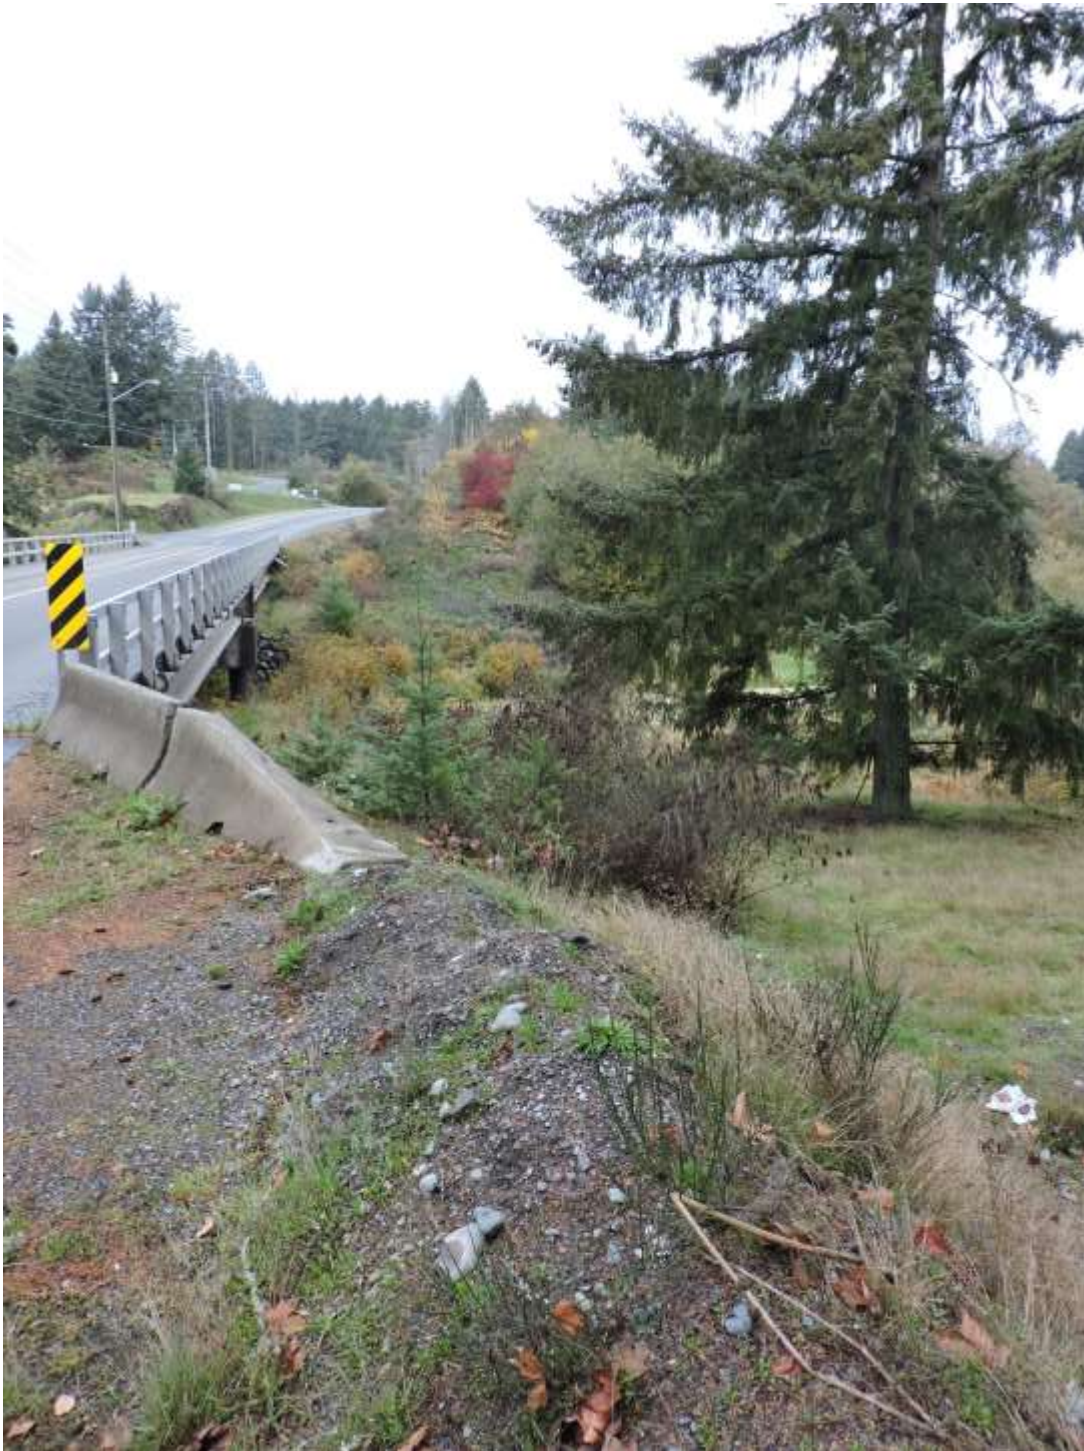
Photo # 8

SITE #	DATE	DESCRIPTION
4	Oct 16 <sup>th</sup> 2019	The one tree located near Site 4 Richard Creek sampling site

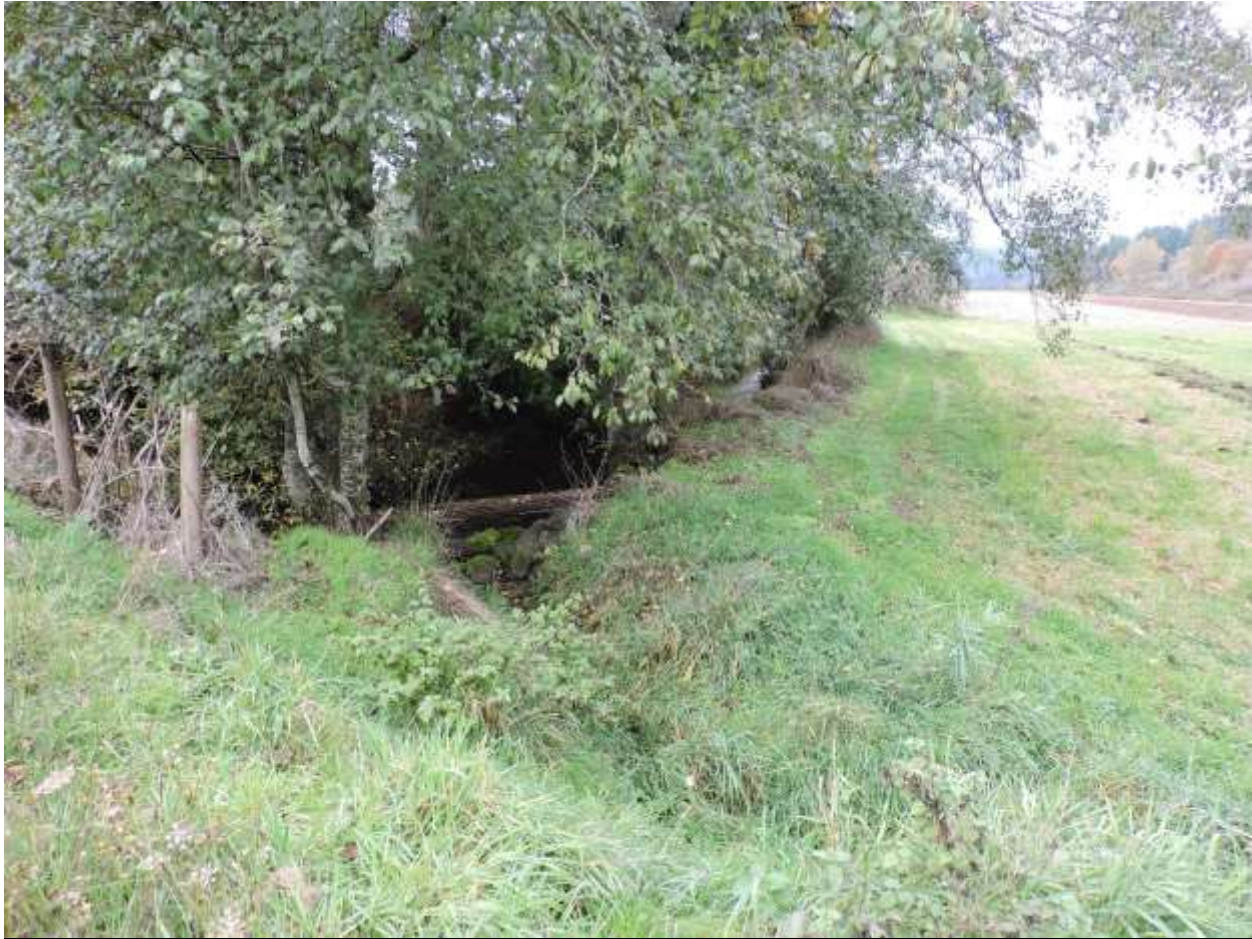
SITE #	DATE	DESCRIPTION
3	Oct 16 <sup>th</sup> 2019	Access to site 3 located at corner of farm field on Richards Trail (road) through deep grassy ditch

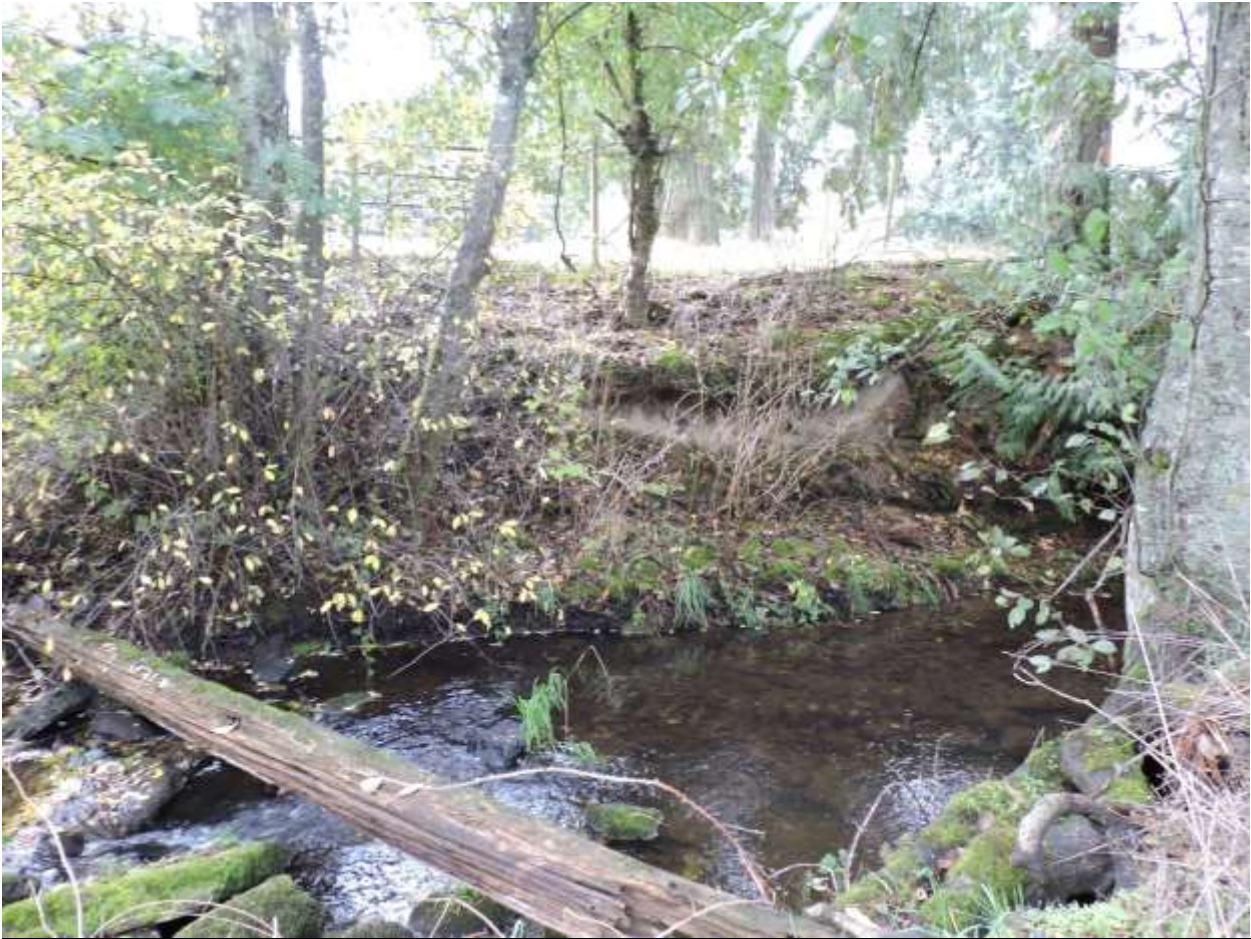
Photo # 9

SITE #	DATE	DESCRIPTION
3	Oct 16 <sup>th</sup> 2019	Riffle area ~5m infront of cement flow-through culvert easily accessible

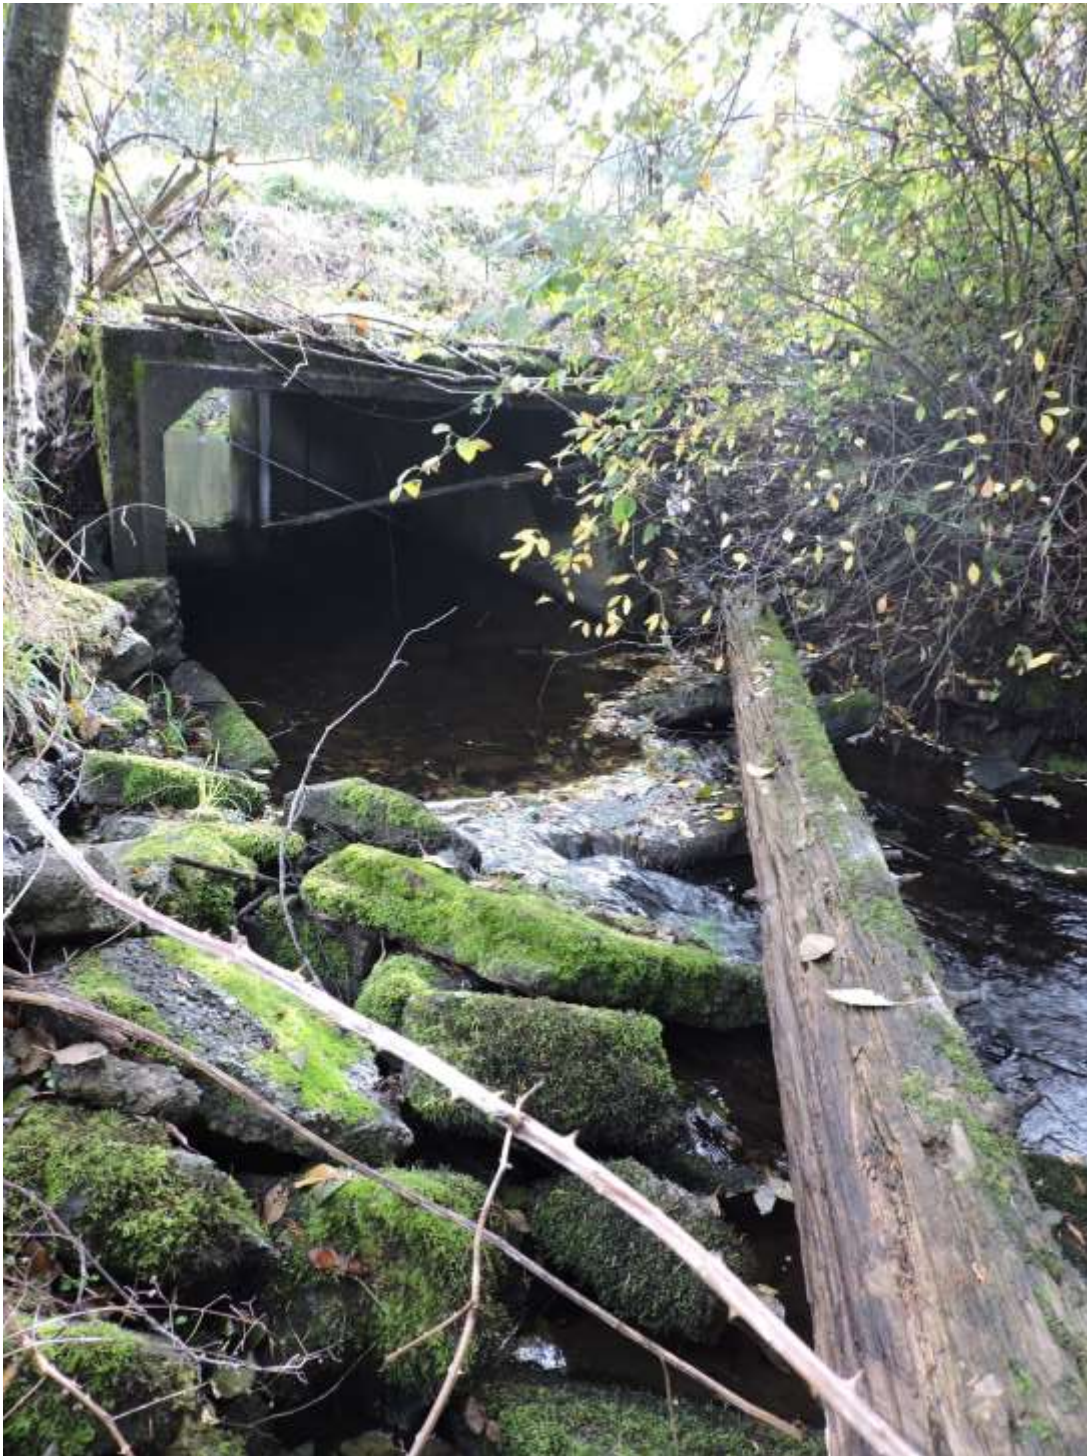
Photo # 10

SITE #	DATE	DESCRIPTION
3	Oct 16 <sup>th</sup> 2019	View of slippery rock hazard and of water flowing through unobstructed culvert

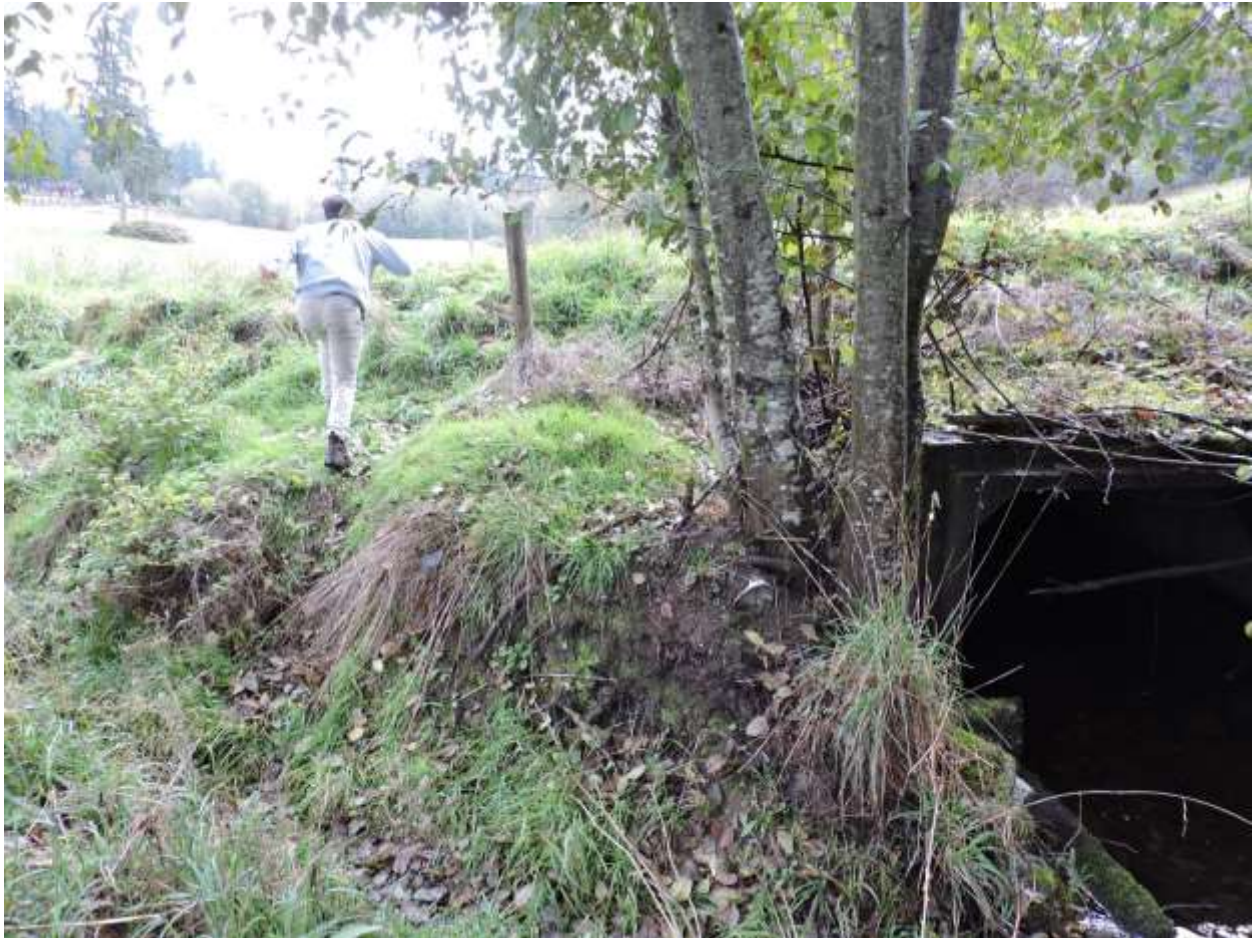
Photo # 11

SITE #	DATE	DESCRIPTION
3	Oct 16 <sup>th</sup> 2019	Access to site 3 located at corner of farm field on Richards Trail (road) through deep grassy ditch

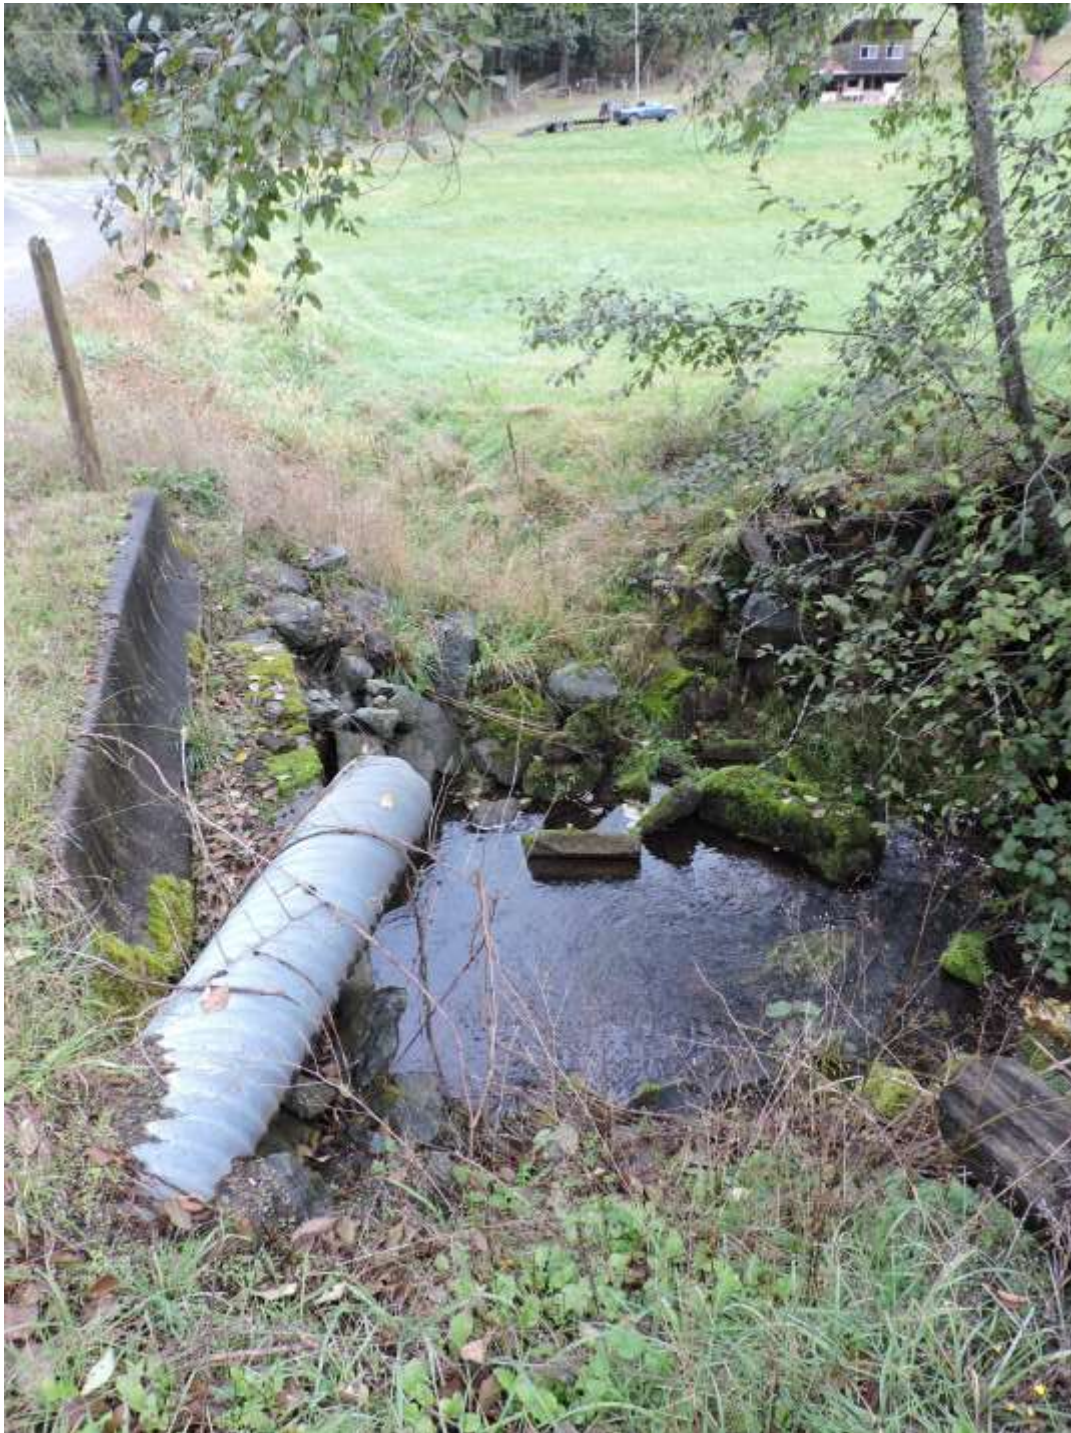
Photo # 12

SITE #	DATE	DESCRIPTION
3	Oct 16 <sup>th</sup> 2019	Less desirable side of culvert for sampling potentially due to large boulders limiting invertebrate Hess sampler method

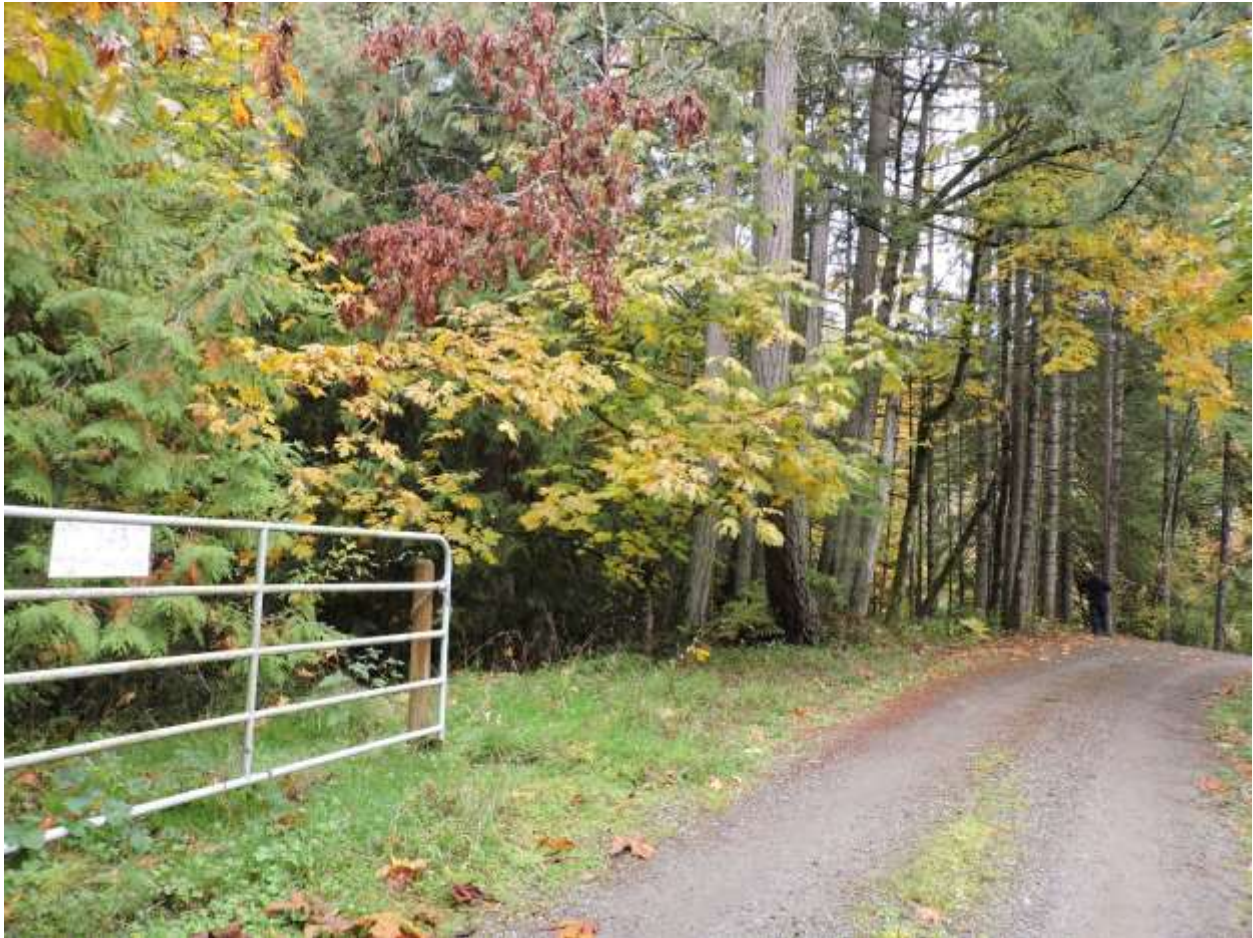
Photo # 13

SITE #	DATE	DESCRIPTION
2	Oct 16 <sup>th</sup> 2019	Access to Site 2 through gravel driveway on private property. Nearly 100% canopy cover from mature forest.

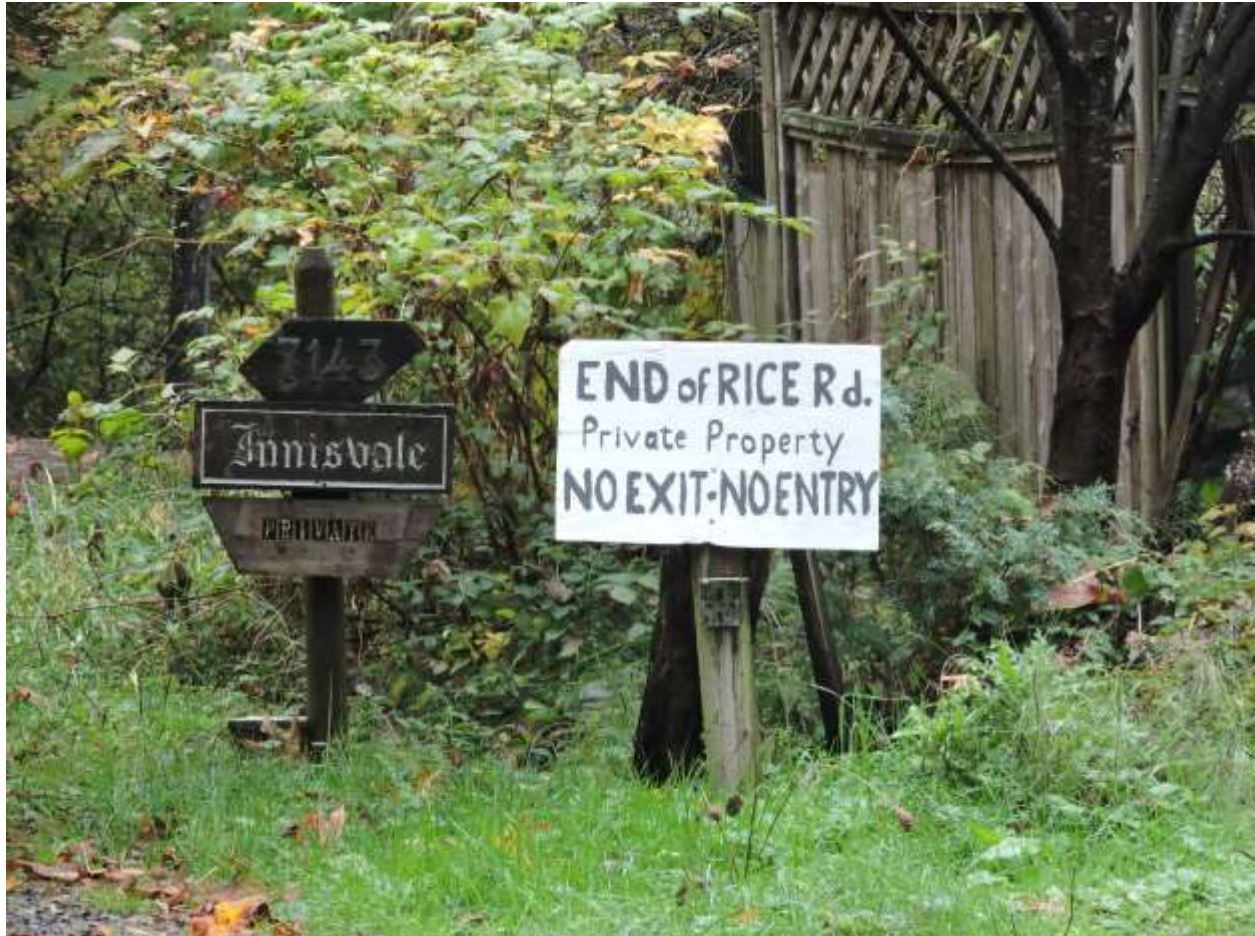
Photo # 15

SITE #	DATE	DESCRIPTION
2	Oct 16 <sup>th</sup> 2019	Access to Site 2 on private property "Innisvale" farm

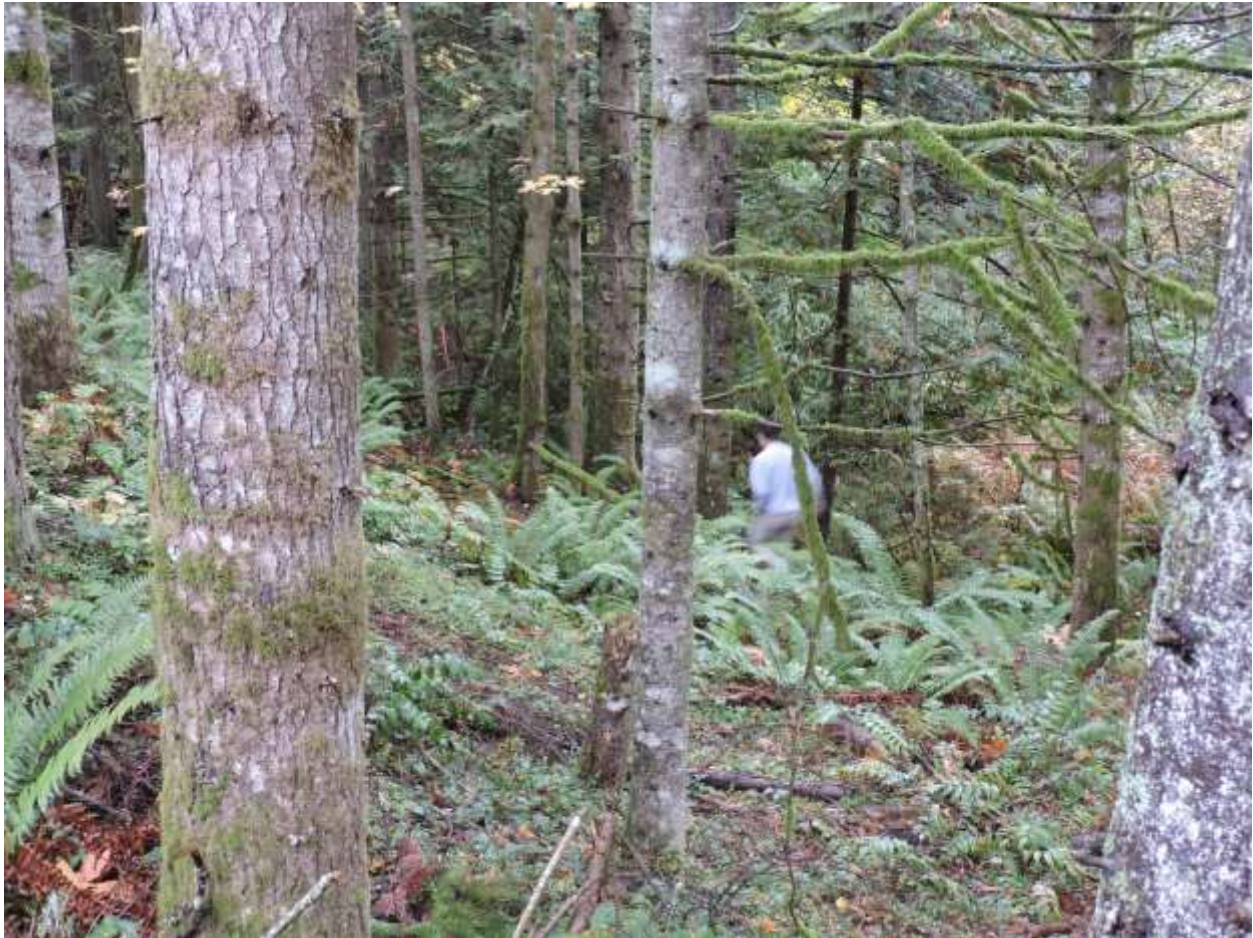
Photo # 16

SITE #	DATE	DESCRIPTION
2	Oct 16 <sup>th</sup> 2019	Access through uneven terrain to pink flagging tape seen in background

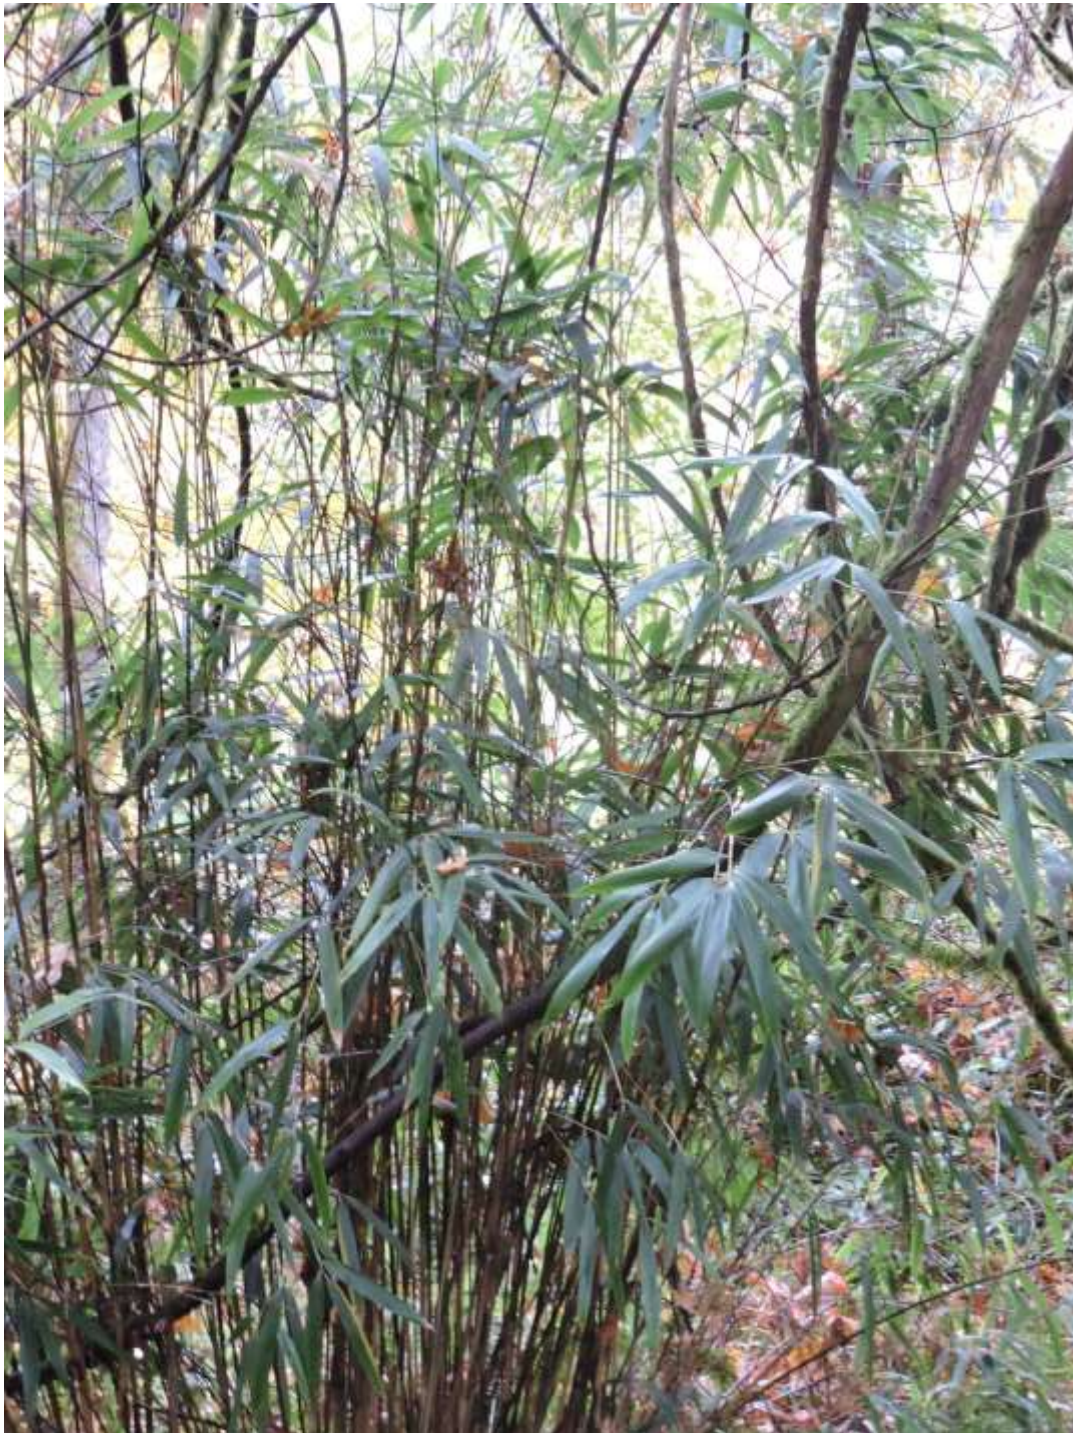
Photo # 17

SITE #	DATE	DESCRIPTION
2	Oct 16 <sup>th</sup> 2019	Potential invansive species (possible bamboo) located in clearing area between driveway and creekside. 3+ plants.

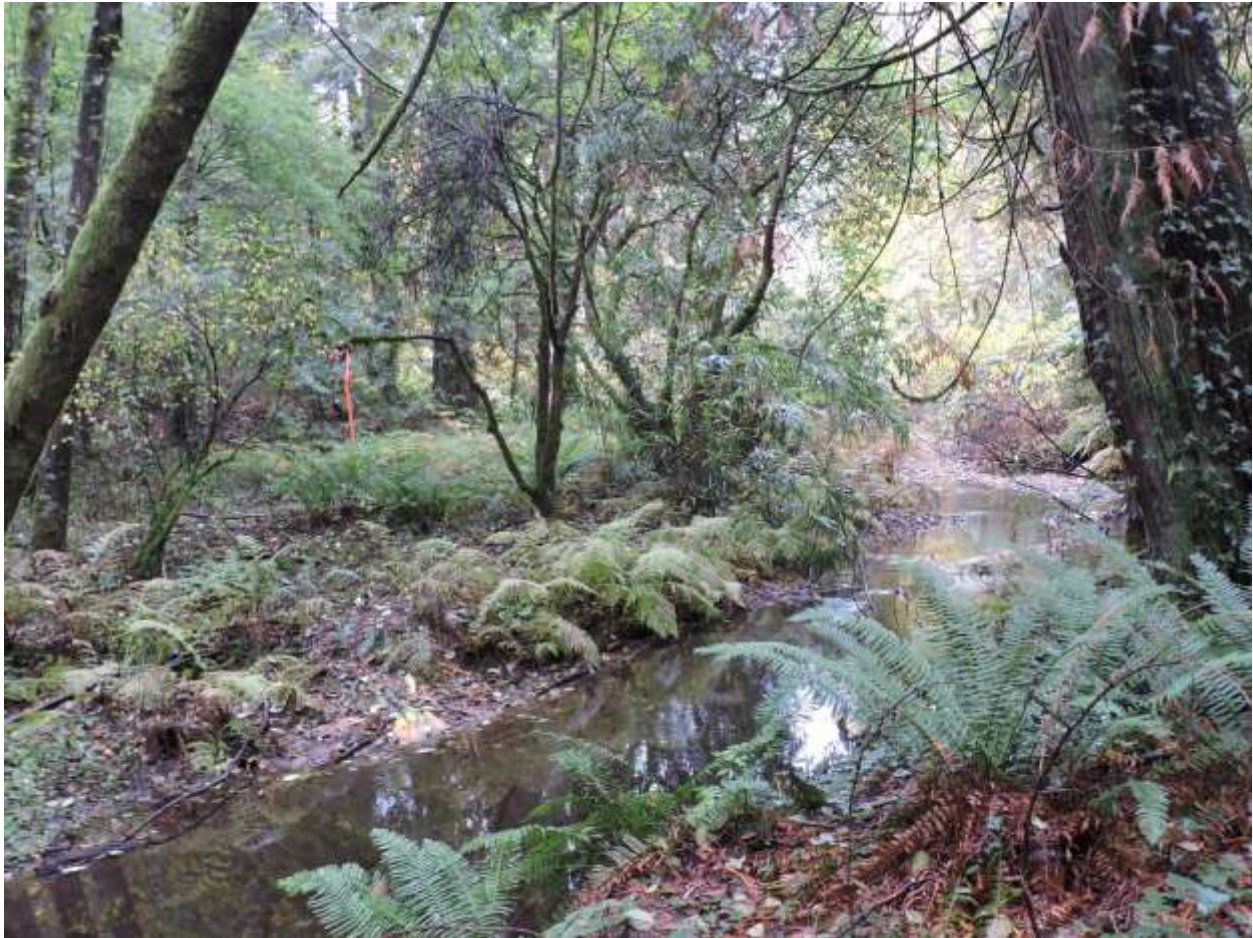
Photo # 19

SITE #	DATE	DESCRIPTION
2	Oct 16 <sup>th</sup> 2019	Orange flagging tape marking possible location of sample site.
