**WATER QUALITY, MICROBIOLOGY, AND INVERTEBRATE  
SAMPLING IN RICHARDS CREEK, CROFTON, BC**

RMOT 306 - Environmental Monitoring

December 13, 2019

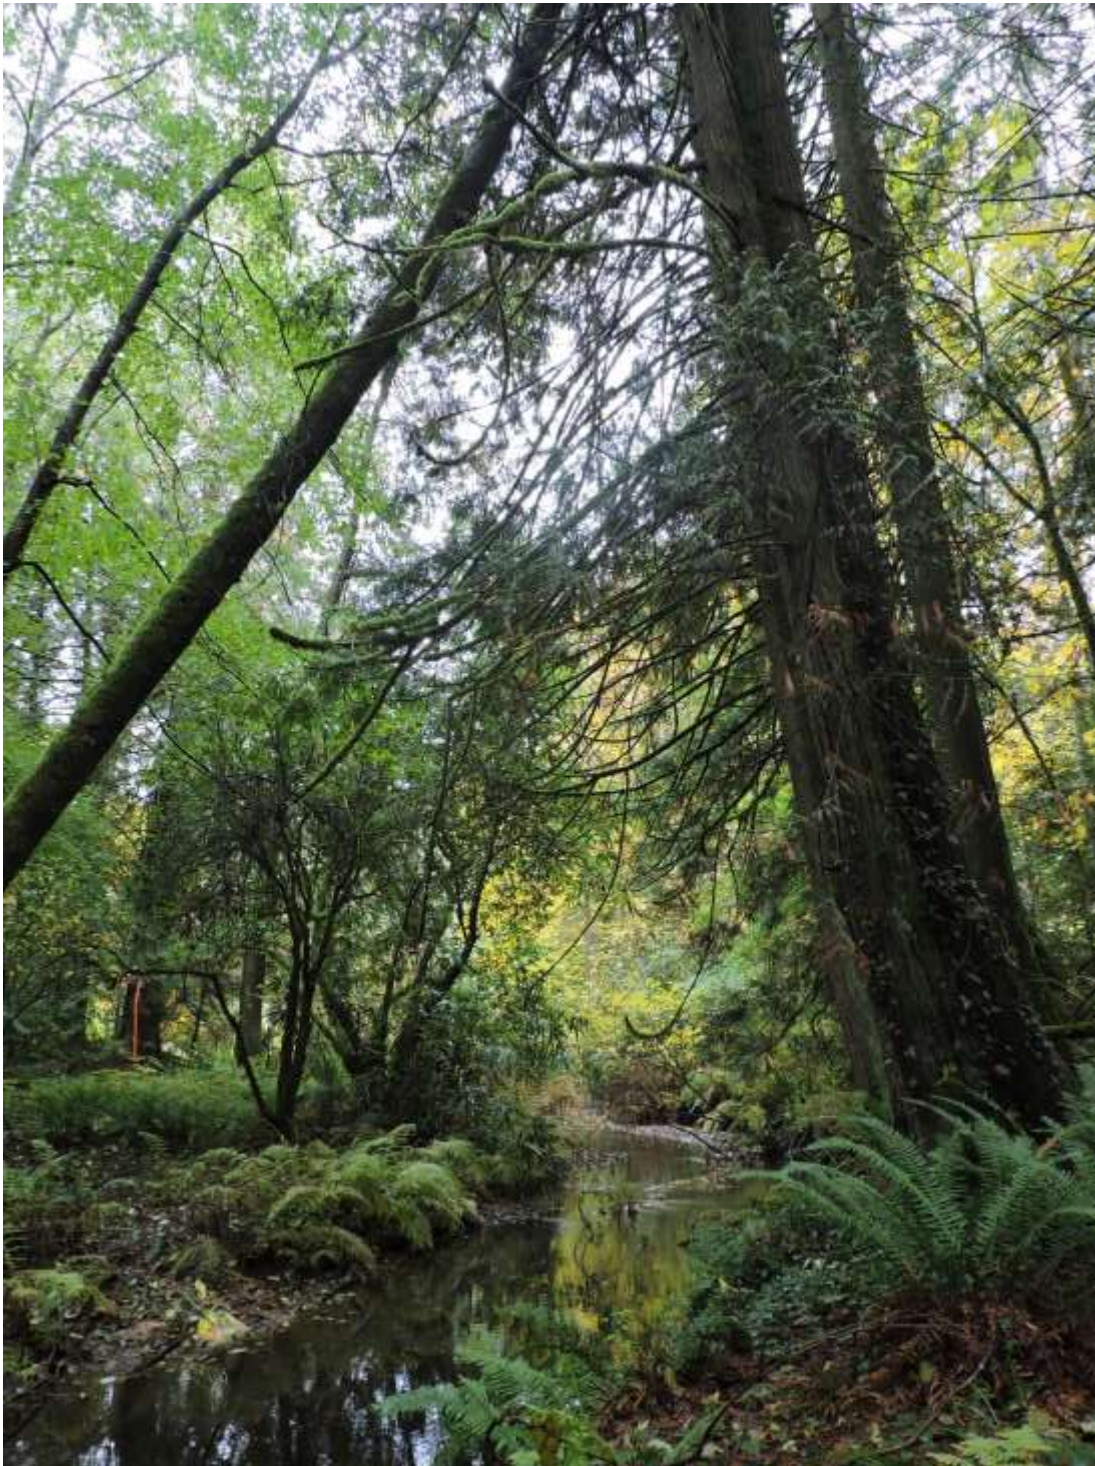
Photo # 19

SITE #	DATE	DESCRIPTION
2	Oct 16 <sup>th</sup> 2019	Riffle and glide habitat types with nearly 100% canopy cover

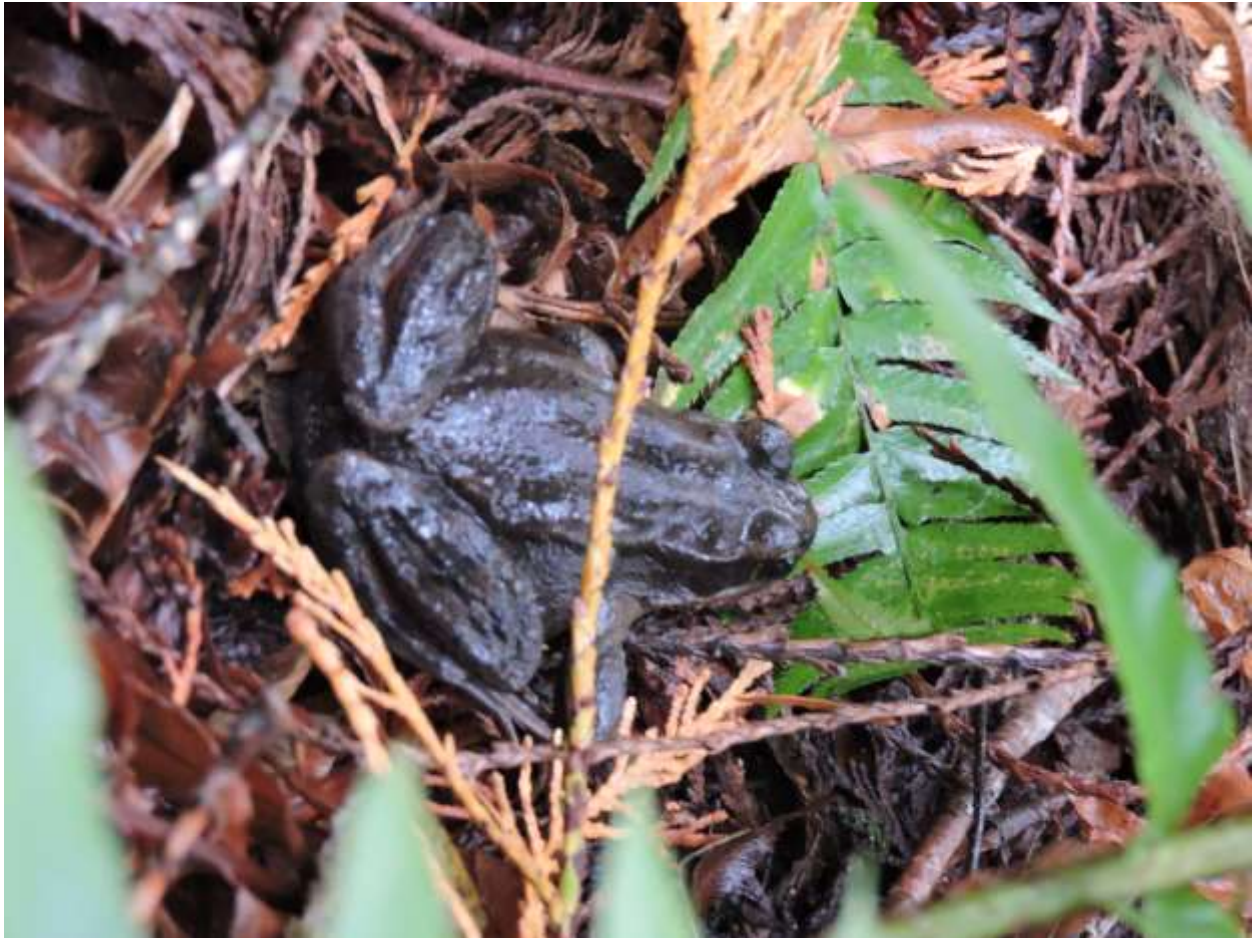
Photo # 21

SITE #	DATE	DESCRIPTION
2	Oct 16 <sup>th</sup> 2019	Frog located on forest floor surrounded by vegetation

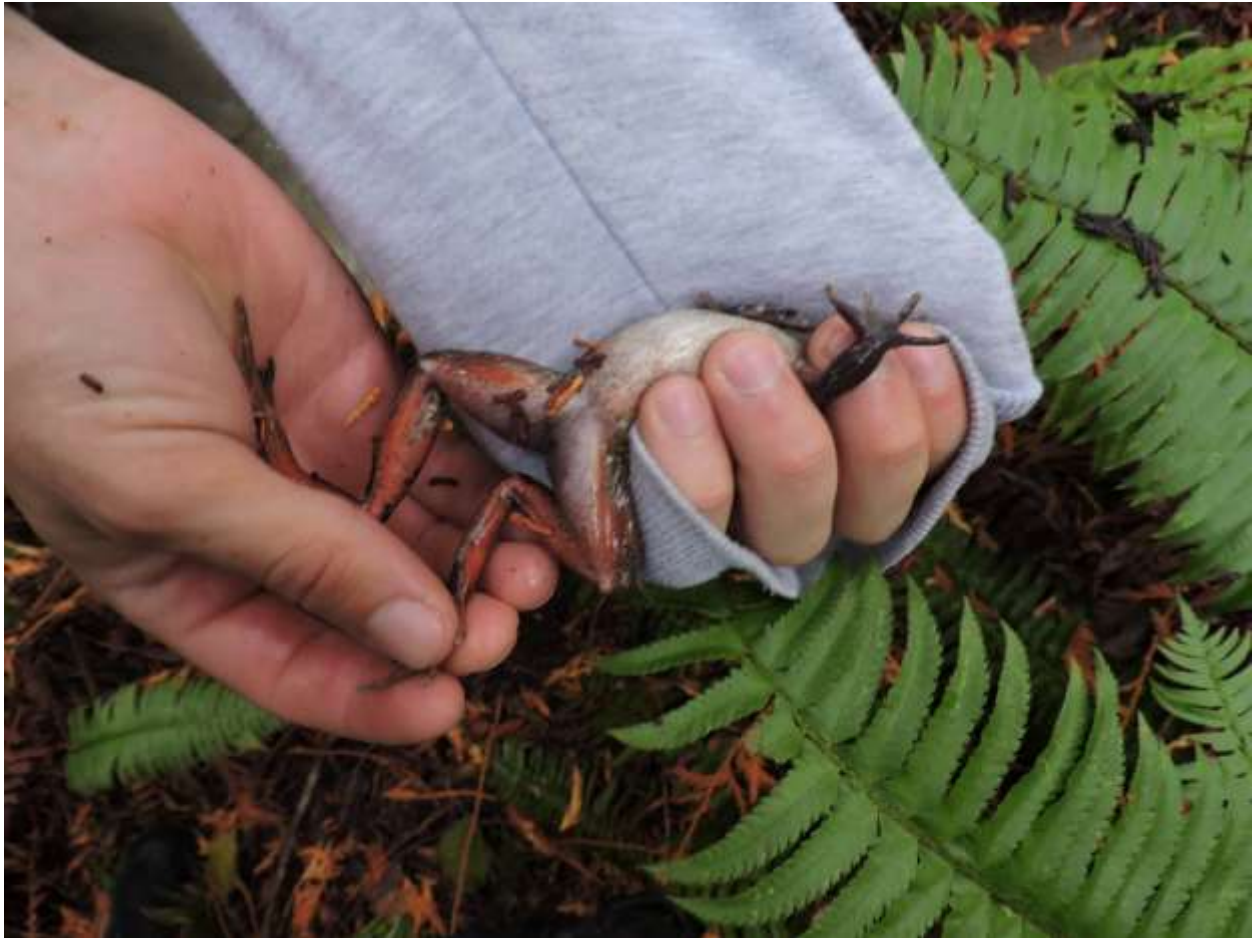
Photo # 22

SITE #	DATE	DESCRIPTION
2	Oct 16 <sup>th</sup> 2019	Confirmed Red-legged frog species, <i>Rana aurora aurora</i> . Gently captured, quickly photographed, and immediately released. No observable issues noted with ambulation after short (<20 seconds) handling duration.

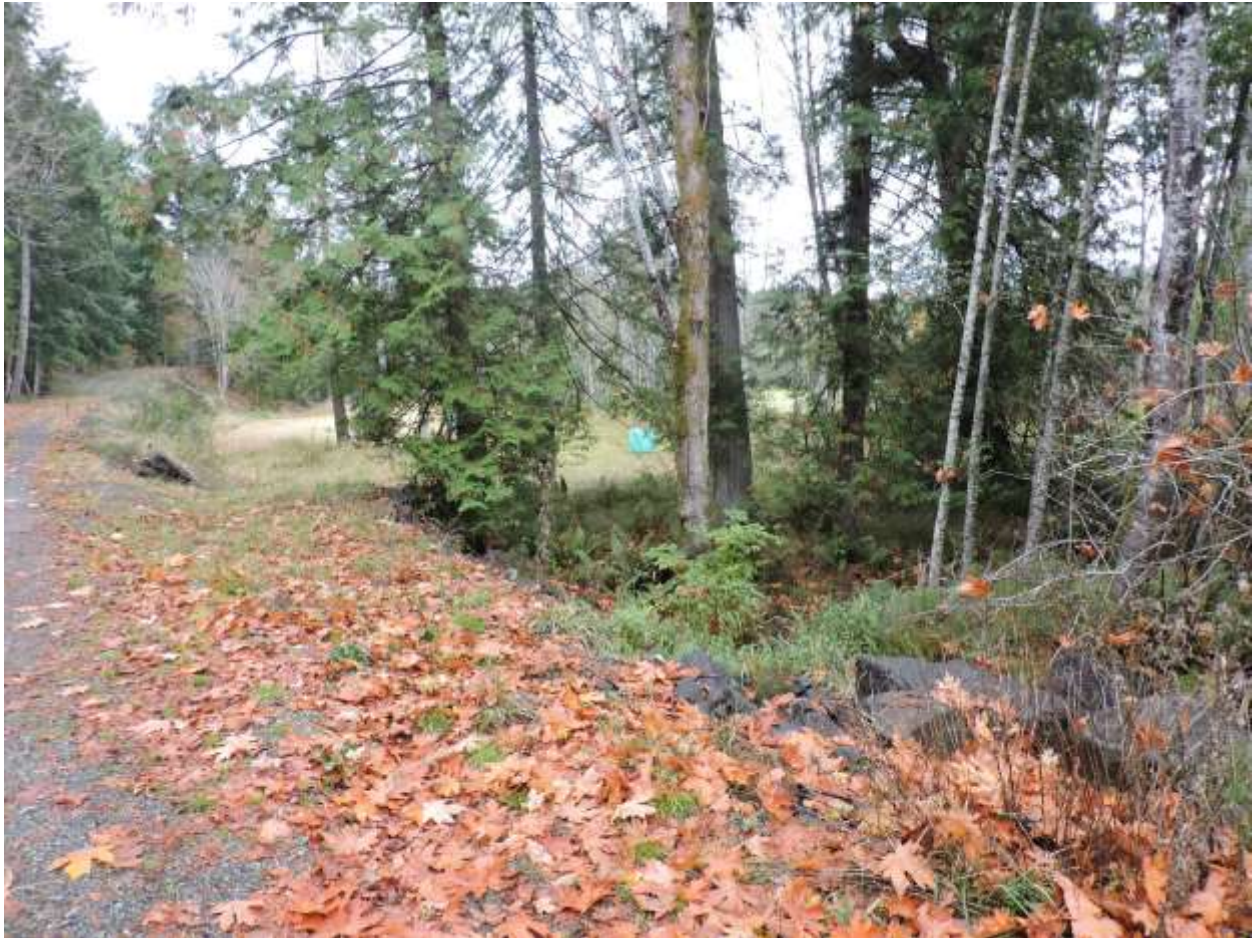
SITE #	DATE	DESCRIPTION
1	Oct 16 <sup>th</sup> 2019	Access to Site 1 via gravel parking area near farm access road.

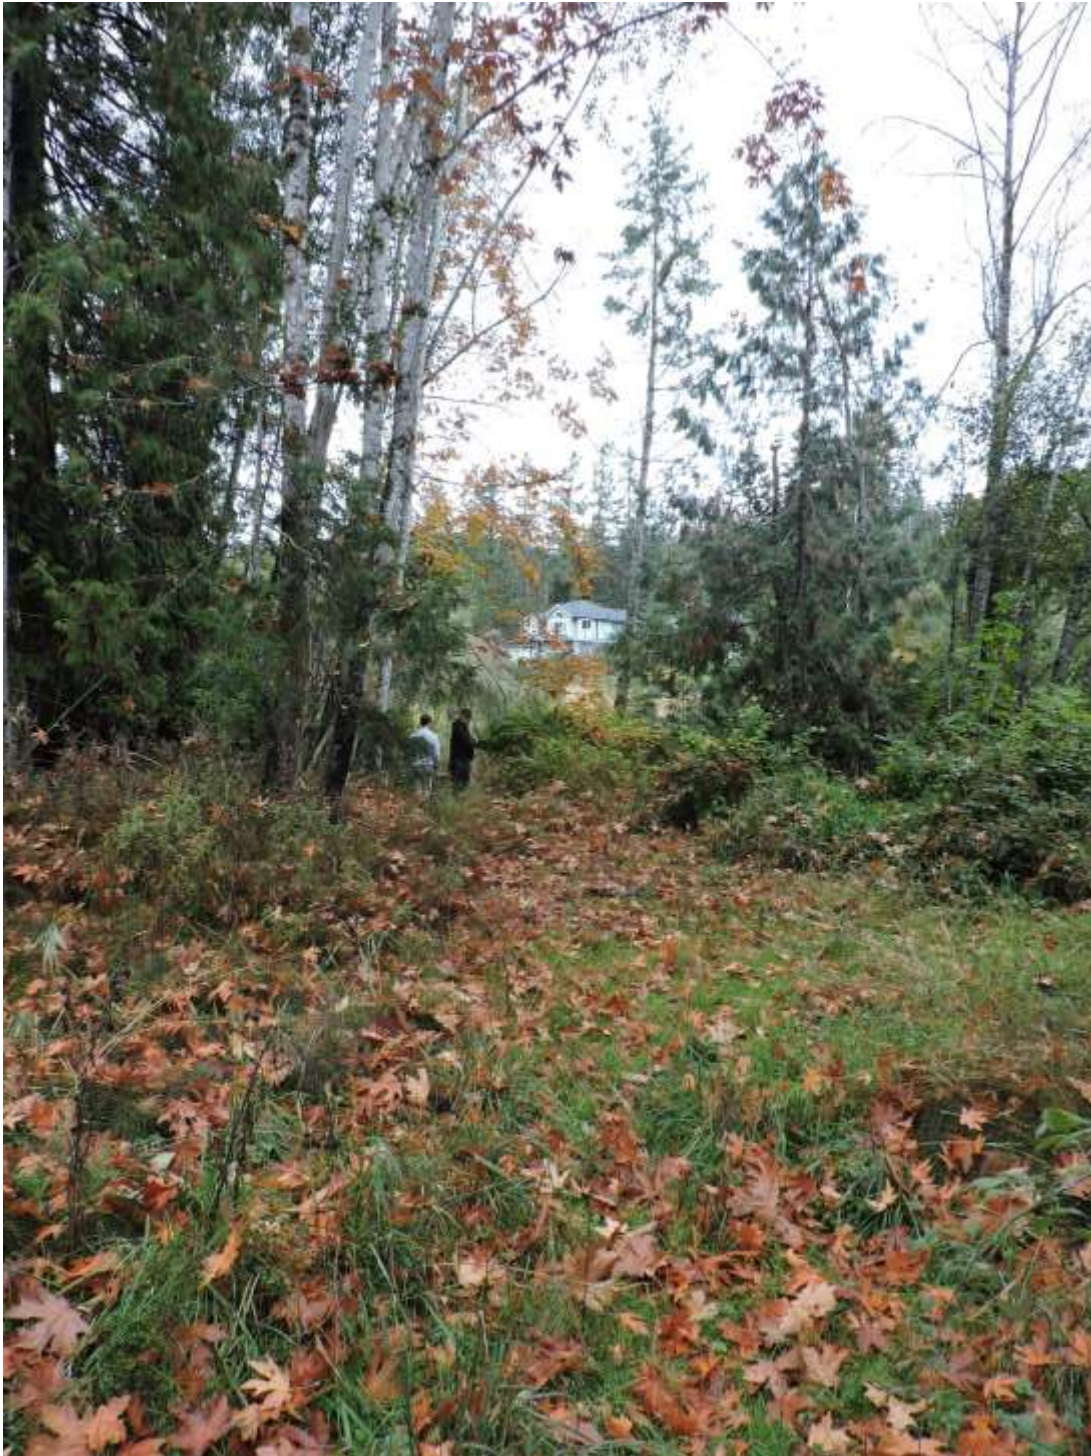
Photo # 23

SITE #	DATE	DESCRIPTION
1	Oct 16 <sup>th</sup> 2019	Level terrain with long grass and canopy cover ~25%

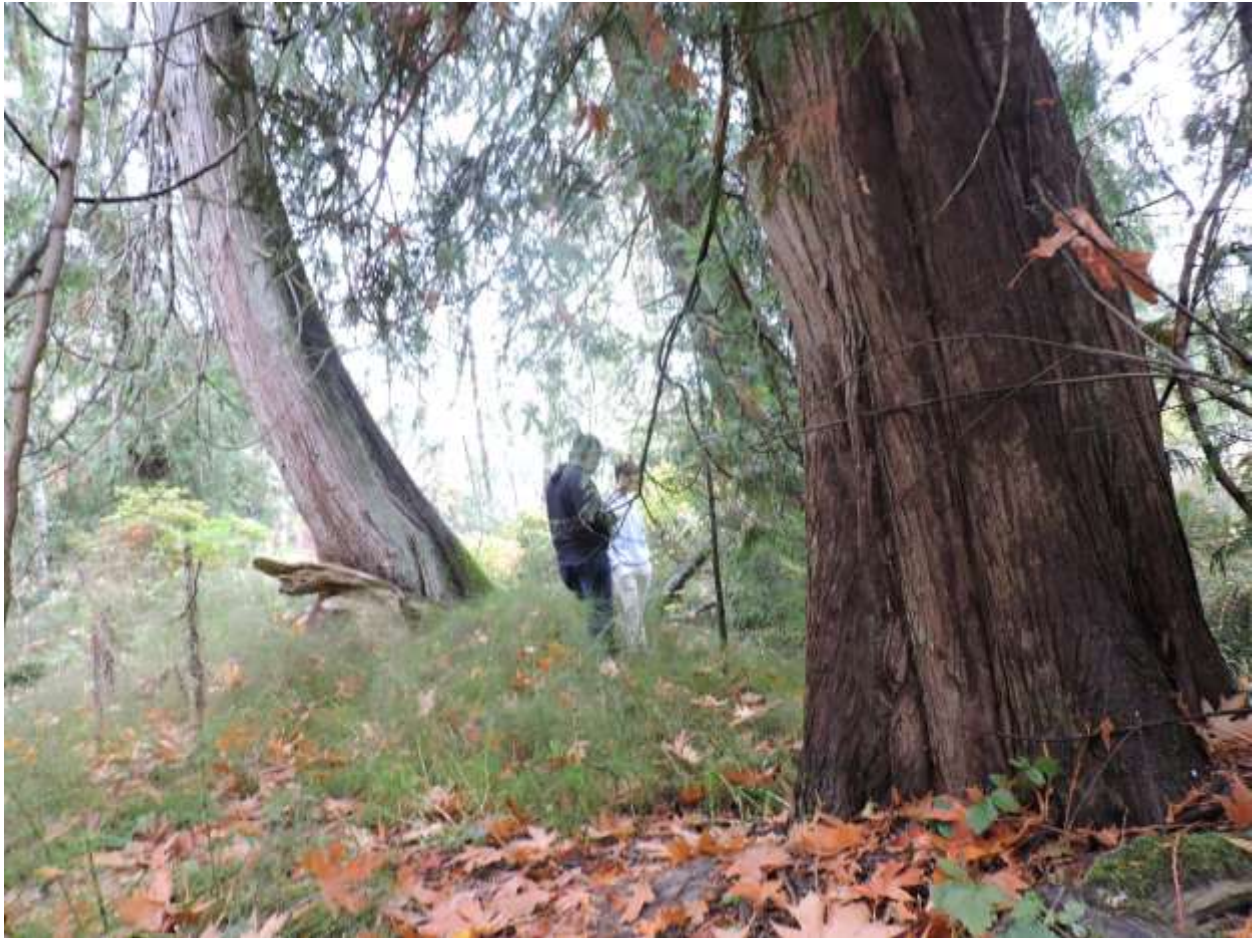
Photo # 25

SITE #	DATE	DESCRIPTION
1	Oct 16 <sup>th</sup> 2019	Two large cedar trees provide reference for potential sampling location

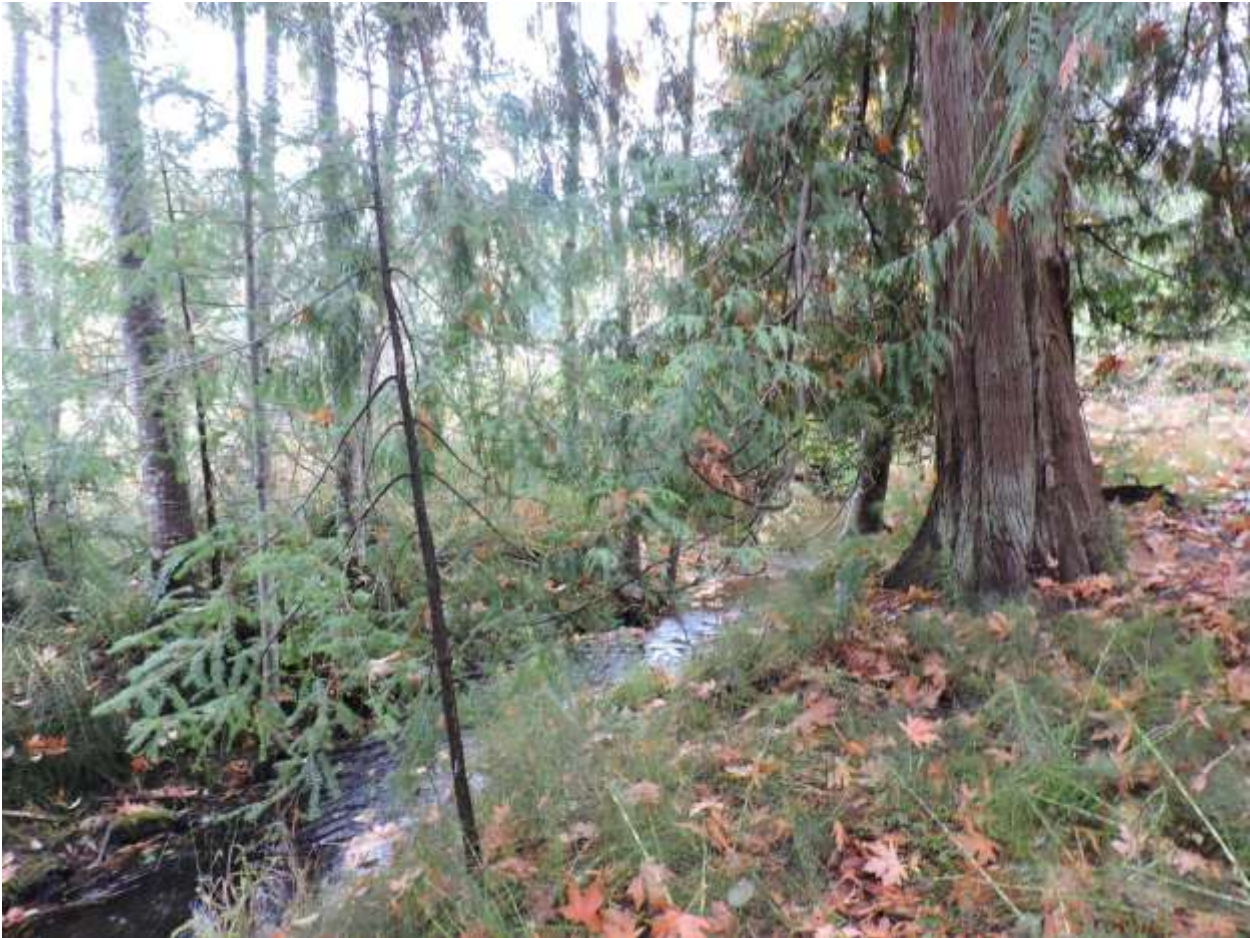
SITE #	DATE	DESCRIPTION
1	Oct 16 <sup>th</sup> 2019	Riffle and glide habitat with little vegetation in riparian area resulting in farm field being visible in background.
