Cottle Creek: Environmental Monitoring Report

Prepared for RMOT 306

VIU 2020

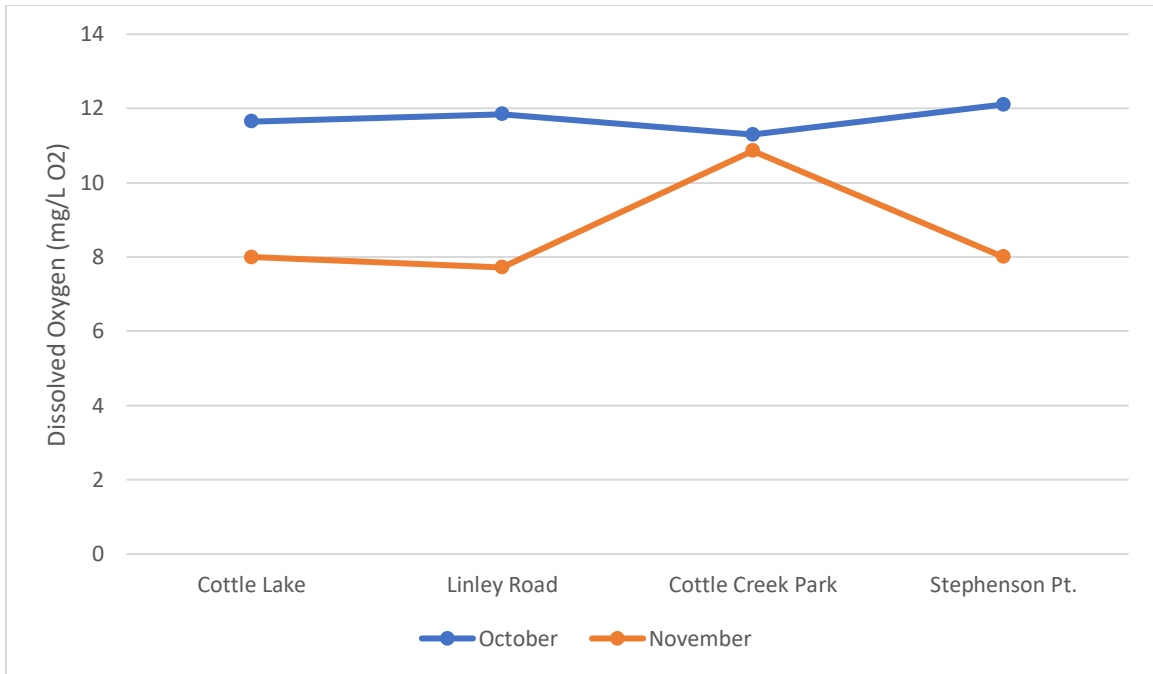
Figure 1: Cottle Creek dissolved oxygen changes, October-November 2020

Dissolved oxygen was well within normal limits for sustaining aquatic life on both sampling sessions, however the dissolved oxygen was overall much lower at the sampling sites on the second session in November; dissolved oxygen concentration decreased by 4 mg/L at most sites, however remaining in the acceptable range of 4.0-8.0 mg/L (RISC 1998) (figure 1). Heavy rains were experienced during the November sampling session, which most likely accounted for the lower dissolved oxygen as the

water was washed with much debris and sediment. Additionally, turbidity increased at some stations as much as 3-7X from the October session to the November session, which can also be accounted for by the heavy winter rain in November which brought much more sediment into the stream. However, turbidity remained within acceptable guideline levels.

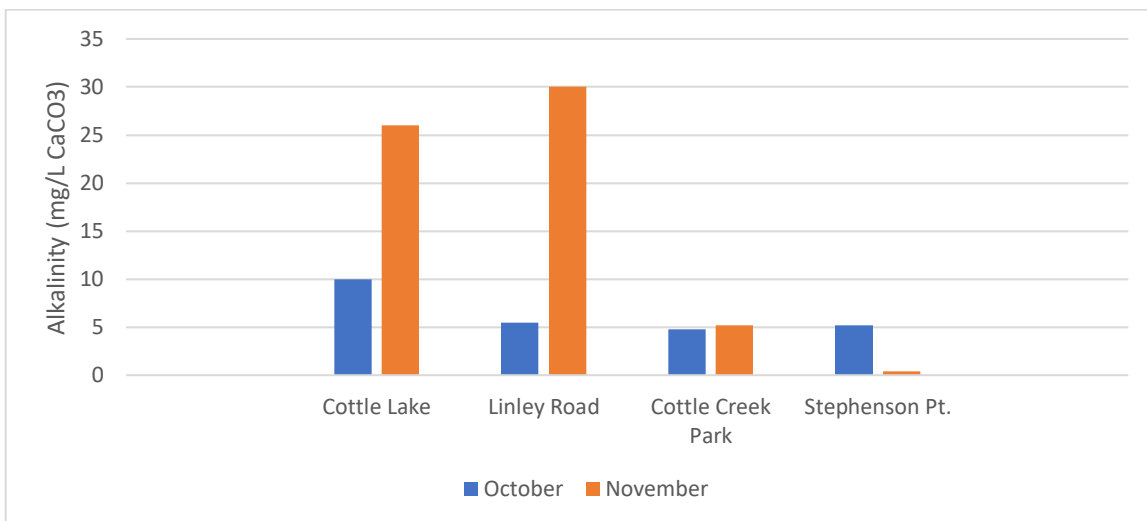
Figure 2: Cottle Creek alkalinity changes, October-November 2020

The changes in alkalinity observed during our stream sampling periods were diverse and broad, especially in the sites located further up in the water shed. Sites #1 and #2 were within the acceptable alkalinity range of 0-20 mg/l CaCO_3 during the first sampling session, and after the second sampling session with heavy rains, both sites were above the acceptable range into 25-30 mg/L (figure 2). However, in the lower sites the results contrasted the upper sites as alkalinity stayed the same or decreased significantly, as in site #4. The mass fluctuations in alkalinity can be accounted for by the heavy rainfalls experienced in November, with the additions of minerals and bases being washed off banks and runoff into the stream.

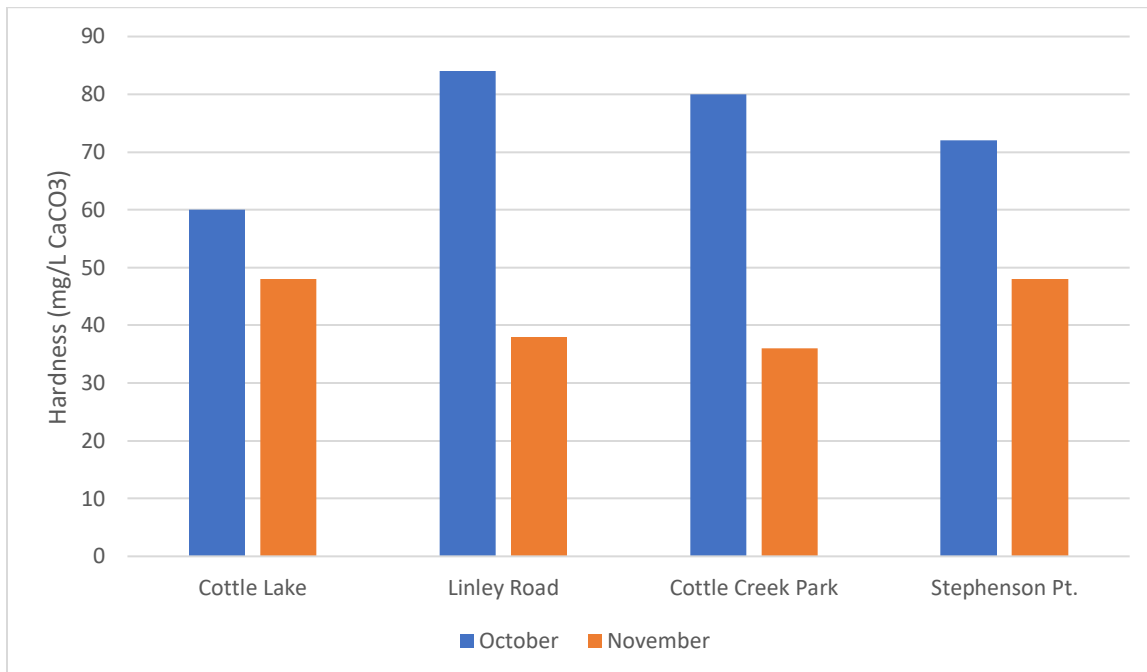
Figure 3: Cottle Creek hardness changes, October-November 2020

Hardness levels examined at all the sites showed that in October all 4 sites were within the recommended levels of 60-120 mg/L CaCO₃ (RISC 1998). During November, the sites experienced a massive decrease in hardness levels, with all sites falling below the acceptable lowest range of 60 mg/L (figure 3). The additional rain in November introduced a lot of naturally soft rainwater into the system, which dramatically lowered the hardness to dangerous levels; soft water increases the toxicity of metals, especially to aquatic life forms living in stream systems (RISC 1998).

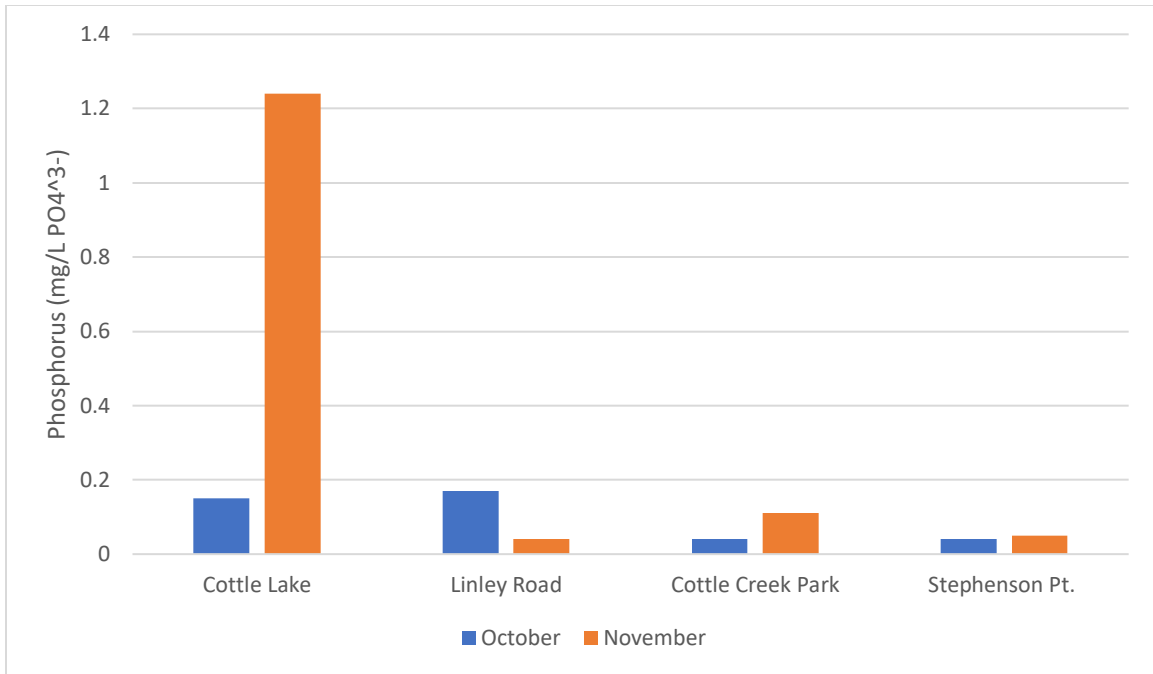
Figure 4: Cottle Creek phosphorus changes, October-November 2020

Lastly, phosphorus levels were found to be naturally high in Cottle Creek between both sampling sessions, as results were all well over the acceptable range of 0.005-0.015 mg/L PO_4^{3-} for aquatic life (RISC 1998). In particular, site #1 experienced a massive increase in phosphorus during the November sampling session to levels above 1.2 mg/L (figure 4). This site was located near a horse stable and large flat sloping grasslands, which may have experienced runoff from the nearby surrounding areas into the creek from the rain-washing nutrients into the system. Phosphorus is the limited nutrient in freshwater, and in excessive cases can cause eutrophication (RISC 1998), however that is experienced more in lake systems. The phosphorus levels experienced were still relatively low, with the highest recording being only just above 1 mg/L, so the findings were declared non substantial as no imminent problems were found for an increase of phosphorus in running water systems.

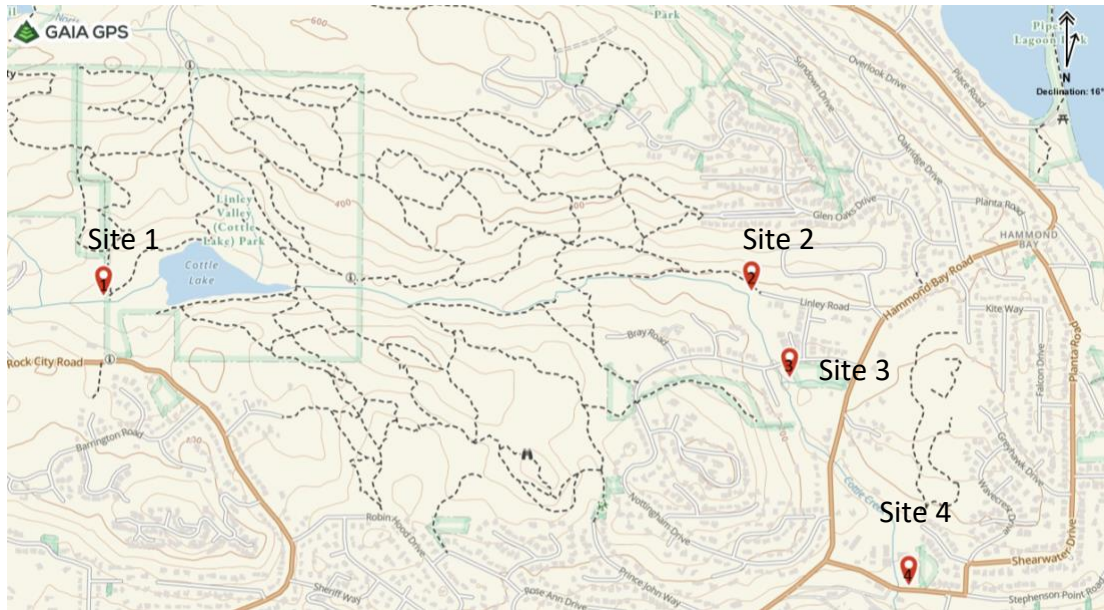
Figure 1: Cottle Creek Sample Station Locations

- 1) Upper Cottle, Rock City Road
- 2) Upper Cottle, Linley Road
- 3) Lower Cottle, Nottingham Drive
- 4) Lower Cottle, Stephenson Point Road

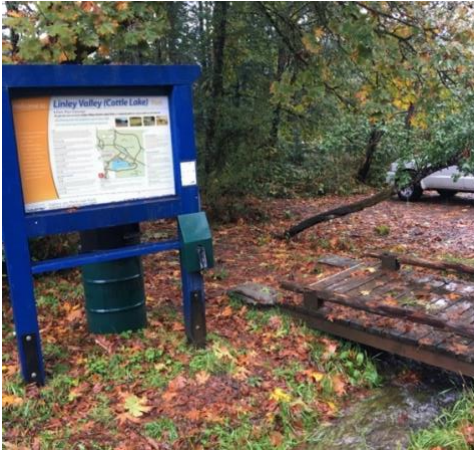
Site #1: Upper Cottle (0428331mE, 545224mN). Plant life includes many deciduous trees with a mixture of coniferous. The leaf debris is potentially very slippery in addition to the wet bridges (2) and the stairway down to the site. The stairway is engineered with grips for shoe ware and a railing. The site is approximately 5 minutes from the parking lot, the rest is well built trail.

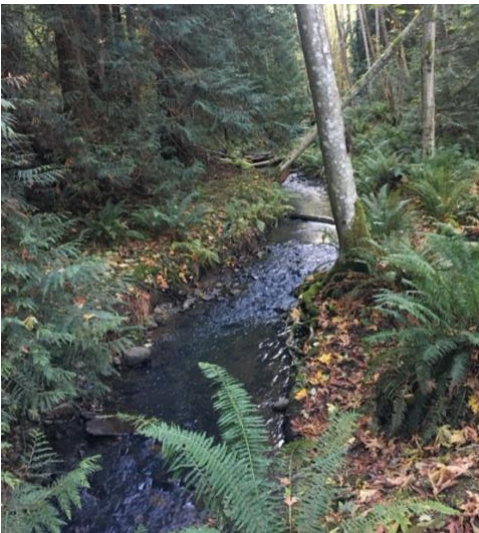
Site #2: Upper Cottle (0430133mE, 5451971mN). The plant life around this site consists of coniferous and deciduous trees. Leaf litter and wet sword fern create a potentially slippery surface to work on. The site has extremely accessible excess and being careful of slips and trips is the biggest hazard for this site.

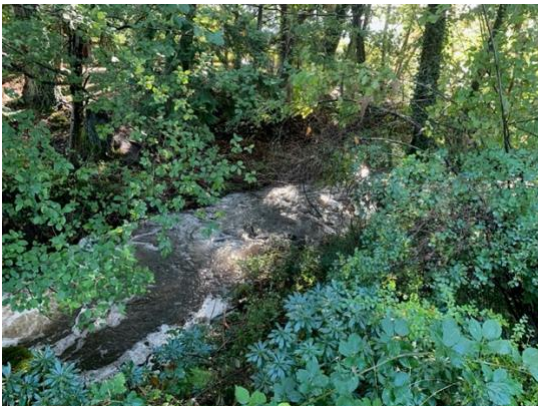
Site #3: Lower Cottle (0430561mE, 5451389mN). The plant life surrounding this site is thicker brush and shrubs, along with coniferous and deciduous trees. The branches the group will be working in are eye level therefore conducting data collection may require eye protection.

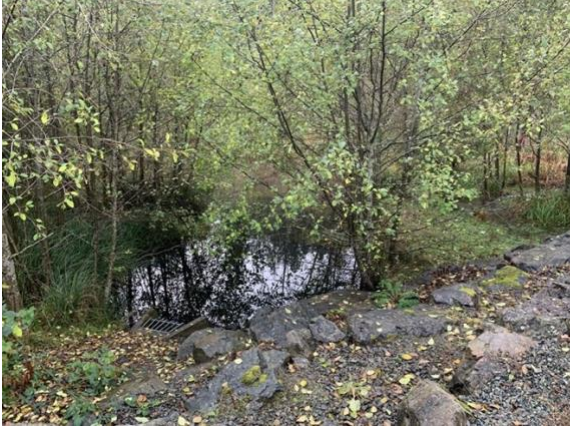
Site #4: Lower Cottle (0430561mE, 5451389mN). The plant life around this site is primarily deciduous trees and long grass. The rocks surrounding the site add to the slipping risk. This site has good access.

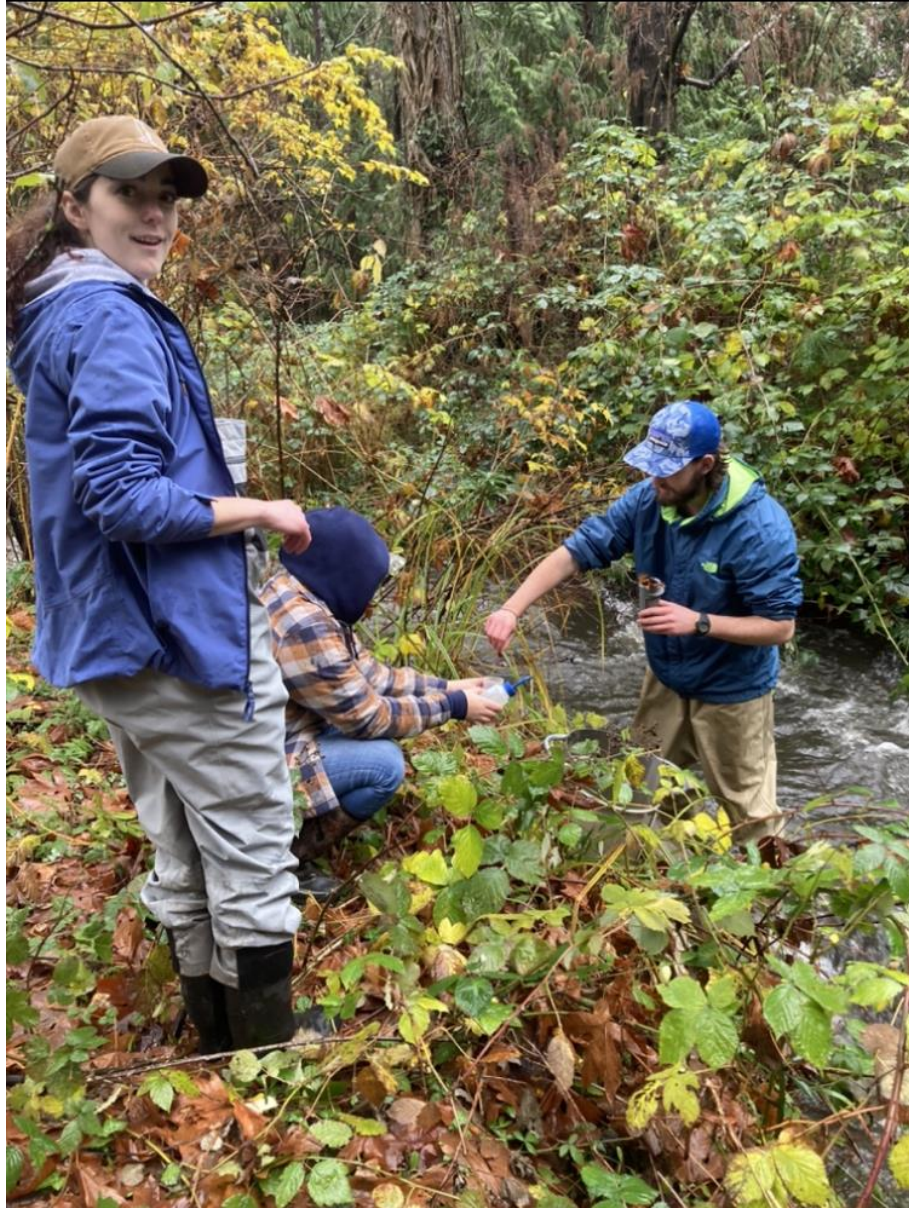
Mariah, Olivia, and Riley taking invertebrate samples on November 18, 2020. (Photo by Cassidy)
