Water Quality and Invertebrate Analysis of the Englishman River, Parksville, BC

Prepared By:
RMOT 306 Environmental Monitoring Students
Kade Pilton
Emily Maijenburg
Mallory Blake

Prepared For:
Mr. Owen Hargrove, Vancouver Island University

December, 2020

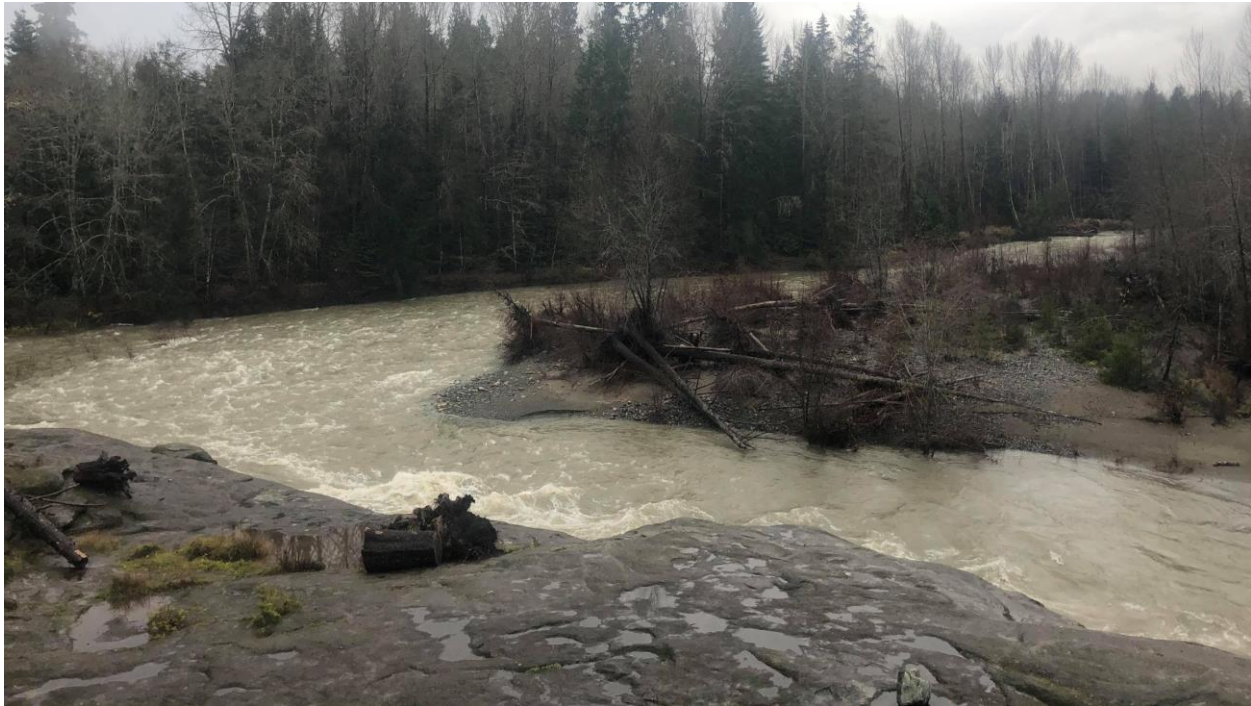
Figure 2: High water levels due heavy precipitation event.

the second sampling period on November 18, 2020, ambient air temperatures ranged between 10 degrees and 12 degrees celsius. Weather conditions saw mixed precipitation with periods of sun and cloud. Flows during the second sampling period increased dramatically which inhibited the ability to safely measure some specific parameters including discharge, wetted widths, and depths.

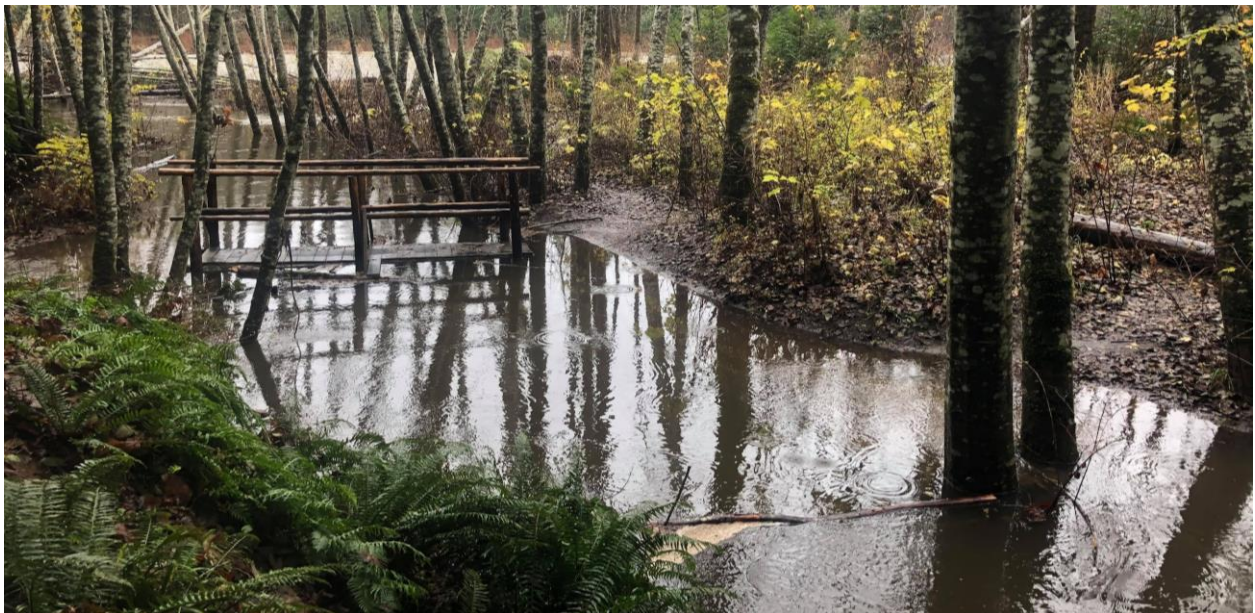
Figure 3: High water levels limiting trail access.

Due to limited time, resources and there was a delay in sampling for final field samples. This would generally not be an issue, however, there was a large amount of precipitation overnight which resulted in altered field conditions. This includes the river being blown out and dangerous. The water was incredibly turbid and dangerous to traverse and work around in some of the sites. The large amounts of precipitation on the Englishman caused sections of the riverside trail to be flooded and difficult to navigate. This did alter two sampling locations slightly. Additionally, the stream was too dangerous to cross at nearly all points due to its increased velocity. Therefore, wetted width, velocity, and average depth were not measured during the second sampling period. Other considerations include time constraints, loss of data, access to sampling locations and access to laboratory equipment.
