WATER QUALITY AND STREAM INVERTEBRATE ANALYSIS
FOR COTTLE CREEK, NANAIMO, BC

RMOT 306: Environmental Monitoring Students

Vancouver Island University

December 12, 2021

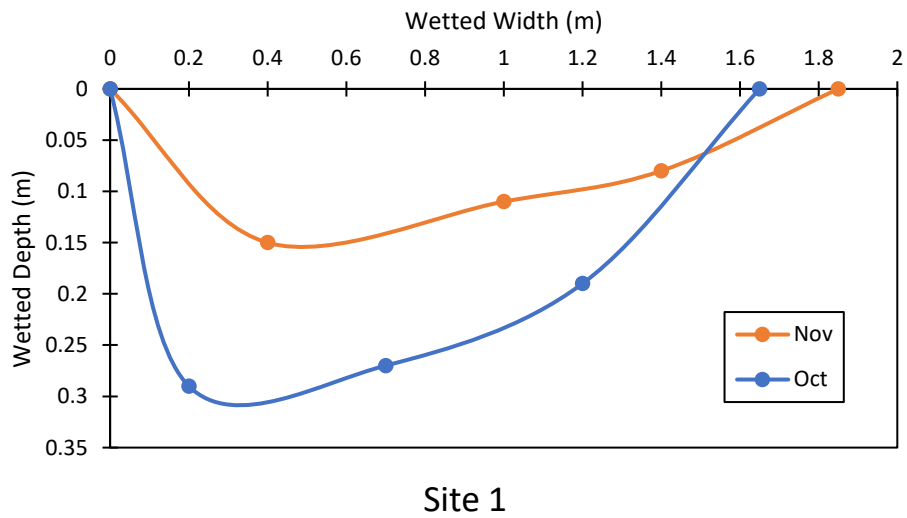
Figure 3. Wetted cross-sectional profile facing up-stream at Site 1 along Cottle Creek (figure 2), measurements recorded on October 27, 2021, and November 24, 2021.

Figure 3 represents the two wetted measurements of Site 1. Closer to the zero mark on the x axis, it is evident that the bank there is subject to erosion, whereas the other bank is more subject to sediment deposition, although the channel is relatively straight along the sampling location. The sediment was cobble and this site, based on the profile of the stream and the invertebrate community, although with no mayflies (Ephemeroptera) present in the sample, indicates that there could be some habitat loss. The evidence also suggest that this part of the creek had an average water column velocity of 0.151 m/s and 0.253 m/s and had a discharge of 0.062 m³/s and 0.051 m³/s during the sampling events (Table 3). Site 1 had the slowest and least amount of water flowing out of all four sampling locations.

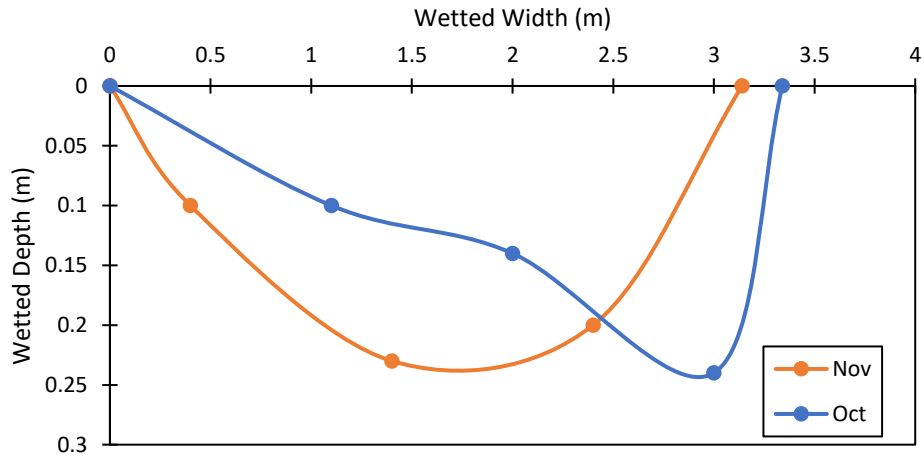
Figure 4. Wetted cross-sectional profile for Site 2 facing down-stream along Cottle Creek (figure 2), measurements recorded on October 27, 2021, and November 24, 2021.

Figure 4 represents the two wetted measurements of site 2, taken in October and November respectively. Site 2 is located at the downstream mouth of Cottle Lake and was measured in a turn. The inside of the turn was roughly 1.9 m along on the x-axis and was subject to mainly deposition of sediments, with less of a riparian zone and more of a cobble island. The outside turn was more likely subject to heavy erosion creating a deeper pool on the edge of the bank. The average water column velocity was calculated to be 0.286 m/s and 0.318 m/s, which made site 2 one of the slower sites along the creek, this could be due to being slightly downstream of the lake. The average discharge of was calculated to be 0.153 m³/s and 0.180 m³/s (Table 3). Site 2 had the second least volume of water flowing through per second for the four sampling locations.

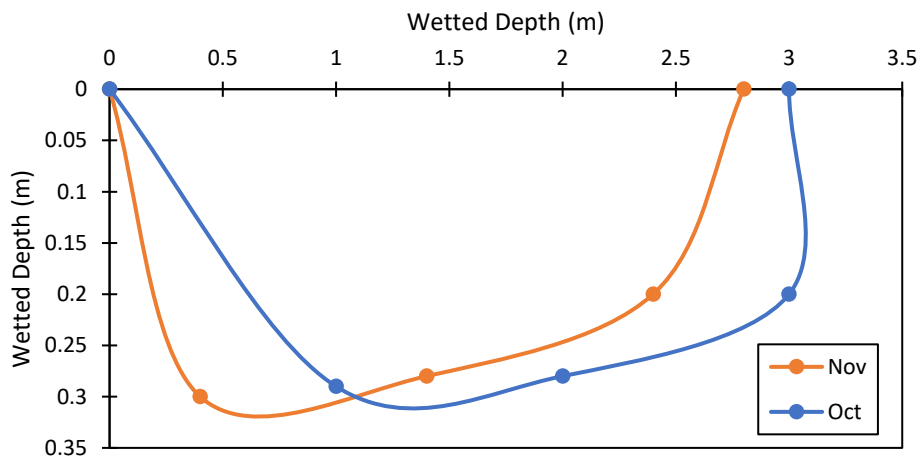
Figure 5. Wetted cross-sectional profile for Site 3, facing up-stream along Cottle Creek (figure 2), measurements recorded on October 27, 2021, and November 24, 2021.

Figure 5 represents the measurements at Site 3 in October and November respectively. The site was in a straight part of the channel and just upstream was skunk cabbage and other plants. The sediment was cobble, but it was not overly loose. Just downstream was a stretch of riffles. There was some evidence of erosion along the sides of the banks, but nothing too extreme. Site 2 had the highest discharge value and the fastest average water column velocity compared to all four sites. The velocity was calculated to be 0.368 m/s and 1.24 m/s, and the discharge was calculated to be 0.283 m³/s and 0.903 m³/s. This site also had the highest percent saturation of oxygen, but it did not seem to be the best habitat for aquatic life, such as fish or invertebrates.

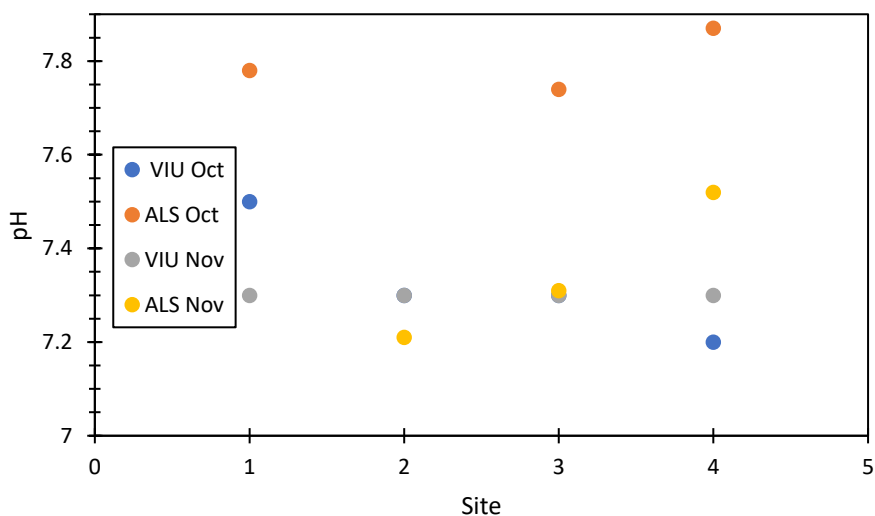
Figure 7. pH (measured in pH units) results from samples obtained at Cottle Creek on October 27, 2021, and November 24, 2021. The results are from both the VIU Laboratory and ALS Laboratory.

pH is the measure of how acidic a solution is depending on the concentration of hydrogen ions (H^+). The solutions' pH is measured on a scale of 0 to 14 with numbers lower than 7 being more acidic, and higher numbers being more basic, while 7 is considered neutral. It is measured on a logarithmic scale meaning that small changes in pH can pose a huge impact because the concentrations of H^+ ions change by the factor of every tenth power. For example, 10^{-1} is pH of 1 and 10^{-2} is pH of 2. In addition, higher concentrations of H^+ affect the bioavailability of metals by dissolving them, whereas the metals precipitate under alkaline conditions. PH for the first (October) and the second (November) rounds of sampling suggest consistent results along the four sites. Negligibly higher pH was recorded after the second sampling event, although it was expected to be lower due to the reaction of carbon dioxide and rainwater in the atmosphere. The mean pH of the first and second round of samples were 7.32 and 7.33 respectively and site 1 had the highest pH for both rounds due to the increased photosynthetic activity in this area.

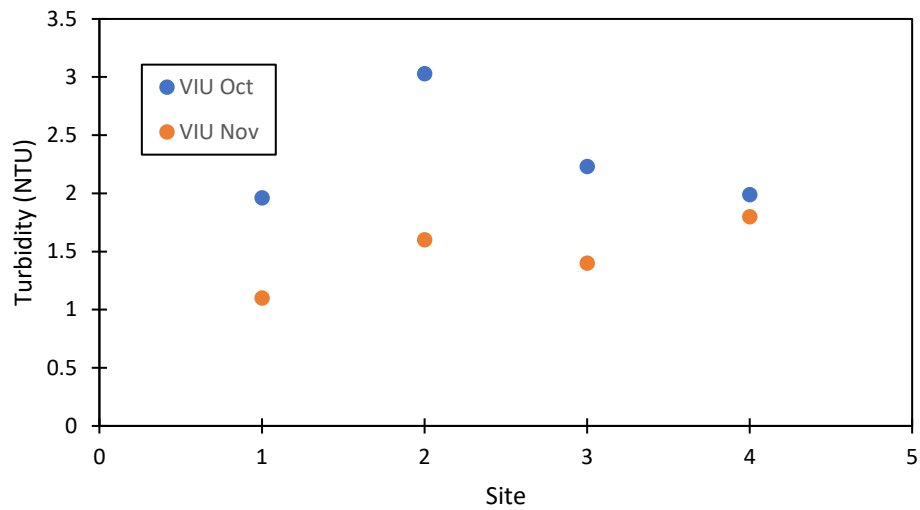
Figure 9. Turbidity (measured in NTU) results from samples obtained at Cottle Creek, on October 27, 2021. The results are from the VIU Laboratory.

Turbidity is the measure of total suspended solids (TSS), it is measured in Nephelometric Turbidity Units (NTU), reflecting the “cloudiness” of a water sample using a spectrophotometer, specifically a nephelometer. This machine measures the scattering of light by the suspended solids through the sample. The results from the first sampling event measured higher turbidity than the second sampling event. These results are most likely due to the rainfall as the rainwater washed most of the suspended solids away. Site 2 had an increase in turbidity of 2.76 NTU, possibly due to the lake and its productivity.

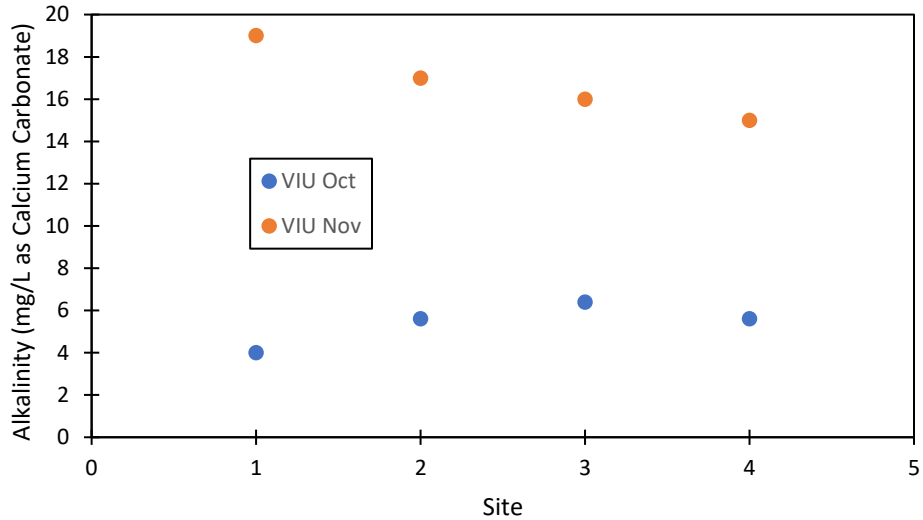
Figure 10. Alkalinity (measured in mg/L as CaCO₃) results from samples obtained at Cottle Creek on October 27, 2021, and November 24, 2021. The results are from the VIU Laboratory.

Alkalinity reflects the buffering capacity of a water sample. A higher alkalinity reflects the ability to resist pH changes. It is measured in mg/L as CaCO₃ which represents the bicarbonate equilibrium and depends on the presence of carbonate rock such as limestone, in the sediments and area surrounding the stream. In coastal BC lakes and streams, it is expected to obtain results less than 20 mg/L as CaCO₃, which was the case. The alkalinity from the first sampling event was quite a bit lower than the second sampling event suggesting that possibly the rain had increased the acid neutralizing capacity of Cottle Creek.

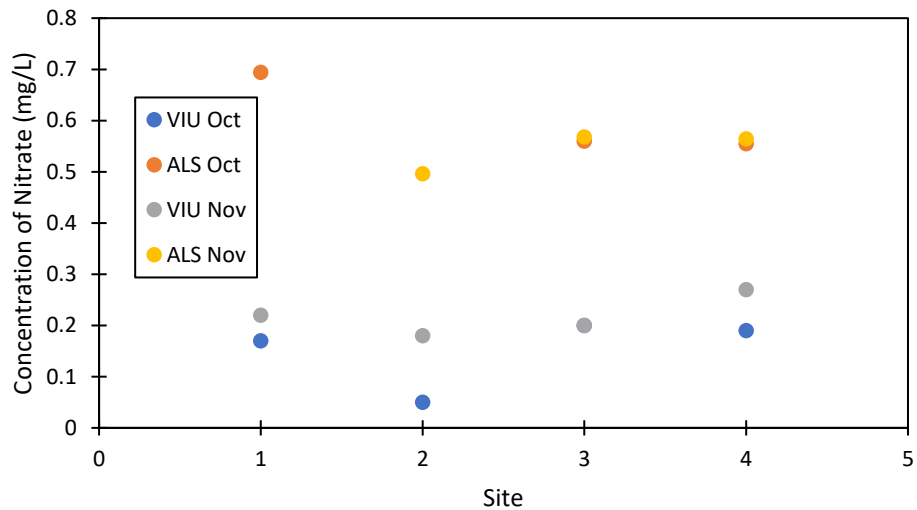
Figure 12. NO_3^- (measured in mg/L) results from samples obtained at Cottle Creek on October 27, 2021, and November 24, 2021. The results are from both the VIU Laboratory and ALS Laboratory.

Nitrate reduction test is conducted to determine if there is an enzyme called nitrate reductase present in water. Many kinds of bacteria have different ways of reducing NO_3 to NO_2 to nitrogenous gases. While some bacteria, have the ability to reduce NO_3 all the way to nitrogenous gases, while others only reduce it to NO_2 as they may lack the necessary nitrate reductase enzymes to fully reduce nitrate to its gas form. First and second line of samples tested at VIU Laboratory yielded means of 0.12 and 0.20 respectively. Results from the first, third, and fourth sites are measured 0.17, 0.19, and 0.20 respectively for the first line of samples. Test results from ALS also shows a higher reductase activity meaning VIU results are consistent with ALS Laboratories' results. Second line of samples are evenly distributed, however, showed an overall higher reductase activity than the first. The reason for that would be due to the heavy rainfall prior to the second round of sampling. ALS results also yielded higher reduction probably due to the fact that it took quite some time delivering the samples bottles to the laboratory. Reductase activity must have continued during that time period.

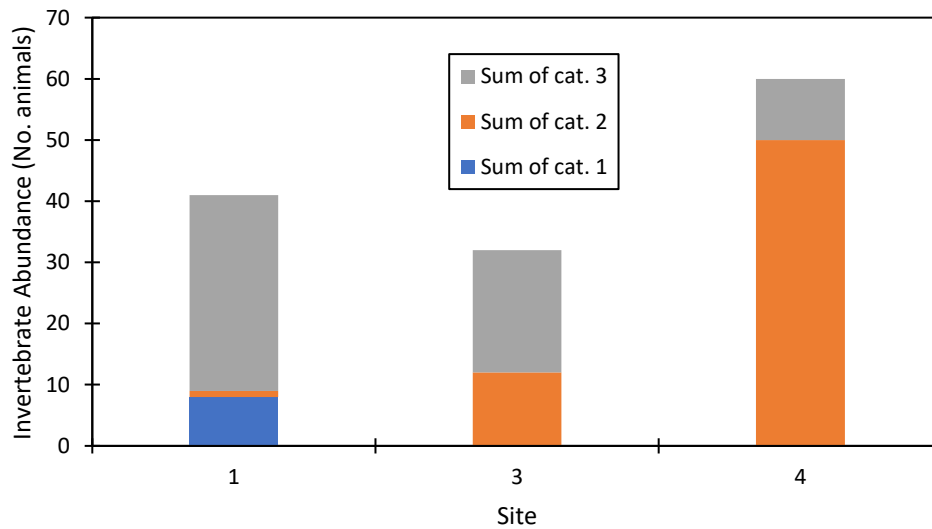
Figure 14. Abundance of stream invertebrate categorized by site and pollution tolerance categories 1 through 3 obtained on October 27, 2021, at Cottle Creek, Nanaimo, BC (Figure 2 for site location information).

Each site was different in terms of the abundance and density of invertebrates. Site 1 had a total of 40 organisms, and a density of 444 organisms per square metre. Site 3 had a total of 32 organisms, and a density of 356 organisms per square metre. Site 4 had a total of 60 organisms, and a density of 667 organisms per square metre (appendix). In terms of species categories, Site 1 and Site 3 had mostly category 3 species, while Site 4 had mostly category 2 species. Only Site 1 had any category 1 species, while Sites 3 and 4 did not have any (figure 14).

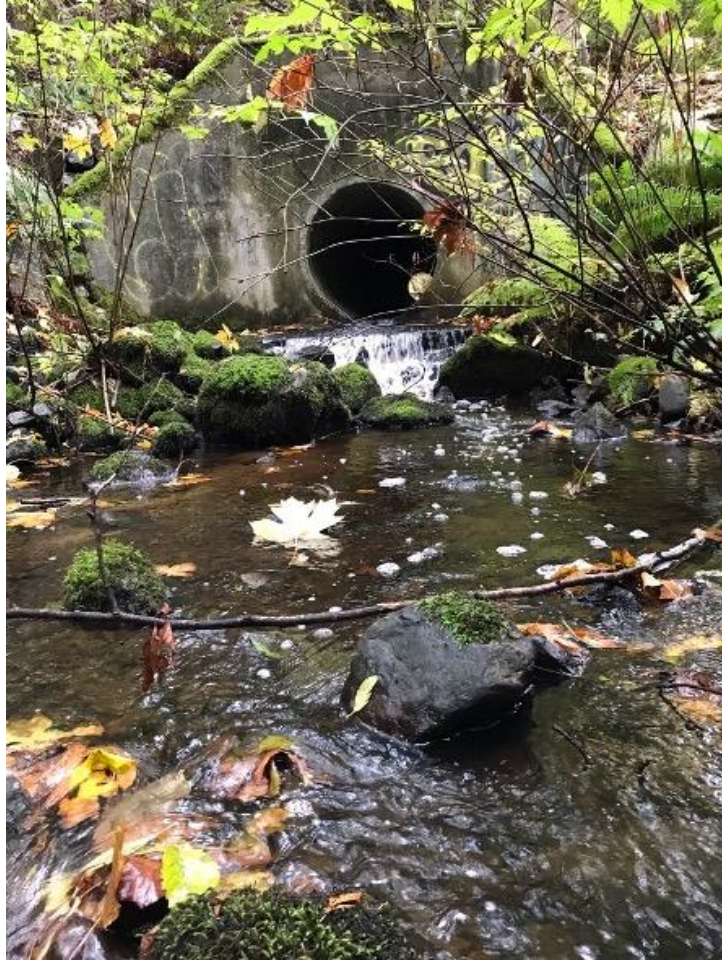
Appendix C. Culvert at sampling site 1 on October 20, 2021, Cottle Creek, Nanaimo, BC.

Within the confines of Linley Valley Cottle Creek Park, there were some potential environmental concerns that were spotted during the initial survey of the sample sites. Near Site 1, there was a culvert running underneath Landalt Road, which could potentially have an environmental impact (Appendix C). Near Site 2, there were two abandoned vehicles that could potentially pose environmental impacts (Appendix H, I). Along the creek there were various forms of litter and waste found in the form of tires, wrappers, and beverage containers/aluminum cans, which could pose threat to the environment. There could also be a risk of contamination from residential and city infrastructure along the creek, for example, construction, or wastewater runoff.
