# Water Quality and Stream Invertebrate Assessment for the Millstone River Project Proposal

Presented by:  
Derek Arsenault  
Taylor Brouwer  
John Kodama

RMOT 306 – Environmental Monitoring  
Vancouver Island University  
Nanaimo, BC  
December 4, 2020

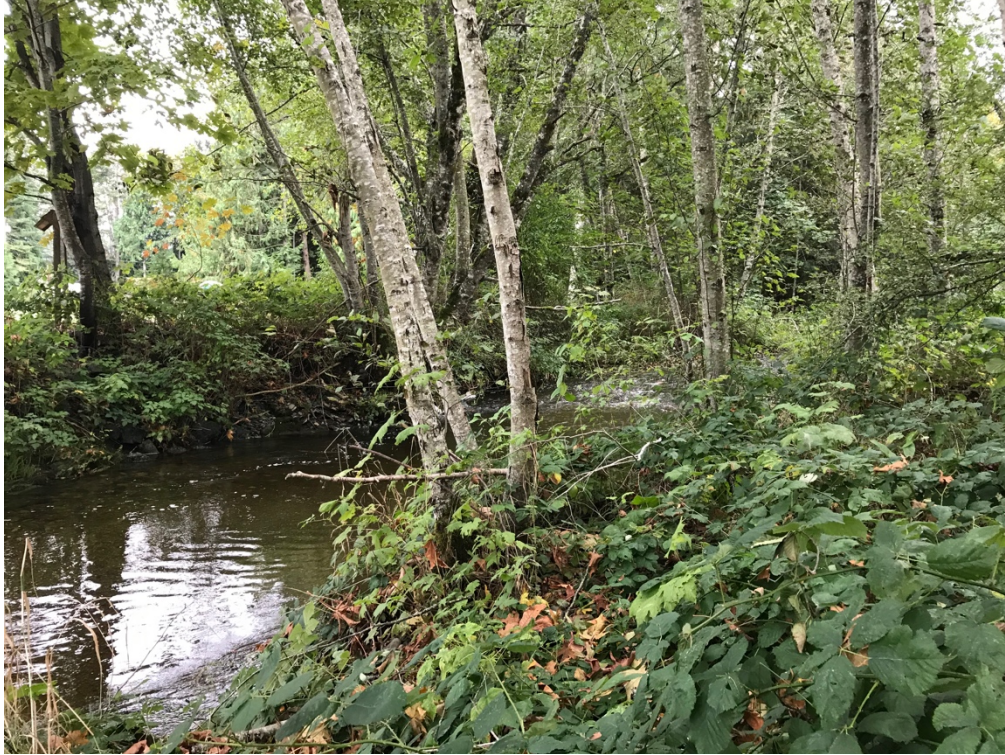
*Figure 2 - Site 1 location*

Site 1: Benson Creek, which flows into Brannen Lake from the south west, and is a tributary of the Millstone River. The testing location is on the south side of the bridge on Biggs Road where it crosses Benson Creek, next to the parking lot of Camp Caillet. The site has a dense riparian area but is quite close to the campground and agricultural areas. The water here is relatively shallow and slow moving.

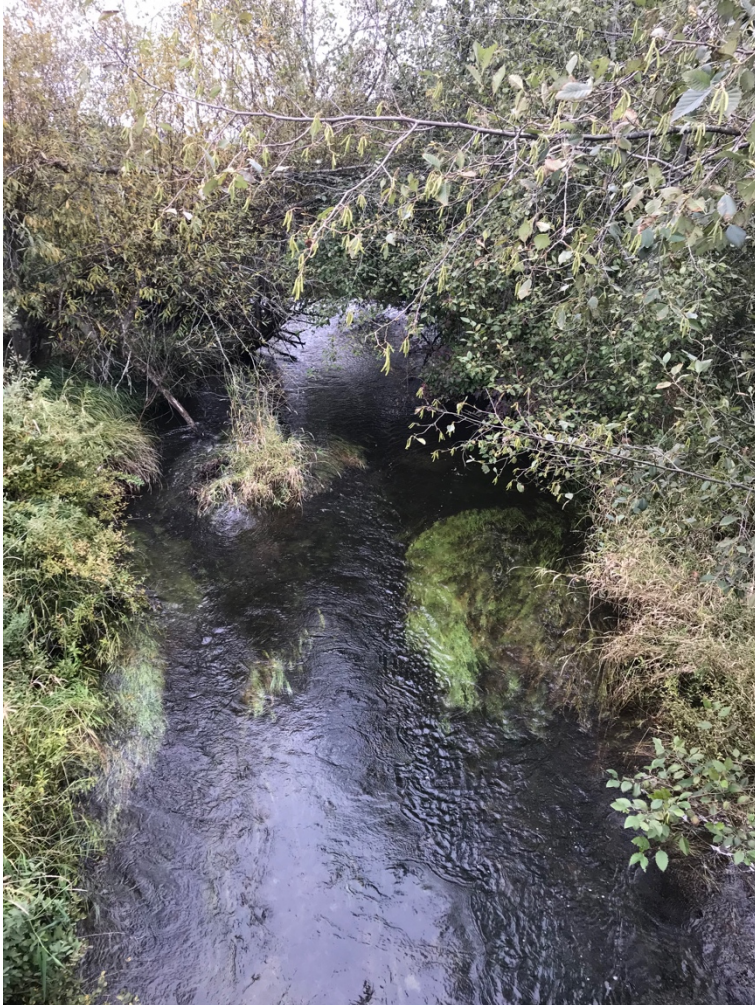
*Figure 3 - Site 2 location*

Site 2: Millstone River just south east of Brannen Lake, also on Biggs Road where it crosses the river. The sampling site is just north of the bridge, less than a kilometer east of site 1. This site is surrounded on all sides by agricultural areas, but again has a dense riparian area. The water is again shallow, but with a stronger current.

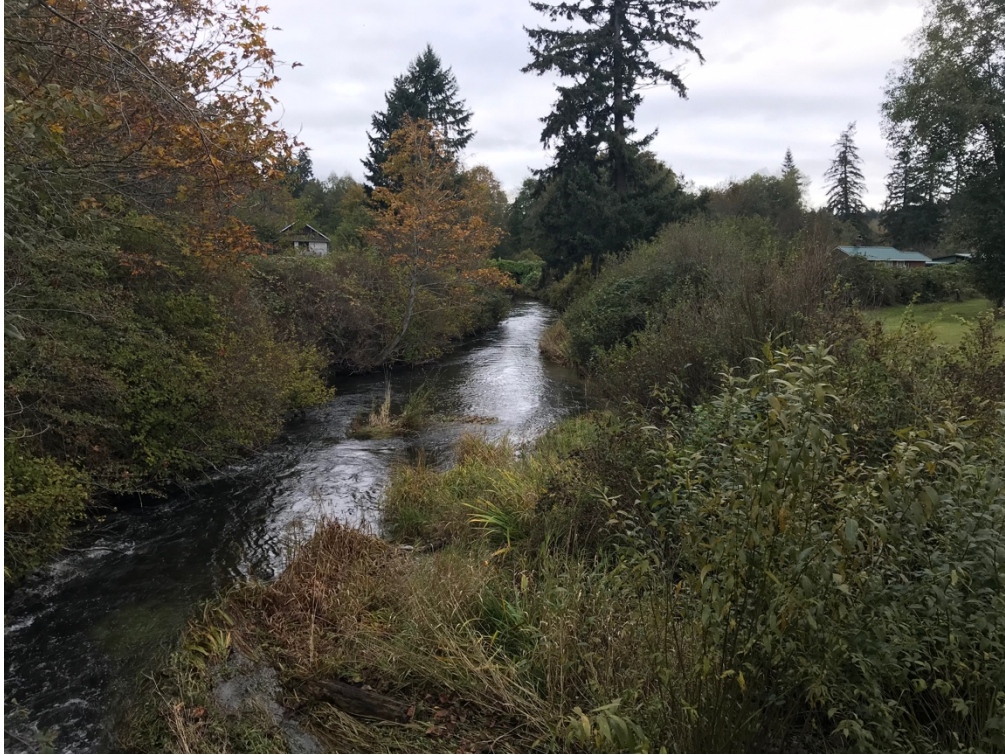
*Figure 4 - Site 3 location*

Site 3: Millstone River at the junction of Maxey Road and Durnin Road on the southwest side of the bridge crossing. This area is rural residential with private yards on either side of the river. Again, this allows for a dense riparian area. The water here is deeper than either of the two previous sites. Upstream it is flowing quite fast, but in our sampling site it is relatively slow.

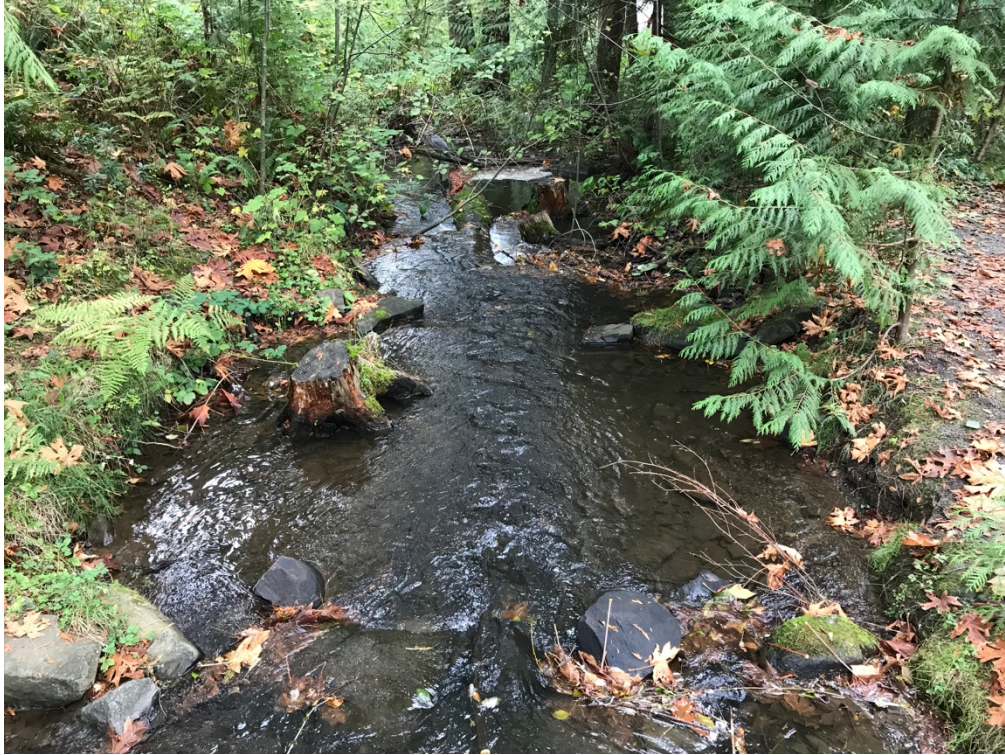
*Figure 5 - Site 4 location*

Site 4: Millstone River, located inside Bowen Park at the downstream outlet of the duck pond in the side channel. The easiest area to access, the side channel, as discussed in the introduction, is used for salmon spawning and therefore of particular interest to the study. Very shallow, but somewhat swift, water running out of the duck pond. Good riparian coverage, by design.

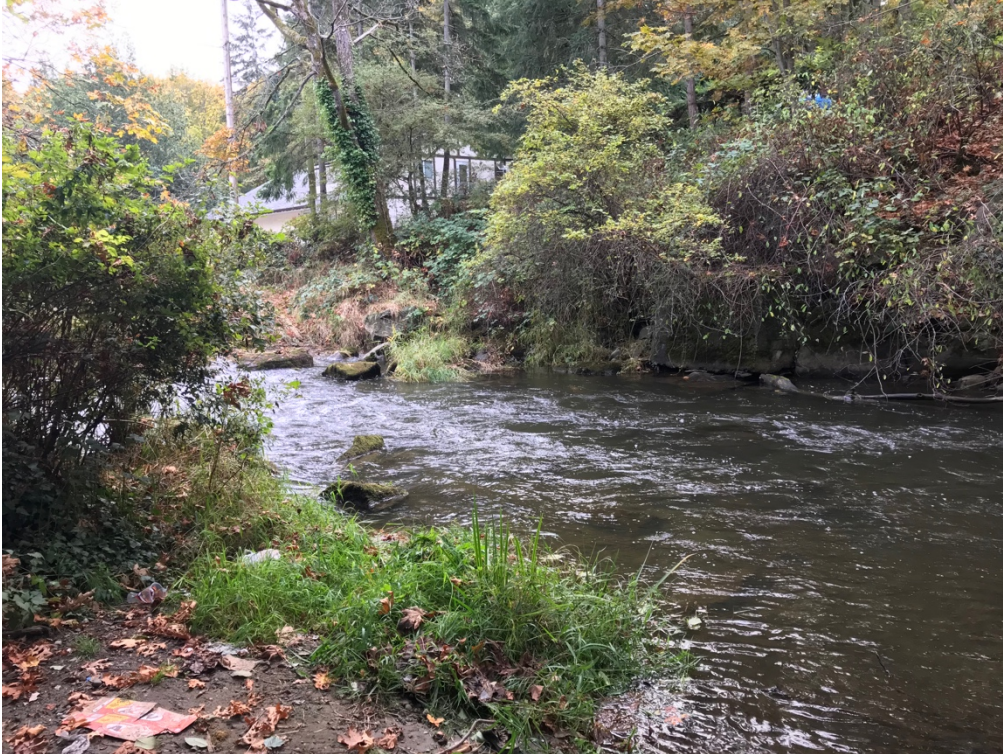
*Figure 6 - Site 5 location*

Site 5: Millstone River, at the end of Barsby Avenue. This area has seen the most changes since 2008 as it used to be undeveloped by now there are multiple apartment buildings and condos being built. The construction is still ongoing but will not provide any obstacles to accessing the site. Also, due to an increased homeless presence in Nanaimo it is possible to encounter refuse, human waste, or drug paraphernalia in the area and therefore caution must be taken. This is the widest, deepest, and fastest area of the river included in the study. The riparian area is still quite dense at the test site, which is located just east of the footbridge at the end of the street leading into Barsby Park.

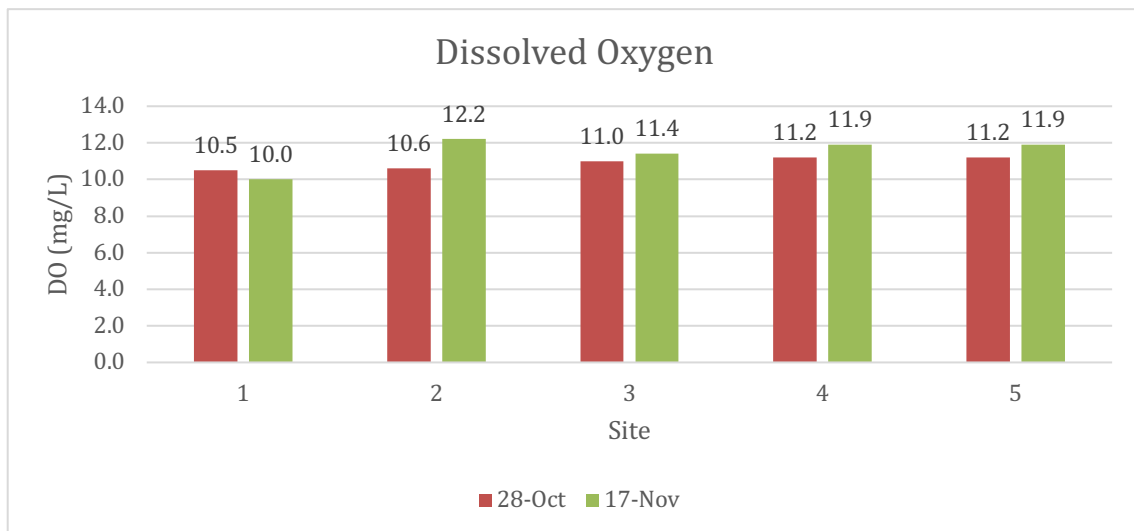
Dissolved oxygen remained consistent between the two sampling dates and did not appear to be affected by the increased flow after the rain events.

Figure 9 - Dissolved oxygen for all sites over both visits

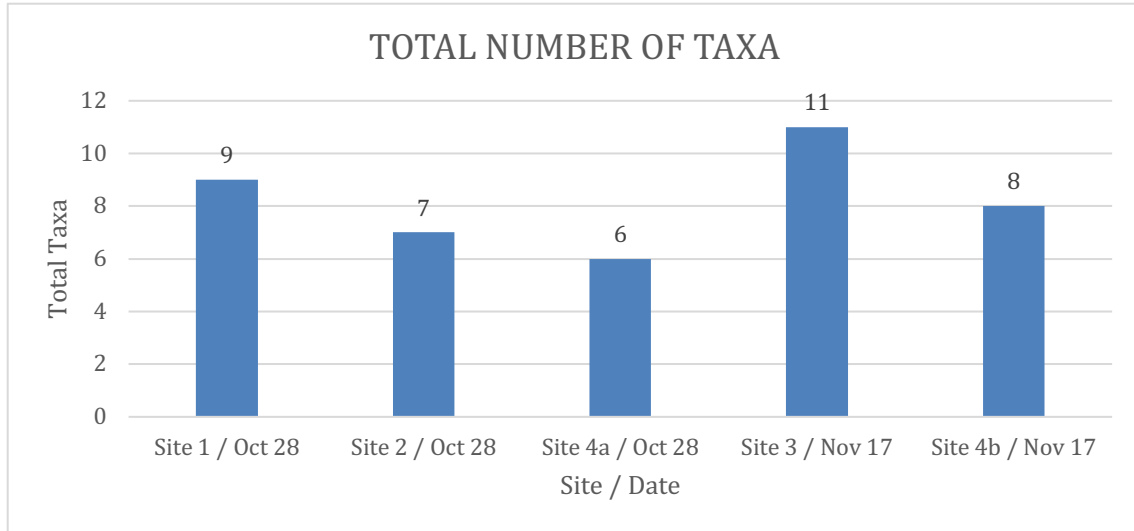
Figure 17 - Total number of taxa of stream invertebrates for all samples
