# **DATA REPORT**

## **Water Quality and Stream Invertebrate Assessment for the Millstone River, Nanaimo, BC, (Fall 2021)**

Students of Vancouver Island University RMOT 306 (Environmental Monitoring)

13 December 2021

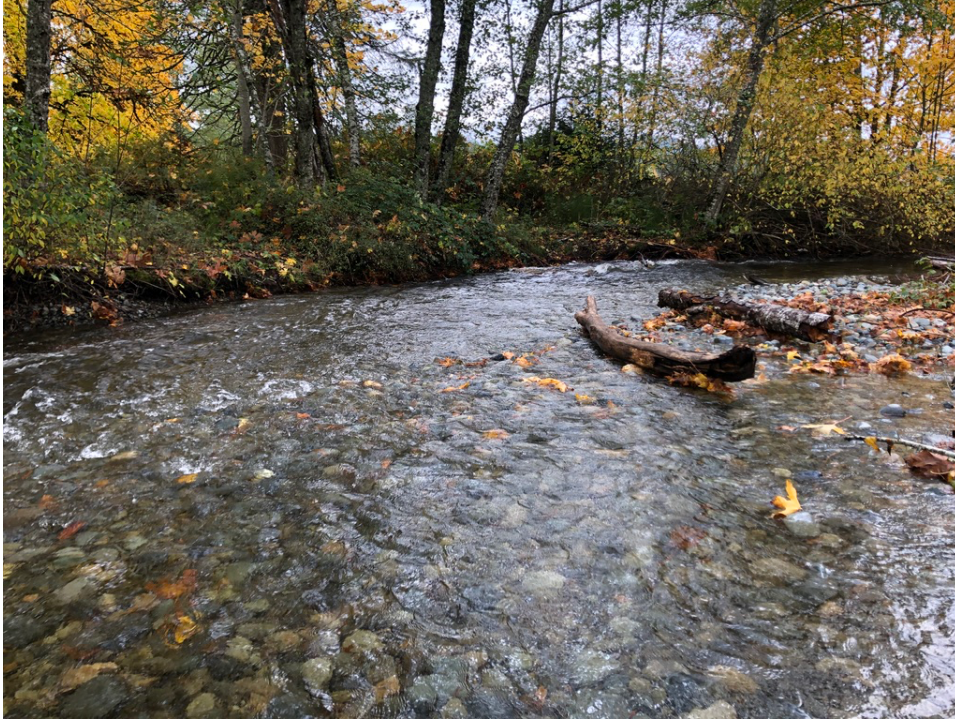
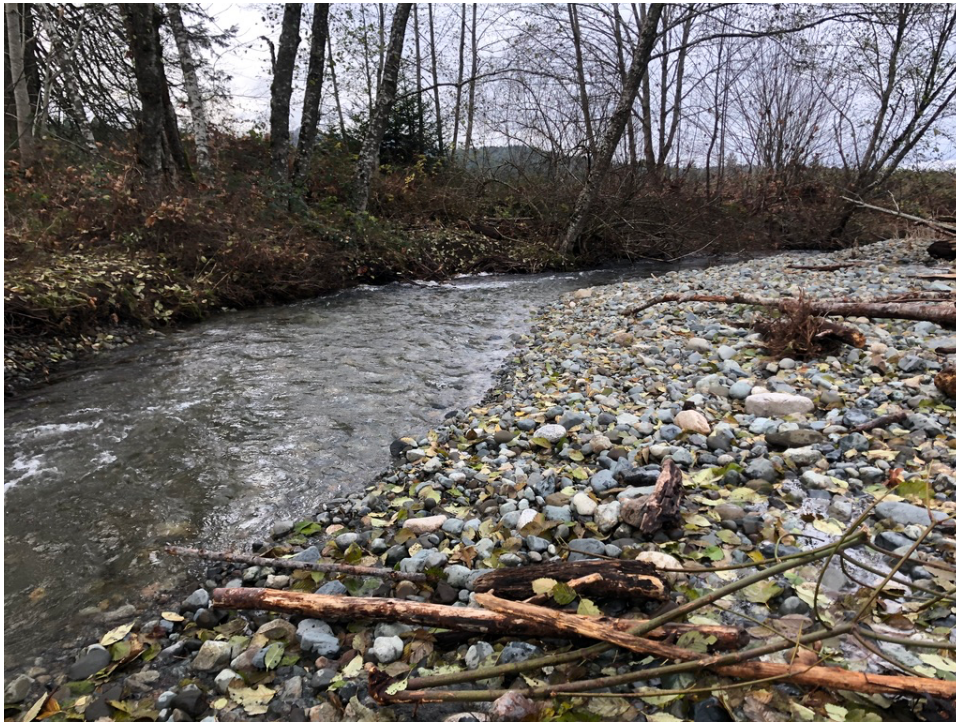
**Site #1 (Figure 2 and 3)** is unlike the other four sampling locations because it is located on Benson Creek which is a tributary of the Millstone River (10 U 422740mE, 5450751mN). This site has public access, with a trail right beside the bridge leading down to Benson Creek. Just upstream of where sampling took place is Camp Caillet which is one of the largest Scouts Canada camps on Vancouver Island. The immediate surrounding areas are nearly all farm fields with some residential properties mixed in. The substrate for this site consisted of 5% Fines, 10% Gravel, 80% Cobble, 5% Boulders, and 0% Bedrock. The main tree species on the left and right sides of the creek consisted of red alder (*Alnus rubra*) with an estimated canopy cover of 25% but other tree species such as big-leaf maple (*Acer macrophyllum*) were present. The creek was quite wide in some sections and had a few undercut banks and large tree roots which could provide salmonids with excellent habitat. The understory plants consisted mostly of Himalayan blackberry (*Rubus armeniacus*) and snowberry (*Symphoricarpos albus*). The instream cover was estimated to be at 10% and there were eleven pieces of large woody debris noted. The gradient at this site was determined to be 2.5%. During our initial site visit on October 13, the flow rate was fairly low for all sites, but we did anticipate higher flows as time went on. Some sources of pollution for this site could include noise pollution, or fuel leaking from vehicles due to the proximity of the road to the creek. Other potential sources include creosote from the bridge which may prove to be harmful to the riparian area, garbage from easy public access, and runoff and eutrophication from the nearby agricultural areas. Some hazards outlined for this sampling location include tripping hazards such as roots or wet rocks. There are also sharp bushes, the possibility of drowning, busy traffic, and possible dangerous animal encounters.

**Figure 2:** Photo from Site 1 During Low Flow

**Figure 3:** Photo from Site 1 During High Flow

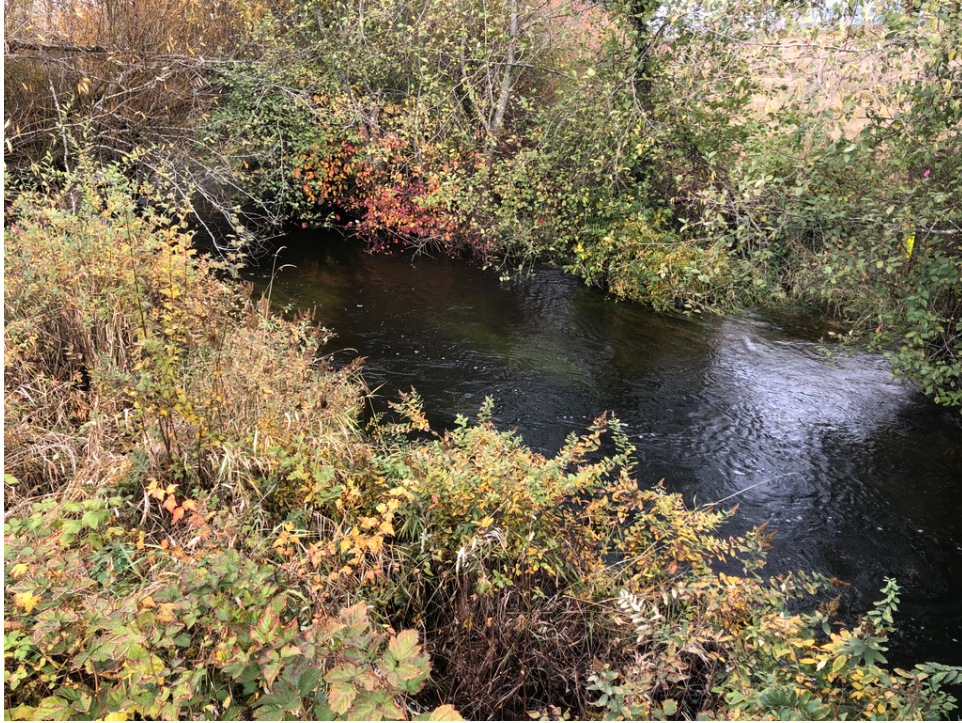
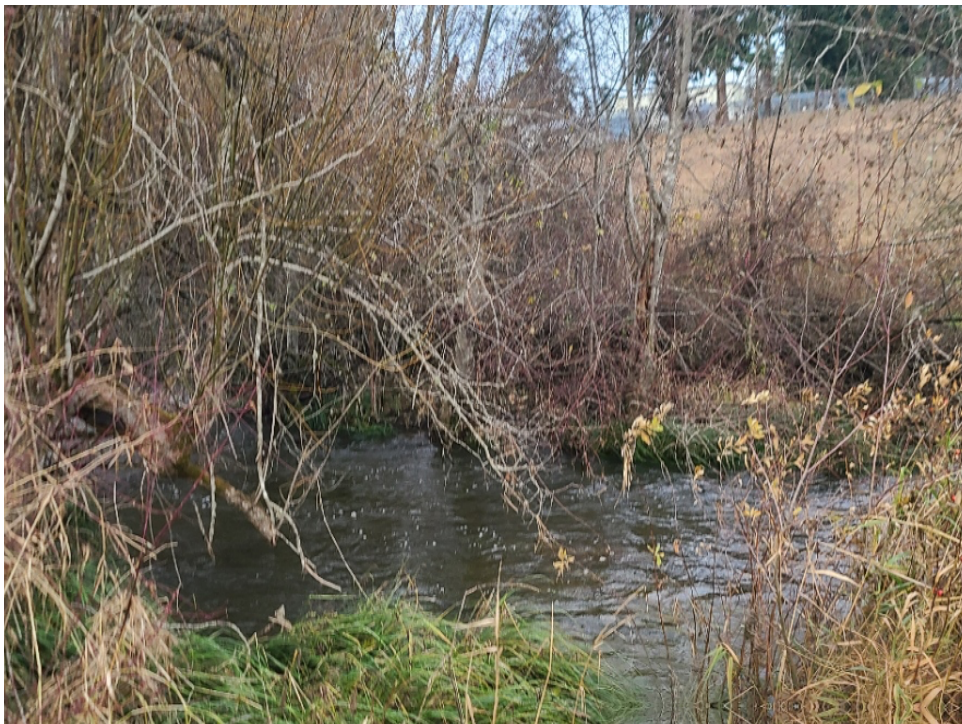
**Site #2 (Figure 4 and 5)** was the first site we started sampling for the Millstone River and the rest of the locations all take place in the Millstone (10 U 423343mE, 5450840mN). This site had public access by a little trail just off the road by the bridge that goes over the river. Just upstream of this sampling site is Brannen Lake and the Nanaimo Correctional Centre. The immediate surrounding area is slightly forested, and the rest is all farm fields and the Nanaimo Correctional Centre buildings. The substrate for this site consisted of 40% Fines, 30% Gravel, 30% Cobble, 0% Boulders, 0% Bedrock. The site had ample vegetation on both river sides, with tree cover giving us an estimated 10% canopy cover. There were many understory plants such as Himalayan blackberry (*Rubus armeniacus*), hardhacks (*Spiraea douglasii*), and cutleaf blackberry (*Rubus laciniatus*). The instream cover was estimated to be at 45% and there were three pieces of large woody debris noted. The gradient at this site was determined to be 1.5%. Some sources of pollution for this sampling site include runoff and eutrophication from nearby agricultural areas, garbage, and oil from the road and bridge that travel across the river. Some hazards identified for this site include busy traffic as there is no actual parking lot available, and there is a considerable hill on the road that could prove to be slippery in wet or frozen conditions. When getting in and out of vehicles it was important to stay vigilant. Other hazards included tripping on tree roots, sharp bushes, the possibility of drowning, and dangerous animals.

**Figure 4:** Photo from Site 2 During Low Flow

**Figure 5:** Photo from Site 2 During High Flow

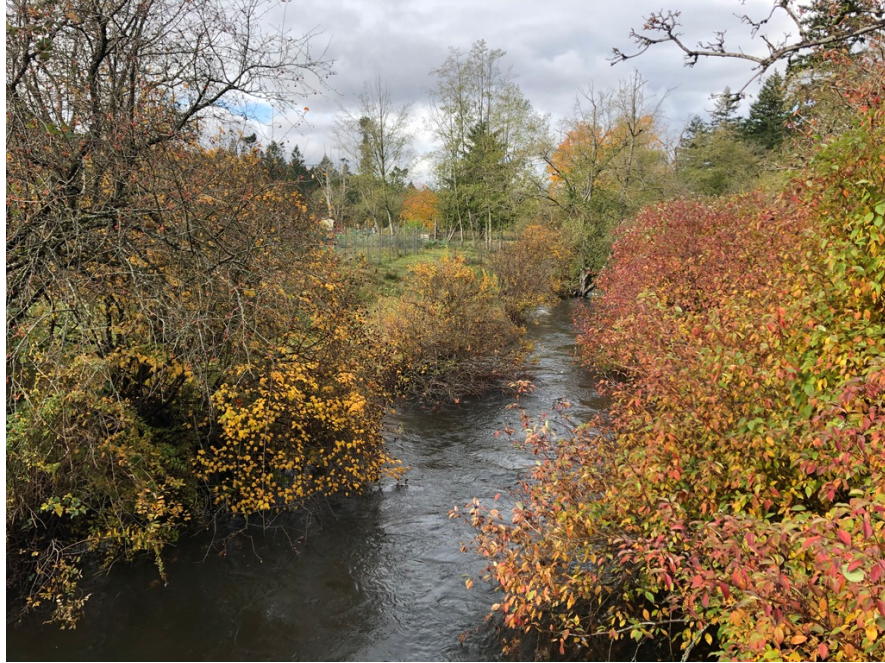
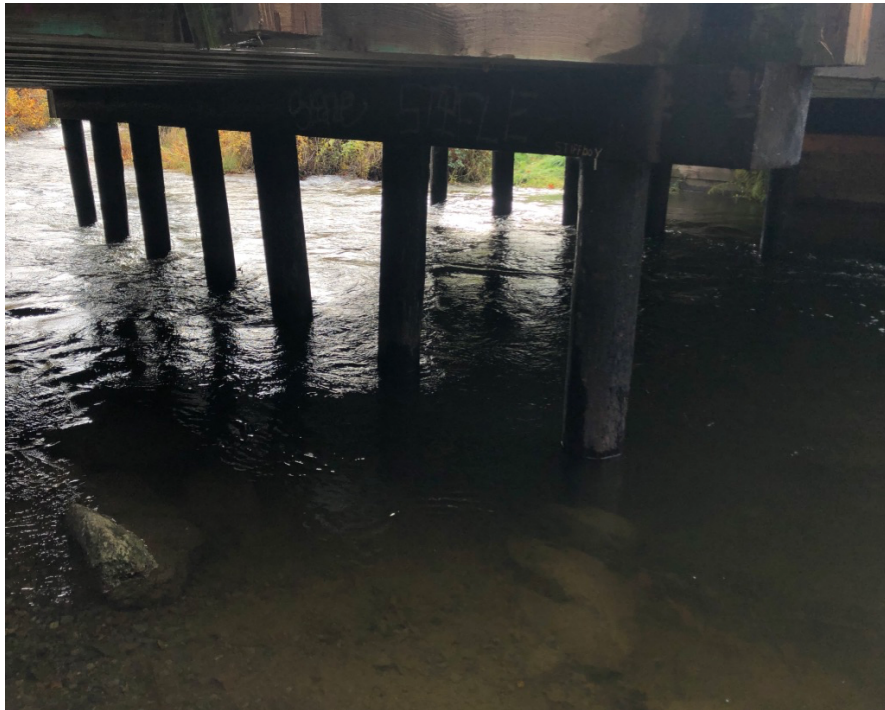
**Site #3 (Figure 6 and 7)** had easy public access on either side of a bridge that goes across the Millstone River (10 U 426310mE 5448965mN). The immediate surrounding areas are dominated by residential dwellings and some small farming fields. The substrate for this site consisted of 30% Fines, 30% Gravel, 30% Cobble, 5% Boulders, and 5% Bedrock. The dominant trees on the left bank were cherry trees and, on the right, it was a species of cottonwood tree which gave us around 20% for canopy cover. The site had understory vegetation such as skunk cabbage (*Lysichiton americanus*), lady fern (*Athyrium filix-femina*), and invasive Himalayan blackberry (*Rubus laciniatus*). The instream cover was estimated to be at around 45% with some grass-like vegetation growing in the river and there was one piece of large woody debris noted. The gradient at this site was determined to be 1%. Some sources of pollution for this sampling site include pollution from the road and bridge such as oil and creosote from the bridge may prove to have some impact on the river. Other potential impacts include garbage from easy access and nearby residents, or potential runoff and the associated impacts of eutrophication from nearby farmland. Possible impacts from septic tanks may be present. Some hazards identified for this site include tripping hazards, loose substrate, muddy conditions, some sharp bushes, a risk of drowning, and fruit trees nearby on residential properties may attract dangerous animals. The creosote used to treat the bridge may additionally have negative impacts on the riparian area downstream.

**Figure 6:** Photo from Site 3 During Low Flow

**Figure 7:** Photo from Site 3 During High Flow

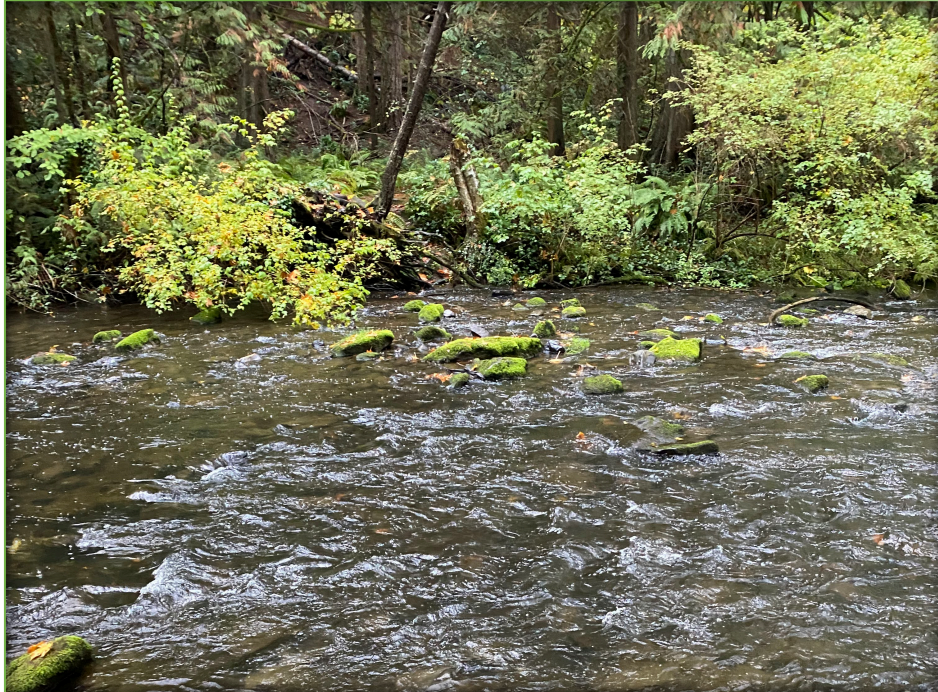
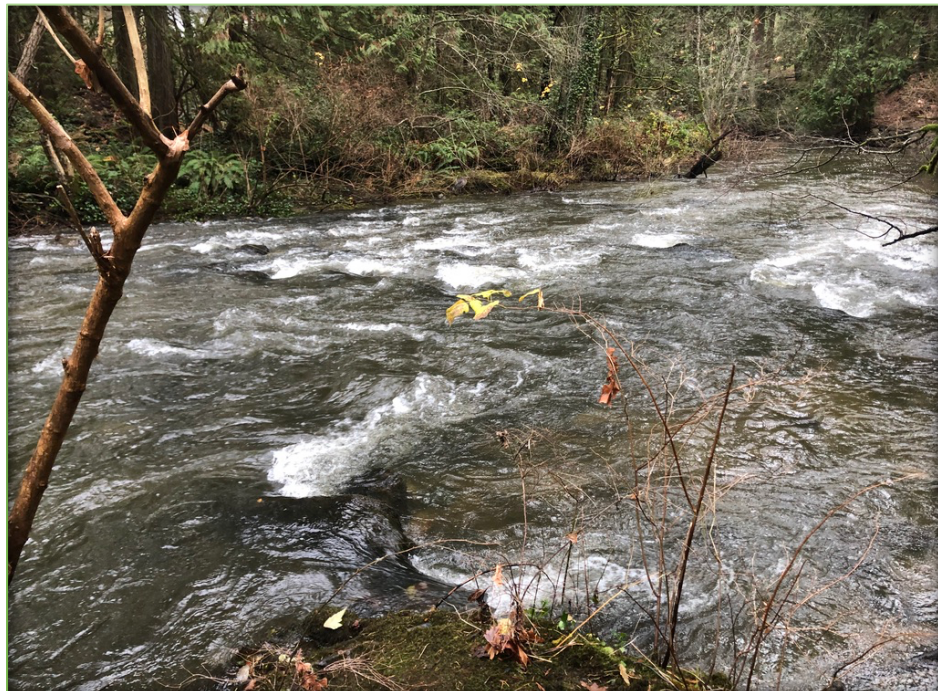
**Site #4 (Figure 8 and 9)** had easy public access through Bowen Park in Central Nanaimo (10 U 430329mE 5447276mN). The immediate surrounding areas were forested but Bowen Park is surrounded by residential housing and developments. The substrate for this site consisted of 30% Fines, 30% Gravel, 20% Cobble, 15% Boulders, and 5% Bedrock. The dominant trees on the left bank were Douglas fir (*pseudotsuga menziesii*) and Western red cedar, while on the right it was mostly red alder trees (*Alnus rubra*). This gave us an estimated 60% canopy cover due to how forested the surrounding areas were. The site had understory vegetation such as invasive English ivy (*Hedera helix*), sword fern (*Polystichum munitum*), ocean spray (*Holodiscus discolor*), and salmonberry (*Rubus spectabilis*). The instream cover was estimated to be at 40% and there were three pieces of large woody debris noted. The gradient at this site was determined to be 1%. Some sources of pollution for this sampling site include pollution from the nearby park parking lot, and garbage from park visitors. Some hazards identified for this site include dangerous animal encounters - Including pets from people on trails, sharp bushes, and of course the possibility of drowning or being swept away by the river.

**Figure 8:** Photo from Site 4 During Low Flow

**Figure 9:** Photo from Site 4 During High Flow

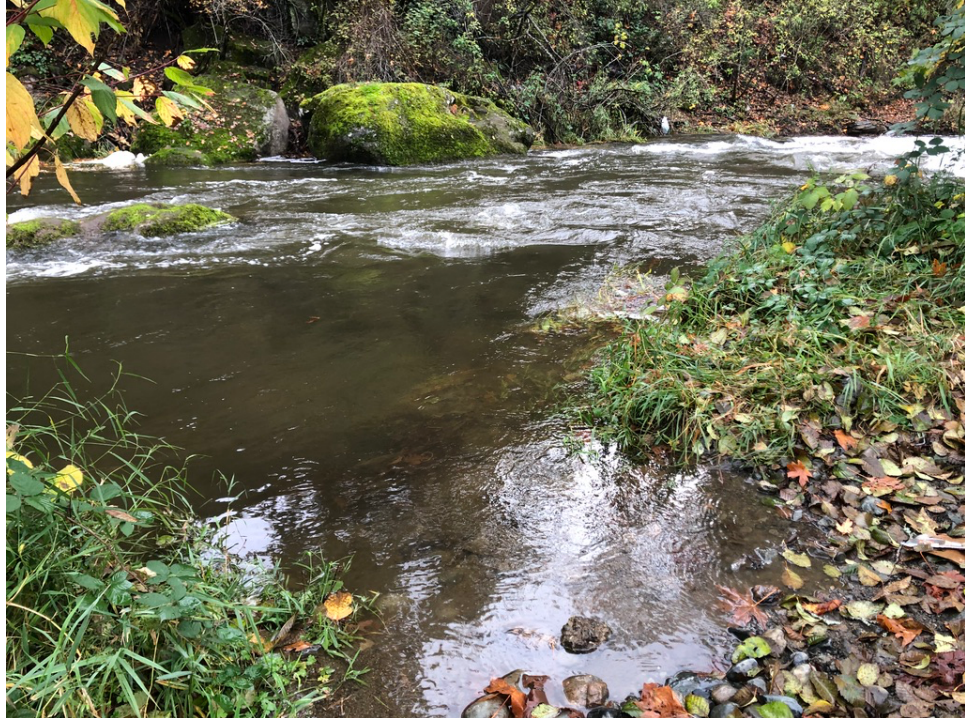
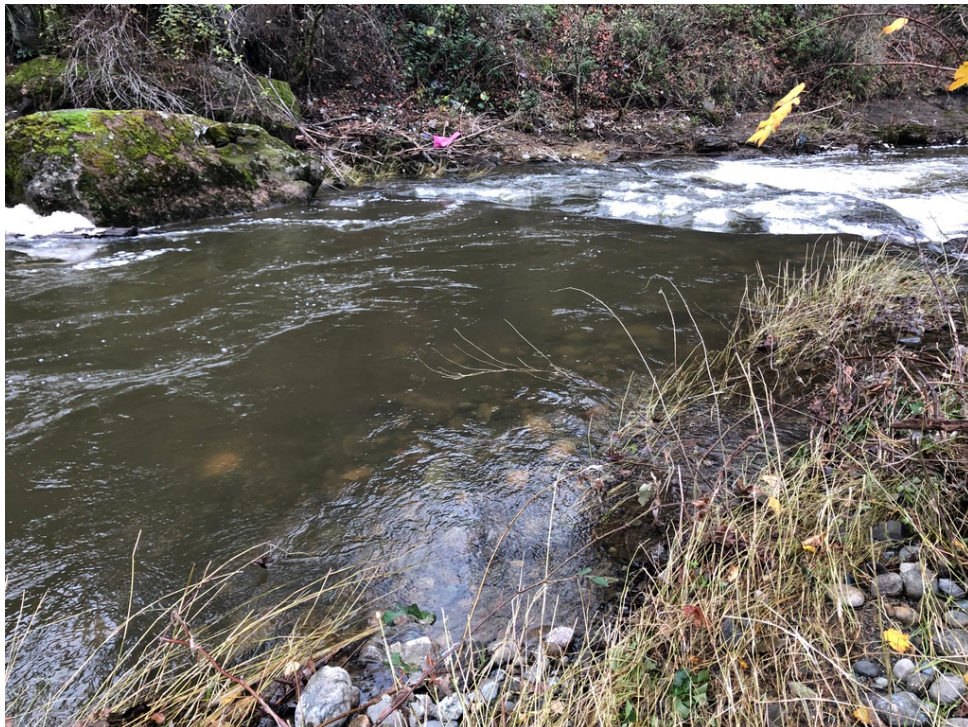
**Site #5 (Figure 10 and 11)** had easy public access like the other sites through a small walking path through a forested area with a paved trail in Barsby Park (10 U 431008mE 5447205mN) and was the sampling site closest to the ocean. Although this is a park, it is relatively small, and it is surrounded by developments and high traffic areas. The substrate for this site consisted of 20% Fines, 15% Gravel, 10% Cobble, 30% Boulders, and 25% Bedrock. The dominant trees noted for the right bank were red alder trees (*Alnus rubra*) and this gave us an estimated 10% of canopy cover. Other understory vegetation on site included grass, invasive English ivy (*Hedera helix*), and ocean spray (*Holodiscus discolor*). The instream cover was estimated to be at 35% and there were five pieces of large woody debris noted. The gradient at this site was determined to be 2%. Some sources of pollution for this sampling site include pollution from the busy highway above such as oil, tires, or garbage blowing out of vehicles. There was plenty of garbage already present on site, along with a handful of homeless structures. Some hazards identified for this site include tripping hazards, wet rocks, muddy substrate, a possibility of drowning, needle pricks, there was busy traffic getting to the sampling location, and of course dangerous wildlife encounters.

**Figure 10:** Photo from Site 5 During Low Flow

**Figure 11:** Photo from Site 5 During High Flow

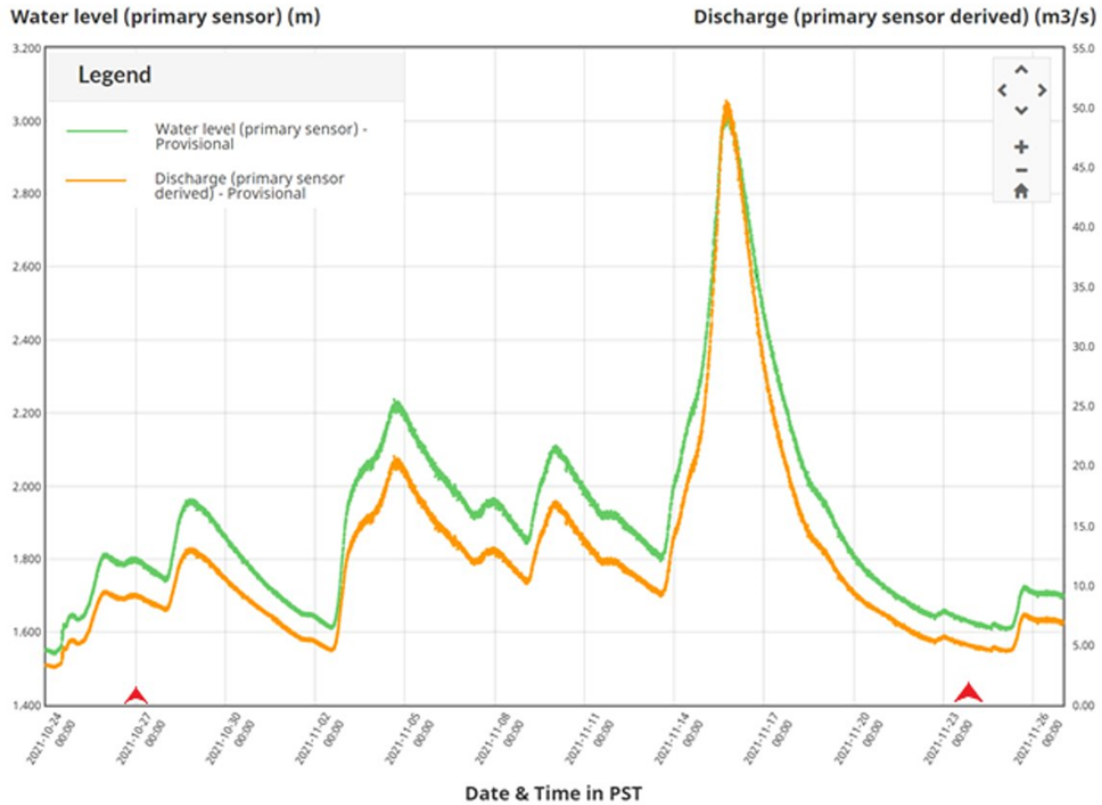
When comparing water discharge data from the time between sampling event one and two, we can see the result of this rainfall on the Millstone River (**Figure 13**). When looking at data from previous years we were able to conclude that water levels in the river were the highest they have been since 2010 (Water Level and Flow... 2021).

**Figure 13:** Graph of Water level and Discharge of the Millstone River from October 24, 2021, to November 26, 2021 (Water Level and Flow... 2021)

During sampling event 1, we attempted to capture the state of the river after a period of low flow conditions. At that time the Millstone River was at a water level of 1.77m (**Table 2**). During sampling event two, we attempted to capture the state of the Millstone River after a period of high flow conditions; at the time of sampling the water levels had fallen to a level of 1.61m from a peak of 3.03m (Water Level and Flow... 2021).

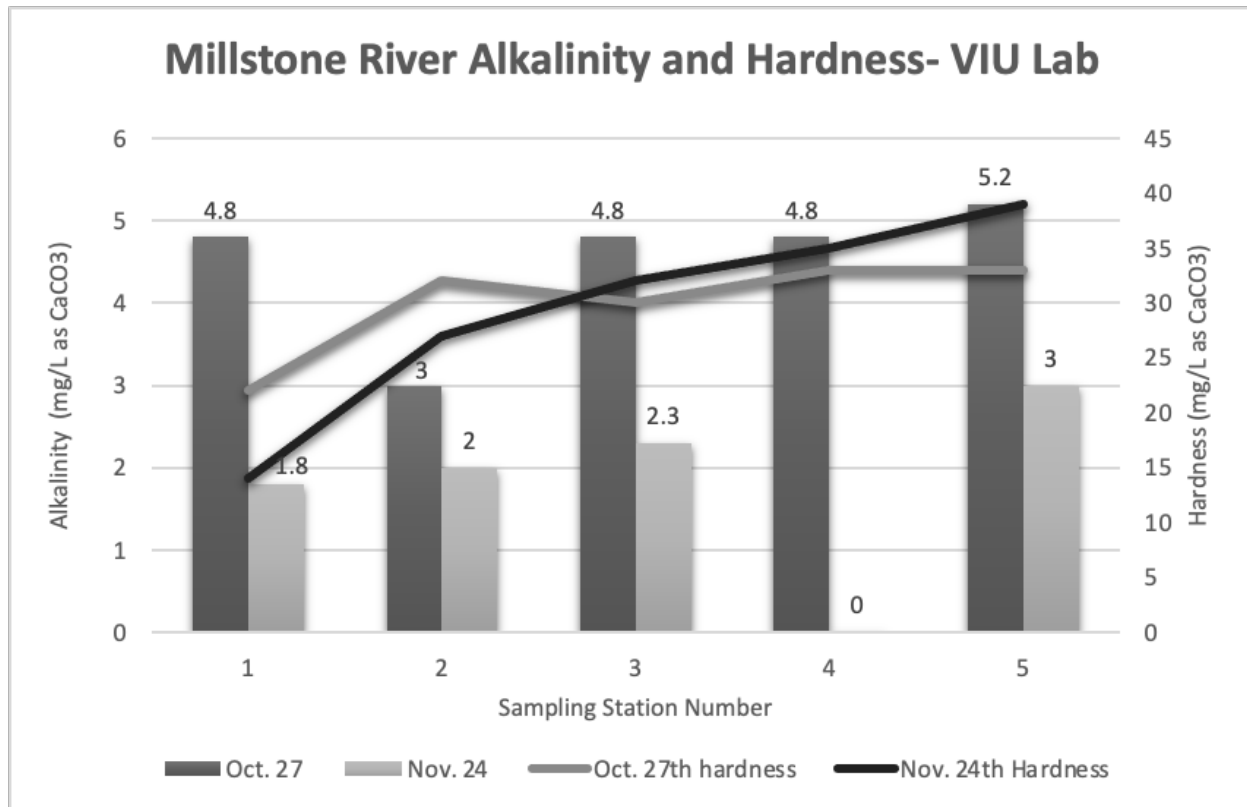
**Alkalinity:** The results from the first sampling event in October ranged from 3 mg/L to 5.2 mg/L as CaCO<sub>3</sub> with the most drastic change between site 1 and site 2 (4.8mg/L to 3mg/L). Due to the location of site 2 being directly downstream of Brannen Lake, the sudden drop in alkalinity could represent a lack of CaCO<sub>3</sub> coming from the lake. Likely there are more rocks and sediments within the Millstone River than Brannen Lake that contain calcium carbonate, so this may contribute to the increase in alkalinity upstream and further downstream from the lake. The November sampling showed a similar data trend with alkalinity continuing to increase

**Hardness:** The sum of magnesium and calcium concentrations within water or a stream or river contributes to how “hard” or “soft” water is. The guidelines outlined in (BCMOE 2021) classify “soft water” as CaCO<sub>3</sub> concentrations less than 60mg/L, “moderate” at 60-120 mg/L, and “hardwater” at any concentration over 120mg/L. The hardness of the Millstone River

between both sampling events correlated with both alkalinity, conductivity, and turbidity with all data showing increasing values the further from the headwaters the samples were collected. The first sampling event had concentrations ranging from 22mg/L to 33mg/L with a steady increase from sampling stations 3 to 5. The most substantial increase was displayed at sampling stations 1 to 2 where the hardness of the water increased from 22mg/L to 32mg/L immediately downstream of Brannen Lake (**Figure 16**). Likely at site 2 there was an increase in the number of dissolved cations (such as calcium and magnesium) that entered the Millstone River from the lake and thus contributed to the sharp hardness increase. The second sampling event showed a similar trend with the hardness of the river ranging from 14mg/L to 39mg/L with another sharp increase from site 1 to site 2 (14mg/L to 27mg/L as CaCO<sub>3</sub>). Due to all samples being less than 60mg/L as CaCO<sub>3</sub> during both sampling events, the Millstone River at the time of the sampling was considered to have soft water.

**Figure 16:** VIU Lab Data Comparison Between Alkalinity and Hardness on the Millstone River

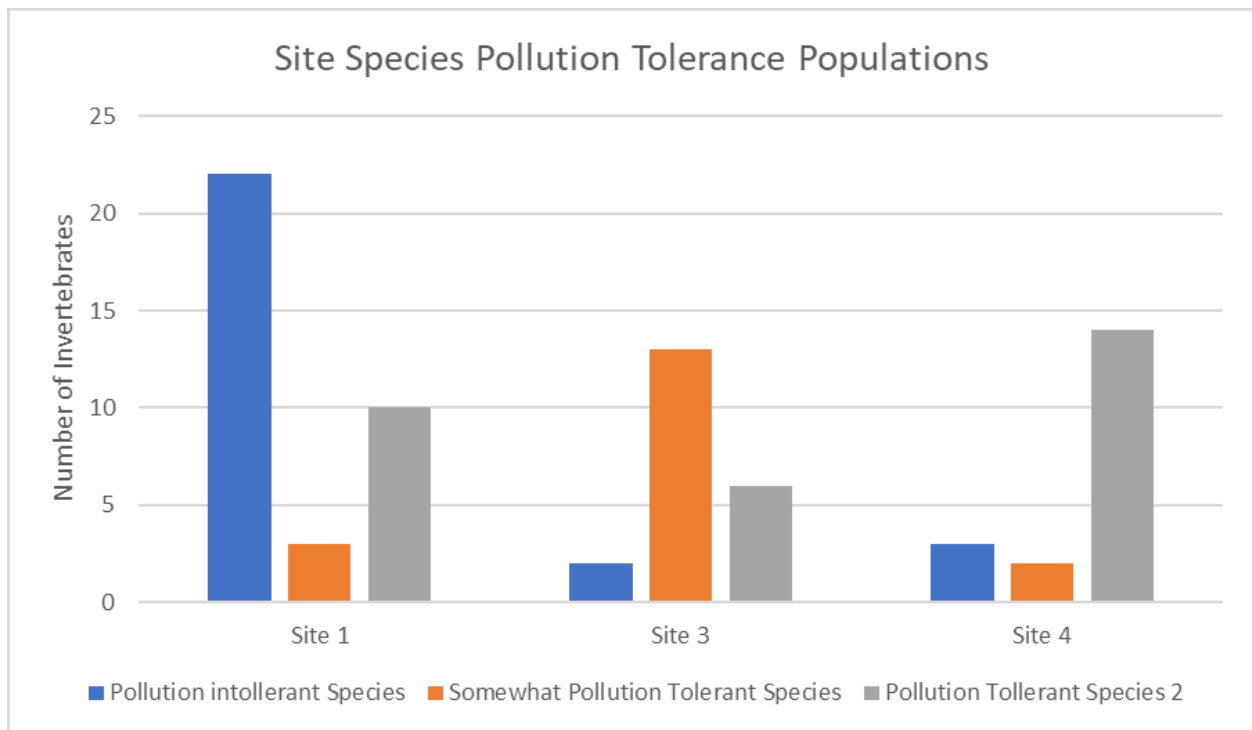
The invertebrate sampling conducted on the Millstone River produced a total of 75 invertebrate individuals and five broad taxonomic groups. Invertebrate density was calculated and site 3 was found to have the highest density at 233.33 animals/m<sup>2</sup> (**Figure 21 and 22**). Moving downstream, site 4 had 105.56 animals/m<sup>2</sup> which was the lowest of all sample sites (**Figure 23 and 24**). Site 1 fell in between the other two sites with a density of 194.44 animals/m<sup>2</sup> (**Figure 19 and 20**). Notably prominent species through all sample sites consisted of

aquatic worms, mayfly, and freshwater shrimp. The prominent species for site 1 was mayfly larva, which is a pollutant intolerant species (**Figure 25**). The prominent species for site 3 was freshwater shrimp which are considered somewhat pollution tolerant (**Figure 26**). The prominent species for site 4 was aquatic worms which are pollution tolerant (**Figure 27**). When looking at each of the sites prominent species there is a trend of species becoming more tolerant to pollution as one travels downstream (**Figure 18**). This suggests greater pollution levels further downstream.

**Figure 18:** Site Species Pollution Tolerance Populations Chart

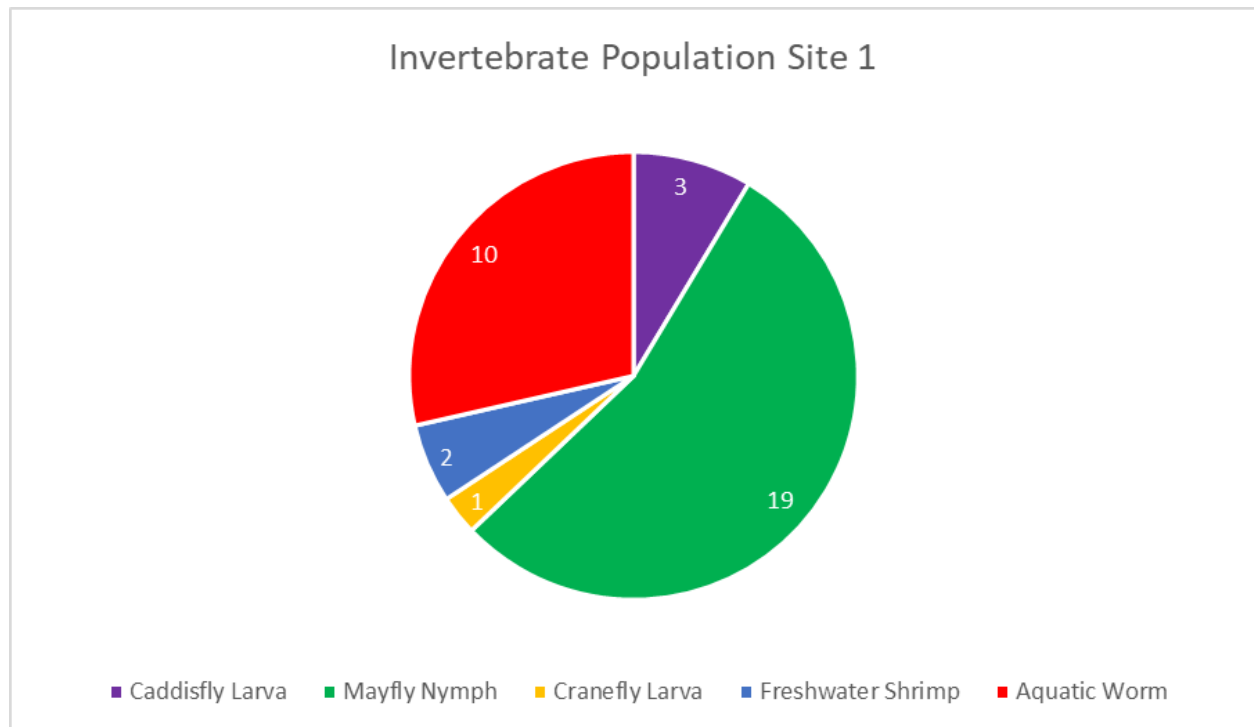
**Figure 25:** Invertebrate Population Site 1
