Water Quality and Stream Invertebrate Assessment on Richards Creek,
North Cowichan, B.C.

RMOT 306

Vancouver Island University

December 13th, 2021

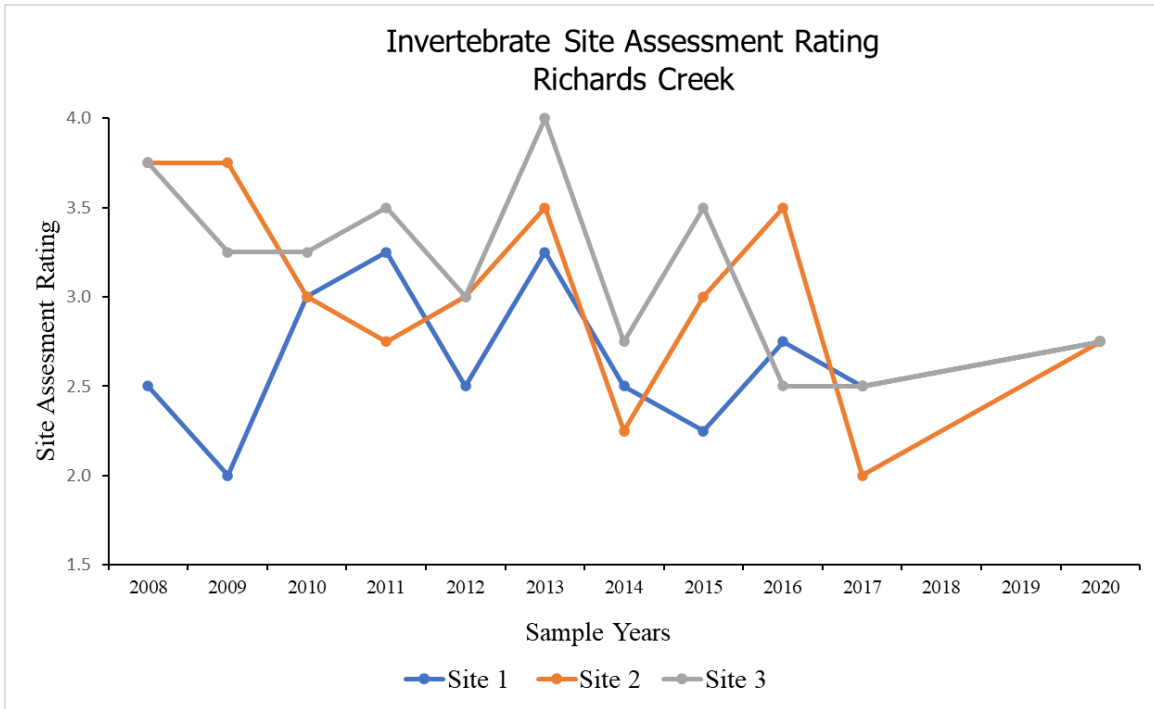
Figure 2: Data compiled from 2009 to 2020 representing the downward trends in stream health (Brown et al. 2008. Anderson et al. 2009. Brooks et al. 2010. Dorey et al. 2011. Dorey et al. 2012. Seibert et al. 2013. Aikman et al. 2014. Der et al. 2015. George et al. 2016. Bull et al. 2017).

For Site 3, Category 3 once again displayed the most abundance over the other two categories, with 30 individuals captured representing 3 different species. In this site, the most abundant taxon was the aquatic worm (*oligochaeta*), which is considered pollution tolerant. Therefore, the tolerance index this once again calculated to be 2.75, which is suggesting that this site has marginal stream health. The results taken from Richards Creek show a trend when compared to previous years where sampling has been done. Figure 2 was created to better compare past studies from 2008 to 2017. In the report done in 2009 by Anderson et al. (2009), the site assessment rating for Site 1 was scored as a 2 with Site 2 and Site 3 scoring above a 3. The 2012 report done by Coopsie and Senkiw (2012) showed a variation in their site assessment score. Site 1 was scored 2.5 as marginal with Site 2 and 3 showing acceptable scores of 3. In 2015 the site assessment rating done by Der et al. (2015) shows Site 2 and Site 3 were scored as a 3 and 3.5 indicating acceptable levels of stream health, whereas Site 1 showed a lower score of 2.5. Even with several spikes in numbers for positive overall health, there has been a steady downward trend in stream health over the last 13 years. Although the reason behind the decline in stream health is unconfirmed at this time, it is highly likely to be attributed to agricultural runoff combined with the changes in weather and temperature due to climate change. However, it should be noted that the recorded data may have some margin of error because sampling and analysis are completed by different students every year rather than a consistent team.

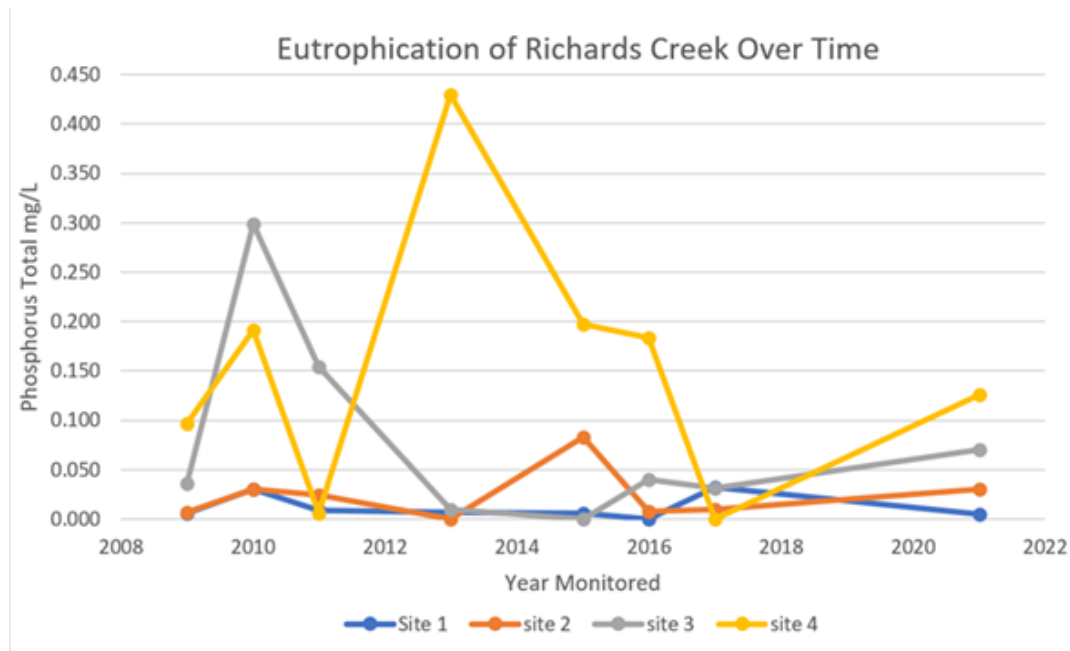
Reviewing several years worth of past VIU creek water quality reports and examining the rise and fall of recorded phosphorus to determine the trophic level (graph) shows that even back to 2008, Richards Creek has been largely eutrophic. Looking at Figure 3, both 2010 and 2013 show a drastic increase in phosphorus levels of sites 3 and 4 but not 1 or 2. It can be inferred that an event occurred affecting those areas. Effluent spills, increased

construction or most likely heavy rainfall resulting in agricultural runoff draining into those areas of the creek closest to them could be the cause of these abnormal spikes in phosphorus. The results taken in 2021 by our team show a gradual increase in phosphorus the further downstream testing is done which is more densely populated with agricultural farmland. Unfortunately, due to improperly recorded or absent data from 2018-2020, it is not possible to say whether there has been a gradual increase in phosphorus from 2016-present or if there were spikes previously and we are presently in decline. With future detailed recording, a gradual trend will be possible to graph.

Figure 3: Phosphorus Levels in Richards Creek Showing Eutrophication Changes

More testing can be done to determine the exact cause for the increase in phosphorus levels found within Richards Creek. It would be beneficial to inform all agricultural practices that run alongside Richards Creek of the consistent decrease in stream health over the last 13 years. There may be alterations done within these agricultural practices that could assist in restoring previously recorded productivity within Richards Creek. One such alteration might be to put in place a large riparian zone around the creek. This might prevent runoff, flooding and further eutrophication. Another suggestion may include putting up proper fencing to prevent livestock from accessing the creek to lower contamination levels.

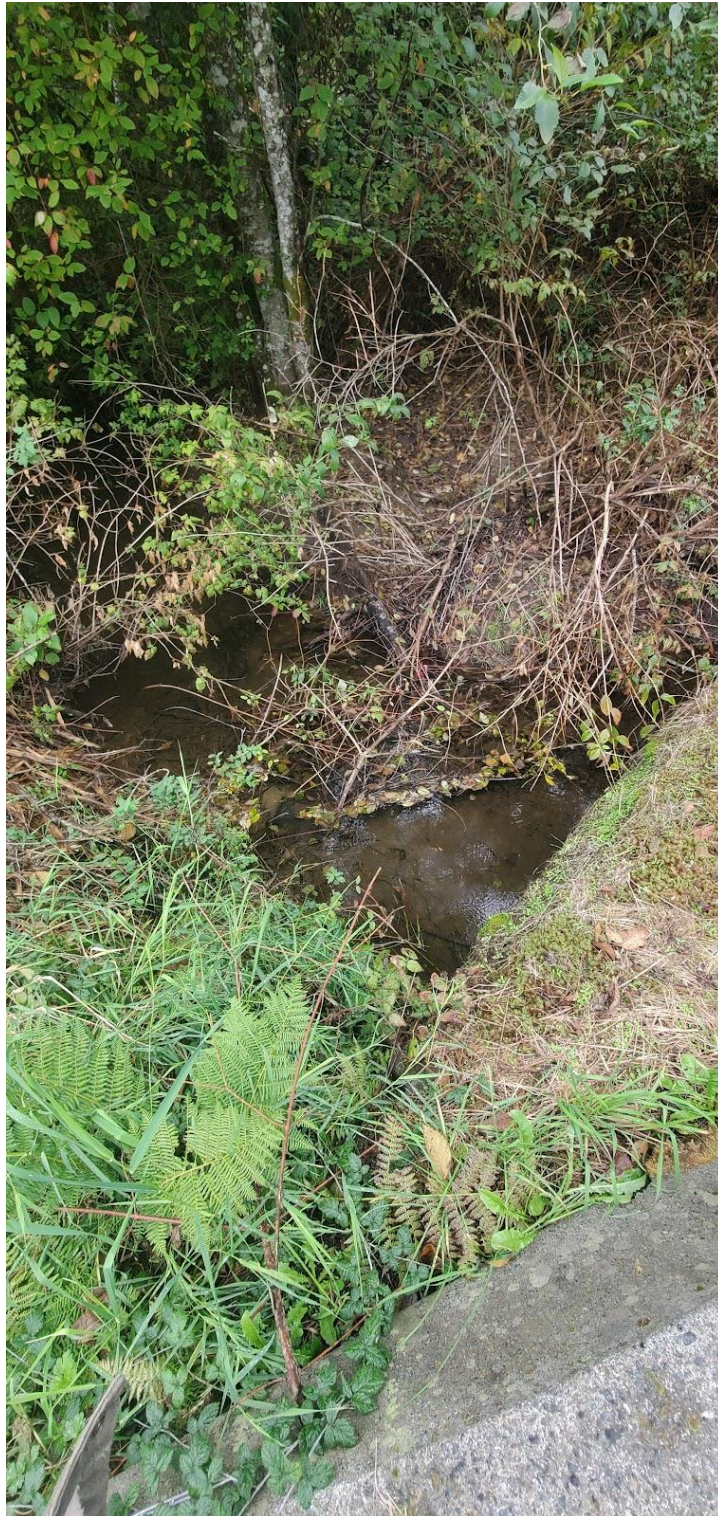
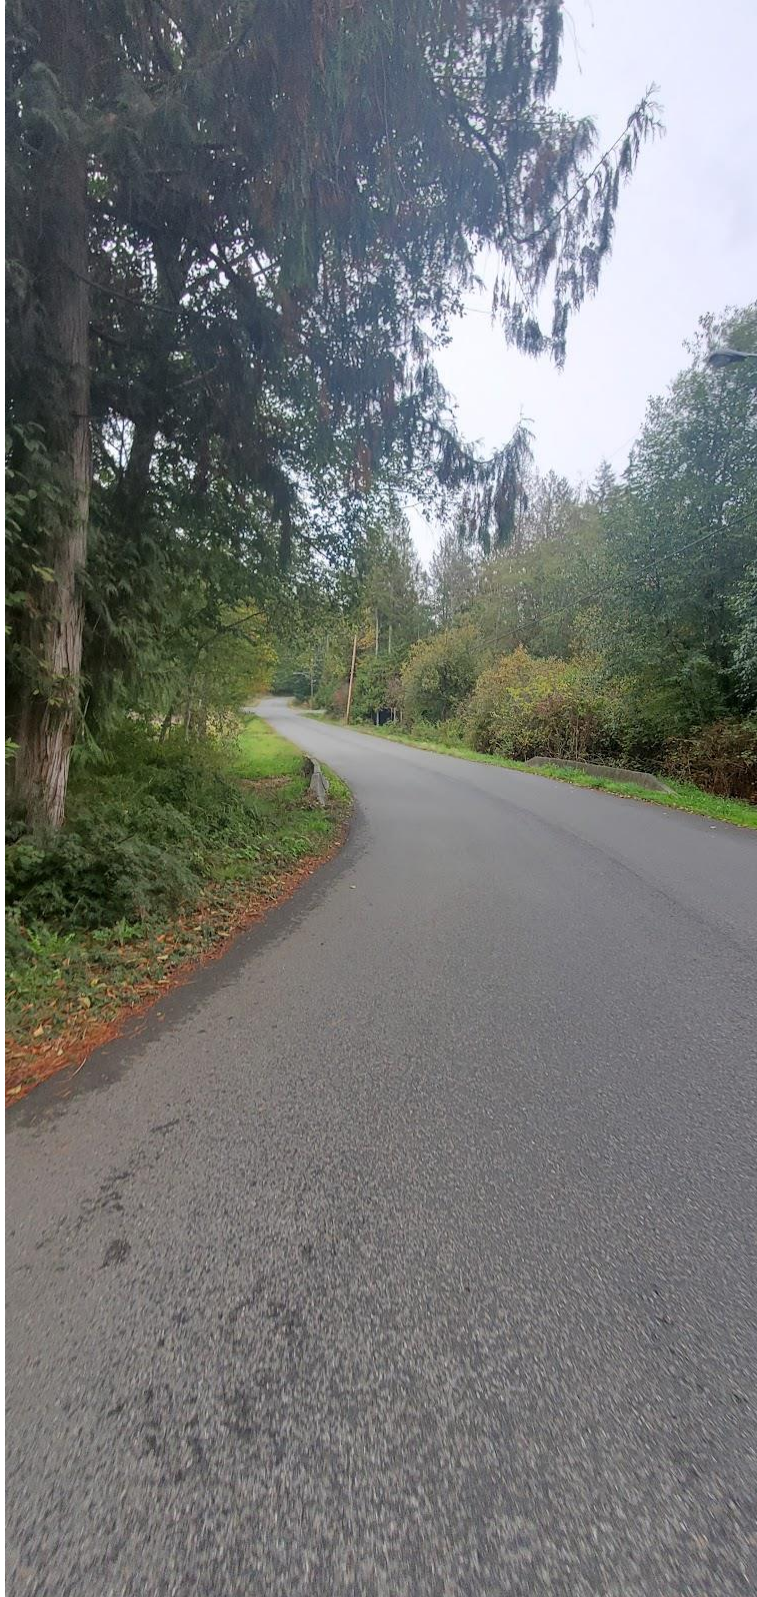
Site 1 at the Escarpment Way Crossing is accessed along the banks just off the side of the road. There is a single pipe culvert that allows the creek to pass unobstructed underneath the road. The surrounding riparian area is densely packed with saplings and wild grasses that shade the area. The substrate within the site is sandy with deep pockets where root systems have grown.

Photo of Sample Site 1, Escarpment Way, October 26th, 2021

Photo of Sample Site 1, Escarpment Way. October 26th, 2021

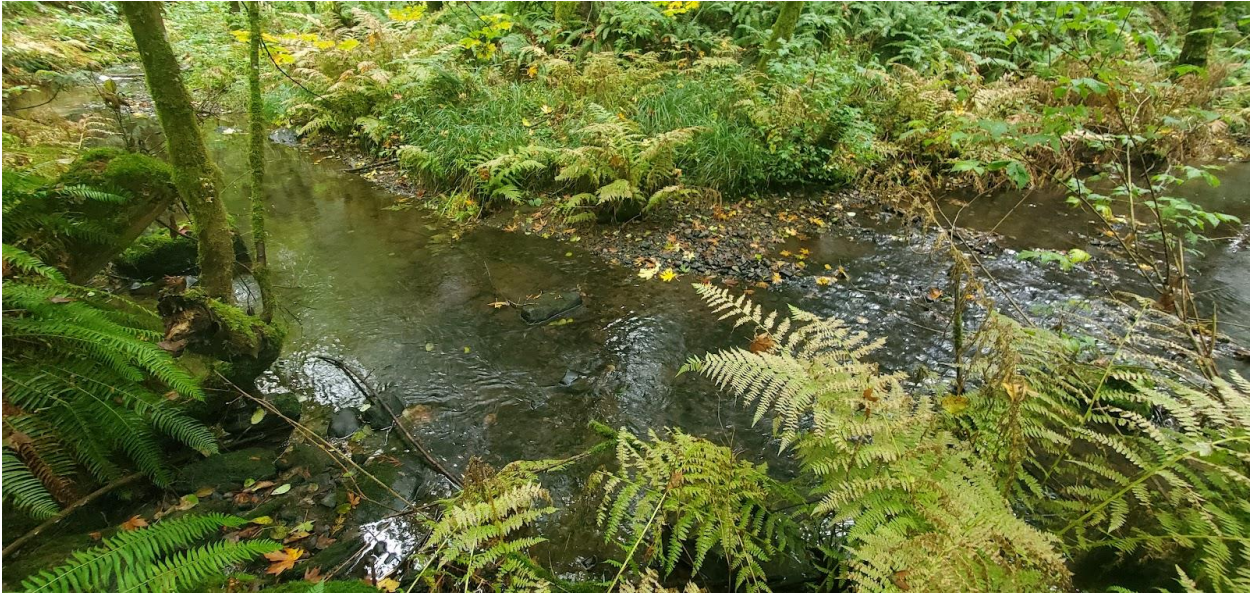
Site 2 at the end of Rice Road is in a more isolated location with a dense riparian area showing more sword ferns and cedar tree coverage. The substrate of this site consists of

cobble and sand within the stream bed with loamy soil along the banks. To access this site a 4-minute hiking trail was made from the road into the gully.

Photo of Sample Site 2, Rice Road. October 26th, 2021

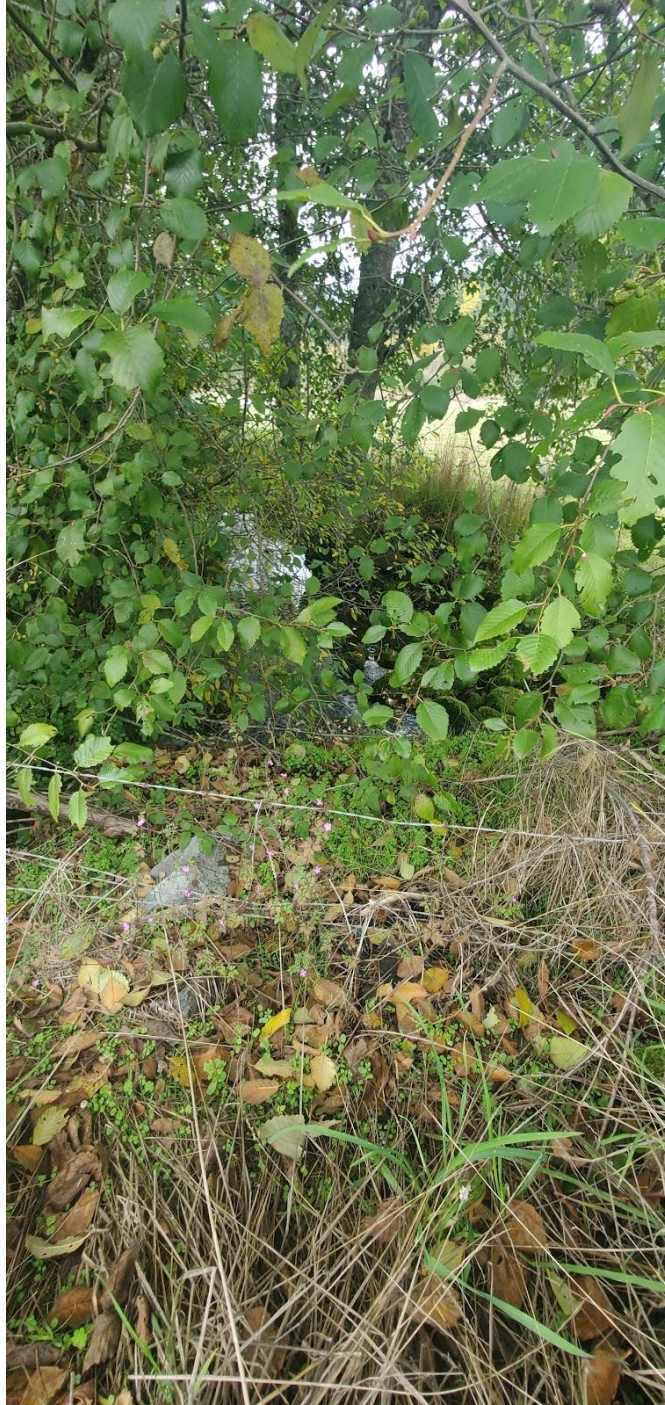
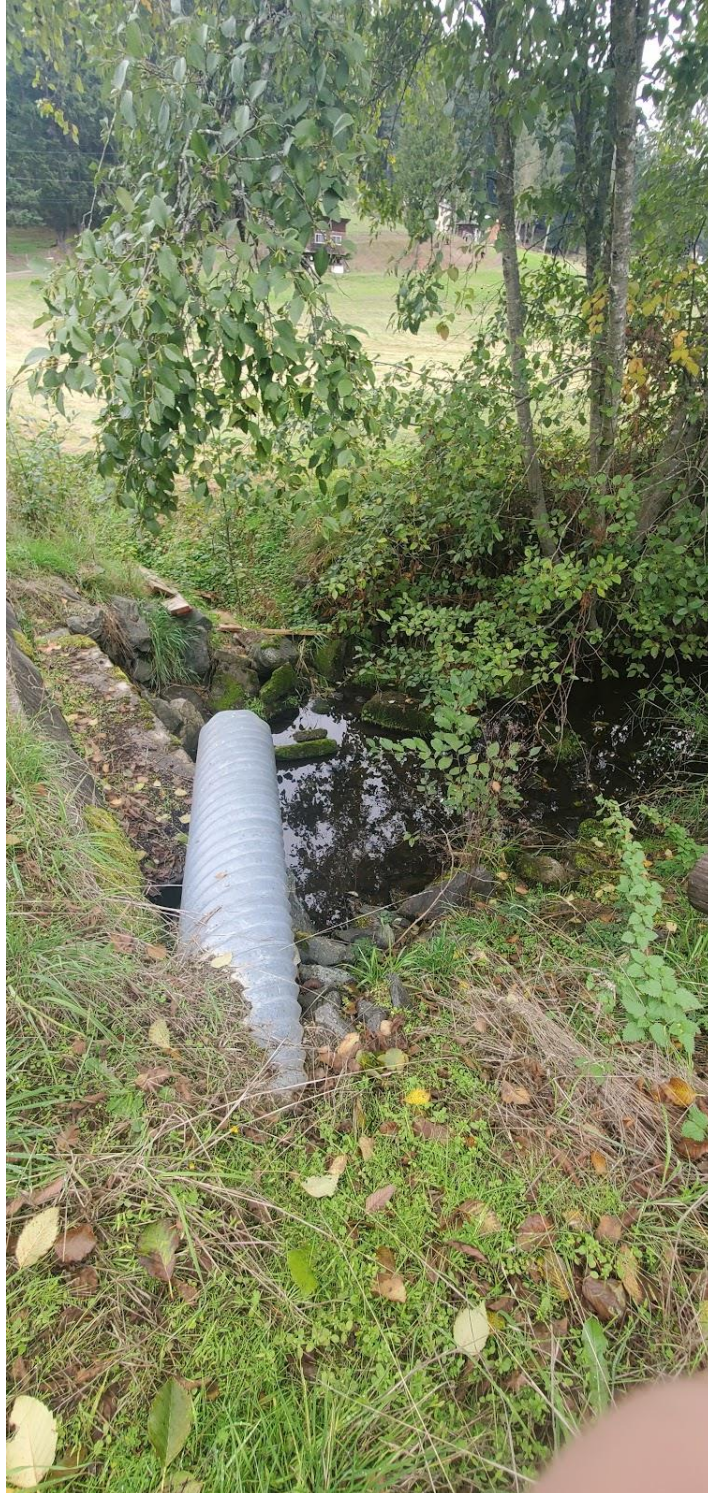
Site 3 at the Richard Trail Crossing is accessed along the banks beside the road. To allow the creek to run unobstructed, there is a large bridge culvert installed. There are several large agricultural practices alongside the banks, which is a potential concern for contamination. The surrounding riparian area consists of various brambles and small maples providing adequate shade. The substrate at this site is primarily stones and boulders with several pieces of large woody debris.

Photo of Sample Site 3, Richards Road. October 26th, 2021

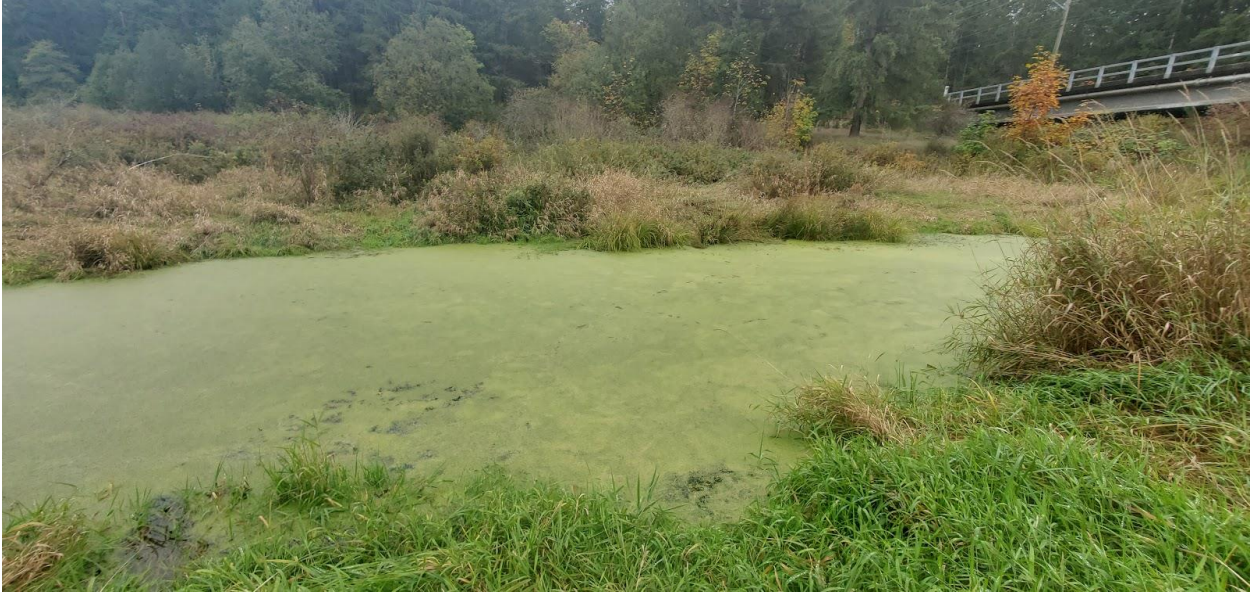
Site 4 at the Herd Road Crossing is located under the roadway accessed by foot on a steep gradient with dense English ivy and brambles blocking the access trail. This site is surrounded by a marshy riparian area, with a deep pool forming within the creek. Due to the unknown depth of the site, several tests were unable to be performed (invertebrates, velocity, wetted depth, wetted width), due to various safety concerns. During the second collection of samples, site 4 was completely inaccessible due to heavy flooding.

Photo of Sample Site 4, Herd Road. October 26th, 2021
