Water Quality and Stream Invertebrate Assessment of the C.W Young Channel, Englishman
River, British Columbia (Fall 2023)

Vancouver Island University

Executive Summary

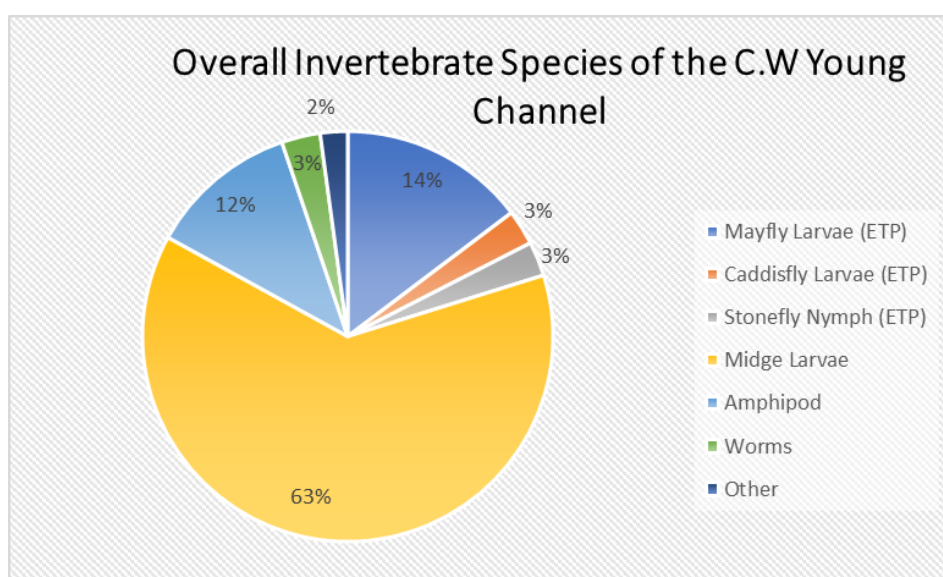
As result, we were able to collect a total of 1442 insects across four sites, each site being sampled twice. Within this population we were able to identify 12 different taxa. The most dominant species we found was midge larvae (Figure 13). This taxon made up 63% of the total number of invertebrates counted, the second most abundant was mayfly larvae making up 14% of the total number sampled and third was scud closely following up mayflies at 12% (Figure 13). Although midge larvae were the most abundant at each site, the predominant species are the other sites varied significantly. This is not surprising as each site has a notably different instream habitat and stream morphology.

Figure 13:Grand Total of Sampled Invertebrate Derived from All 4 Sites of the C.W Young Channel.

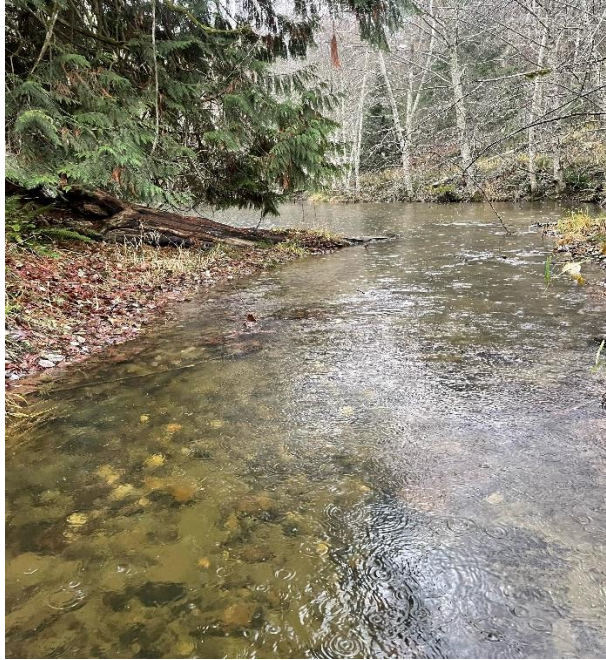
Photo 1: Site #1 of the C.W. Young Side Channel (facing downstream).

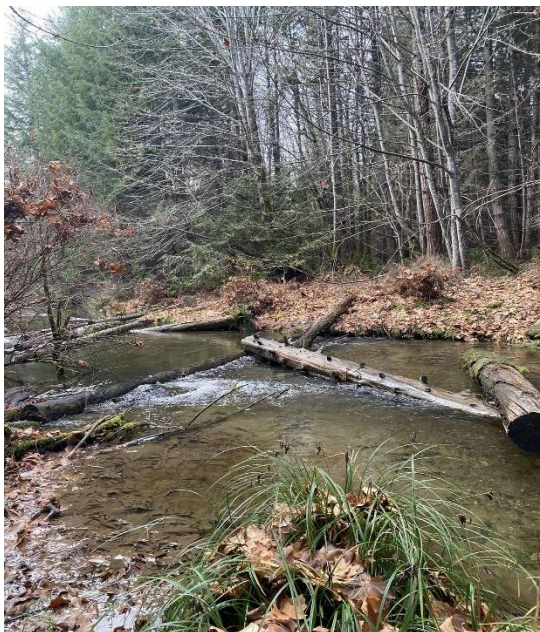
Photo 3: Site #3 of the C.W. Young Side Channel (facing upstream).

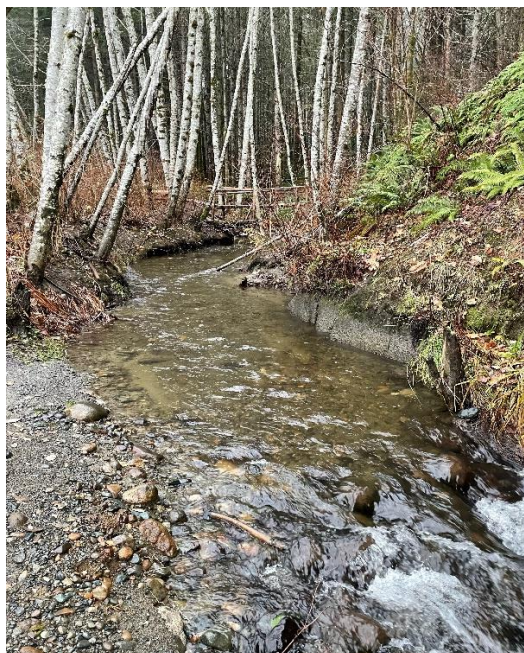
Photo 4: Site #4 of the C.W. Young Side Channel. This is the outflow of the side channel (facing upstream).
