**A Habitat, Water Quality, and Stream Invertebrate Assessment Report
for Cottle Creek in Nanaimo, BC**

RMOT 306
Vancouver Island University
Nanaimo, BC

December 12, 2023

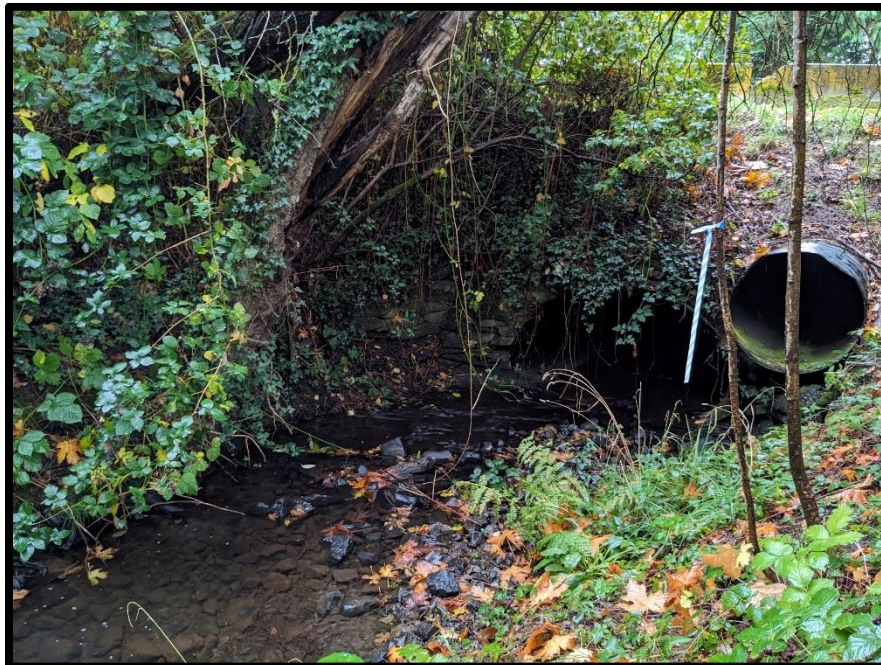
Figure 8. Site 4, looking downstream. Note the two culverts in place to control varying levels of flow (Taken on October 10, 2023).

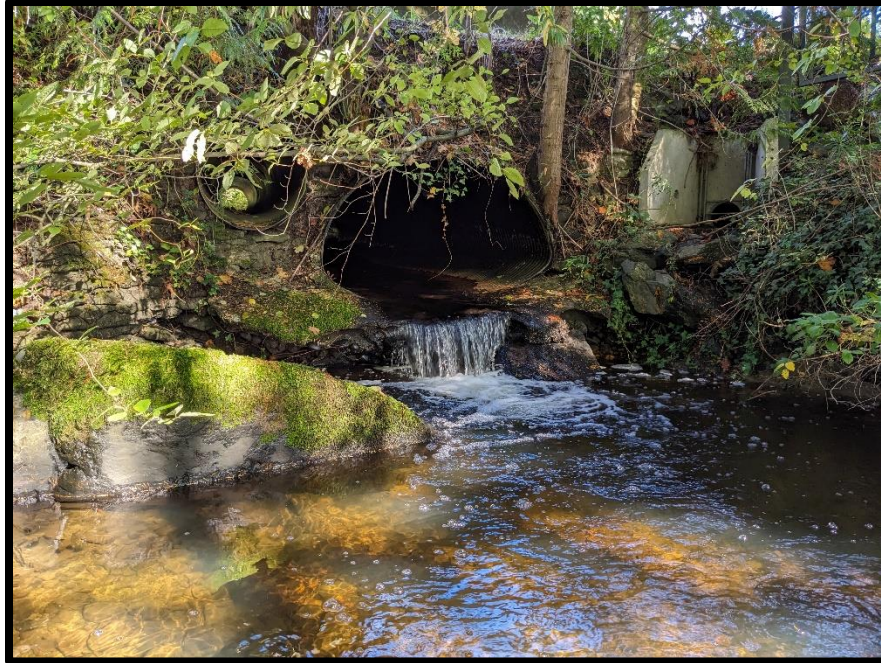
One considerable issue with Cottle Creek that needs to be addressed is the large culvert found at site 4, which is also the barrier for pacific salmon to enter the watershed from the ocean. Perhaps one of the most common fish passage problems with culverts is the formation of a drop-off at the downstream end, which is the case for Cottle Creek (Kerr Wood Leidal Associates et al., 1980). From what has been assessed, the drop is less so due to erosion and more so due to poor installation, as the culvert should be in a spot where the gradient of the creek is near 0% and

Figure 9. The downstream end of the culvert from site 4, with a drop-off that prevents pacific salmon from entering into Cottle Creek (Taken on October 11, 2023).

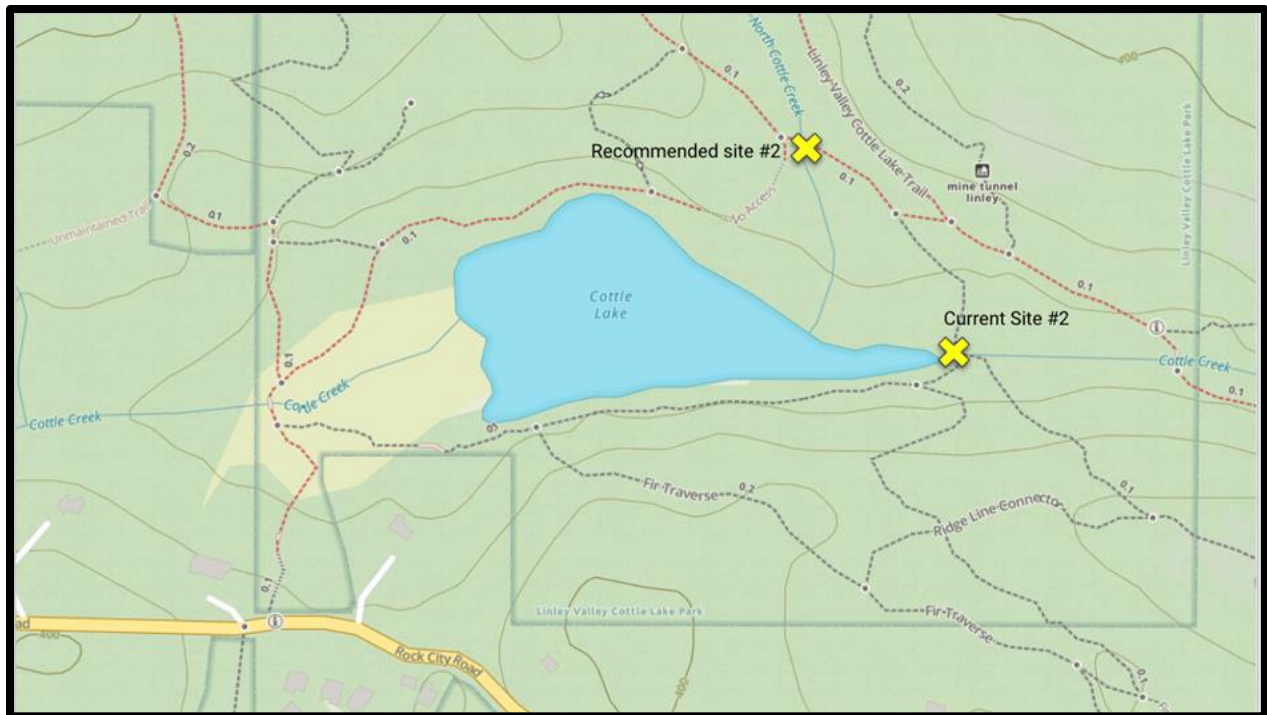
Figure 14. Cole Herbert - A map of Cottle Lake and the surrounding area, showing the location of site 2 for the 2023 survey and a recommended new location for future studies.
