Water Quality and Stream Freshwater Macroinvertebrate for the Millstone River, Nanaimo, BC

Erik Dunn, Aaron Jordens, Kevin Petersen, and Paul Veit

RMOT 306

Vancouver Island University

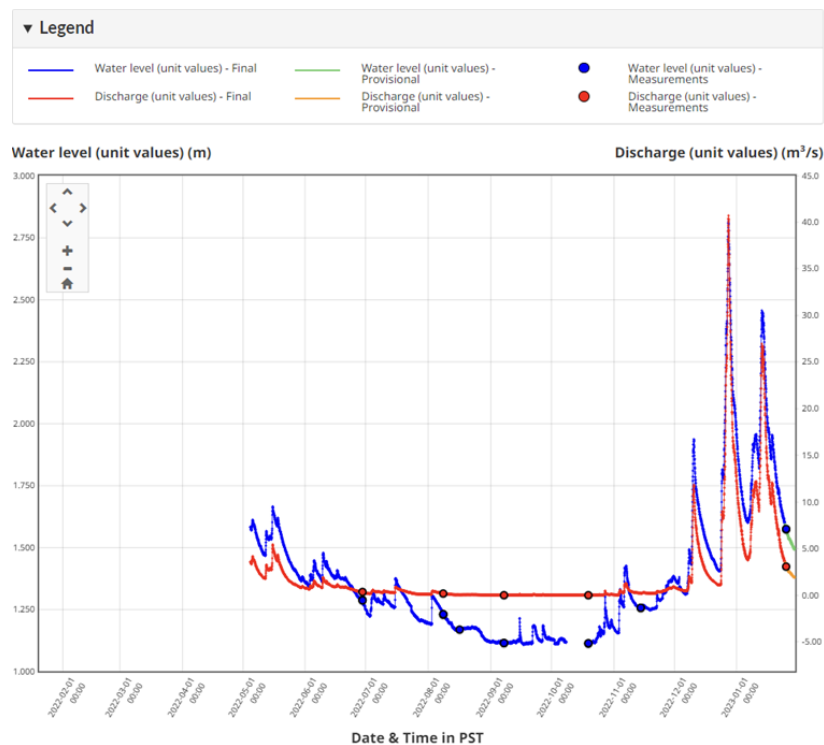
Figure 1. Hydrometric data of the Millstone River between May 2022, and January 2023 (Natural Resources Canada 2023).

increased water toxicity. Of significant concern is the low water levels that the Millstone River faces during the summer months from July to September (Figure 1). This can result in an increase in nutrient and toxin concentration and a reduction in dissolved oxygen levels (Gaboury and Kehler 2012).

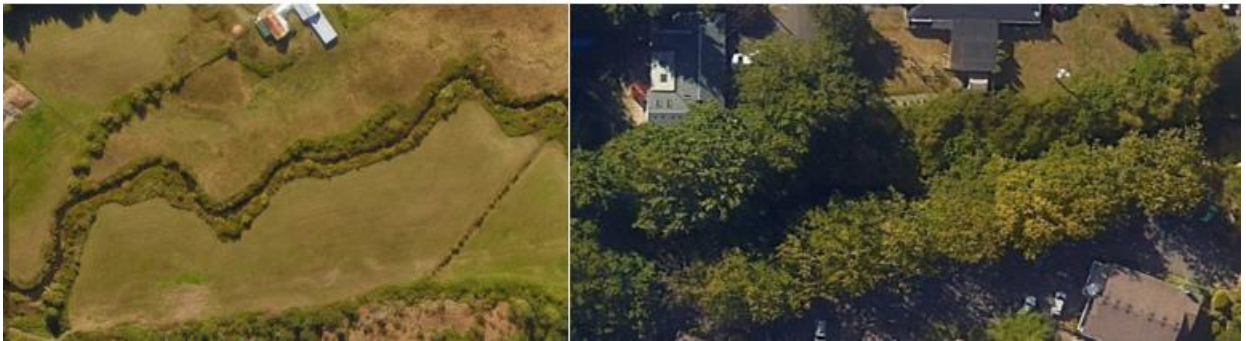
Figure 2. Snapshot of riparian area GIS analysis of the Millstone Rivers Agricultural and Urban Areas (Google Earth 2023).

remained in a degraded state for more than twenty years leaving little room from agricultural and urban expansion around the system (Google Earth 2023). Nearly all of the agricultural irrigation licensees for the Millstone River were created in the 1950s. This suggests that most of the agricultural development and subsequent degradation of the systems riparian area occurred during this time (Ministry of Forests 2023).

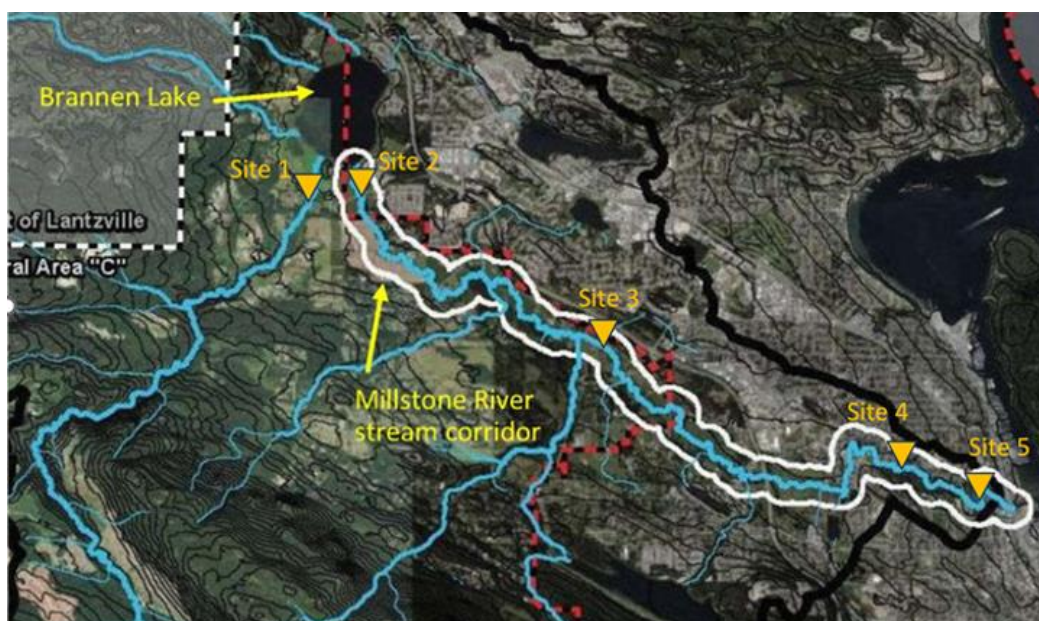
Figure 3. Selected sampling sites (Water Bucket 2021).

Each of the 5 selected sites was carefully chosen to accurately reflect the characteristics of the stream system, avoiding any uncharacteristic representations. The selection criteria considered the stream type, flow patterns, widths, depths, and canopy cover to ensure that these locations served as representative stream samples. The evaluation of these sites focused on water quality, habitat conditions, and biodiversity abundance. It is crucial to acknowledge that access to these sites significantly influenced the bias in site selection, and these locations were chosen based on data from previous years (Figure 3) (Table 2).

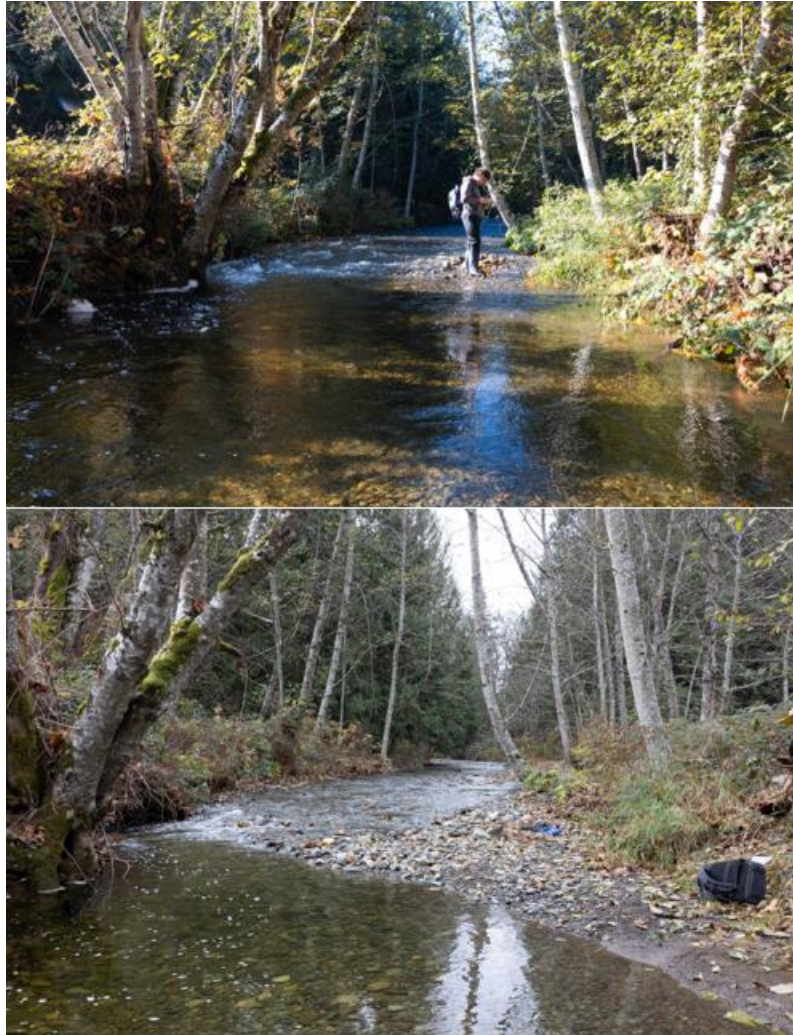
Figure 4. Photograph of Millstone River Site 1.

Site 1 was located on Benson Creek, a tributary of the Millstone River, which flows into Brannen Lake. Access to this site was available upstream of the Biggs Rd bridge. This tributary served as a water quality control site that discharges to the overall system and the adjacent lake. The stream was lined with dense vegetation on both sides, but this did not provide any significant protection above the water. The tree canopy above the stream also offered only minimal protection. Extensive rural properties were nearby, including the local

scout camp "Camp Caillet". The creek bed was mainly cobblestone with some gravel substrate, and plenty of leaf litter was in the creek bed (Figure 4).

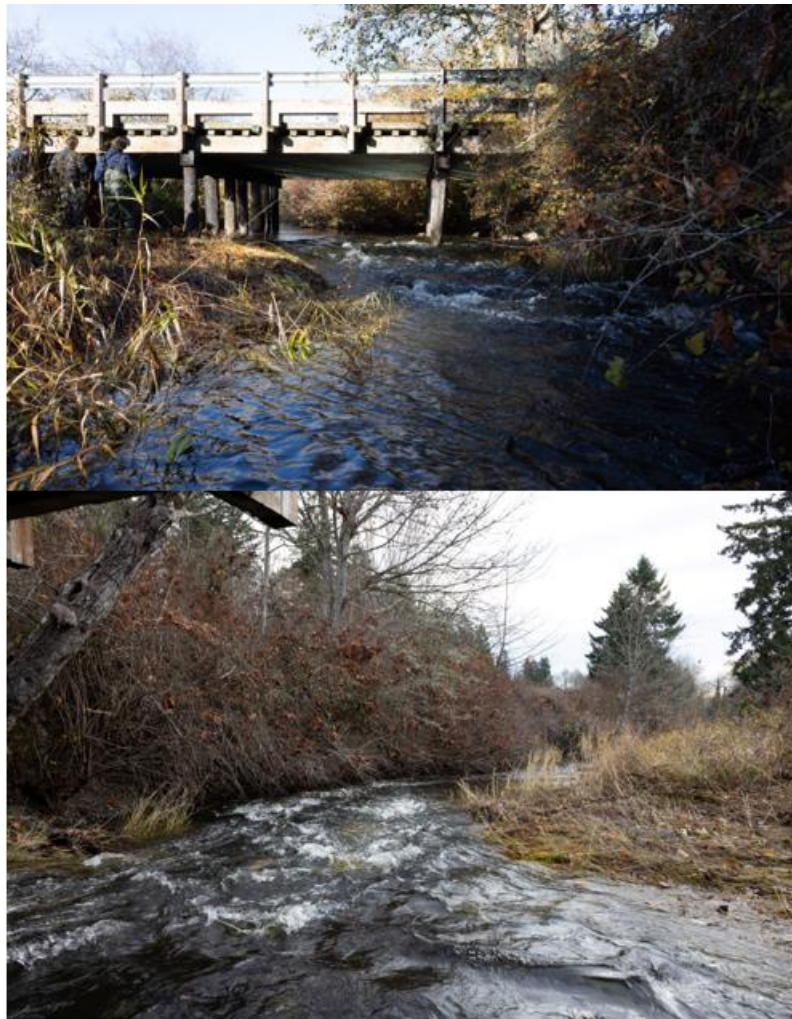
Figure 6. Photograph of Millstone River Site 3.

Site 3 was located at the junction of Maxey Rd and Durnin Rd at the bridge beside a residential property. This site is downstream of another small tributary and allowed data to reflect on any changes this flow may have caused to the stream. Stream banks at this site were lined with shrubs and a few tall trees. This left a very open canopy, and tall grasses were

present leading up to the site. The streambed was mostly cobblestone and had no minimal leaf litter present, unlike other sites (Figure 6).

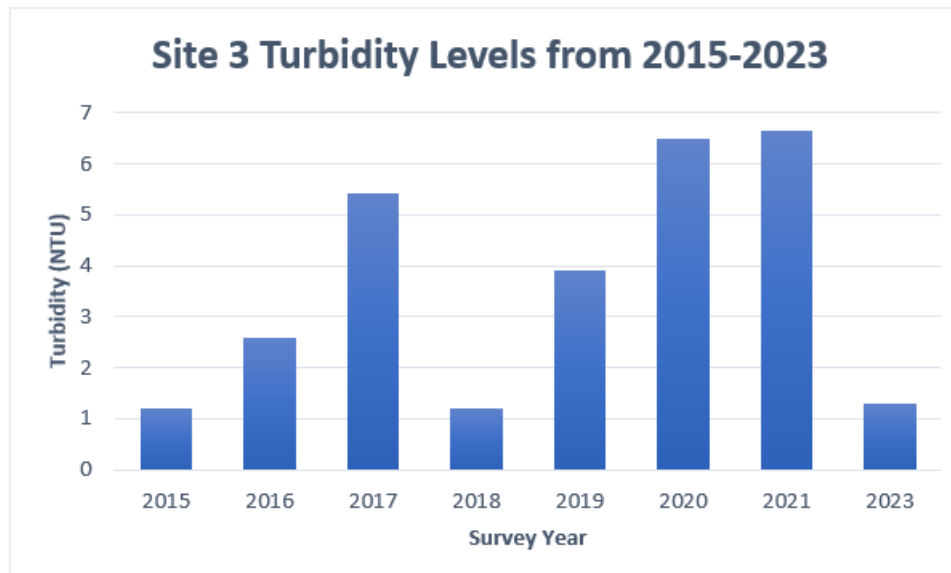
Figure 9. Turbidity levels measured at Site 3 of the Millstone River between 2018 and 2023 (Kollman et al. 2021; Arsenault et al. 2020; Ng Cornish et al. 2019; Boldt et al. 2018; Hobkirk et al. 2017; Lawson et al. 2016; Sunduk et al. 2015).

Figure 9 illustrates the turbidity trend that has occurred from 2015 to 2023 at site 3. There was no survey conducted on the Millstone River in 2022 and, as a result, there is no data to include from that year. Site 3 was chosen for this graph because it was deemed to be the best representation of the whole stream at a single site and because there was insufficient data from previous surveys to show turbidity levels at all five sites. All data in Figure 9 are from samples collected in the month of November and were collected at period of high-water flow.

The drastic differences illustrated in Figure 9 are likely the result of the differences in rainfall and weather activity between each year. Environment and Climate Change Canada shows that 2021 had very high levels of fall precipitation, and 2020 had lower levels similar to 2023 in the fall but had more precipitation throughout the summer (Gov of Canada 2023). Using the same government data, high precipitation levels are seen in the fall of 2016 and 2017 while 2015 and 2018 had far lower levels of fall precipitation. This data correlates with the turbidity levels observed over the 9-year period. It is also possible that previous construction and development projects near the Millstone River contributed to the amount of sediment entering the stream (Arsenault et al. 2020 and Ng-Cornish et al. 2019). Since acceptable turbidity levels vary from stream to stream, it is hard to gauge

whether the turbidity levels observed in the Millstone River can be considered normal (Taccogna and Munro 1995). If the previous high turbidity levels observed in 2020 and 2021 have not had significant impacts on the ecosystem, then it is likely that the low turbidity levels observed in 2023 are not alarming. With previous construction projects ending, the lower levels observed in 2023 may actually be an indicator of the stream turbidity returning to normal levels. Further monitoring of turbidity in the future and possibly more frequent surveys throughout the year may be necessary to better determine a normal level of turbidity within the Millstone River.

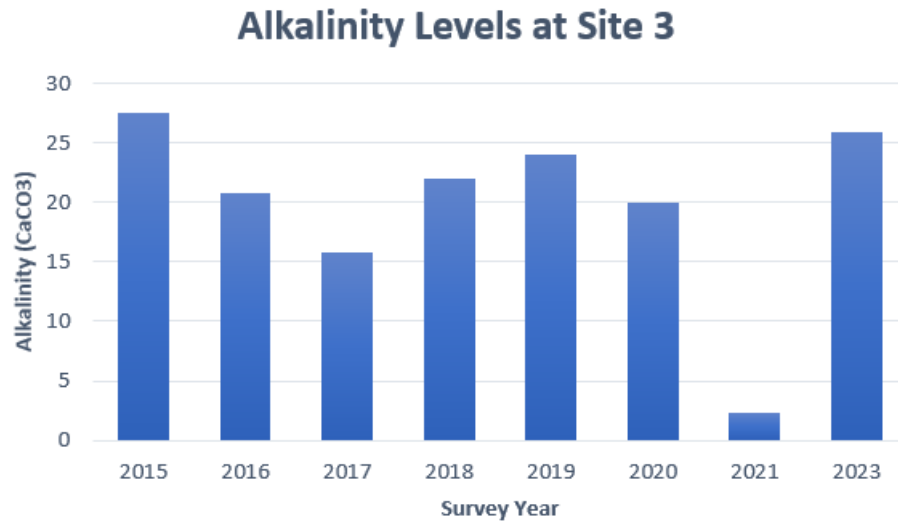
Figure 11. November alkalinity readings at site 3 between 2015 and 2023 (Kollman et al. 2021; Arsenault et al. 2020; Ng Cornish et al. 2019; Boldt et al. 2018; Hobkirk et al. 2017; Lawson et al. 2016; Sunduk et al. 2015).

Over the past nine surveys that have been conducted on the Millstone River there has been a fairly stable trend in alkalinity levels. When using measurements from site 3 as an example, alkalinity levels have typically remained between 20-28 mg/L (Figure 11). Levels closer to 15 mg/L were observed in 2017 but returned to levels over 20 mg/L the following year. Very low alkalinity levels were observed in 2021 and this may have been influenced by a heavy rainfall and flood event that preceded the November water sampling day (Kollman et al. 2021).

This high level of alkalinity is likely acting as an excellent buffer against acidity in the Millstone River. This may be why pH levels observed in the river between sites 2 and 5 remain between 7.2 and 7.4 regardless of weather influences (Figure 10). This healthy buffer will likely persist in the future as there is a significant amount of exposed bedrock in the Millstone River and there is likely a fair amount of CaCO_3 introduced from several tributaries that empty into the river. However, the alkaline buffer against acid influence in the ecosystem does not mean that the stream is impervious to damage from foreign effluents. Clean water inputs are required in order to maintain a healthy stream ecosystem and to prevent the natural buffer system from being stressed beyond its limits.

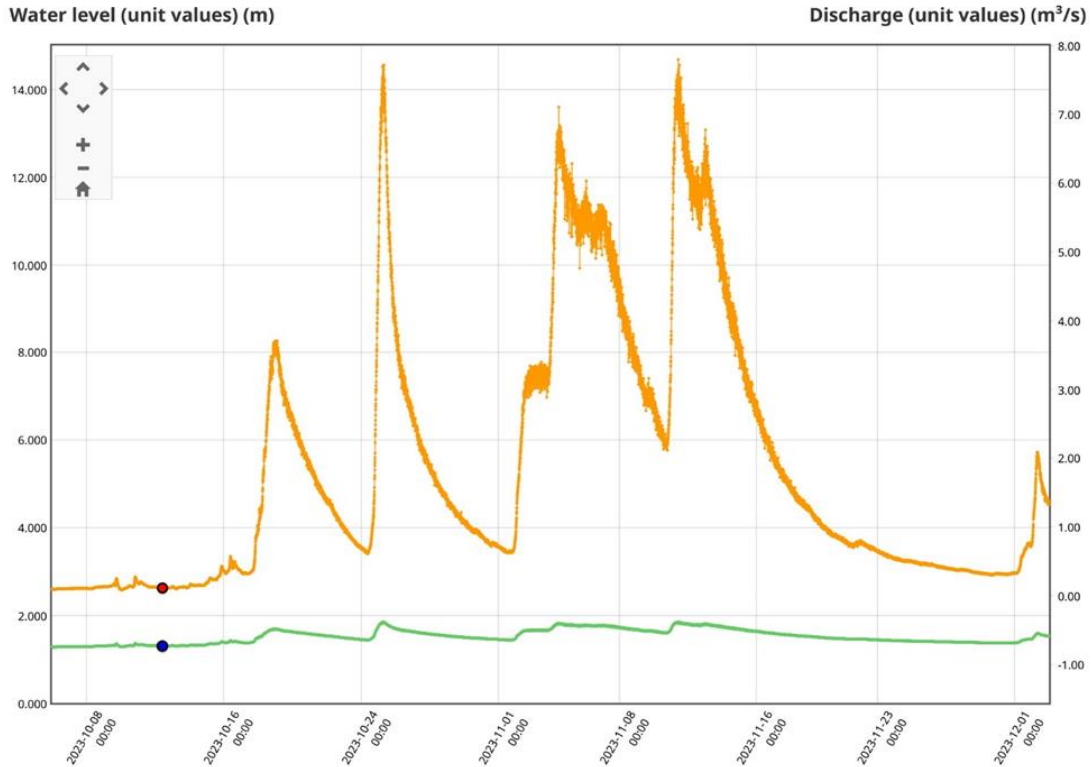
Figure 12. Millstone River Water level in meters and Flow Discharge in m³/s between October 10, 2023, and December 1, 2023.

When measuring the site for the October 31, 2023 visit, the last rainfall was observed on the 24th with 60mm recorded. On the flow chart (Figure 12), it is observed that the two site measurements were both recorded just after rain events with measurements being on the tail end of high flows. Though the water level was slightly higher on the second visit, it was also recorded that velocity was slightly higher except for site 2 which is the first site off Brannen Lake (Figure 13). Table 10 lays out the recorded measurements of the stream during this “low” site visit, while Table 11 Shows the “high”. Site 1 is a shallow stream site as demonstrated by the wider wetted width but losing some of the mean depth. Site 3 also tapered off with water level rising but did not affect mean depth as much as site 1. The rest of the sites are relatively similar in width with an increase in mean depth. It is also important to note that site 2 is the first site after Brannen Lake with no other tributaries affecting its flow, so after rain events it is expected to be more consistent to the lake level and outflow.

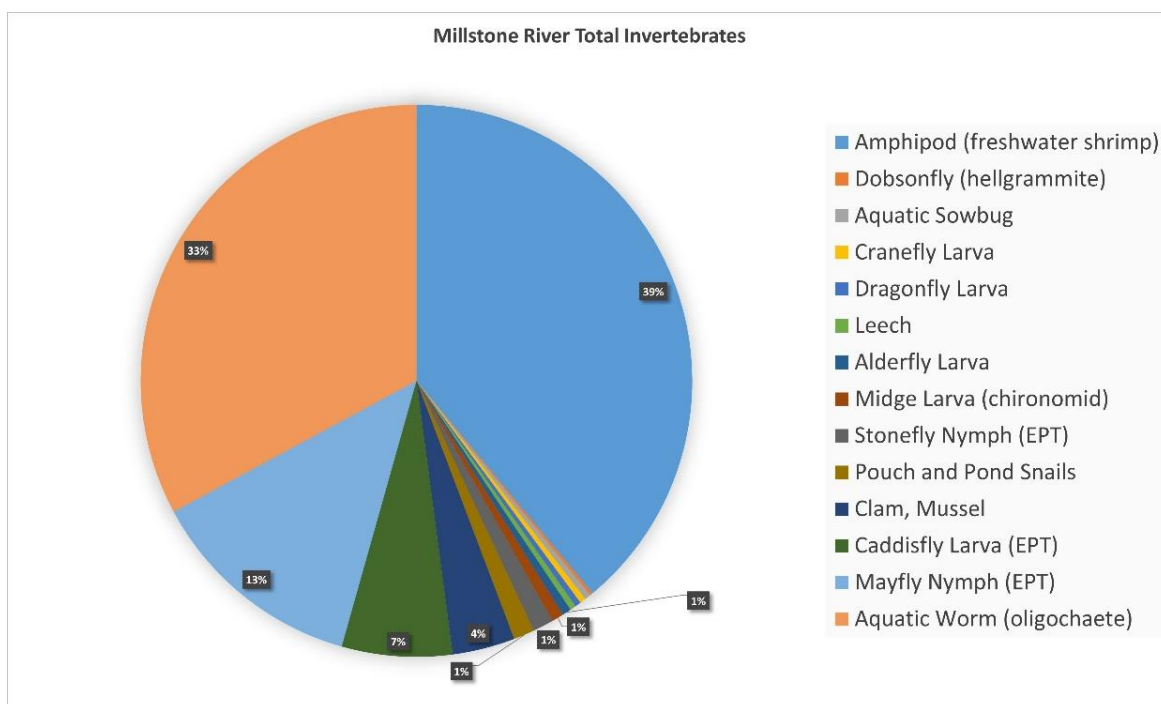
Figure 14. Millstone River Total Invertebrates of the collected 572 individuals.

Using the Hess sampler, invertebrates were collected at site 2, site 3 and site 5. They were collected a total of three times per site on both sampling days. With this method we were able to compare the streams to each other on different sampling days and flow events. Though the flows were similar on both sampling days, October 31st, and November 21st, it is important to note that the first sampling method had very little EPT taxa (caddisfly, mayfly and stonefly) when compared to the second sites. With no other data indicating any significant change, it is assumed that the second sampling time had a better hatch period that was collected. These samples yielded a total of 572 individuals, and 50 taxa with amphipods and aquatic worms making up over 60% of the invertebrates (Figure 14). Overall, the Millstone River scored a “Marginal” site assessment rating and had an overall Shannon-Weiner score of 1.55 which scores poorly.

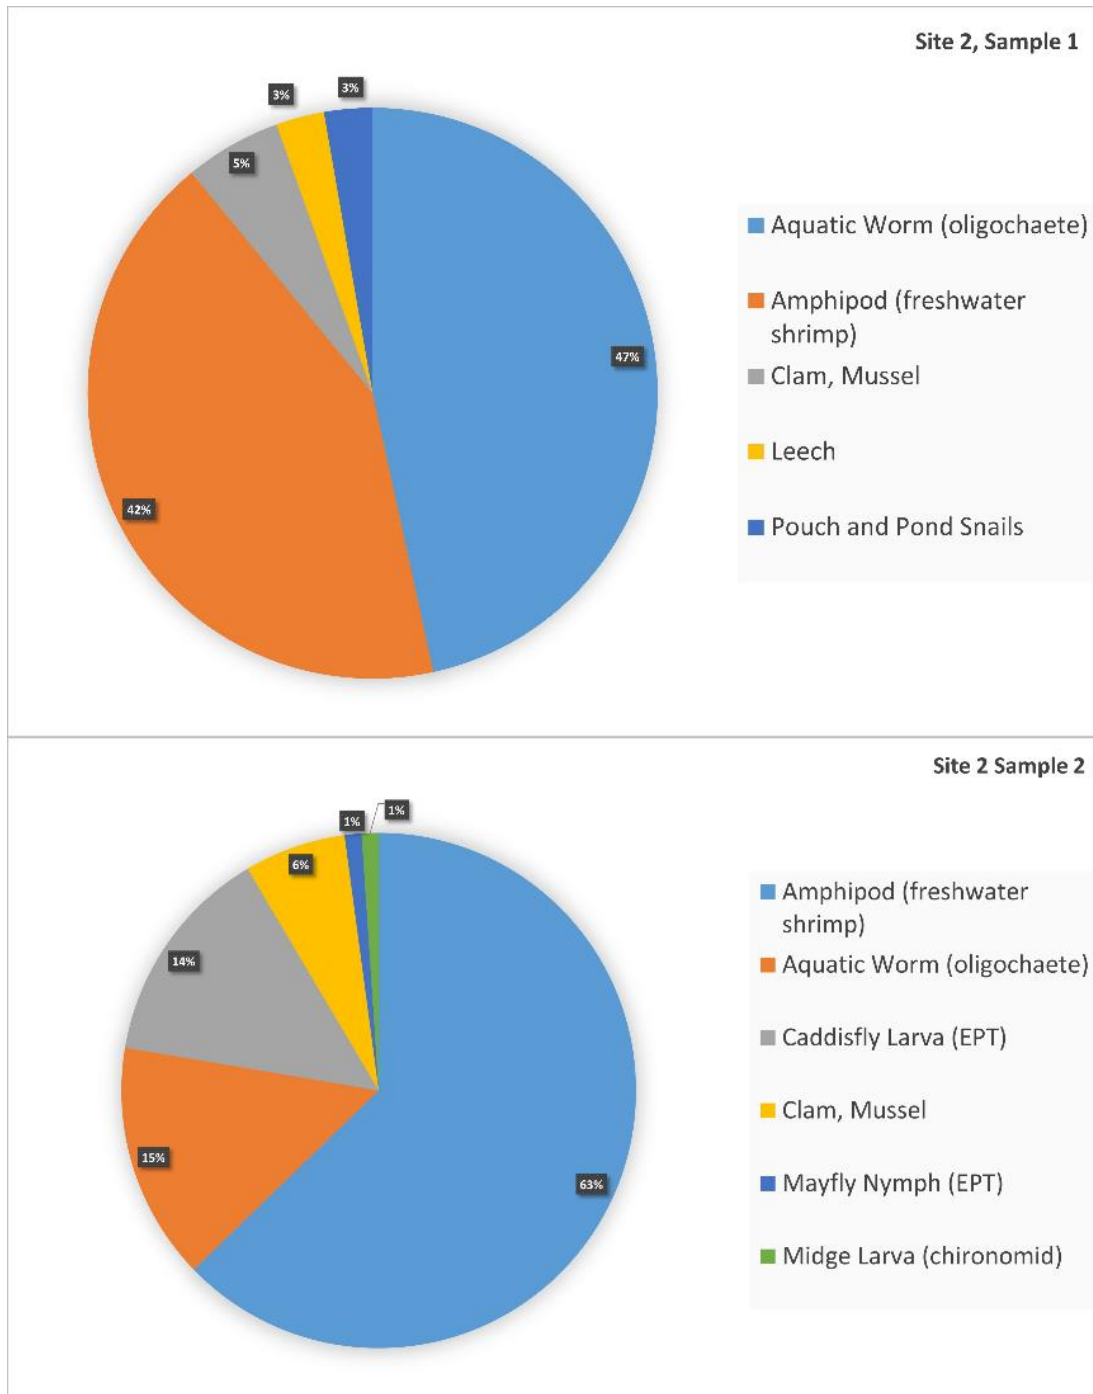
Figure 15. Millstone River Site 2 invertebrate population charts with sample 1 (low) and sample 2 (high).

Site 2's sampling period resulted in a total of 167 invertebrates collected with 16 taxa which gave us a density of 618/m². The "low" flow sampling period had an abundance of aquatic worms and amphipods, making up 89% of the total invertebrate population (Figure 15). The first sample also yielded no pollution intolerant species while it was divided almost evenly between the tolerant and somewhat tolerant species. While the "high" sampling period yielded a higher amphipod population, though there were more of the pollution intolerant species present, such as caddisfly and mayfly. A comparison of the two samples can be seen on Figure 3 with the relative species and the percentage they make up. The Shannon-Weiner index for this site was scored at a 1.22 which is relatively low. (Table 12).
