# **Water Quality and Stream Invertebrate Population Analysis of Holland Creek, Ladysmith BC**

**Prepared by:**

**December 12, 2023**

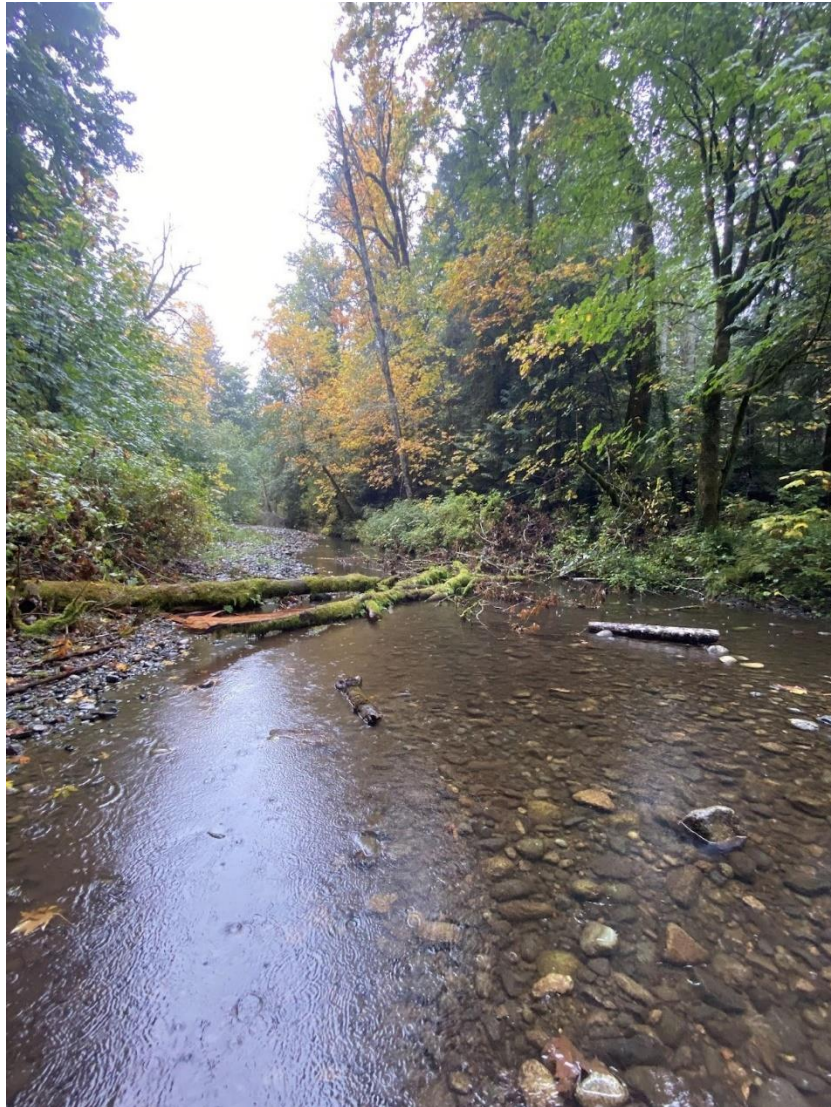
**Figure 2: Upstream view from the bottom of Site 1**

Site 1 is a glide that is located 100m up stream from the Holland Creek Trail Head on Dogwood Drive (10U 440741mE 5425619mN) (Figure 2). You can access this site from the trail beside site 2. This site has 15% canopy cover. The substrate at site 1 is made up of 50% cobble, 35% gravel and 15% sand.

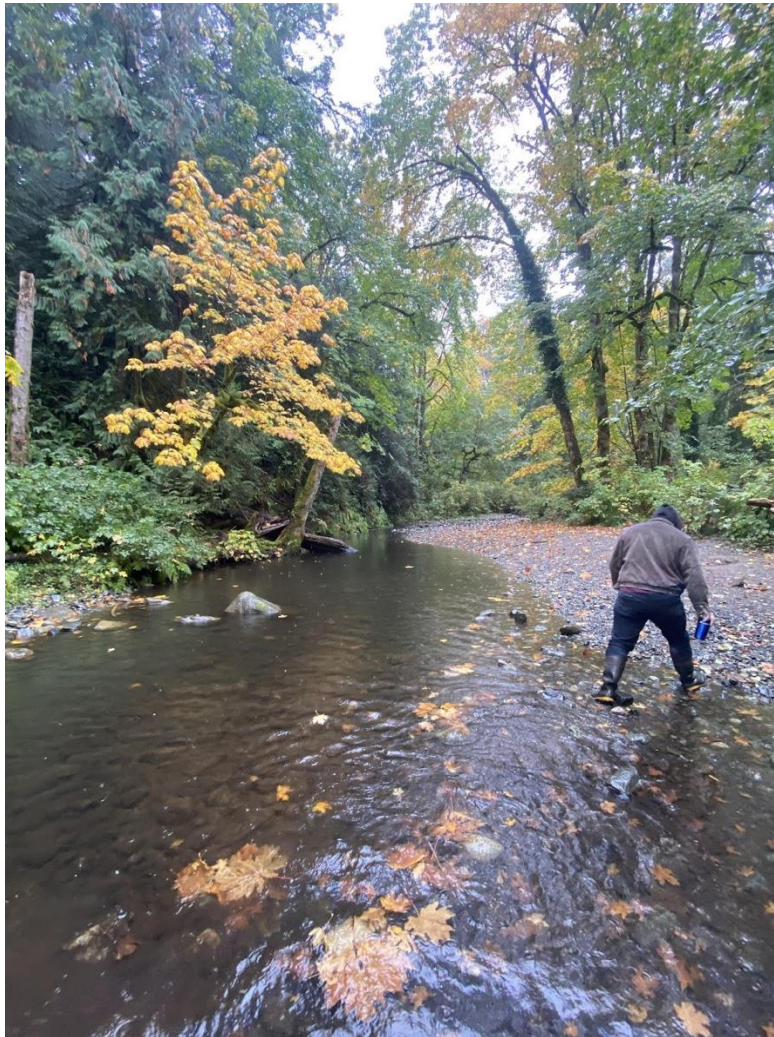
**Figure 3: Upstream view from the bottom of site 2**

Site 2 is a pool located 100 meters upstream from site 1 (10U 440639mE 5425631mN) (Figure 3). Access to site 2 is directly from the holland creek trail. Site 2 is the primary way that our team accesses the creek. This site has a sediment make up of 40% boulder, 20% cobble, 20% gravel, 15% bedrock and 5% sand.

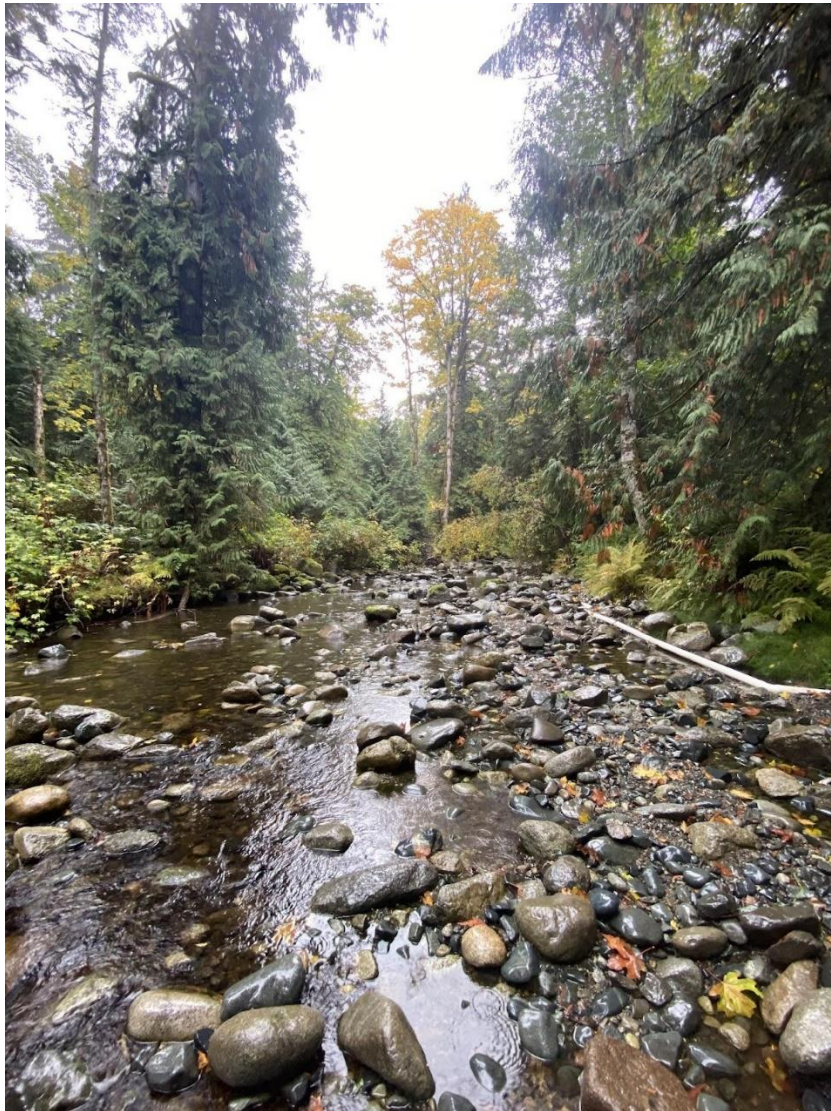
**Figure 4: Upstream view from the bottom of Site 3**

Site 3 is a riffle located 100 meters up stream from site 2 (10U 440551mE 5425666mN) (Figure 4). It is accessed by crossing the creek at site 2 and walking up a trail until site 3 is reached. Site 3 has a sediment make up of 30% boulder 50% cobble, 10% gravel and 10% sand. At this site there is a small pipe that leads to a culvert under the trail. This was put into place for salmon by the Pacific Salmon Foundation and Ladysmith Sportsman's Club
