October 15, 2014

Water Quality, Microbiology & Stream Invertebrate Assessment for
Cottle Creek Nanaimo, BC

RMOT 306 Environmental Monitoring Students

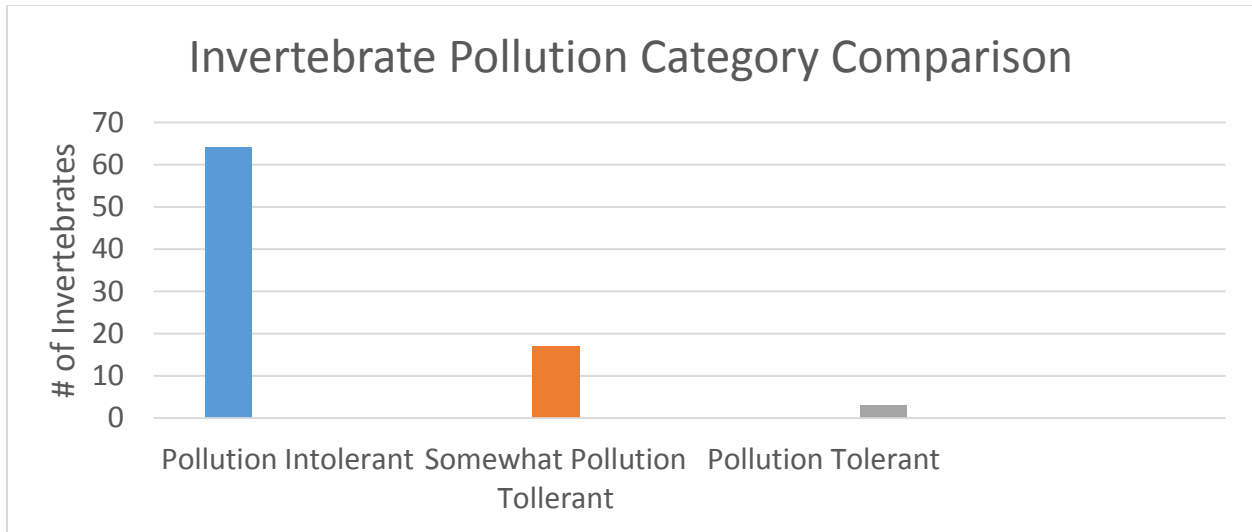
Figure 3 Invertebrate Pollution Category Comparison obtained from sample site three during sampling event one within Cottle Creek, Nanaimo BC. Invertebrate survey field data sheets can be found within the appendix.

Sample station three yielded a total capture of 94 invertebrates. Pollution intolerant species made up 68 percent of this total with 64 captured. All 64 pollution intolerant species captured were those of the EPT taxa. A high number of EPT taxa species indicates good overall stream health. Somewhat pollution tolerant species totalled 17, while pollution tolerant species totalled 13 (Figure 3). Invertebrate density per total area sampled was 252 m² with the predominant taxon being stonefly nymph (EPT). Sampling at this station was particularly difficult as water levels were above waist deep.

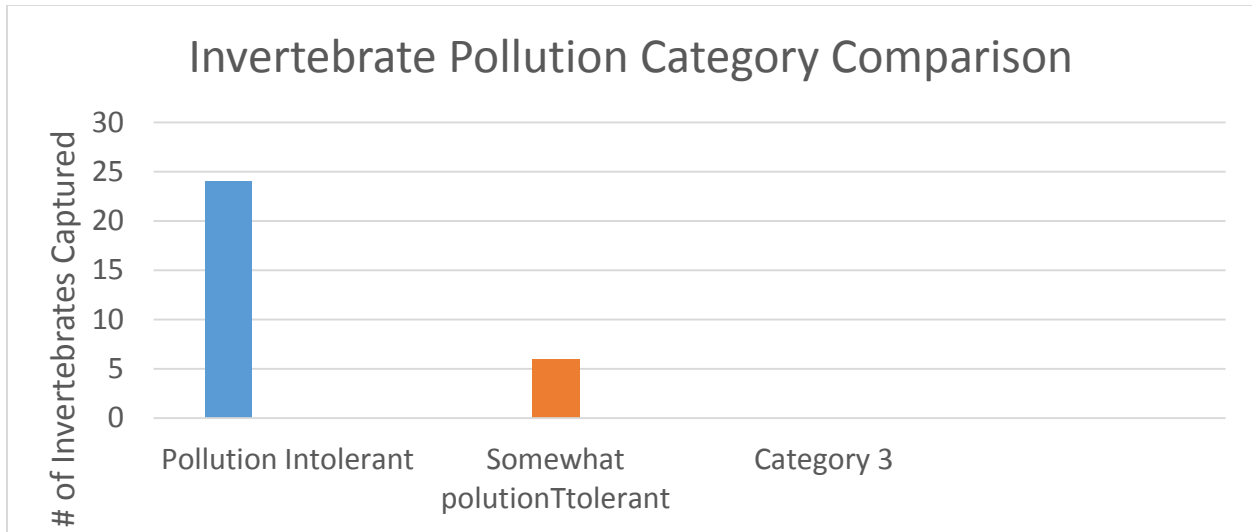
Figure 4 Invertebrate pollution category comparison obtained from sample site four during sampling event one within Cottle Creek, Nanaimo BC. Invertebrate field data sheets can be found within the appendix

Sample station number four yielded 24 EPT taxa species out of a total of 30 captured. Pollution tolerant species captured was 4 while no pollution tolerant species were captured (figure 4). The large amount of pollution intolerant species captured indicates overall good water quality at this site. Invertebrate density per total area sampled was 83 m² while the predominant taxon was mayfly nymph (EPT).

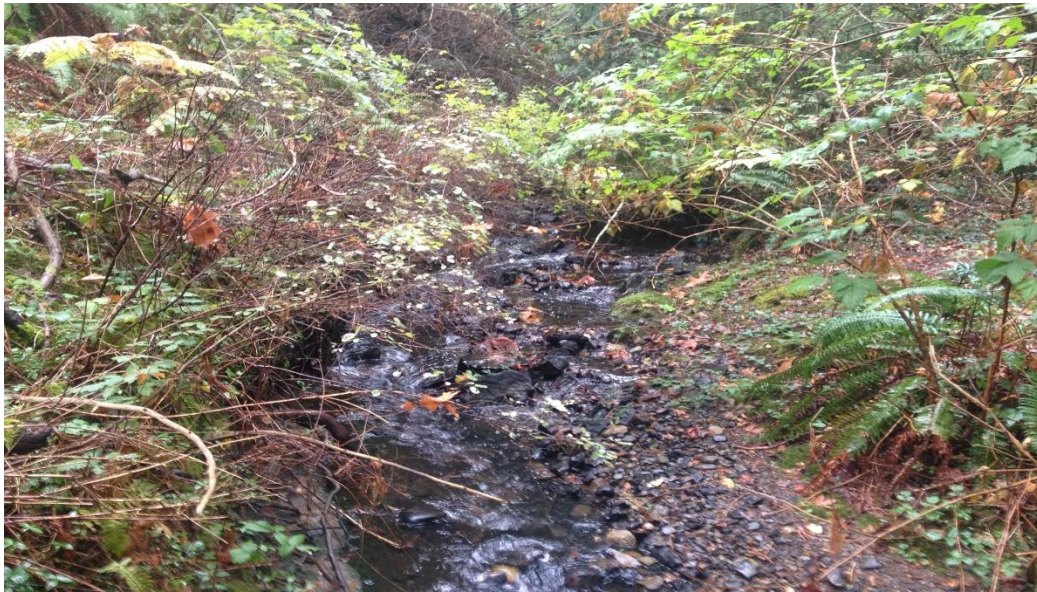
Figure 6: Sample Site #1 Cottle Creek, Nanaimo BC, @Landalt Road (October 15, 2014). From Departure Bay Rd, turn onto Rock City Rd, L on Landalt Rd. Cottle Ck crosses Landalt, and Sample upstream (west) of road.

Site # 1 (Figure 1), is located off Landalt road, which is the upper section of Cottle Creek. Sampling took place west, upstream from the road (Table 1). The sample site is a large flat area, making it possible to conduct water quality and invertebrate sampling. There was one concern present in this location, regarding the water level and foliage during testing times. Since it was early fall the flow of the creek was relatively low and many leaves were beginning to descend into the creek. This affected visibility for collecting invertebrate samples. The substrate at this

site was mainly cobble and gravel, and the surrounding vegetation included a high percentage of Red Cedar (*Thuja plicata*) and Sword Ferns (*Polystichum munitum*).

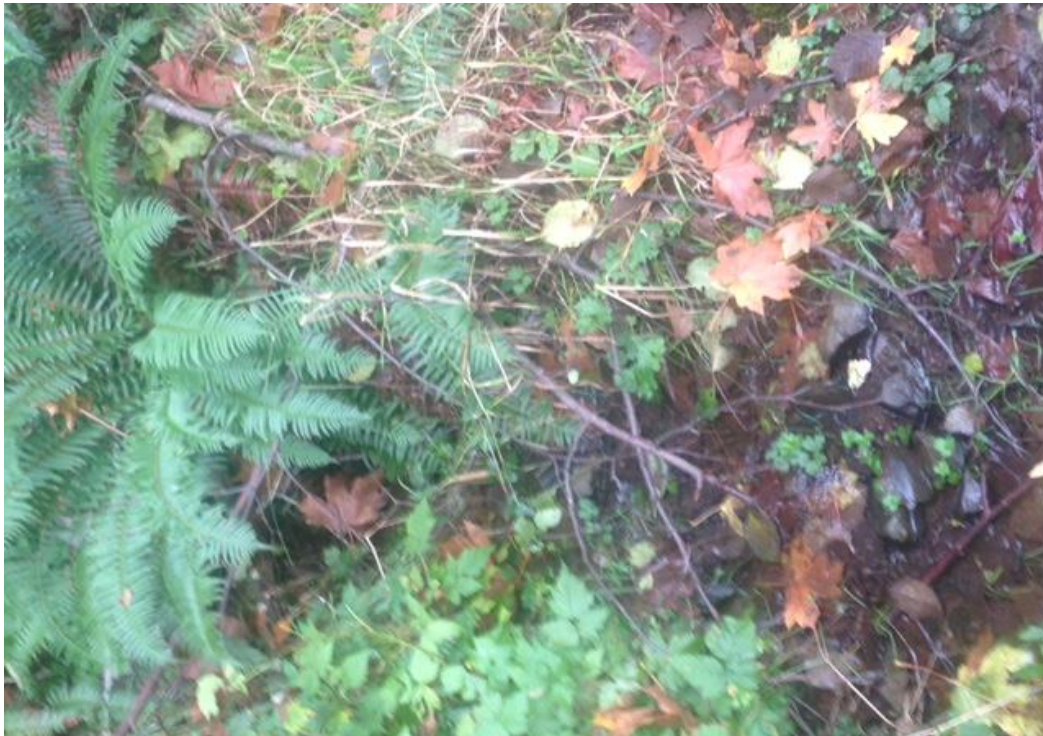
Figure 7: Sample Site #2 North Cottle Creek 100m Downstream from Burma Rd (October 15, 2014). From Hammond Bay, Rd, turn onto Malaspina, than L onto Laguna way, R onto Lost Lake Rd and L onto Burma Rd. Hike down trail to you cross small creek. This is north Cottle Creek. Sample 5m downstream of bridge.

Site #2 (figure 1), is located 100m downstream from Burma Road, which is a part of the northern Cottle Creek watershed. The flow at this site is extremely low so we were unable to conduct stream invertebrate sampling. A potential danger for this site is the large amount of rotten trees that are present and easily pushed over. During the testing there was always potential risk of having a rotten tree fall on a crew member. Extra precautions and due diligence were taken by all crew members regarding this risk. The substrate in this part of the stream was primarily cobble and vegetation consisted of mostly small shrubs and trees.

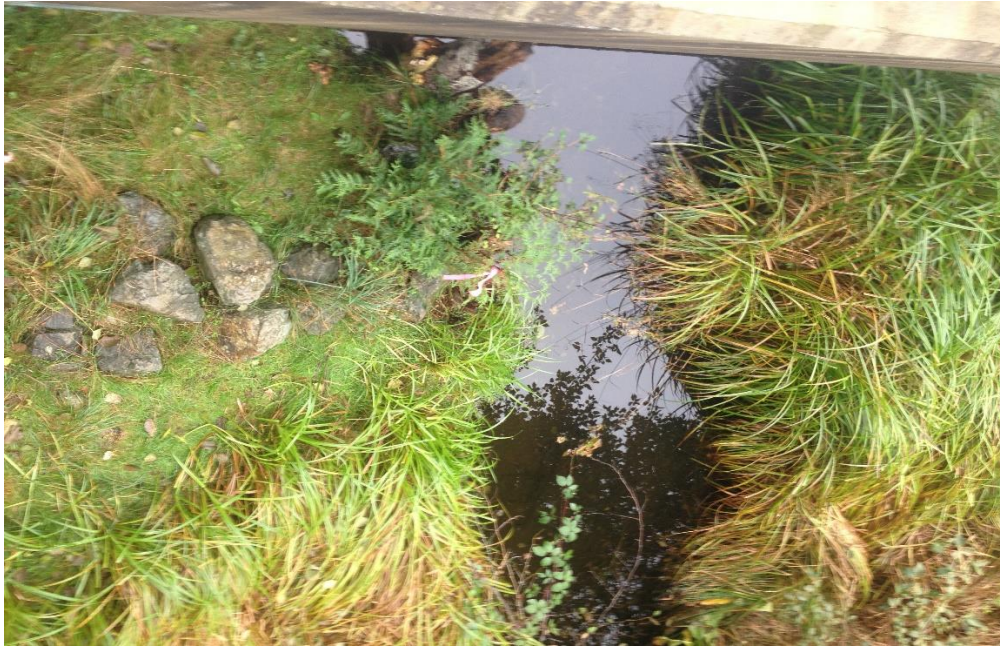
Figure 8: Sample Site #3 Cottle Creek @ Nottingham (October 15, 2014). Going north on Hammond Bay Road turn onto second Nottingham Drive. After about 150 m you will cross Cottle Creek. Sample upstream where road crosses (north).

Site #3 (figure 1), is located on Nottingham drive which is in the lower section of Cottle Creek. The sample site is north, upstream of the bridge crossing. The sample site is small, but has high visibility and is a fairly flat marshland. There is a small rock face that must be scampered down in order to reach the site. The rocks, when wet, were slippery and posed a danger to crewmembers. All members took responsibility to remember to wear proper footwear with grips or wader boots. The flow of the creek was fairly high, especially during the second sampling event, as some heights were recorded over 75 cm. The wetted heights of this area of the creek made it difficult to collect invertebrate samples. However samples were collected approximately 1-2 meters downstream from the sample site under the bridge in the shallower, coarser substrate. The site is described as a low lying area so most of the vegetation consisted of marsh grasses, shrubs and alder trees lining the banks. The substrate in this area was fine silt, clay and mud. The substrate changed briefly as it entered the culvert into cobble and gravel.

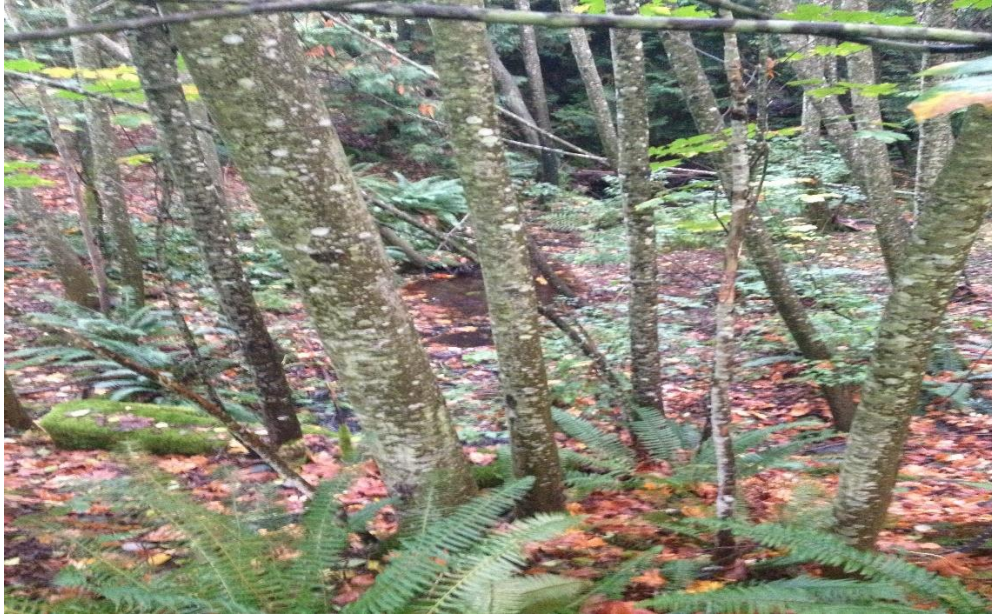
Figure 9: Sample Site # 4 Cottle Creek @ Stephenson Pt RD (October 15, 2014). Going north on Hammond Bay Road turn right onto Stephenson Point Road. After about 150 m you will cross Cottle Creek. Sample upstream from road

Site #4 (figure 1), is located off Stephenson Point road, 150 m from Hammond Bay road to the bridge crossing. The sample site is upstream from the bridge crossing. There was a small incline to access the sample site, otherwise the site was safe and there were minimal dangers. The flow of the creek was moderately faster than that of the rest of the sample sites. The vegetation of the site was mostly shrubs and overhanging trees. The substrate consisted mostly of cobble and the odd boulder.
