Environmental Monitoring Field Project of Cottle Creek

RMOT 306

Vancouver Island University

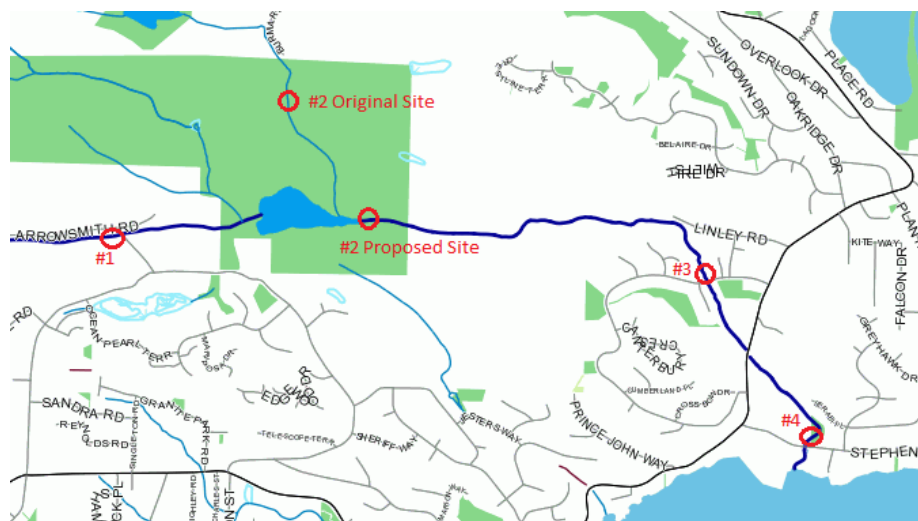
Figure 1: Map of Nanaimo with the four sites chosen for sampling
(Map from City of Nanaimo Website).

Site 1 was located at Landalt road where Cottle creek crosses under the road (49° 13' 5.398"N, 123° 59' 22.280"W) (Figure 1). Sampling took place on the upstream (west) side of the road as the downstream side is fenced off, which was not problematic. This site had approximately 75% canopy cover with lots of leaf litter on the ground and in the stream. The creek bed was a mix of cobbles and fines. See Table 1 for a full list of the hydrology measurements taken on October 25th, 2015 from all sites. Some hazards in this area include slippery surfaces, wildlife, vehicles and a steep gradient hike down to the creek from the road. Table 2 provides a full list of the site safety assessment taken on October 22nd, 2015.

Site 2 was moved from north Cottle Creek to downstream of Cottle Lake (49° 13' 7.8"N, 123° 58' 35.3"W) (Figure 1). Site 2 is located along a walking trail which provided easy access. The stream bed was made up of primarily cobble and has a gradient of 5°. Some potential hazards in this area include tree roots which are a tripping hazard, and people in the area because of the nearby walking trail. Overall, this site provides relatively good footing around the creek. Furthermore, due to being at the mouth of Cottle Lake, canopy cover was approximately 30%.

Site 3 was located where Cottle Creek crosses Nottingham Drive. Sampling took place on the upstream (North) side of the road (49° 13' 1.221"N, 123° 57' 30.919"W) (Figure 1). The biggest hazard at site 3 was the steep climb down from the road to the creek, and the potholes

Site 4 was located where Cottle Creek meets Stephenson Point Road. The sample location was again upstream (north) of the road ($49^{\circ} 12' 41.207''\text{N}$ $123^{\circ} 57' 11.402''\text{W}$) (Figure 1). Site 4 showed a diversity of riffles and glides. The substrate consisted of cobbles, boulders and gravel, and canopy cover was estimated to be 70%. Some potential hazards at Site 4 were the inherited risks of vehicles and people in a residential area, as well as wildlife, such as Columbian black tailed deer (*Odocoileus hemionus columbianus*).

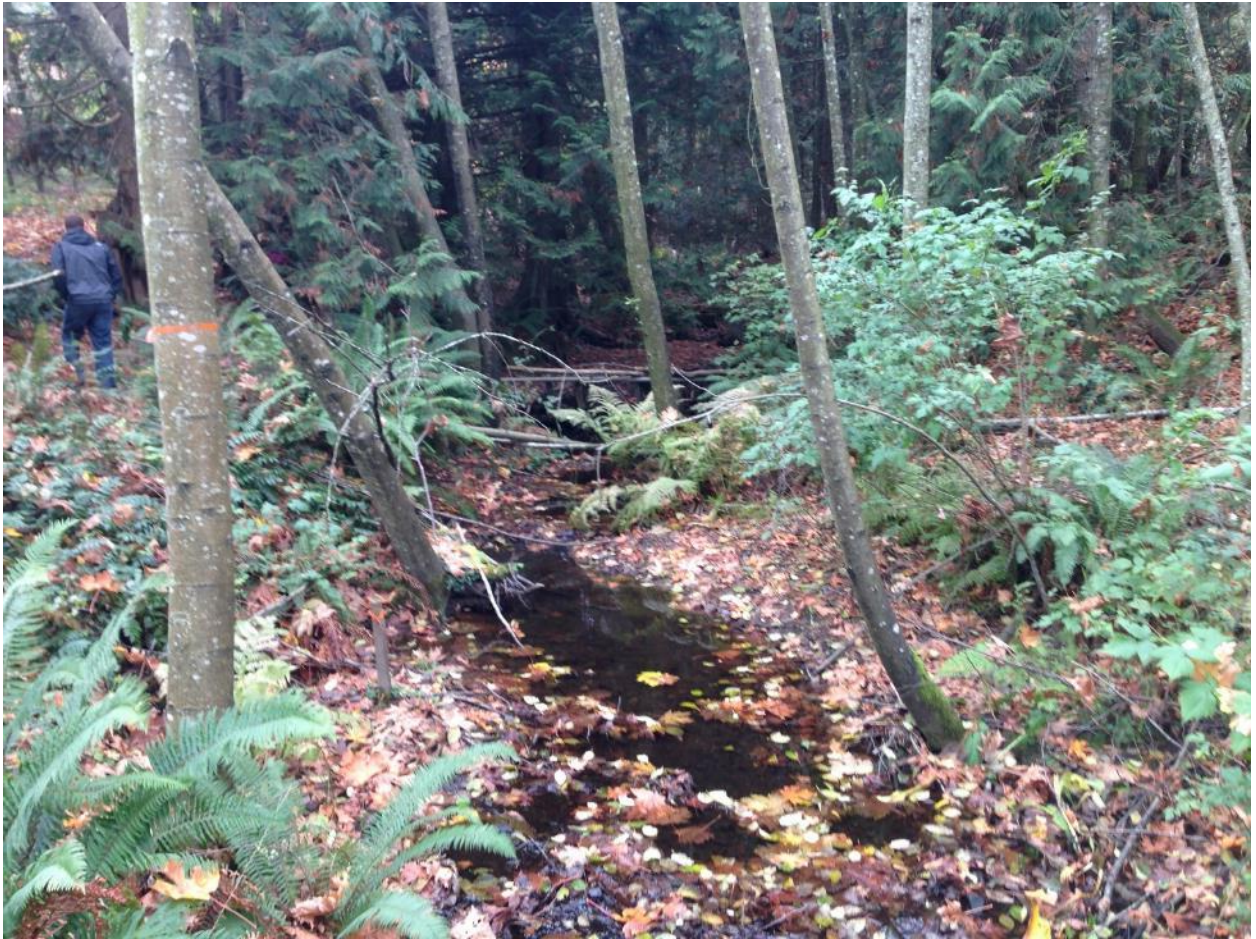
Figure 2: Overview of Site 1 facing west/downstream. Photo taken October 22, 2015 by Lane Vienneau.

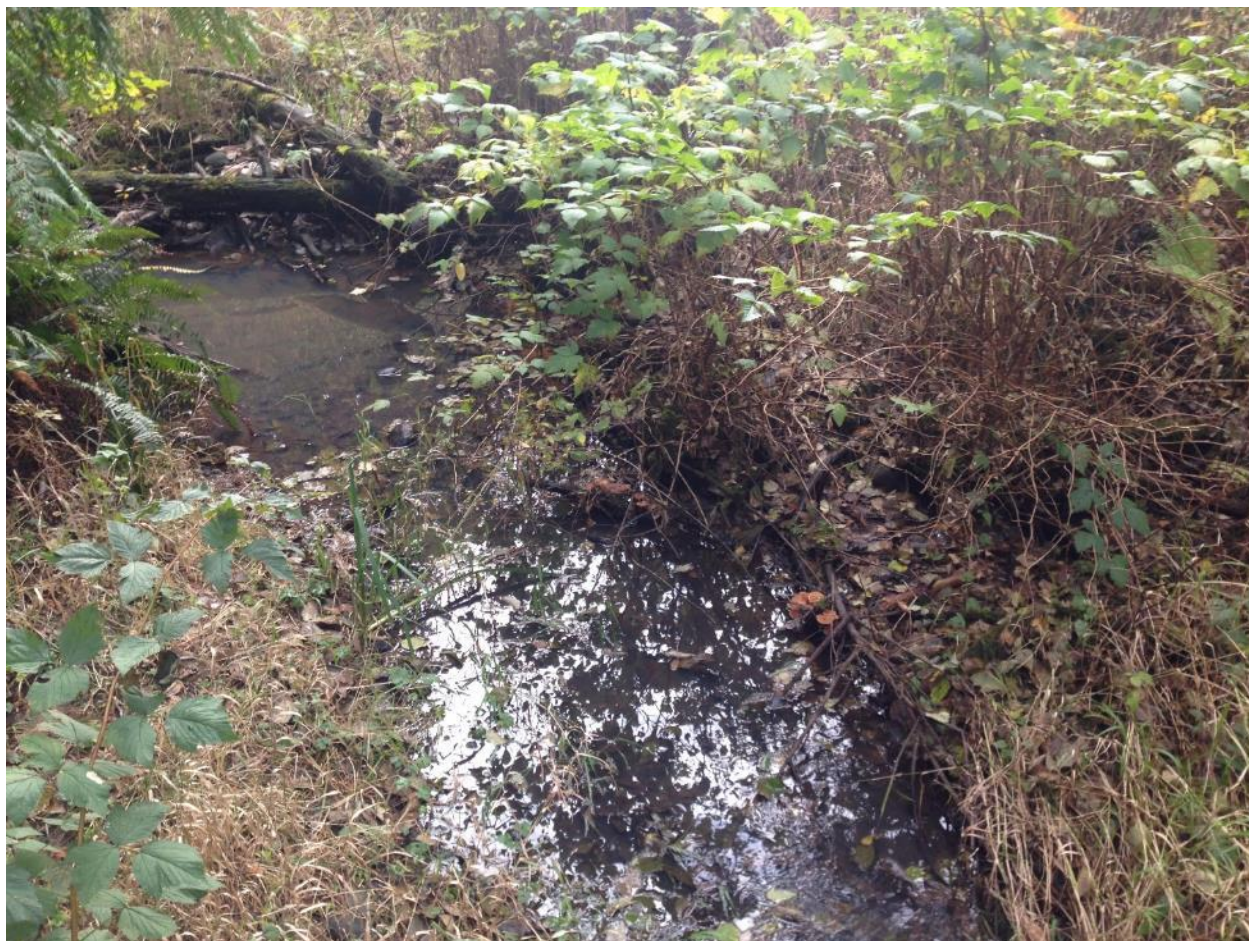
Figure 3: Overview of Site 2 facing south/downstream. Photo taken October 25, 2015 by Lane Vienneau.

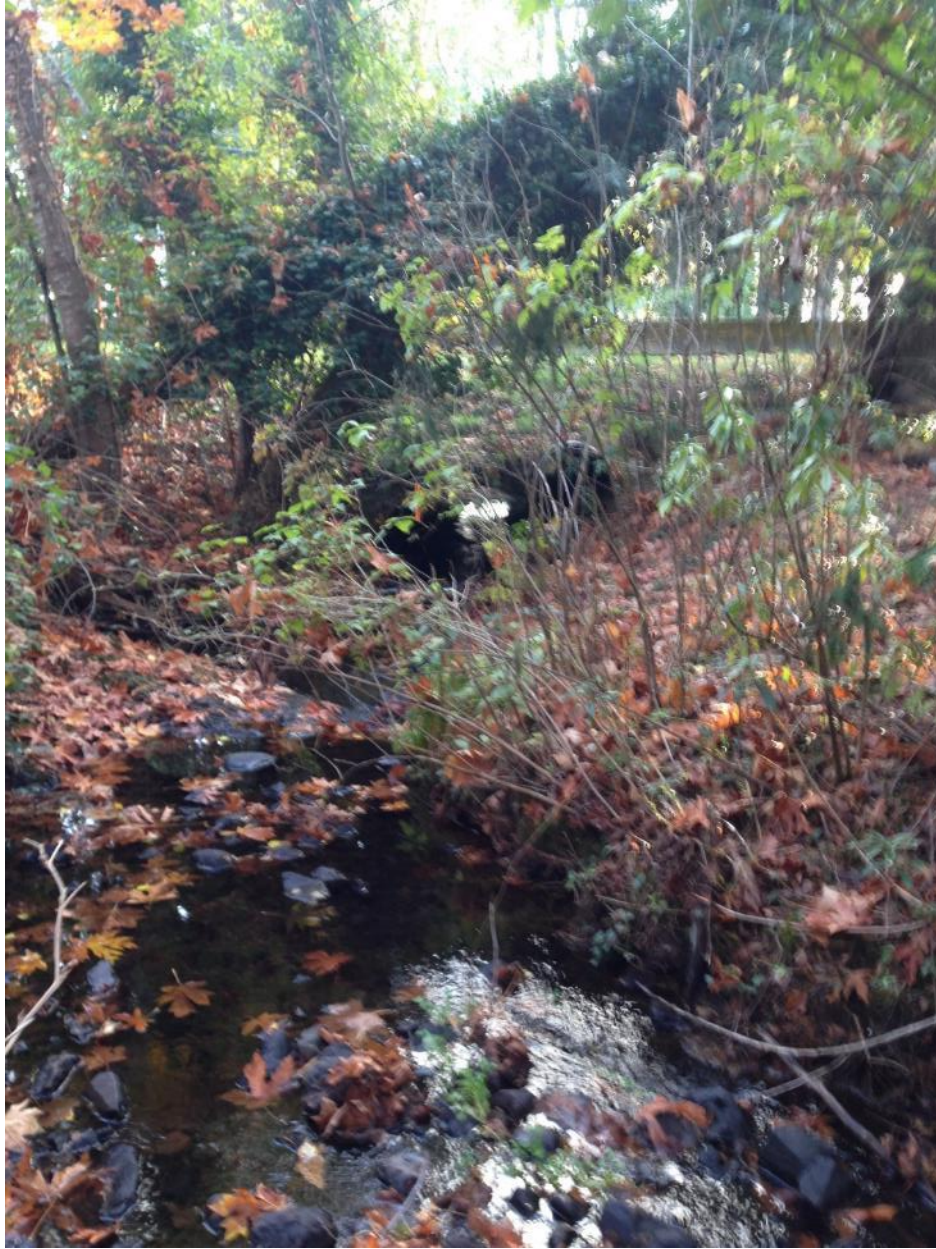
Figure 5: Overview of Site 4 facing southeast/downstream. Photo taken October 22, 2015 by Lane Vienneau.
