Departure Creek

Environmental Monitoring Project Final Report

For the RMOT 306 Environmental Monitoring course

December 14, 2012

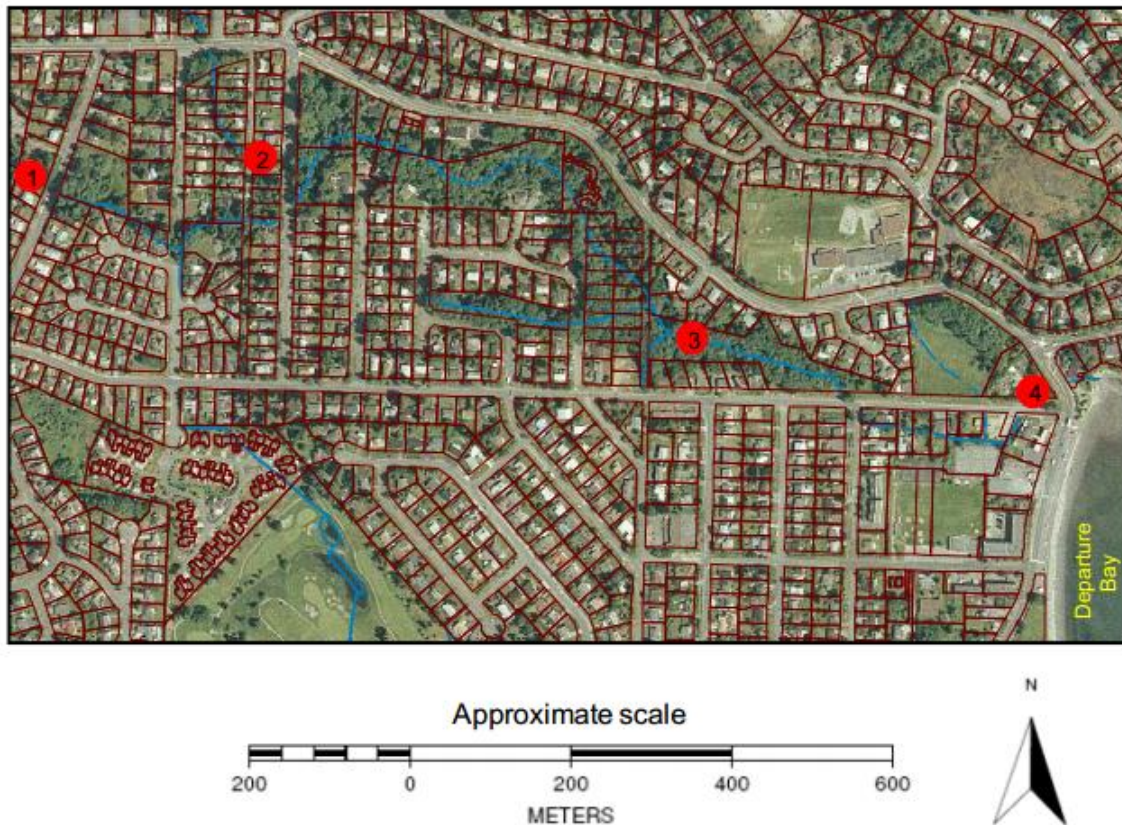
Figure 2. Site map of Departure Creek in Nanaimo BC, showing the four sampling locations (Demers, 2007). Note that our Site 2 was located on the opposite side of the street.

This study focused on 4 stations along an approximately 1700-metre stretch of Departure Creek upstream from where the creek empties into Departure Bay. Sites were numbered from 1 (furthest upstream) to 4 (closest to the ocean) in accordance with the numbering system used in previous years. A map showing the approximate location of the sites is shown in Figure 2.

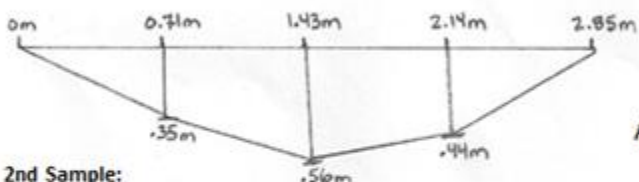
Flow = 0.95m/s

Discharge=0.78m³/s

Avg Depth = 0.45m

Figure 6. Flow and Depth Results of Departure Cr. From Site #4 of the 1st Sample Event (Oct. 31, 2012) and the 2nd Sample Event (Nov. 21, 2012).

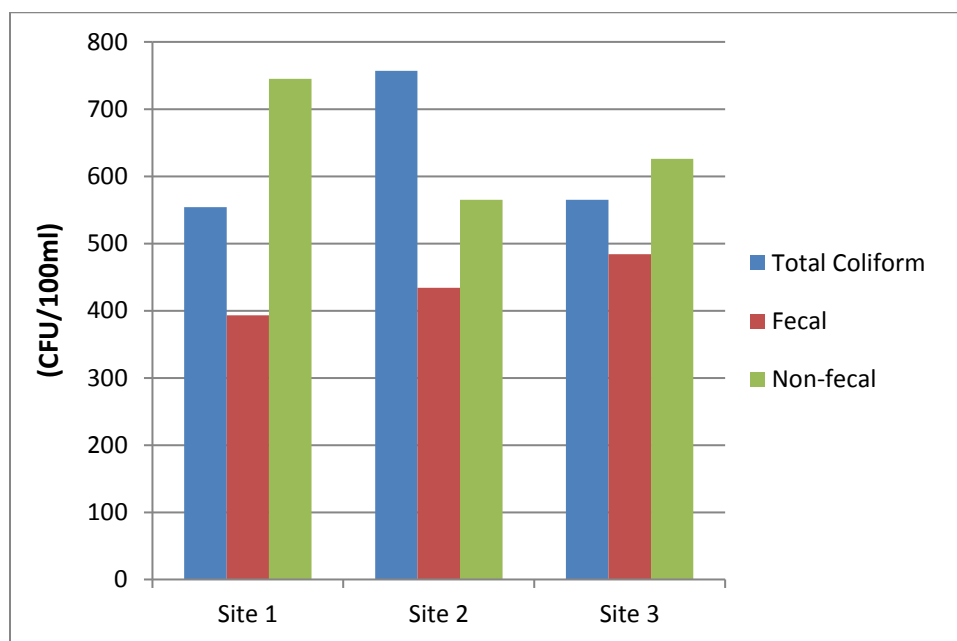
Figure 7. Coliform Levels Detected during Microbiology Analyses of Departure Cr. (October 31, 2012) performed at VIU

A microbiology analysis was also performed at the VIU lab on water samples taken from the first three sites on the 1st sampling event of Oct. 31 only (see Figure 7). Results concluded that fecal coliforms were high in Departure Creek and this could be due to a large, local population of deer and many household pets from surrounding residences excreting around the creek, and the large amount of rainfall carrying it into the water system.

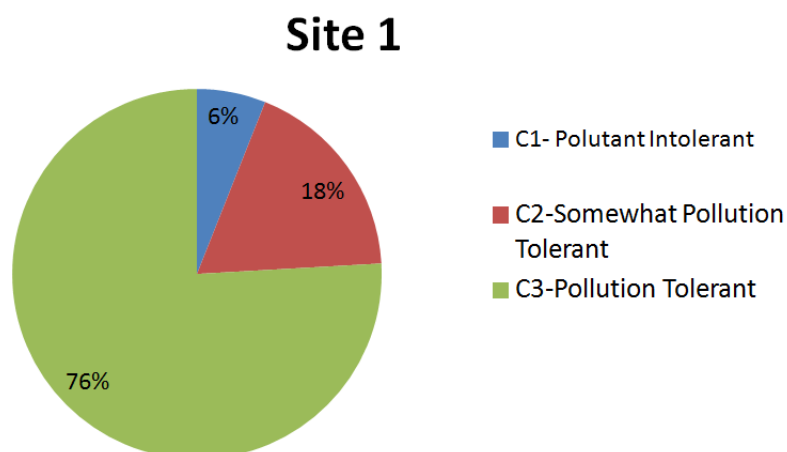
Overall Site Assessment: 2.5 (marginal to acceptable)

EPT index: 3 (marginal)

Shannon-Weiner Diversity Index: 0.567

Figure 8. Invertebrate pollution tolerant categories of taxa according to the stream keeper's guide of invertebrates sampled at site #1 on Oct. 31, 2012 on Departure Creek.

The density of pollution tolerant and intolerant invertebrates is compared at all three sampling sites, and again it should be noticed how the density of pollution tolerant species decreases significantly from upstream site 1 to downstream site 3 (Figures 8-10).

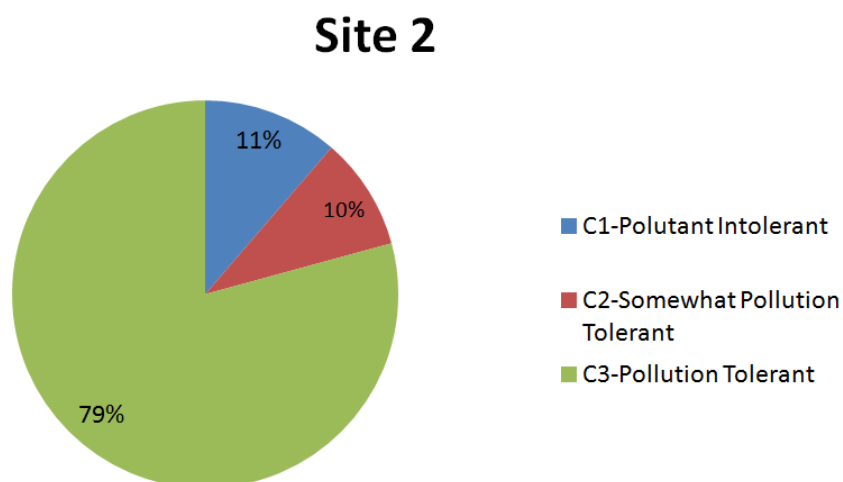
Overall Site Assessment: 2.25 (just above marginal)

EPT index: 3 (marginal)

Shannon-Weiner Diversity Index: 0.583

Figure 9. Invertebrate pollution tolerant categories of taxa according to the stream keeper's guide of invertebrates sampled at site #2 on Oct. 31, 2012 on Departure Creek.

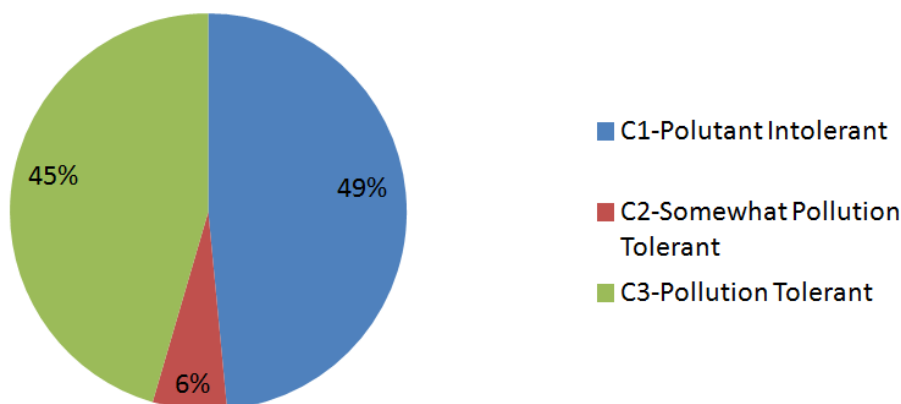
Site 3

Overall Site Assessment: 3.25 (just above acceptable)

EPT index: 6 (acceptable)

Shannon-Weiner Diversity Index: 0.651

Figure 10. Invertebrate pollution tolerant categories of taxa according to the stream keeper's guide of invertebrates sampled at site #3 on Oct. 31, 2012 on Departure Creek

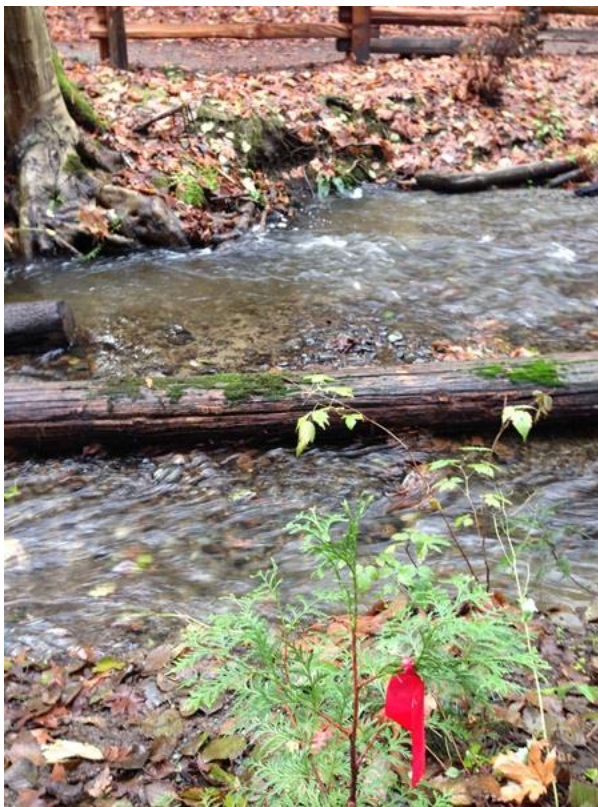
View from opposite bank; November 21, 2012. Note the large logs that have appeared in the stream during the past month.

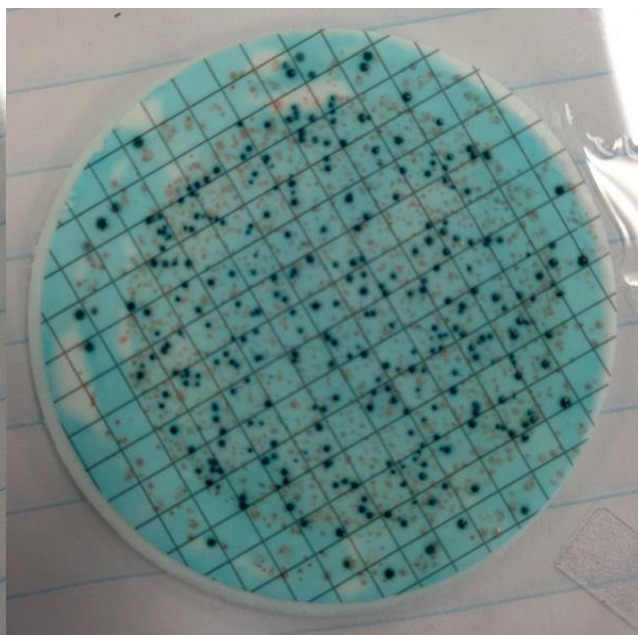
Site 1 Coliform Plate (50 mL filtered)

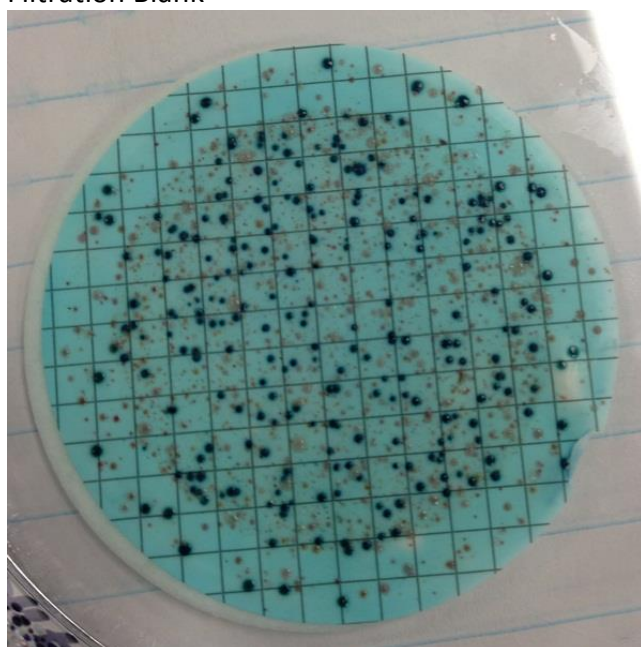
Site 2 Coliform Plate (50 mL filtered)

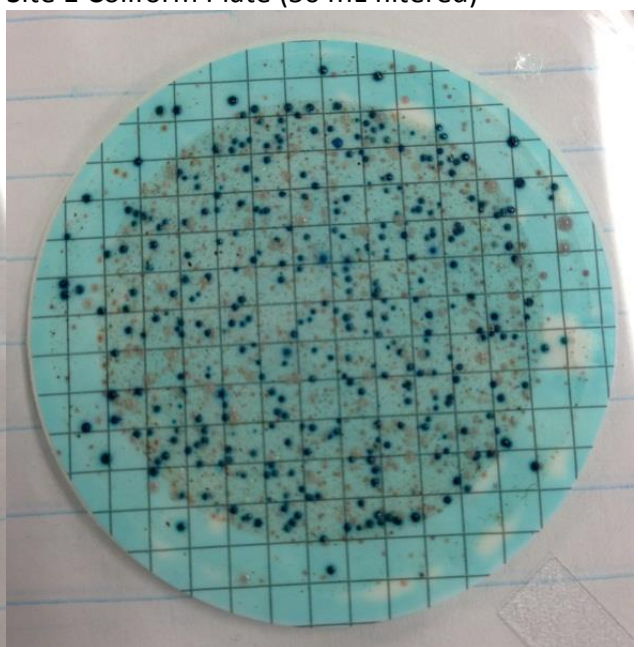
Site 3 Coliform Plate (50 mL filtered)
