Water Quality Analysis and Stream Invertebrate Assessment of Departure Creek, Nanaimo, BC 2014

RMOT 306 Environmental Monitoring Students

Vancouver Island University

Dec 12th, 2014

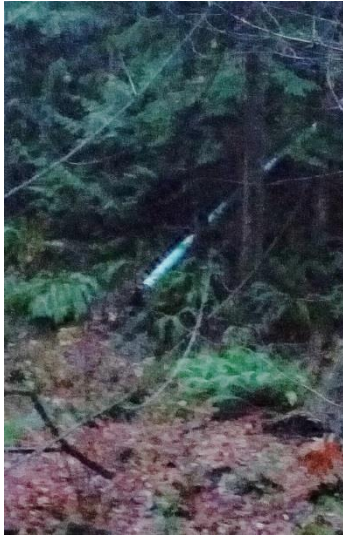
Figure 1. A drainage pipe leading from a residence into Departure Creek near Site 3.

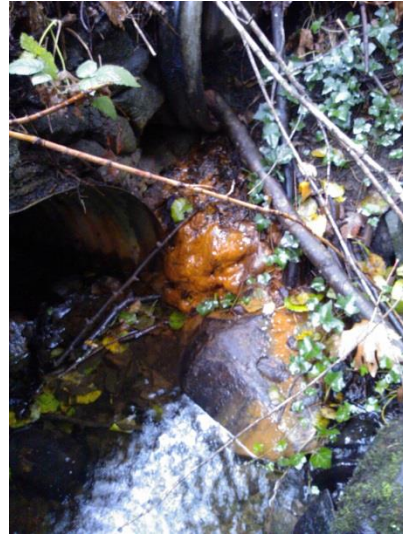
Departure Creek is a fairly slow moving stream that follows a steeply banked wooded ravine from north of Neyland Rd to where it empties into Departure Bay. It is in an urban setting of residential homes and fairly busy streets. Departure Creek is around 3 km in total length, and originates from two creeks, Joseph Creek and Keighley Creek. Joseph Creek is sourced from a ditch near Wellington Secondary School and Keighley Creek is sourced from the Nanaimo Golf Club (Harbour City River Stewards, 2013). Departure Creek runs through a wooded ravine amidst large neighbourhoods and busy streets, which can all create potentially toxic runoff in the rainy season. Some homes have drainage pipes from their backyards and driveways that deposit directly into the creek (Figure 1). Most environmental issues associated with the creek are rooted in the effluents from the surrounding urban area. These could include oil from the streets, cleaning products from residential homes and driveways, and any number of pollutants from the nearby gas station on Departure Bay Rd. Also noted were several storm drains that empty into the creek north of Woodstream Park. At the second site on Joseph Creek, an orange slimy substance could be distinctly seen near a drain emptying into the stream

(Figure 2). Although no garbage was found near Departure Creek in Woodstream Park, some rubbish could be seen in other sections of the creek, particularly near Newton St.

Figure 2. A slimy orange substance directly below a pipe draining into Joseph Creek at Site 2.

A recommendation for future groups working sampling Departure Creek is that a site be set up at the convergence of Departure Creek's main stem, and it's tributary Joseph Creek. A site at this location could potentially give information on how the addition of water from Joseph Creek is affecting the Departure Creek water compared to a sample taken upstream of the convergence. It could also be recommended that a study be conducted into the source of high levels of fecal coliforms in the water located between site 3 and site 4. Levels of coliforms spiked from 200 fecal coliform colonies per 100mL of water at site 3 to 688 in site 4. This could be a variety of factors, and a more in depth look might provide the source and an opportunity to clean up or resolve the problem.

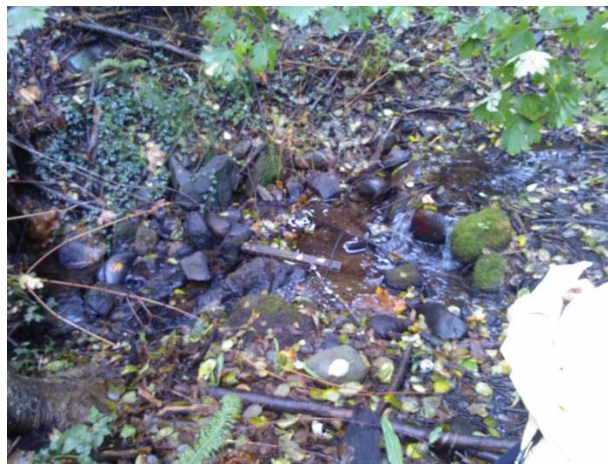
At Site 2 the stream is approximately 1.5 metres across on a moderate to steep grade. The stream is a riffle here, with small waterfalls falling in several levels. The streambed is composed of boulders and gravel (Figure 5). Vegetation surrounding the stream is made up of ferns, skunk cabbage, Douglas Fir (*Pseudotsuga menziesii*) and Red Alder (*Alnus rubra*). Some introduced bamboo has also taken root. The canopy cover is approximately 90%, and there is no instream cover to be observed. Access to the creek is via the road and is fairly easy.

Figure 5. Sampling Site 2 on Joseph Creek, a Departure Creek tributary.

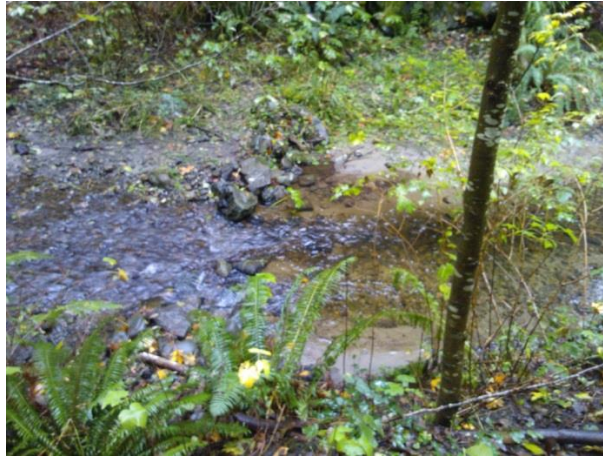
At Site 3 the stream is approximately 4.5 metres wide in this section, on a moderate grade, and is composed mainly of cobble and fines (Figure 6). The water is a riffle and turns into a glide further downstream. Vegetation in the area is varied, including Red Alder, ferns, salmonberry (*Rubus spectabilis*), Western Red Cedar and Big Leaf Maple (*Acer macrophyllum*). Canopy cover is approximately 30-40%, while instream cover is approximately 10%. Access to the creek is easy, with a trail going from the parking lot on Bay St to the creek side; however, one side of the creek bank is eroded and slightly hazardous.

Figure 6. Sampling Site 3 of Departure Creek in Woodstream Park.

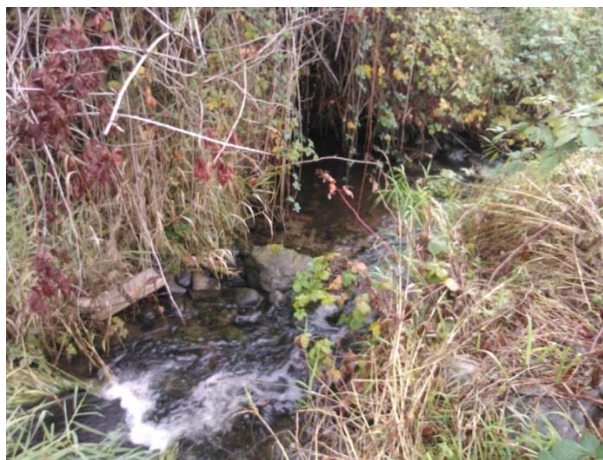
The stream at Site 4 is approximately 2 metres wide and on a slight gradient. It is mainly a glide, and the streambed mainly consists of fines and boulders, with some cobble (Figure 7). Vegetation in the area is mainly Himalayan Blackberry (*Rubus armeniacus*) with some salmonberry. There is next to no canopy cover, while in stream cover is about 50%. Access to the creek is easy, as it is located right next to Bay Street, as well as Departure Bay Road. However, it is also hazardous due to the proximity to the road, and extra caution must be taken at this site.

Figure 7. Sampling Site 4 of Departure Creek, at the intersection of Departure Bay Rd and Bay St.
