**DEPARTURE BAY CREEK WATER QUALITY AND FRESHWATER INVERTEBRATE  
ANALYSIS**

**18 December, 2015**

## EXECUTIVE SUMMARY

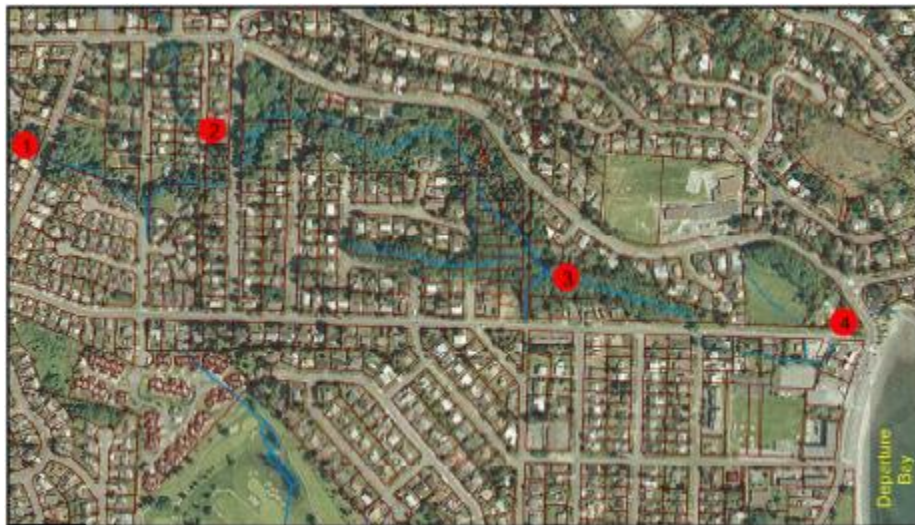
**Figure 1: Map showing Station #1 to #4 along Departure Creek (Map modified by Eric Demers, originally from the Regional District of Nanaimo, 2003.).**

The project sampling has been broken down into four predetermined locations, in which all the sampling will occur. These locations were predetermined, as this is an annually replicated study and the samples are taken from the same stations to maintain consistency. These areas of Departure Creek are under significant public scrutiny; therefore precautions will be taken to respect the public in this area, such as whilst taking samples at the bank, and spending minimal time in the water. Below is a list of the four sampling stations, along with details of their specific locations. All four locations can also be seen on a map in Figure 1.

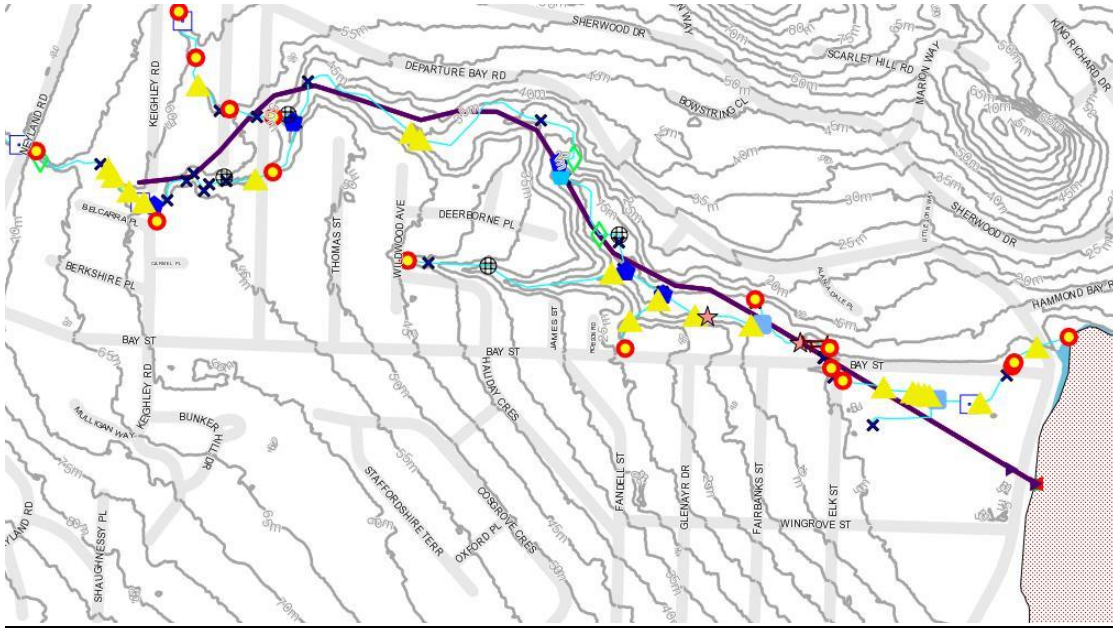
**Figure 2: Topographical map of Departure creek (City of Nanaimo 2015).**

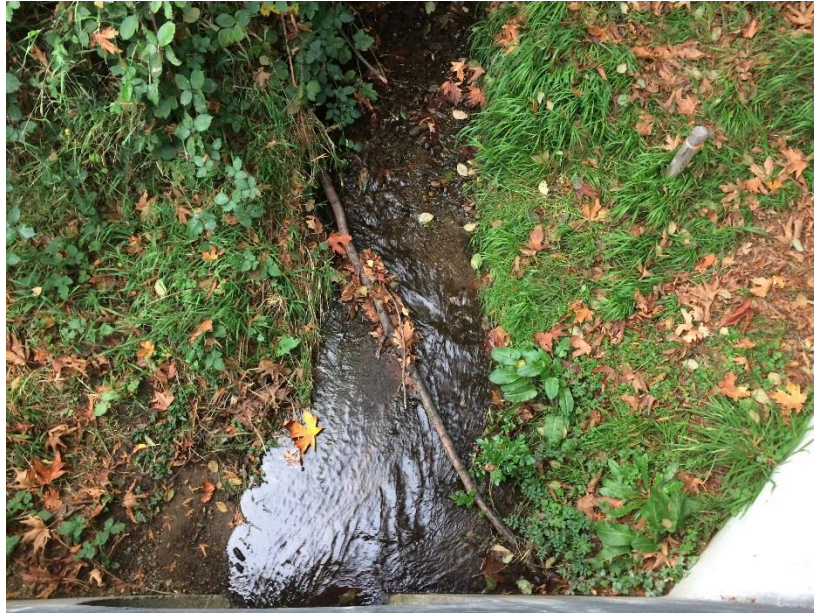
- Station #1 is located the farthest from the outflow of Departure Creek into Departure Bay, approximately 1,700 meters upstream (see Figure 3). This is immediately upstream of Neyland Road where it crosses Departure Creek. This Station was also given an approximate UTM coordinate of 5451108 meters north and 428056 meter east.

**Figure 3: Sample Station #1 Overhead view of site (Photograph taken by Gavin Francis on October 21, 2015).**

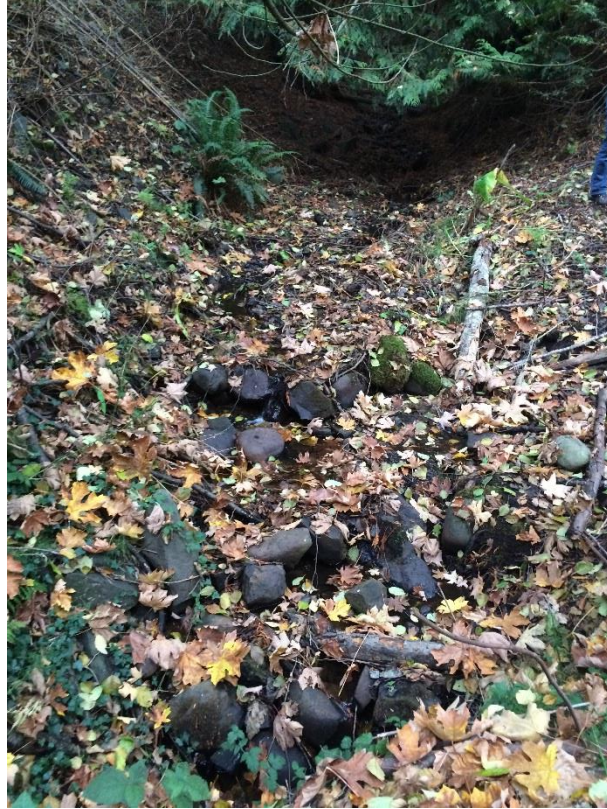
- Station #2 is located approximately 1,300 meters from the outflow of Departure Creek (see Figure 4). This station is actually located on a tributary of Departure Creek which is named Joseph Creek. The station is situated immediately upstream of Newton Street where it crosses Joseph Creek. The approximate UTM coordinate for this location is 5451137 meters north and 428356 meters east.

**Figure 4: Sample Station #2 Overview of site (Photograph taken by Gavin Francis on October 21, 2015).**

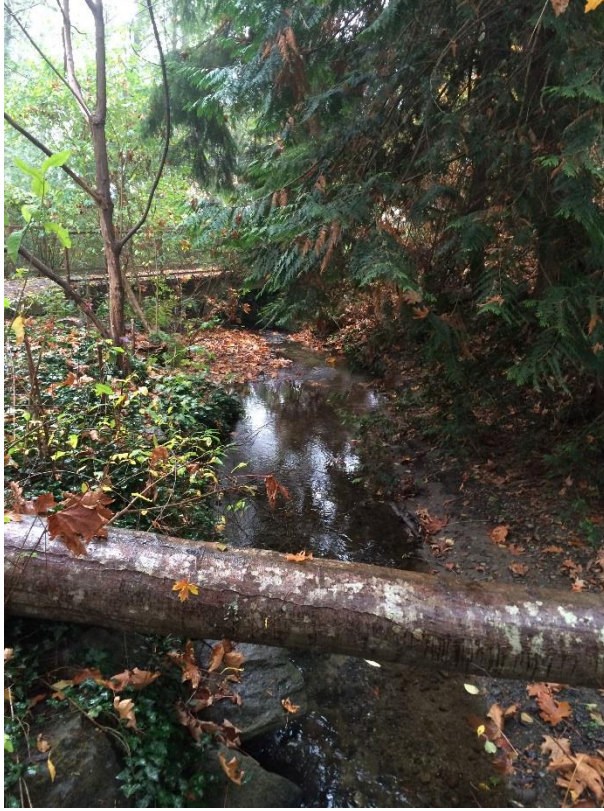
- Station #3 is located approximately 300 meters from the outflow of Departure Creek (see Figure 5). This station is located on Departure creek within Woodstream Park. Specifically this station is located directly upstream of the bridge where Woodstream Park's trail crosses Departure Creek. The approximate UTM coordinate for this station is 5450879 meters north and 428971 meters east.

**Figure 5: Sample Station # 3 Overview of site upstream of Woodstream Park trail bridge  
(Photograph taken by Gavin Francis on October 21, 2015).**

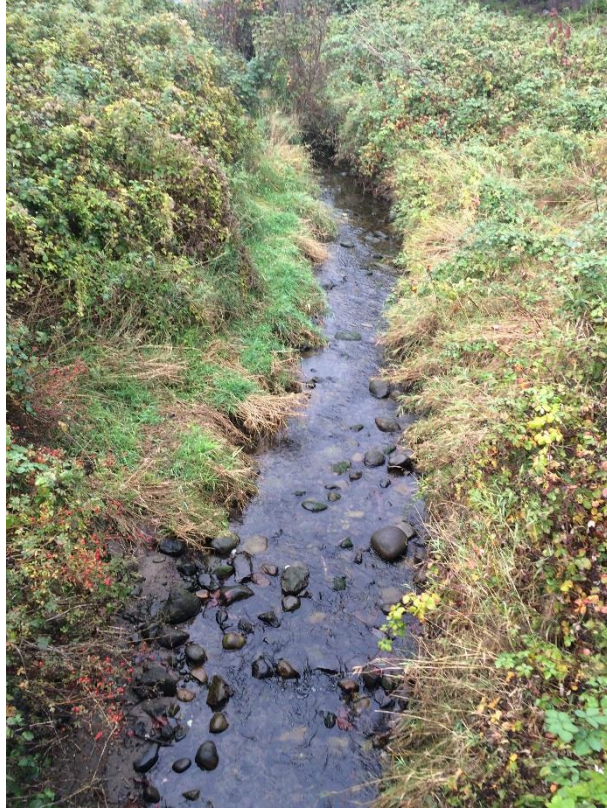
- Station #4 is located closest to the outflow of Departure Creek into Departure Bay, which is approximately 70 meters upstream from the outflow (see Figure 6). This station is located just upstream of the Departure Bay Road pedestrian foot bridge, which crosses Departure Creek. In this case, the station will be accessed from Bay Street. The approximate UTM coordinates for this station are 5450842 meters north and 429334 meters east.

**Figure 6: Sample Station #4 Overview looking upstream from Departure Bay Rd pedestrian foot bridge (Photograph taken by Gavin Francis on October 21, 2015).**

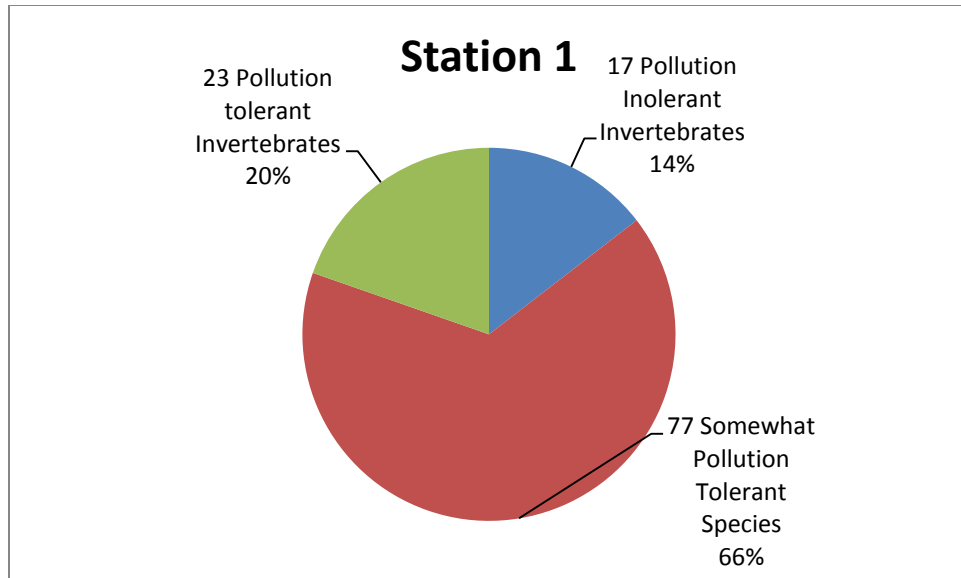
Station 4 was very close to the ocean and the stream invertebrates are affected by the rising tides as opposed to station 1 which is far upstream and the rising tide has no effect on stream invertebrates collected. Hess samplers were used to sample 0.36m squared and the group collected 4 samples at each station, sampling a total area of 1.44m squared in both sites. After analysis it was determined that station 1 had an invertebrate density of 81.25 invertebrates per metre squared and Station 4 had a higher invertebrate density of 175 invertebrates per metre squared. Station 4 likely had higher density from the saltwater that flowed into the stream contained extra nutrients and a higher water level which could increase the total invertebrate density but could lower the diversity, because some species would be unable to survive the saltwater. Station 1 (See Table 6) had 14% of invertebrates captured being pollution intolerant, 20% of invertebrates captured being pollution tolerant, 77% of invertebrates captured being somewhat pollution tolerant (see Figure 7). Station 4 (see Table 7) had only 1% of invertebrates captured being pollution intolerant, 4% being pollution tolerant and 95% being somewhat pollution tolerant (see Figure 8).

**Figure 7: Degree of Invertebrate Species, with Varying Pollution Tolerance, Present at Station 1**

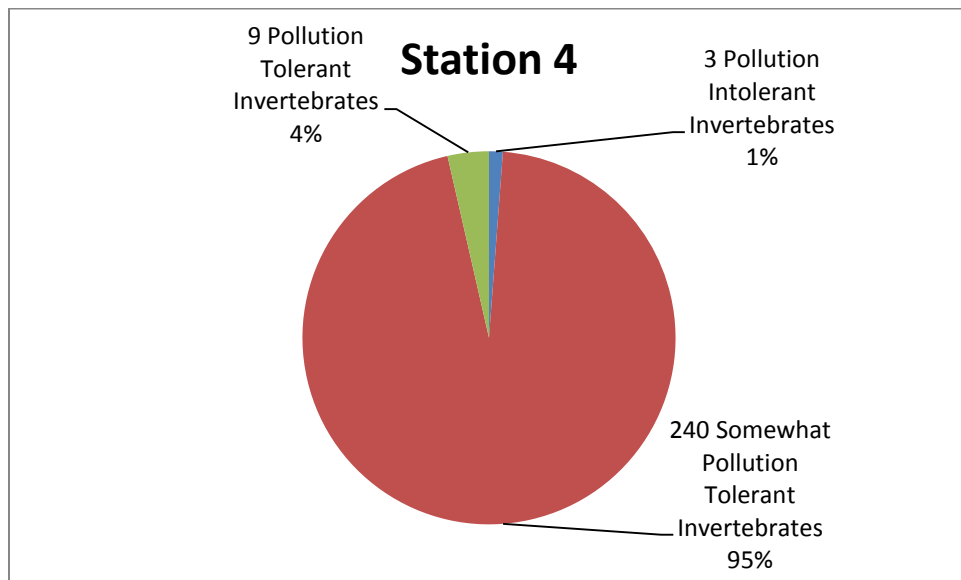
**Figure 8: Degree of Invertebrate Species, with Varying Pollution Tolerance, Present at Station 4**
