Water Quality and Stream Invertebrate Assessment for the:

Millstone River,
Nanaimo, British Columbia, Canada.

RMOT 306 Environmental Monitoring students:

December 13, 2013

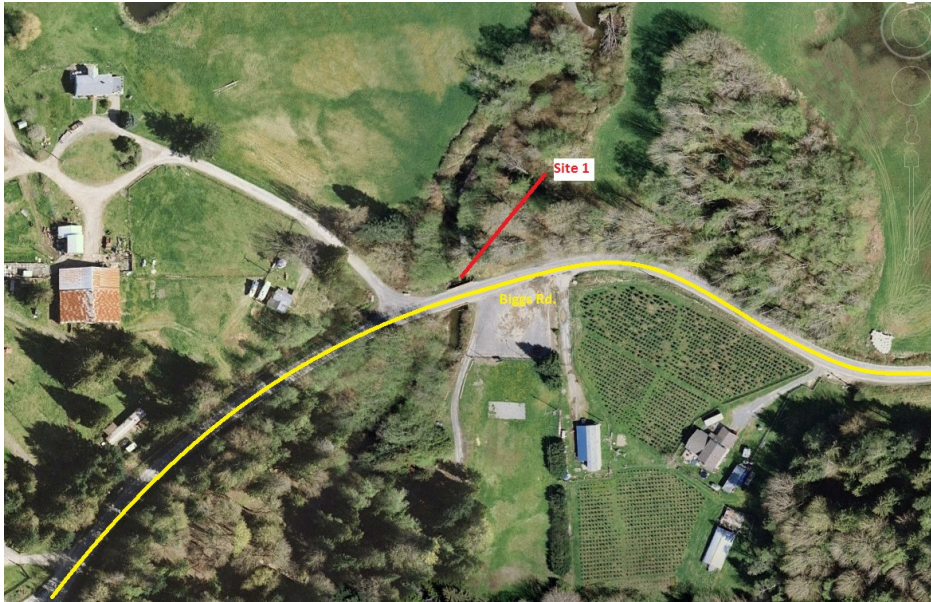
Figure 1: Location of station 1 for water quality environmental monitoring on Benson Creek, Nanaimo, British Columbia.

Station 1 was located at the Biggs Road crossing of Benson Creek (10U0422745mE; 5450710mN) (Figure 1). The samples were taken from downstream of the road crossing. Benson Creek flows into Brannen Lake. Station 1 was surrounded by agricultural land with some riparian area bordering the stream. During Event 1 the stream was observed to be at low flow and substrate consisted of mainly cobble and gravel. The sampling portion includes glide and a riffle with a potential of a pool in increased water level. There was evidence of high flow periods because of potential of the bank full width. During the second event, the stream level was slightly higher. The embankment surrounding the sampling area has a low gradient with an easy trail access from the roadside.

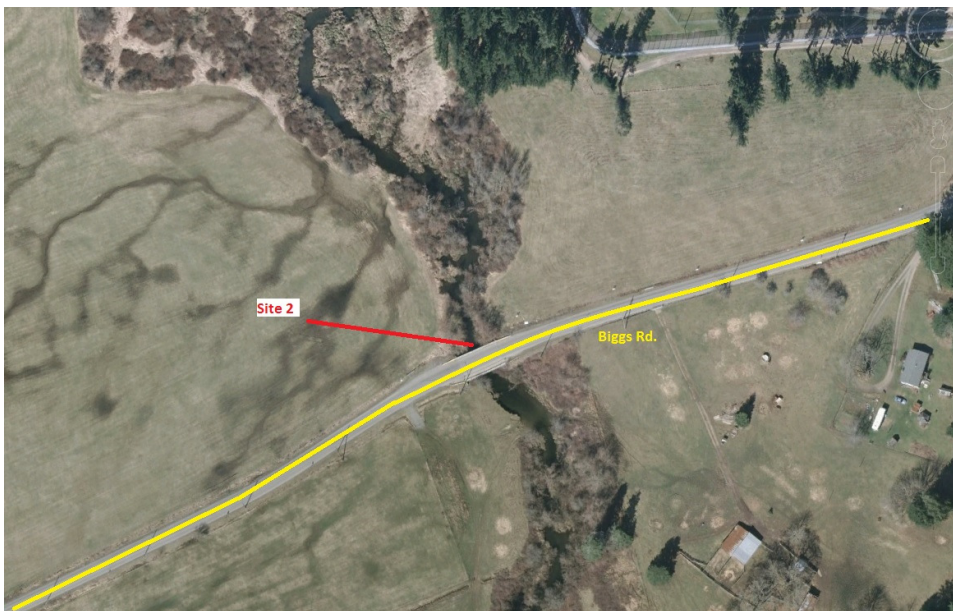
Figure 2: Location of station 2 for water quality environmental monitoring on the Millstone River, Nanaimo, British Columbia.

Station 2 was located at the Biggs Road crossing of the Millstone River (10U4023344mE; 5450818mN) (Figure 2). Sampling took place from the downstream portion of the road crossing. This station was also surrounded by agriculture land. Cobble and gravel comprise the substrate in the sampling area, which was classified as a pool. The access was fair due to the embankment being steep with heavy vegetation. Caution is required when walking to the sample location in-stream.

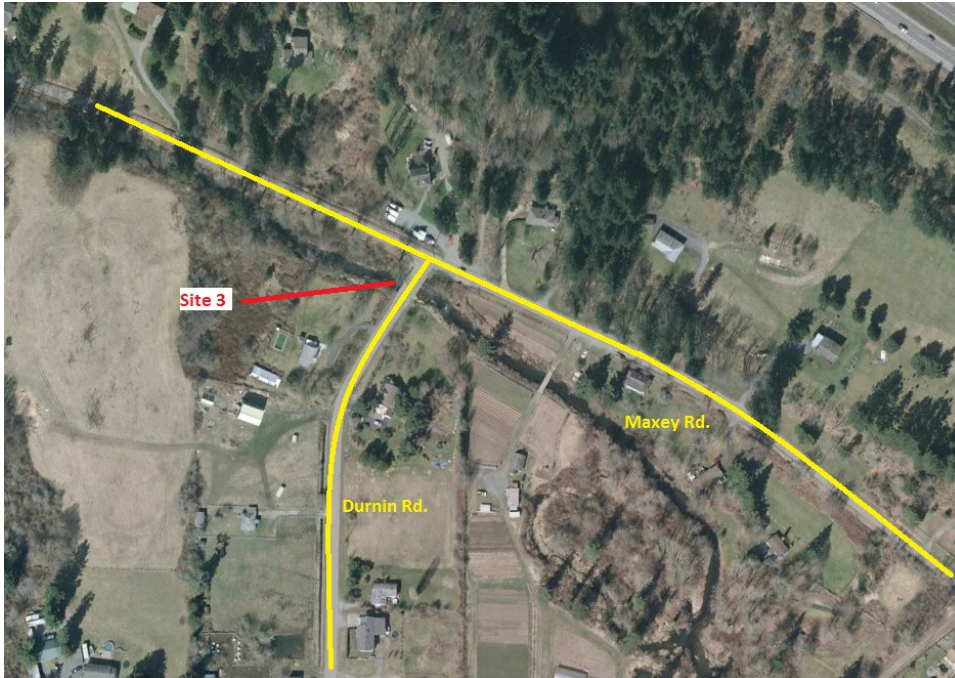
Figure 3: Location of station 3 for water quality environmental monitoring on the Millstone River, Nanaimo, British Columbia.

Station 3 was located at the Durnin Road crossing of Millstone River (10U0426304mE; 5448963mN) (Figure 3). The sample location was on the upstream portion of the road crossing. Surrounding the sample station there were rural properties of residential acreage. At the time of the initial station visit, the stream had a medium flow, compared to increased flow later in the season. This sampling station was a combination of a glide and a pool. The substrate was a combination of cobble, gravel, and boulders. The access trail was absent of vegetation, as well as steep and narrow.

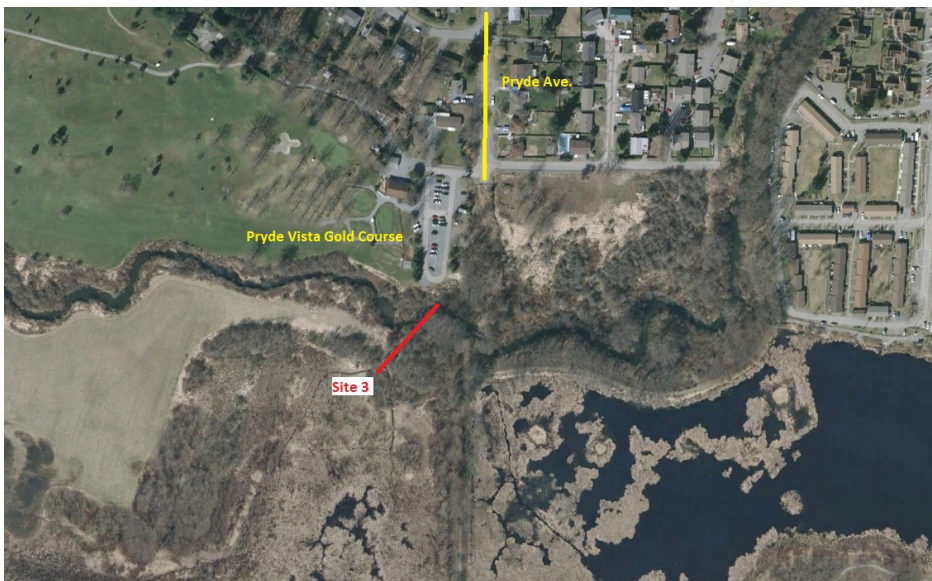
Figure 4: Location of station 4 for water quality environmental monitoring on the Millstone River, Nanaimo, British Columbia.

Station 4 was located at the southeast corner of the Pryde Vista Golf Course parking lot (10U0429080mE; 5447228mN) (Figure 4). This golf course was located at the south end of Pryde Avenue. The access was good and had an easy trail from the parking lot to the sampling location. The surrounding land use is recreational with a treed riparian area. The substrate contained gravel, cobble, and fines. Due to the addition of spawning gravel in August 2011, the predominant substrate was gravel. At the time of the initial station visit the flow was low. There was also a substantial amount of large woody debris in this section. The sampling area was through a glide portion of the river. Students were aware of the direction that golfers hit their golf balls, as a ball from the adjacent course had been found in the stream upon initial visit.

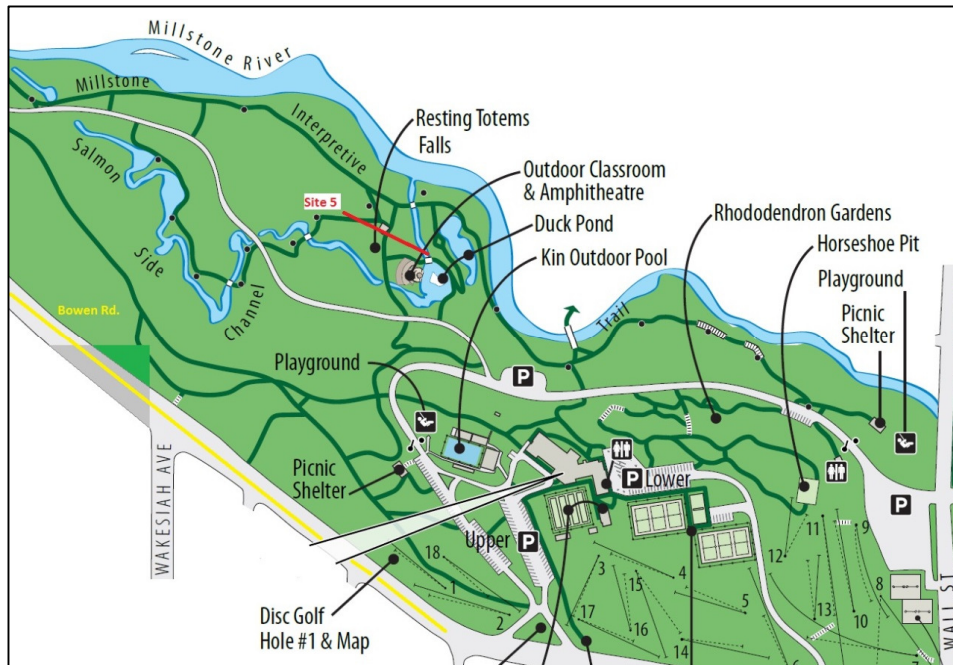
Figure 5: Location of station 5 for water quality environmental monitoring on the Millstone River Side Channel, Nanaimo British Columbia.

Station 5 was located at the outflow of the duck pond of the Millstone River Side Channel within Bowen Regional Park. The sample station was located at the downstream portion of the footbridge for the side channel (10U0430244mE; 5447304mN) (Figure 5). The sample station was easily accessible through footpaths within the park. This side channel was man-made and had a low gradual embankment. The substrate consisted of gravel and cobble and the surrounding land use was classified as recreational urban park with vegetation in close proximity to the side channel. The flow of this section was low and consisted of a glide in the first sampling event and a run in the second.

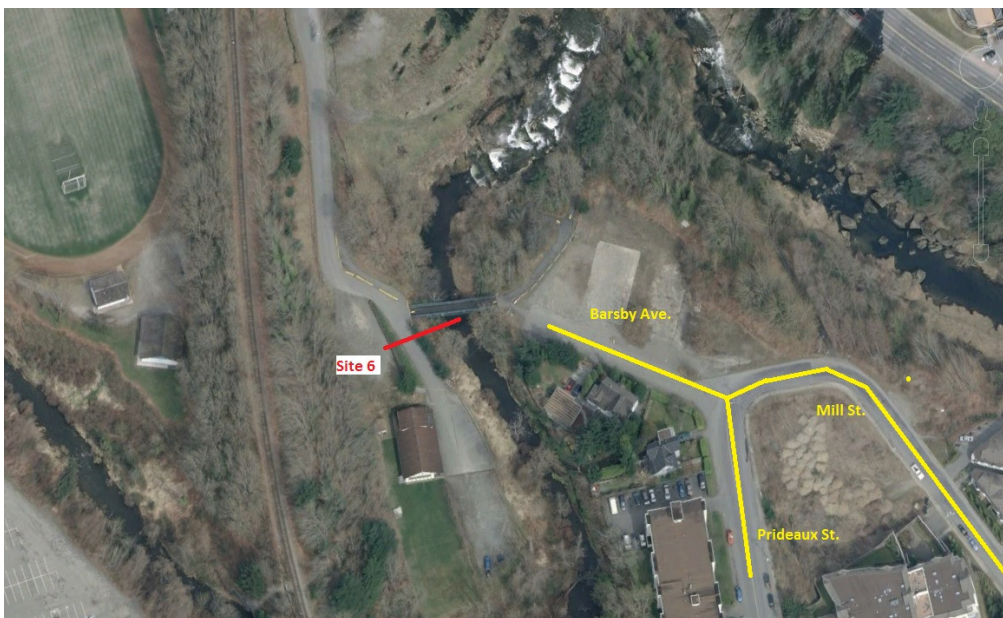
Figure 6: Location of station 6 for water quality environmental monitoring on the Millstone River, Nanaimo, British Columbia.

Station 6 was located by the footbridge crossing of the Millstone River at the end of Barsby Avenue, off of Prideaux Street (10U0430955mE; 5447094mN) (Figure 6). The access was rated as fair due to the steep embankment that was covered with heavy vegetation and human litter. Students used caution when walking to the sample location within the stream because of the human refuse observed on the first station visit on October 19, 2013, as well as

individuals possibly inhabiting the area below the footbridge. The in-stream footing was fair due to the boulder and cobble substrate. At the initial station visit the flow was medium and comprised of a glide, while during the second event the water was higher and flowed in a run.
