Data Report

Water Quality and Stream Invertebrate Assessment for the Millstone River, Nanaimo, BC (Fall 2014)

Report Prepared by:
Students of Vancouver Island University RMOT 306 (Environmental
Monitoring)
Chris Miller, Samuel Isaak, Neil Bacheldor, Iona Kearns

Dec 12, 2014

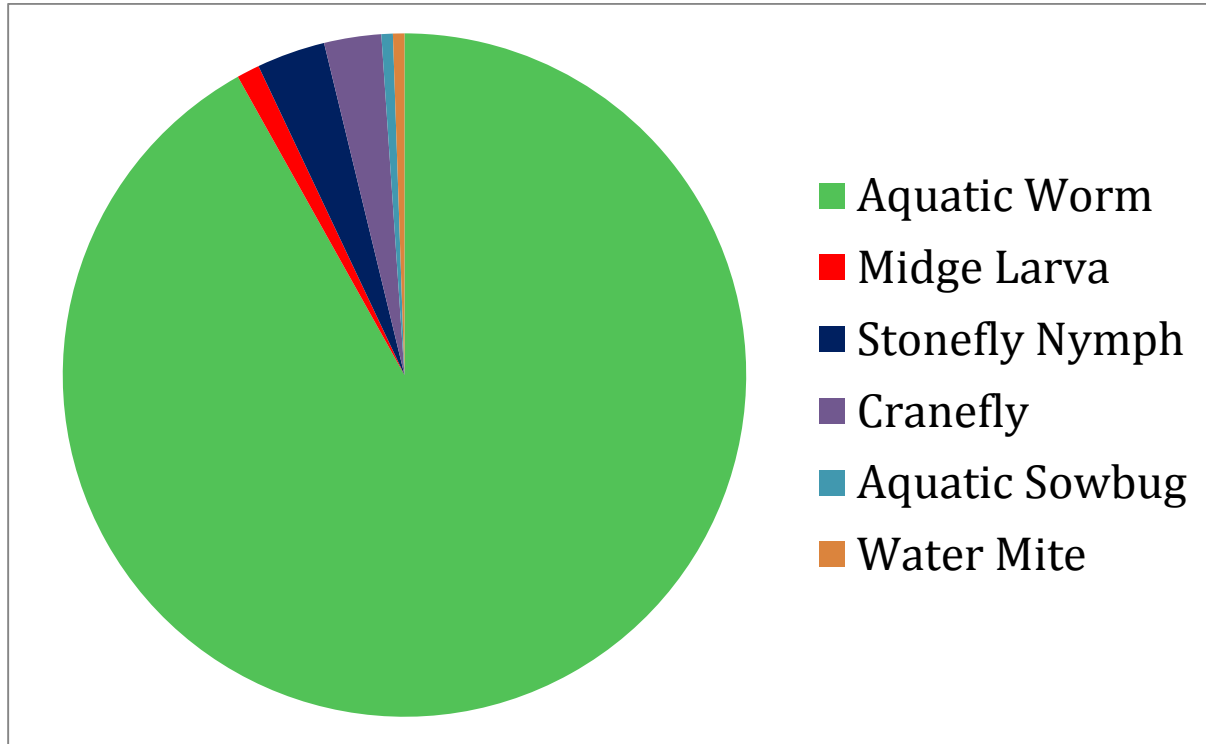
Figure 2: Distribution of invertebrates collected from Site 1 on October 28, 2014 (chart by authors).

The figure above shows the proportion of aquatic worms that were found compared to the other groups. This is a strong indication that the water quality at Site 1 was not healthy enough to support a higher diversity of species and more pollution intolerant groups. Site 1 has an overall average rating of 1.5 based on an average from four indices: pollution tolerance index (marginal, 2), EPT index (marginal, 2), EPT to total ratio (poor, 1) and predominant taxon ratio (poor, 1). The average of 1.5 falls between poor and marginal for this site. The calculations for these indices can be found in the invertebrate survey field data sheets in the Appendix. However, it is known that Site 1 was dry for most of the summer months and had only begun flowing again in September. Therefore, there was not

enough time for an invertebrate community to re-establish itself before the sampling took place. It is also likely that some invertebrates that may have been living in Site 1 were swept away by the high flow occurrence around the sampling date.

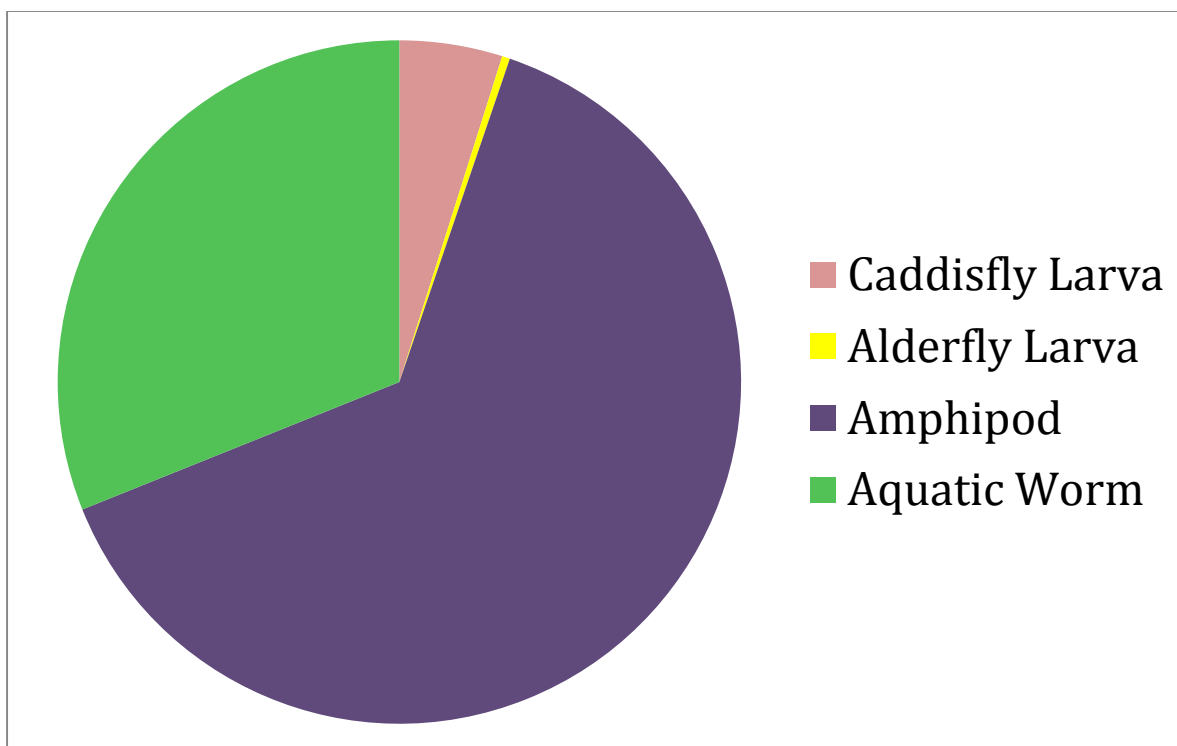
Figure 3: Distribution of invertebrates collected from Site 2 on October 28, 2014 (chart by authors).

The figure above shows the proportion of invertebrates that were found at Site 2. The largest group is amphipods which make up over 60% of the total sample. Aquatic worms make up approximately 30% of the total sample. Site 2 has an overall average rating of 1.75 based on an average from four indices: pollution tolerance index (marginal, 2), EPT index (marginal, 2), EPT to total ratio (poor, 1) and predominant taxon ratio (marginal, 2). The average of 1.75 falls between poor and marginal for this site. This site had flow during the summer and so this distribution is one that is likely consistent year round. Even though this site has a poor-marginal rating, it will be shown in the next section that this site has the highest species diversity according to the Shannon-Weiner Diversity Index.

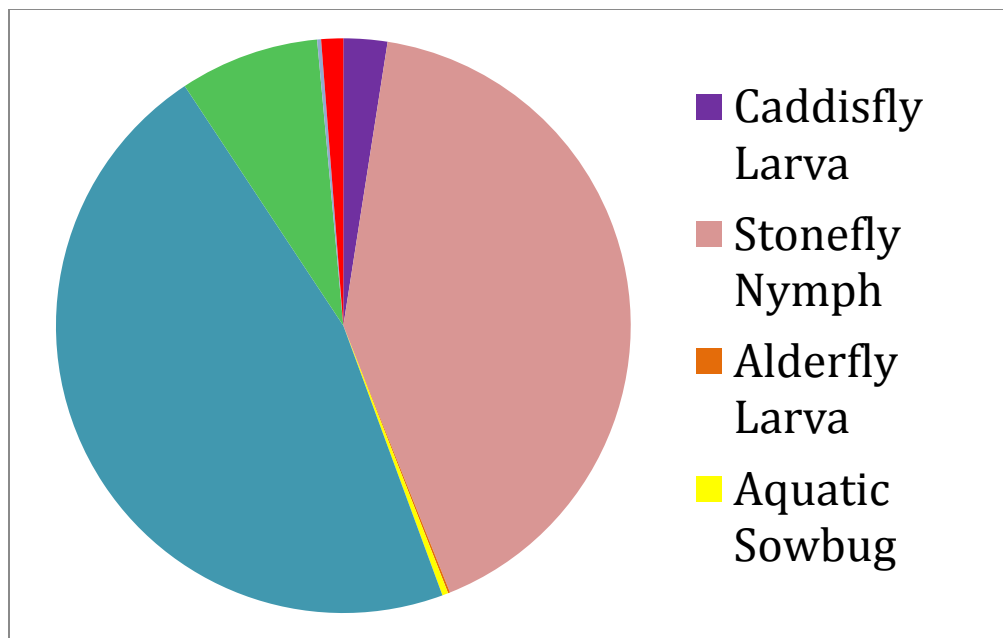
Figure 4: Distribution of invertebrates collected from Site 5 on October 28, 2014 (chart by authors).

The figure above shows that the majority of the sample was comprised of amphipods and stonefly nymphs. Although more species are present, they occur in relatively small amounts compared to the total. However, it is encouraging that the sample is almost 50% stonefly nymphs which are an EPT index species. Site 5 has an overall average rating of 2.5 based on an average from four indices: pollution tolerance index (acceptable, 3), EPT index (marginal, 2), EPT to total ratio (marginal, 2) and predominant taxon ratio (acceptable, 3). The average of 2.5 falls between marginal and acceptable for this site. The calculations that were done to achieve this overall rating can be seen on the invertebrate survey field data sheet in the Appendix. Based on this average rating, Site 5 has the best overall site assessment rating, but in terms of species diversity, the Shannon-Weiner diversity index shows a different perspective.

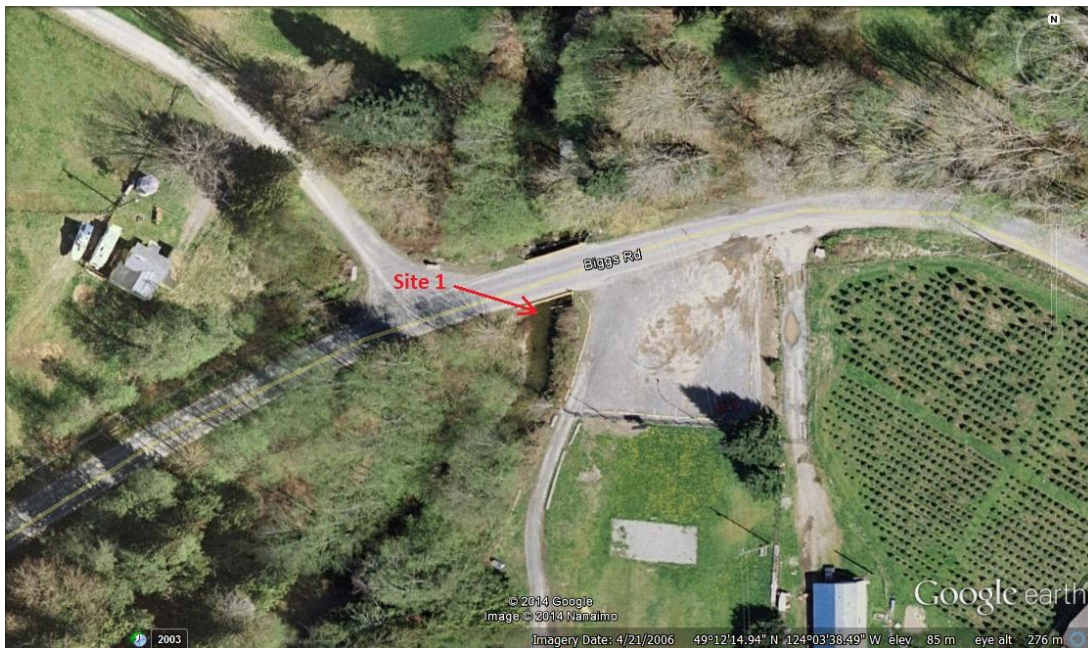
Figure 7 – Site 1 overhead view with flow going north (Google Earth 2014, edited by authors)

Site #1 is located on Benson Creek close to where it enters Brannen Lake (10U 422738mE, 5450707mN (Google Earth, 2014)). The sample site is located where Biggs Road crosses Benson Creek. The best way to access the site is to cross the bridge and to hike down at the SW corner. We noticed an oily film on the bridge possibly from vehicles passing by and saw this as a potential site contamination. This portion of the stream had a slope of 2° and steep embankments housing a riparian collection of Himalayan blackberry, grass and willow (see figure 8 in the appendix). The substrate consisted of approximately 60% cobble, 30% gravel, 5% boulder and 5% sand. Canopy cover was estimated at 50% (see figure 7 in the appendix).

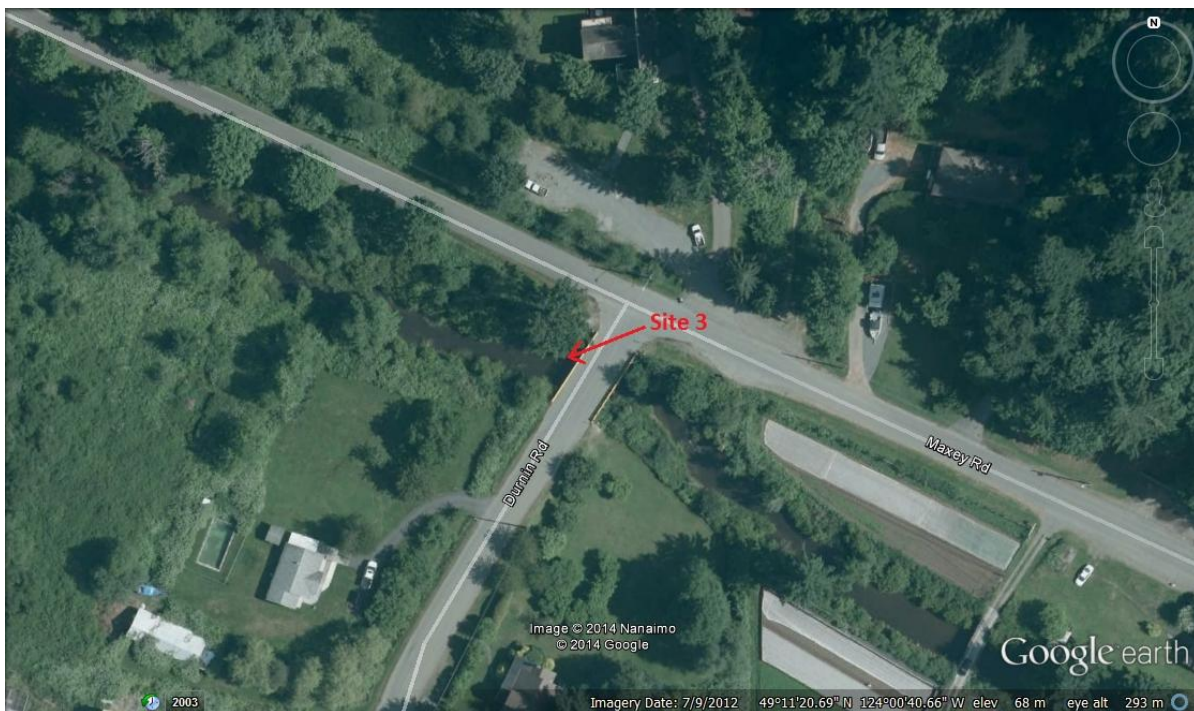
Figure 11 – Site 3 overhead view with flow going southeast (Google Earth 2014, edited by authors)

Site #3 is located at the junction of Maxey Road and Durnin Road (10U 426304mE, 5448953mN (Google Earth, 2014)). Access was gained at the NW corner of the bridge. This site had a slope of 1° and a generally shallow embankment, but was fairly steep at the access point. It is home to a riparian compilation of grass and shrubs (see figure 12 in the appendix). The substrate consisted of leaf litter, approximately 80% cobble, 15% gravel, 4% sand and 1% boulder. Canopy cover was approximately 60% (see figure 11 in the appendix).

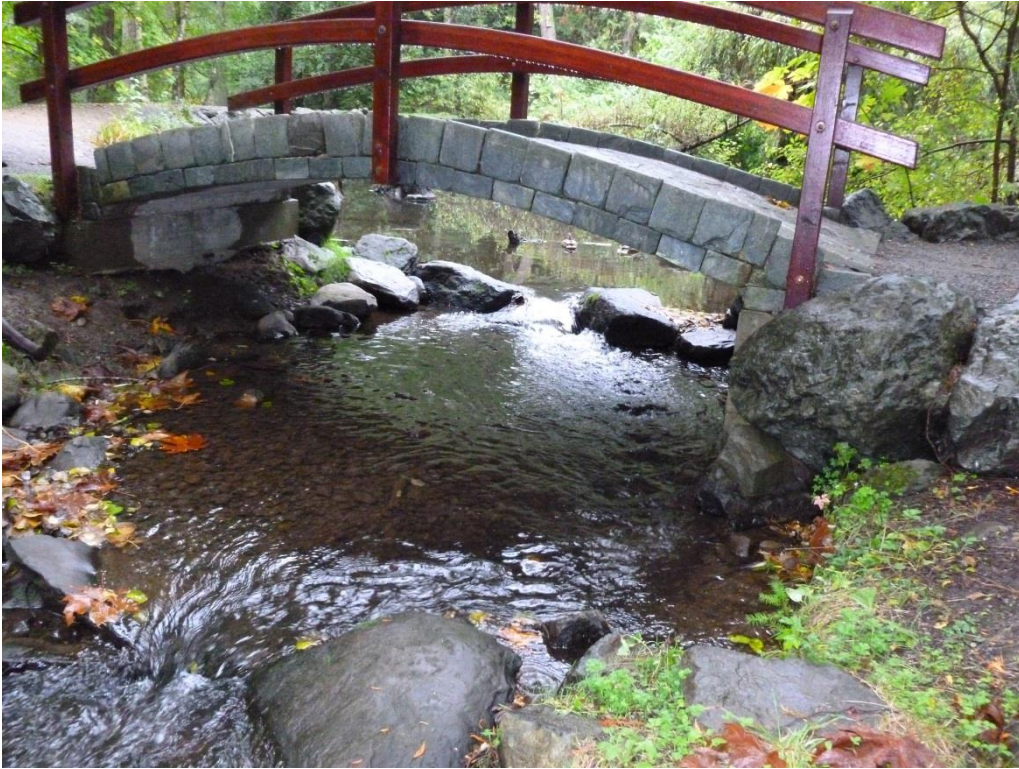
Figure 16 – Site 5 from stream bank looking upstream towards duck pond (Photo by authors)

Site #5 is located further from vehicle access than the other sites, which required carrying equipment a little further (10U 430233mE, 5447304mN (Google Earth, 2014)). This site is on the west side of the duck pond in Bowen Park just downstream from a small footbridge, therefore it had the most human traffic of all the stations. The river is altered from its natural state in the park and the sample site is located in a human made bypass around a waterfall. This site was also the steepest of the sites with a measured 5° slope. The bypass had lower water flow than the other sites and was well structured with LWD and in-stream cover. This site had little to no embankment as it was mostly lined with rocks. It is home to a riparian area consisting of salmonberry, red alder, Western red cedar and big leaf maple. The substrate consisted of leaf litter and approximately 70% gravel, 20% boulder, and 10% cobble (see figure 16 in the appendix).

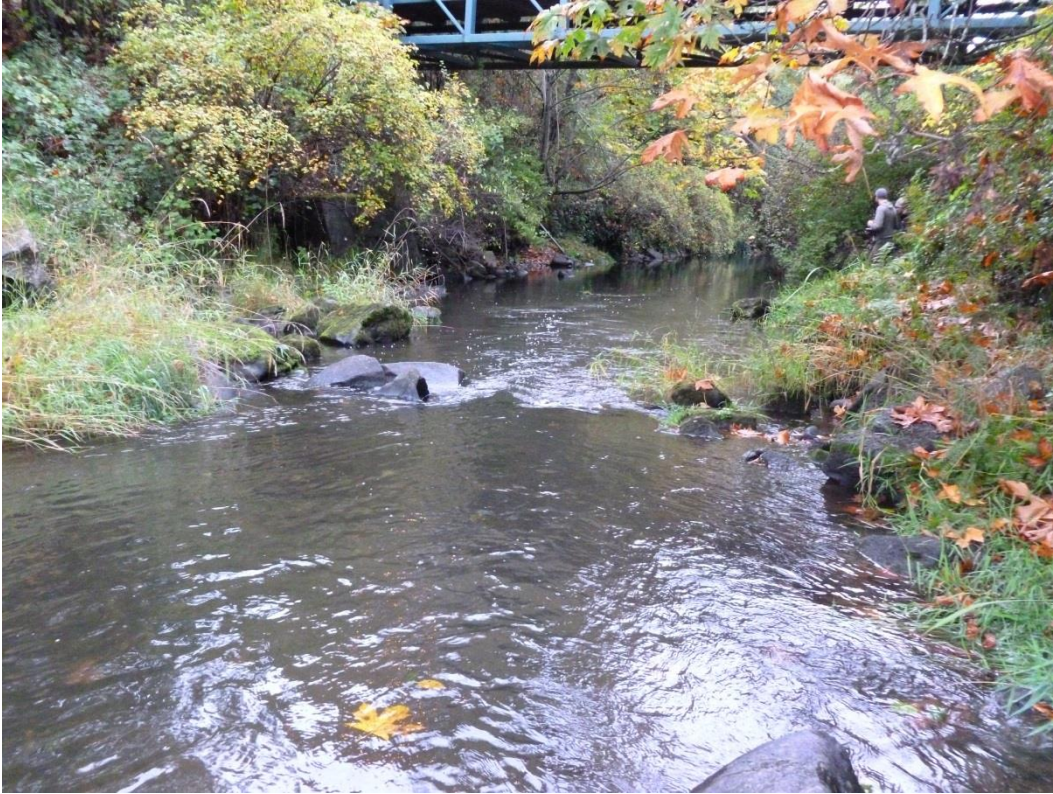
Figure 18 – Site 6 from stream bank looking downstream (Photo by authors)

Site #6 is the closest to the estuary and is located just upstream of the footbridge that connects Prideaux Street and Caledonia Avenue in Barsby Park (10U 430941mE, 5447091mN (Google Earth, 2014)). Access was gained by taking the footpath from Prideaux Street on the north side of the bridge and crossing under it. This site showed the highest water flow as well as significant turbidity. Remnants of the foundation of an old bridge are still present next to the existing bridge. We observed this site to have the most garbage present of any site. It had a slope of 1° and a fairly steep embankment near the bridge, but was shallower upstream. It is lined with big boulders and is home to a riparian assemblage of grass, salmonberry and big leaf maple. The substrate was hard to gauge due to the high turbidity but boulders were visible (see figure 18 in the appendix).
