RICHARDS CREEK VIU STUDENT MONITORING PROGRAM 2013

Prepared by Cassie Seibert, Sara Gregory, Lynnea Parker and Mel Demkiw Prepared
for the consideration of Eric Demers for the RMOT 306, Environmental Monitoring course

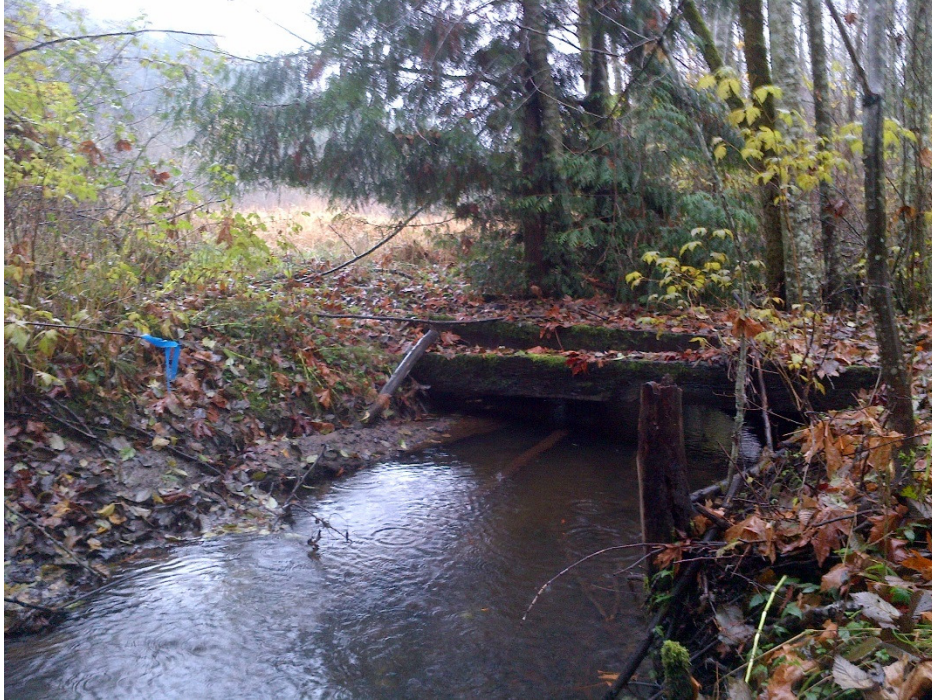
Habitat Characteristics for Site One (Photograph Taken by Mel Demkiw).

Station 1	Station 2	Station 3	Station 4
Ecosystem Type	Forested area	Forested Area	Agricultural Fields	Agricultural Fields
Riparian Vegetation	Salmonberry, sword fern, big leaf maple, red alder Western red cedar.	English ivy, big leaf maple, Douglas fir, Western red cedar	Himalayan blackberry red alder, hardhack	red alder, Douglas fir, big leaf maple, red osier dogwood, Nootka rose, hardhack, Himalayan blackberry, sedges and rushes.
In-stream cover	20%	5%	70%	5%
Canopy Cover	90%	90%	75%	0%

Large woody debris (LWD)	5%	5%	5%	nd*
Small Woody debris	20%	10%	10%	nd*
Substrate	10% clay, 0% sand, 10% gravel, 5% cobble, 5% boulder	40% silt and sand, 50% cobble, and 10% boulder	30% silt and sand, 20% boulder, and 50% cobble	nd*

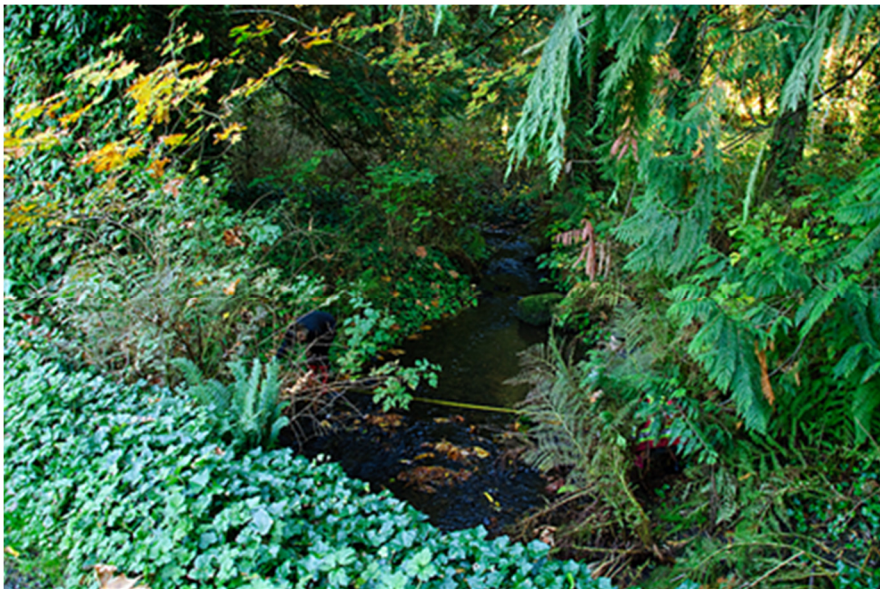
Habitat Characteristics for Site Two (Photograph Taken by Lynnea Parker).

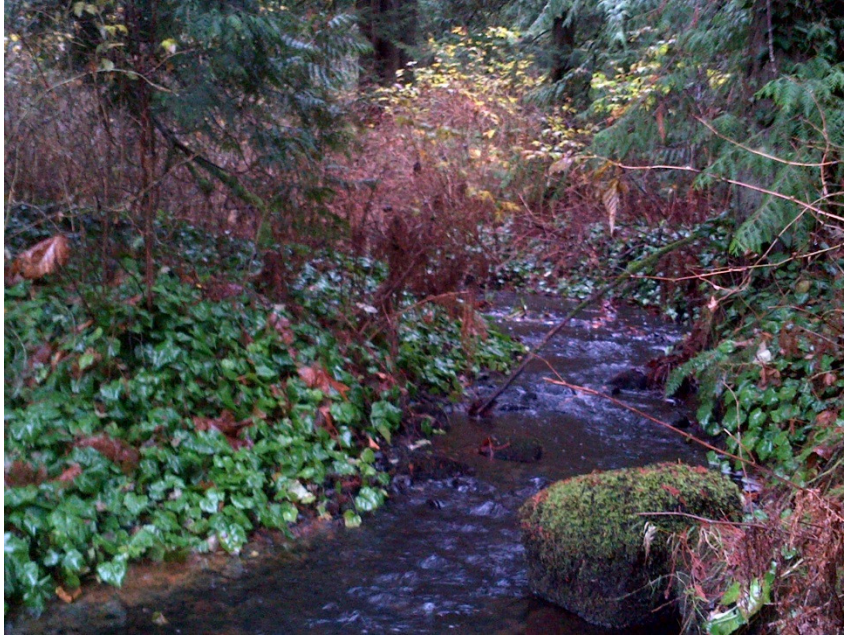
Habitat Characteristics for Site Three (Photograph Taken by Mel Demkiw)

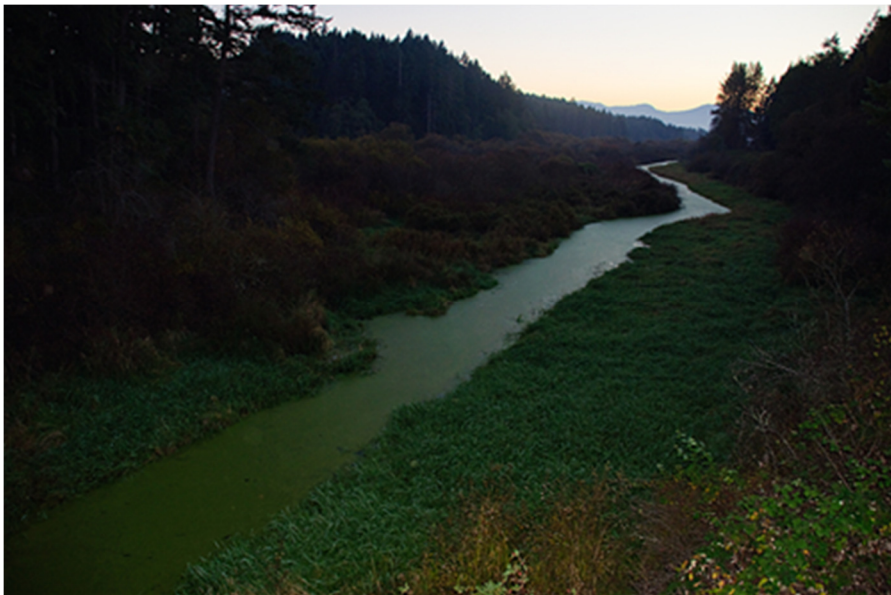
Habitat Characteristics for Site Four (Photograph Taken by Lynnea Parker).

nd* There is no data due to the stream being covered in duckweed and too murky to make these observations.
