Fall 2014 Water Quality and Stream Invertebrate Assessment of Richards Creek, Crofton, British Columbia

RMOT 306

Vancouver Island University Natural Resource Protection Dept.

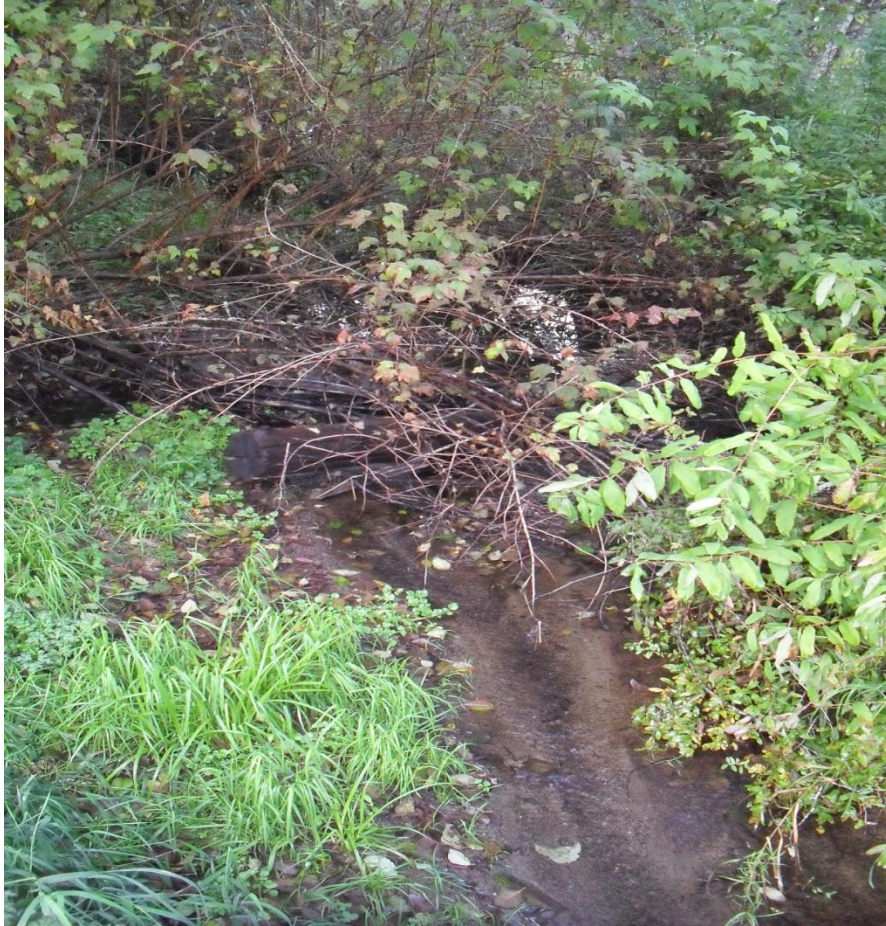
Photo 1. Habitat characteristics of sampling station 1

five-acre agricultural field. The headwater of Richards Creek is approximately 2.12 km upstream at Crofton Lake. Three similar sections of stream riffles with 70% gravel and 30% sand bottom substrate with a gradient of 2% were chosen to be the locations where stream invertebrates, water quality, and microbiology would be sampled. Predominate riparian vegetation consists of Pacific Ninebark (*Physocarpus capitatus*), Red Alder (*Alnus rubus*), Hardhack (*Spiraea douglasii*), and Western Red Cedar (*Tsuga plicata*) (Appendix 1 Photo 1).

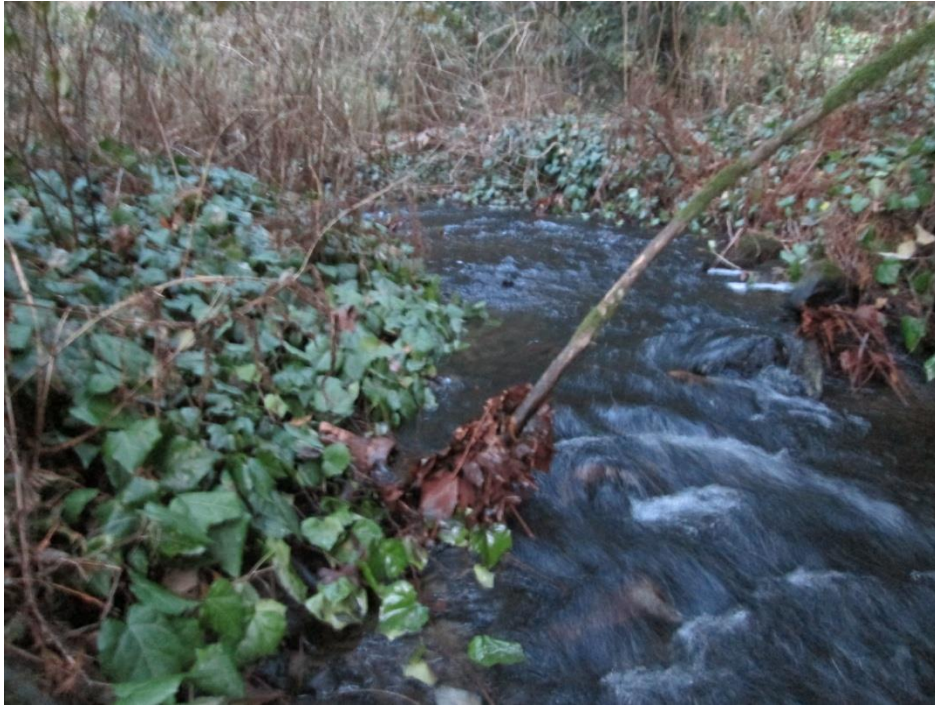
Photo 2. Habitat characteristics of sampling station 2

Sampling station 2 is located on the private residence of Innisvale Farm, at the end of Rice Road.

Sampling took place on the east bank of Richards Creek. Access to the sampling location is down a steep sloped trail that opens to a wide riffled section of the stream. The bottom substrate consisted of 30% bedrock, 20% cobble, 40% gravel and 10% sand with a gradient of 4%. Dense riparian vegetation consisted of Salmonberry (*Rubus spectabilis*), Sitka Sedge (*Carex aquatilis*), Maidenhair Fern (*Adiantum pedatum*), Lady Fern (*Athyrium filix-femina*) and Skunk Cabbage (*Lysichiton americanum*). Invasive species included English Ivy (*Hedra helix*) and Periwinkle (*Littorina littorea*), which comprised approximately 40% of the left and right banks vegetation. Surrounding the sampling site is agricultural land currently in use. There is an intake pipe for residential water in close proximity (25 meters) to the sampling site. The site is easily accessible via Rice Road. Landowner granted permission to conduct water quality samples on their property.

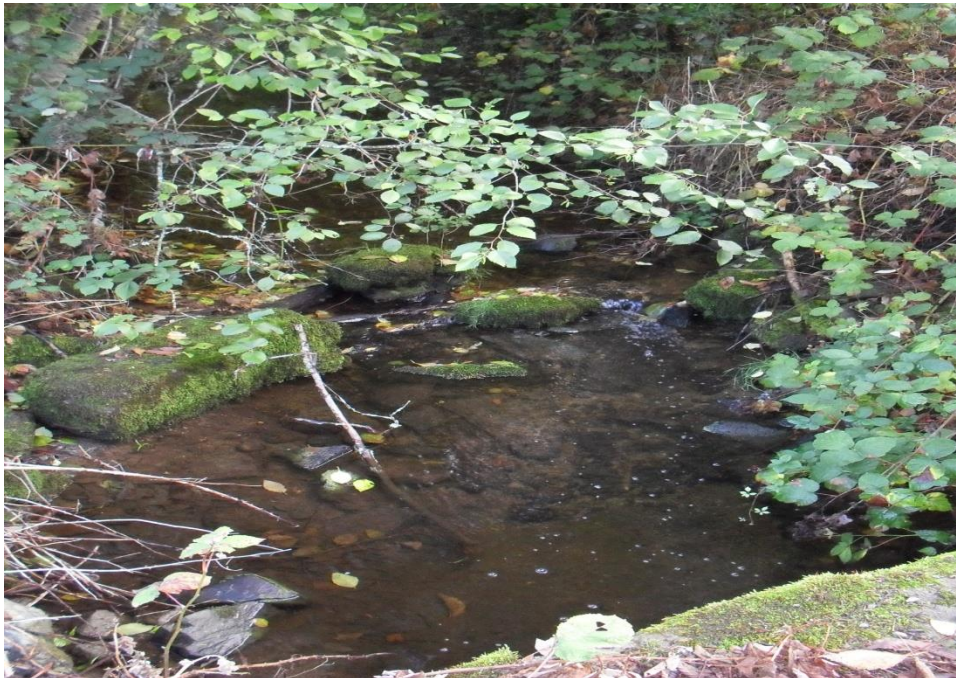
Photo 3. Habitat characteristics of sampling station 3

Station 3 is located off of Richards Trail Road, on the east corner of Pastula farm. Access is directly down an excavated embankment, next to an active agricultural field. A fence paralleling the west bank along the agricultural field blocks access to the stream. There is a storm drain that empties into a pool at the mouth of the culvert where microbiology and water quality samples were taken. Stream invertebrate samples were taken upstream in riffles with substrate composed of bedrock (60%) mixed with 20% gravel and 20% sand. This section of Richards Creek has low gradient of 4% and travels through agricultural land. There is a low amount of riparian vegetation consisting predominantly of Nootka Rose (*Rosa nootkana*) and Red Alder (*Alnus rubus*).

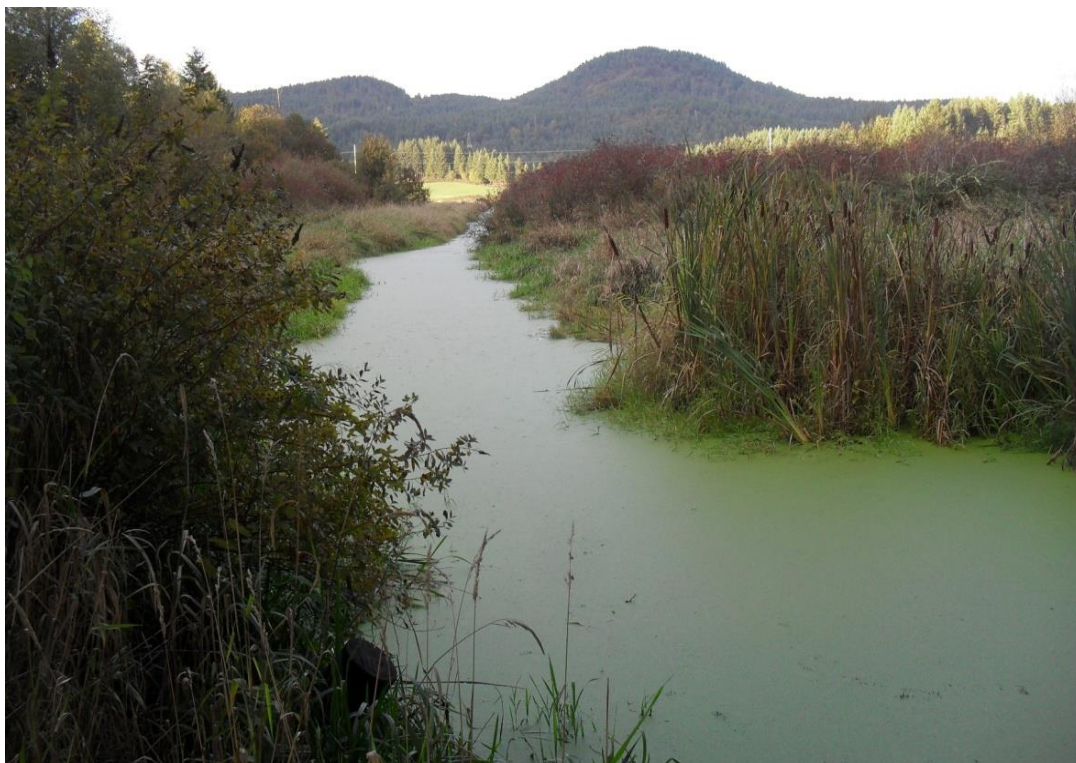
Photo 4. Site 4 looking upstream on October 27/2017

Sampling station 4 is located directly under the Herd Road Bridge, which can be accessed via a footpath on the north side of Herd Road. This site is roughly two kilometers upstream of Somenos Lake. Flat, agricultural land surrounds this section of the creek. Water movement in this location is severely reduced due to the low gradient of 0%. Historically, European settlers drained this area known as the “Somenos flats” for its fertile lowland (Somenos Marsh 2014). Substrate composition could not be determined at this site due to the deep-water depth. There is a low amount of riparian vegetation; Nootka Rose (*Rosa nootkana*), Hardhack (*Spiraea douglasii*), and Scouler’s Willow (*Salix scouleriana*) accounted for 30% of the surrounding vegetation. A species of duckweed (*Lemnoideae sp*) was present in high densities on the first sampling day, indicating nutrient-rich water.
