Water Quality and Invertebrate Analysis of the Beck Creek, Nanaimo B.C.

By; Iliana Stehelin, Thomas Duff, Tyler Reiber and Lucas Phillips

RMOT 306

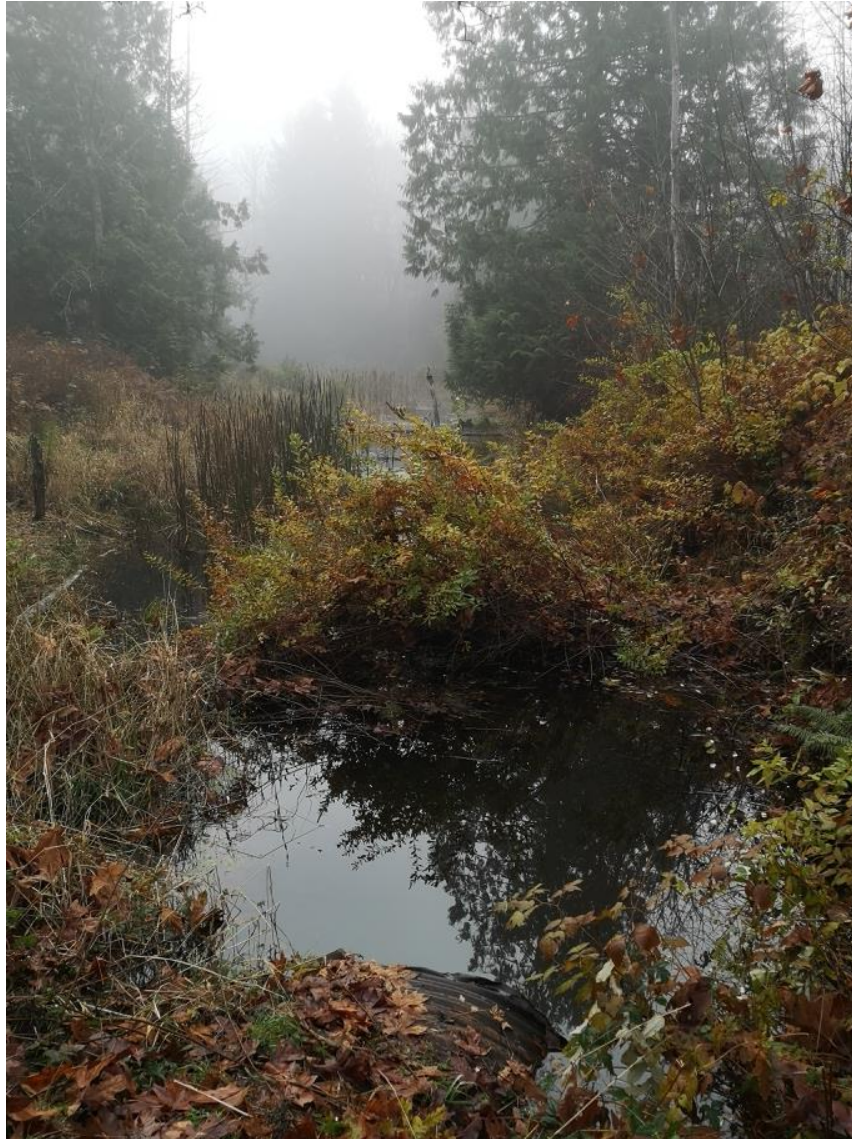
Figure 2: Site One on November 16, 2022

Site one is located furthest upstream at UTM 10 U 433603 E, 5440523 N. This site is accessed by parking on Frames Road and walking past a very large Douglas fir (*Pseudotsuga menziesii*) with graffiti painted on it with blue spray paint. You pass site two on your way to site one. Site one is located just upstream from a culvert and a quad trail. The water levels were higher in this site, forming pools, likely due to a lesser gradient. The pools were stagnant and very murky. Water depth was quite high at site one, even at low flow. An old beaver dam and large quantities of woody debris were observed in site

one. The substrate was observed to be predominantly fines (80%), gravel (15%) boulders (2%) and cobble (3%). The riparian area of this site was limited, and looked as though it had recently been disturbed in some areas by off road vehicles. Canopy cover was estimated at 15 percent. The vegetation that had not been destroyed consisted of grasses, alder (*Alnus rubra*), big leaf maple (*Acer macrophyllum*) and cattail (*Typha latifolia*).

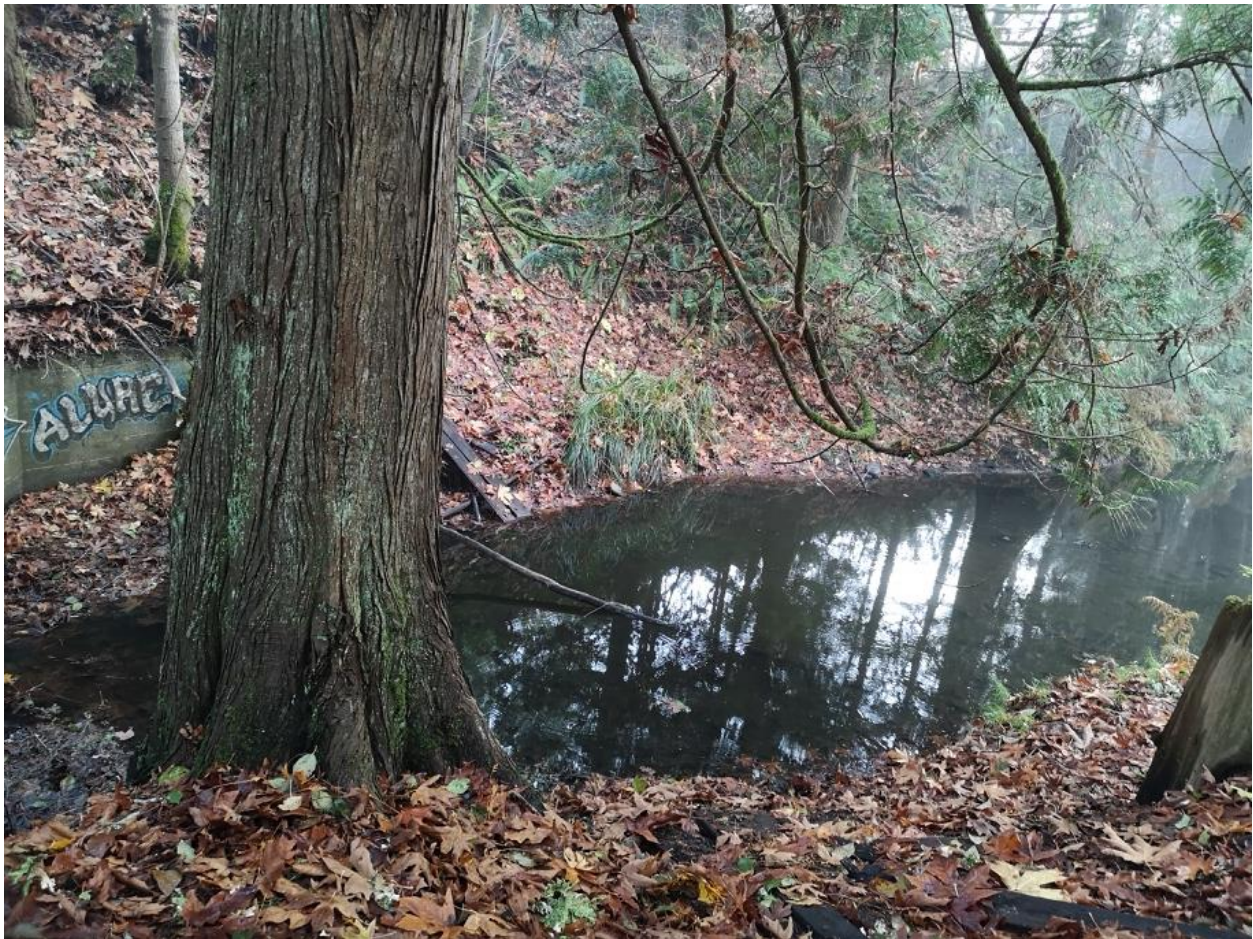
Figure 3: Site Two on November 16, 2022

Site two is located approximately 500 meters downstream of site one at UTM 10 U 433409 E, 5440990 N. To access this site, you walk downstream along the train tracks back towards Frames Road. The site is directly upstream of a large culvert which was partially blocked by woody debris. Sampling took place above the culvert. Water depth was shallower at site two and flow was significantly

increased. The substrate was observed to be predominantly fines (90%), cobble (5%) and boulders (5%). The riparian area of this site consisted of snowberry (*Symphoricarpos albus*), alder (*Alnus Rubra*), bigleaf maple and cedar (*Thuja plicata*). The canopy cover at site two was thicker than site one, estimated at 65 percent. On our first sampling date juvenile Coho salmon were observed here.

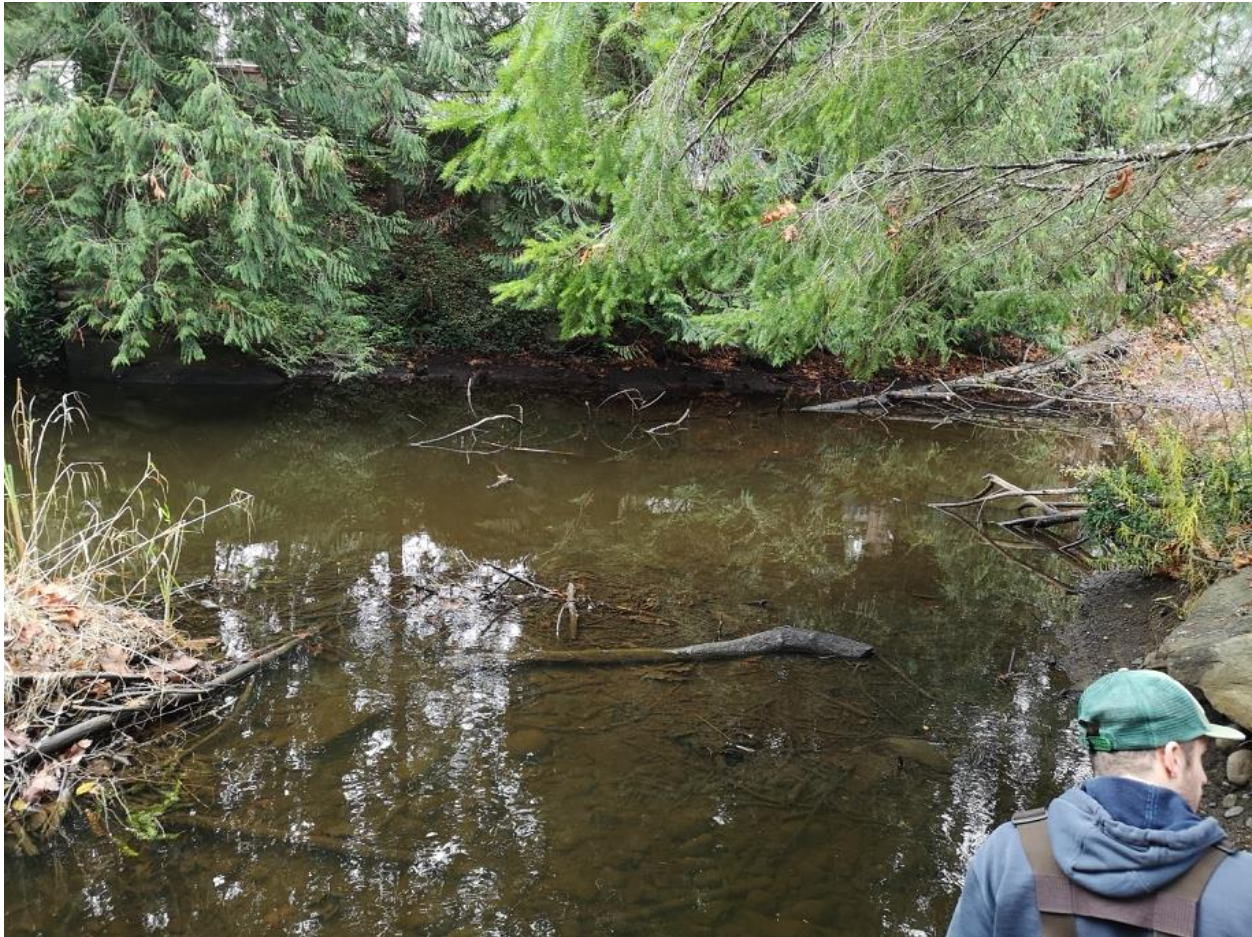
Figure 5: Site Four on November 16, 2022

Site four is situated at the outflow of Beck Creek into the Nanaimo River Estuary at UTM 10 U 433289 E, 5442348 N. This site was accessed off of Maki Road. The bank of this site was also quite steep. A blue heron (*Ardea herodias*) and mallard duck (*Anas platyrhynchos*) were observed at this site on the first site visit. This site is affected by tidal movements, particularly on the downstream side of the culvert. Adult Coho salmon were observed at this site on both sampling days. The substrate was

predominantly fines (65%), boulders (15%), cobble (10%) and gravel (10%). There was very little riparian coverage (35%) comprised of Garry Oak (*Quercus garryana*), Douglas Fir and various shrubs.

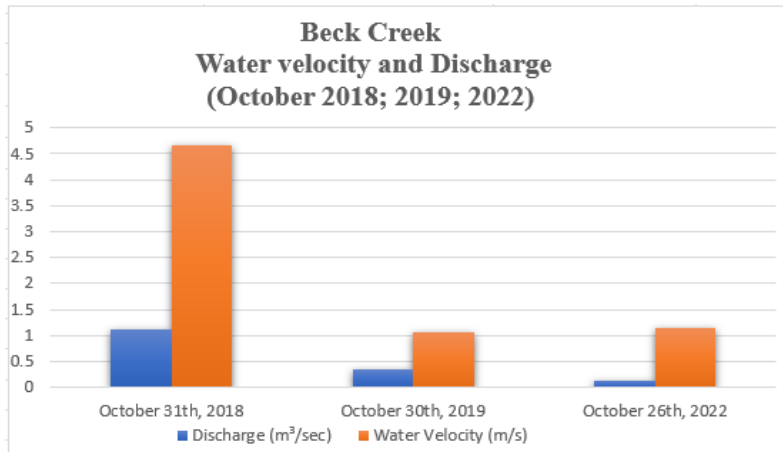
Figure 6. Water velocity and discharge of Beck Creek in 2018; 2019; and 2022 during sampling conducted in the month of October (VIU: de Laplante, Gagne, and Soucy). 2018; VIU: Cooper, Farrow, and Munroe 2019).

Since 2018, groups have conducted hydrology measurements and calculations on site 4 on Beck Creek. When we compare the results obtained in 2022 to those of previous years, we see that the water velocity and discharge are significantly lower than they have been since 2018, especially during the month of November (See Figure 6; Figure 7). In 2020, high water caused getting a proper water velocity and discharge impossible, there for it is absent in the comparison in figures 6 and 7.

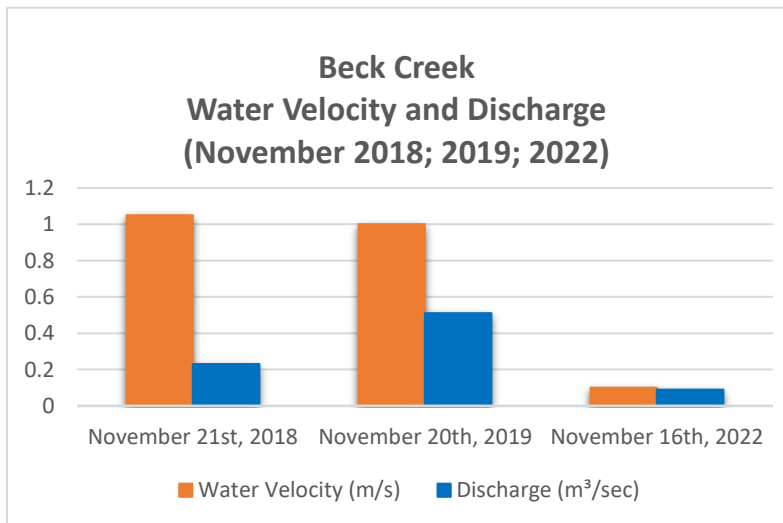
Figure 7. Water velocity and discharge of Beck Creek in 2018; 2019; and 2022 during sampling conducted in the month of November (VIU: de Laplante, Gagne, and Soucy). 2018; VIU: Cooper, Farrow, and Munroe 2019).
