Cottle Creek Monitoring Project

RMOT 306: Sam Hlywka, Zac Eiffert, Mitchell Charbonneau, Johnathan Holden
Environmental Monitoring
Vancouver Island University
Nanaimo

EXECUTIVE SUMMARY

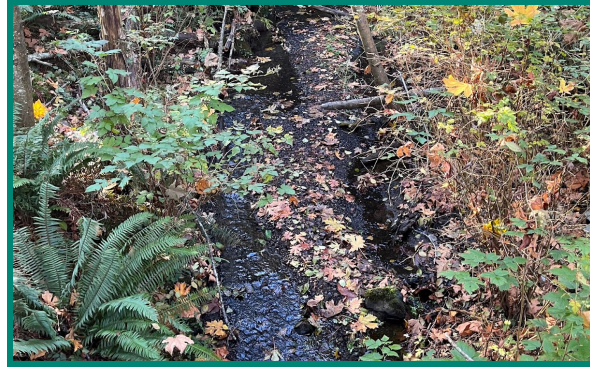
Figure 3. Photo of the Site 1 location as part of the Cottle Creek watershed.

The first sampling location, titled Site 1, is located at the western part of the watershed (Figure 4). It is the only site that lies within Reach 1 of the greater tributary system (Upper Cottle Creek) and is located just upstream of Landalt road (Figure 1). The sample was taken in a small ravine as seen in Figure 3 with the location having minimal gradient and low water levels on both events, only revealing small riffles. Located just upstream of Site 1 was a large sieve/strainer for large woody debris to protect the entrance of the culvert. At the time of both our samplings it appeared that the sieve had not been cleaned out in a long time.

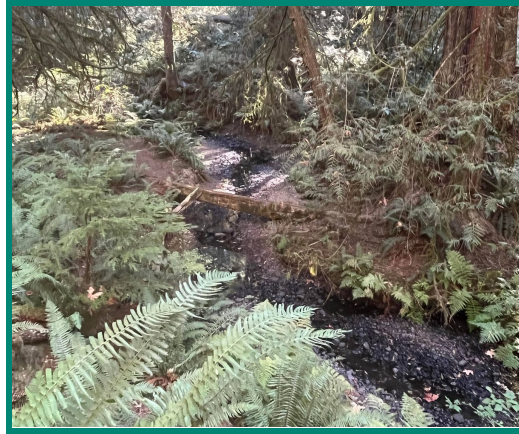
Figure 5. Photo of the Site 2 location downstream of the beaver dam

The second sampling location, titled Site 2, is located just downstream of Cottle lake (Figure 7). This site lies within the upper part of Reach 3 (Lower Cottle Creek) as part of the larger Cottle Creek watershed (Figure 1). The sample was taken in a small windy gorge with a minor gradient allowing for small riffles to occur. At both sampling events there were multiple beaver dams causing problems with good waterflow, however this did not inhibit our ability to sample from the site (Figure 6).

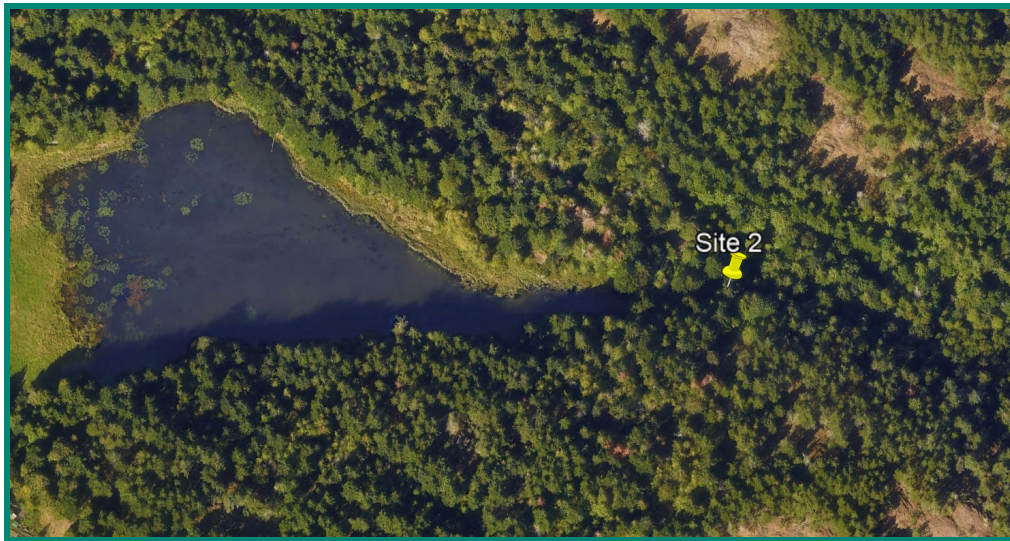
Figure 7. Satellite map showing the area surrounding sampling location Site 2.

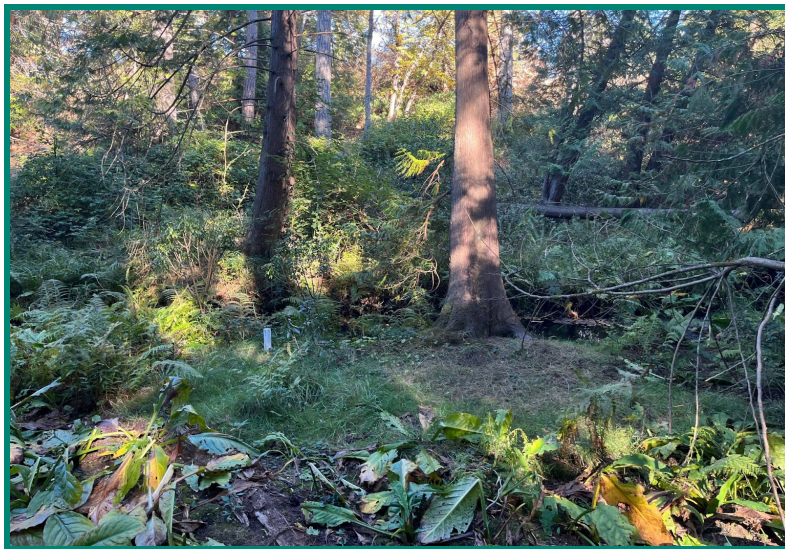
Figure 8. Photo of the Site 3 location as part of the larger Cottle Creek watershed.

Departure Bay (Figure 1). The sample was in a slightly wetter area with skunk cabbage growing in the vicinity; the gradient was minimal with small riffles forming.

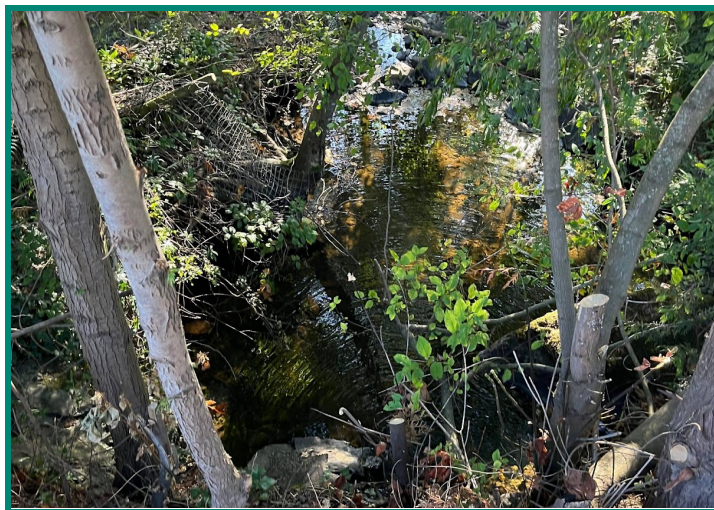
Figure 10. Photo of the Site 4 location as part of the larger Cottle Creek watershed.

(Lower Cottle Creek) just before the stream exits into Departure Bay (Figure 1). It was easily accessible from the pavement as the site sits below a large culvert that empties the stream into a large pool (Figure 10). This pool then meanders its way towards very steep, rocky terrain that acts as a barrier to anadromous fish.

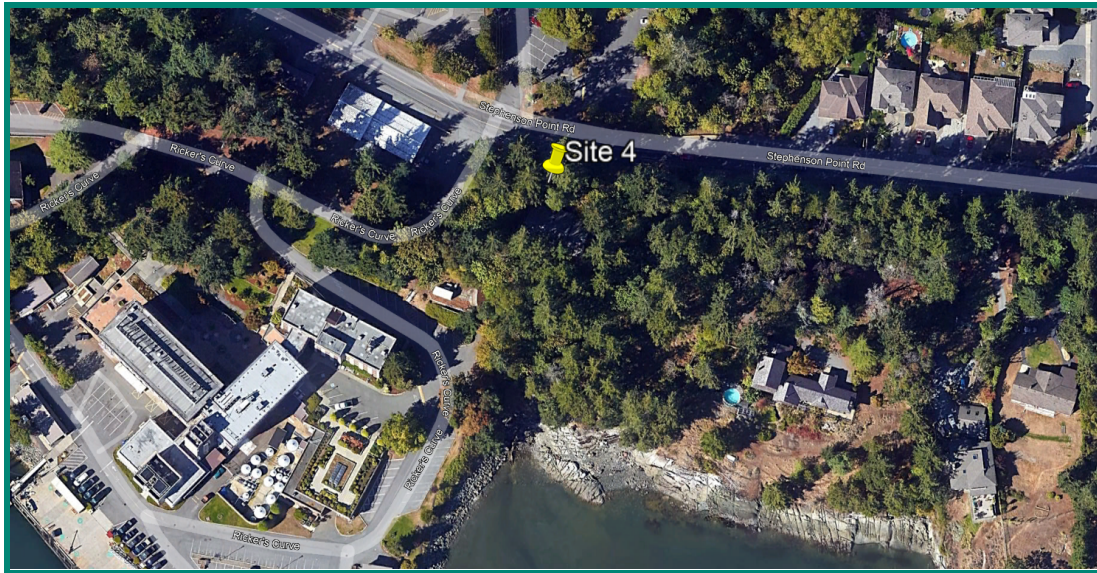
Figure 11. Map showing the area surrounding sampling location Site 4.

The fourth sampling location, titled Site 4, crosses Stephenson Point Road just where Ricker's Curve and Stephenson Point Road meet (Figure 11). This site lies at the tail end of Reach 3

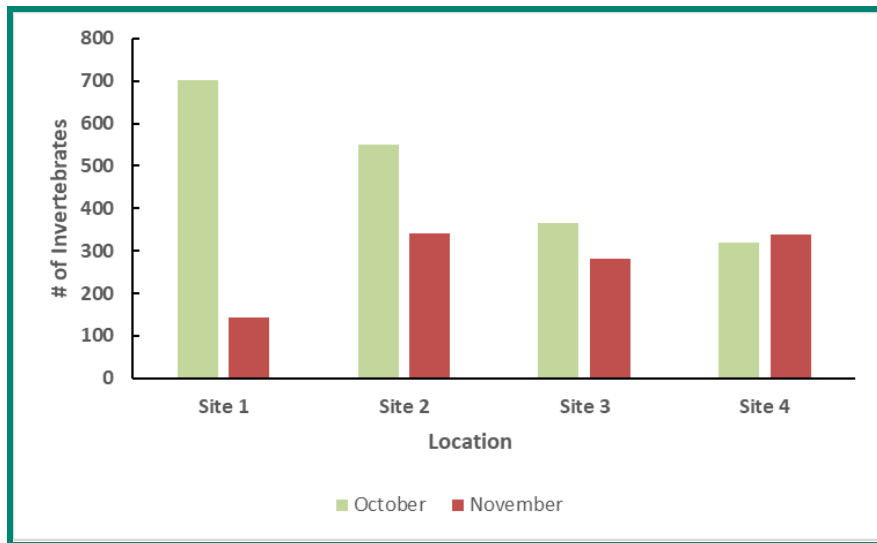
Over the four sample locations and two sampling events, 3040 invertebrates were sampled. Site 1 had the highest single count with 703 invertebrates during the October sampling event and subsequently had the lowest total count of the study in November with 142 total invertebrates (Figure 12). Site 2 saw total counts decrease from 549 in October to 342 in November. Site 3 had 365 invertebrates in October, which decreased to 281 in November. Lastly, Site 4 had a total of 320 invertebrates in October, which increased to 338 sampled invertebrates in November (Figure 12). After calculating the Shannon-Wiener species diversity indexes for all the site samples (appendix 10.2), site 1 had an index of 1.96 in October and 2.04 in November. Site 2 had an index of 1.99 in October and 1.36 in November. Site 3 had an index of 1.81 and 1.65 in November. Site 4 had an index of 1.91 in October and 1.90 in November (Figure 14).

Figure 12. Comparison of total stream invertebrates counted across the four sample locations on Cottle Creek in October and November.

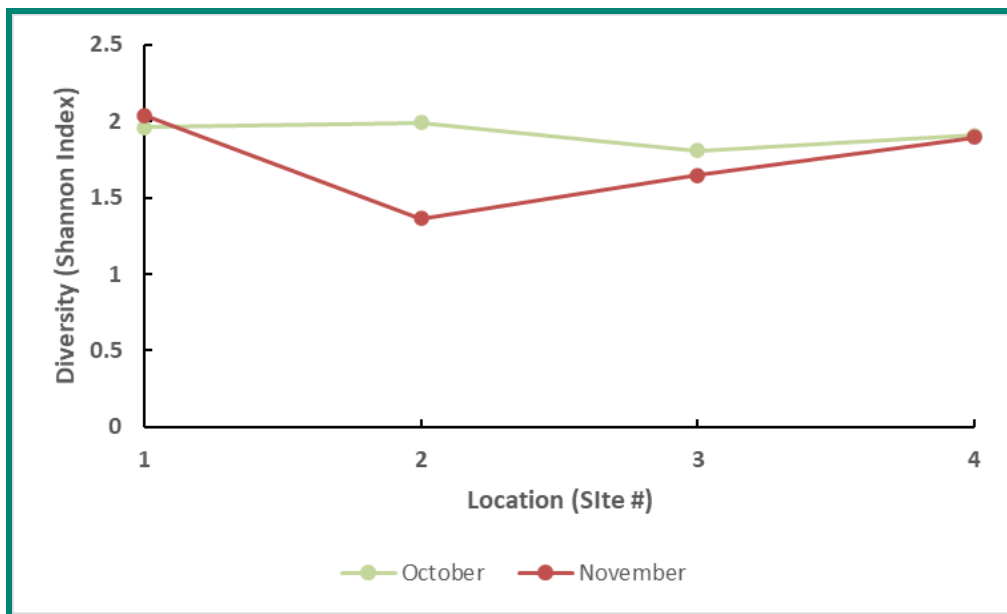
Figure 13. Seasonal change in diversity of stream invertebrates in Cottle Creek across four sampling locations.

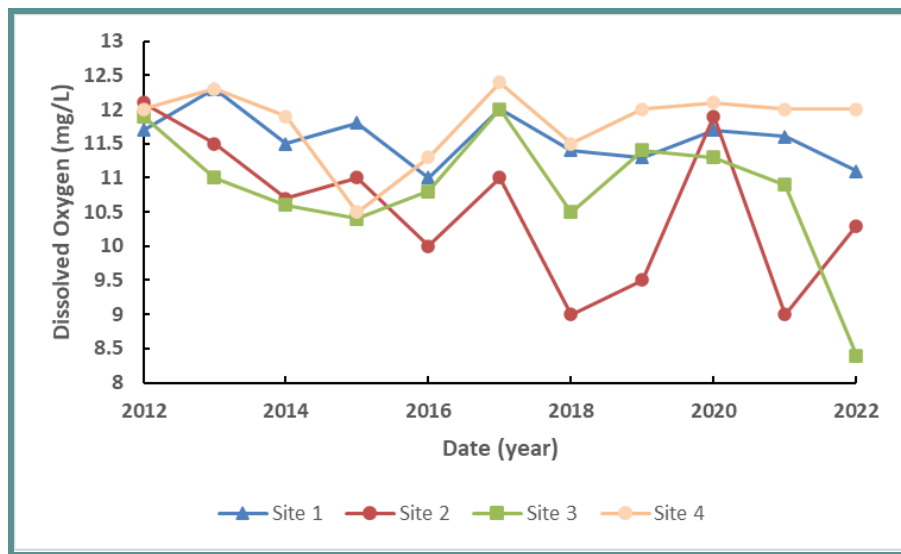
(Table 4). The cause for this decrease is hard to pinpoint as the temperature was not drastically different than any of the locations and may be caused by a variety of reasons. When we look at DO in the context of yearly averages, we can see that DO is highly variable on Cottle Creek with there being no correlation or pattern to results (Figure 16). Site 2 has had the greatest variability in terms of changes seasonally ranging from 9-12 mg/L, while Site 3 remained fairly consistent until this year where we see a large decrease in seasonal averages due to the October sample (Table 4, Figure 16).

Figure 16. Temporal comparison of averaged dissolved oxygen concentrations (mg/L) at each site from 2012 to present.

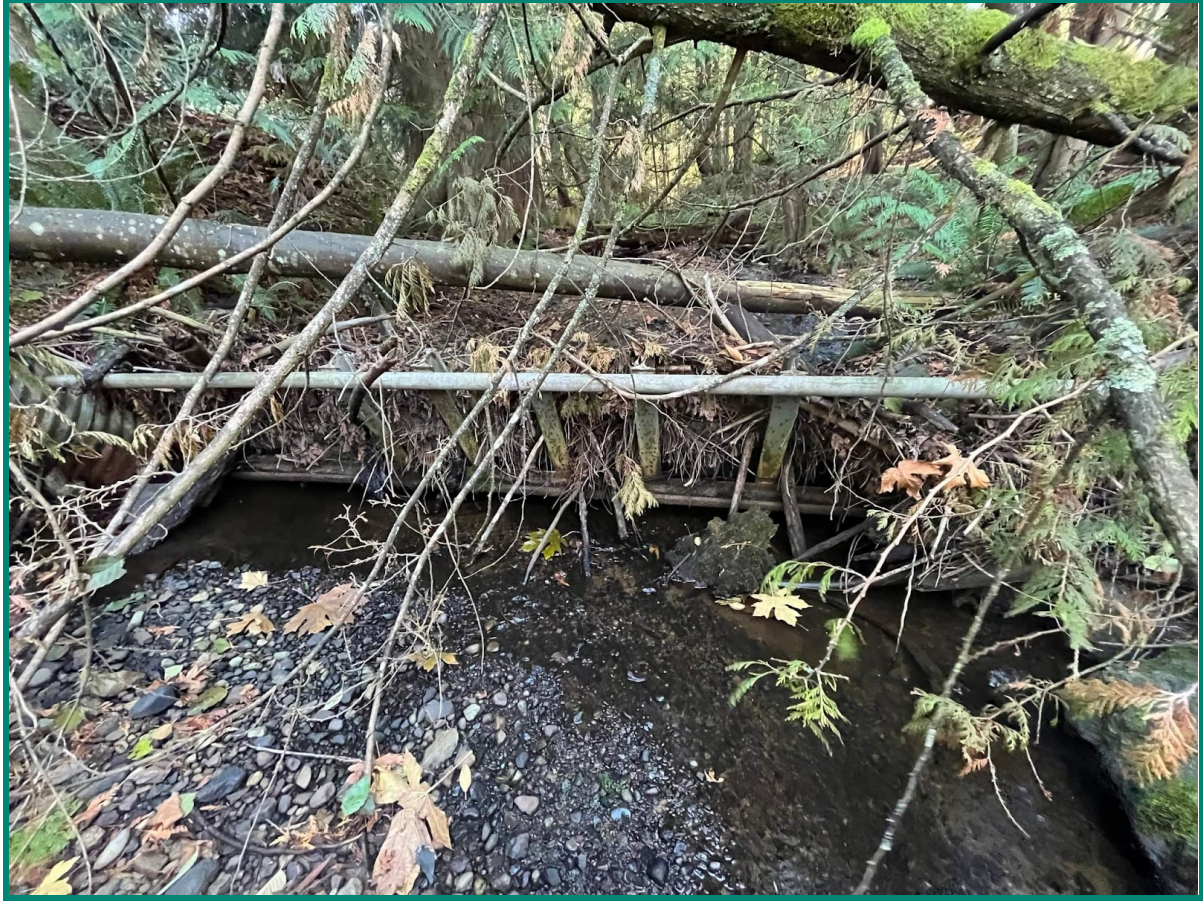
A secondary recommendation is that the culvert sieve at Site 1 be cleared. This sieve – which is illustrated in the figure below – is blocked with what appears to be years if not decades of woody debris. While this built up debris persists in the stream it acts as a barrier to fish passage which in turn could limit the dispersal and sustenance of healthy fish populations.

Figure 18. Woody debris culvert sieve acting as a fish passage barrier at Site 1.

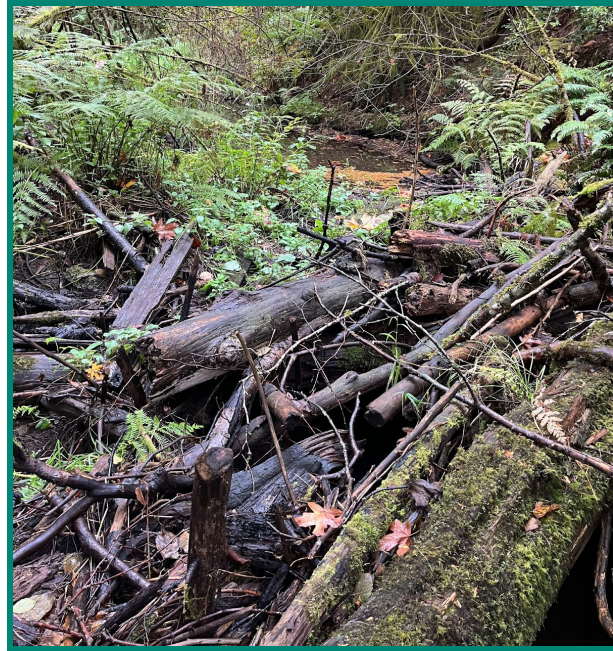
Figure 19. Woody Dam located upstream of Site 2.

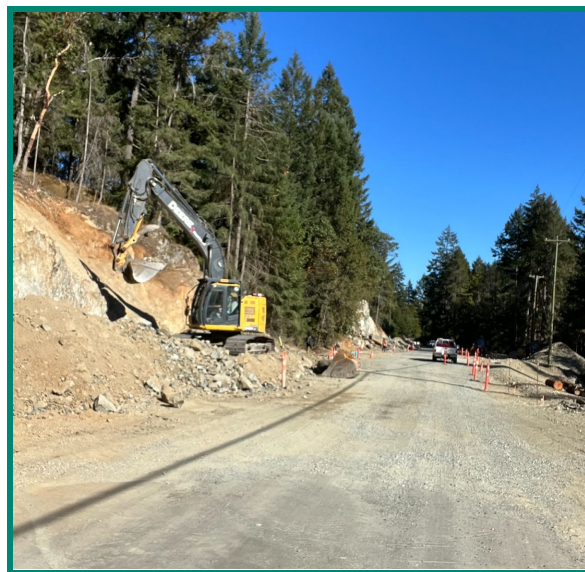
Figure 20. Road Work on Rock City Road, October 12, 2022.

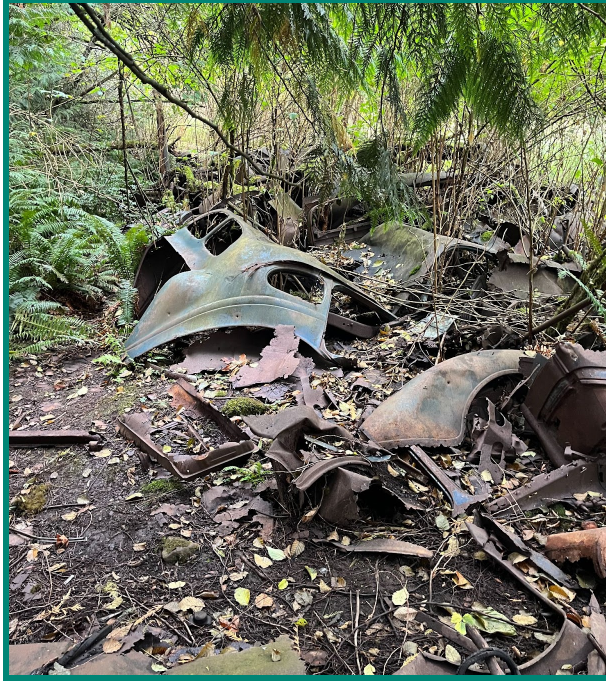
Figure 29. Image of old vehicles upstream of Site 2 (October 26, 2022).

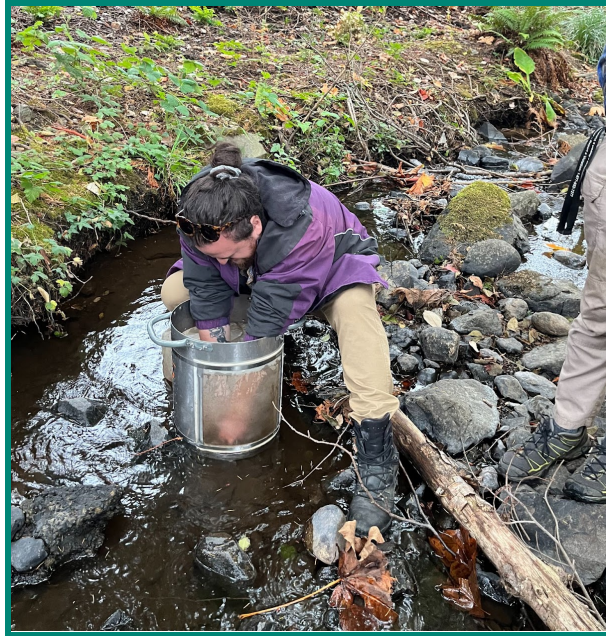
Figure 30. Image of Hess sampling Site 4 (October 26, 2022).

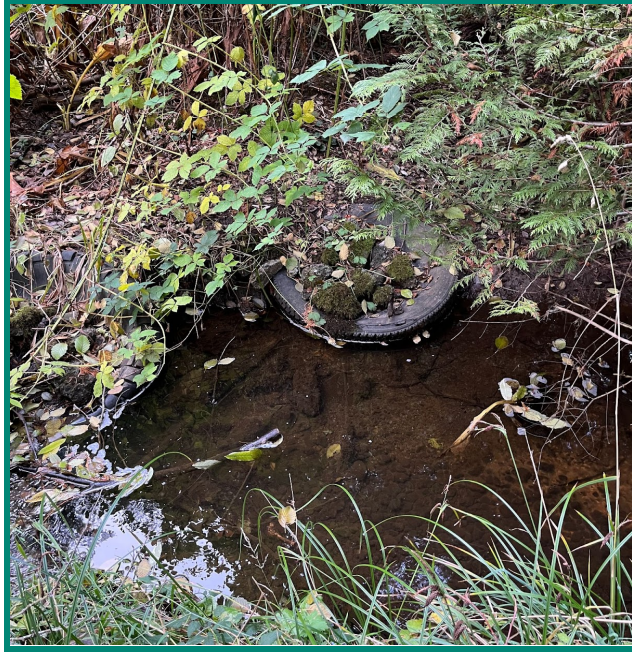
Figure 31. Image of tires in Cottle Creek downstream of Site 3 (October 26, 2022).
