# Water Quality Analysis and Invertebrate Inventory for Departure Creek, Nanaimo BC (Fall 2016)

RMOT 306 - Environmental Monitoring

December 16, 2016

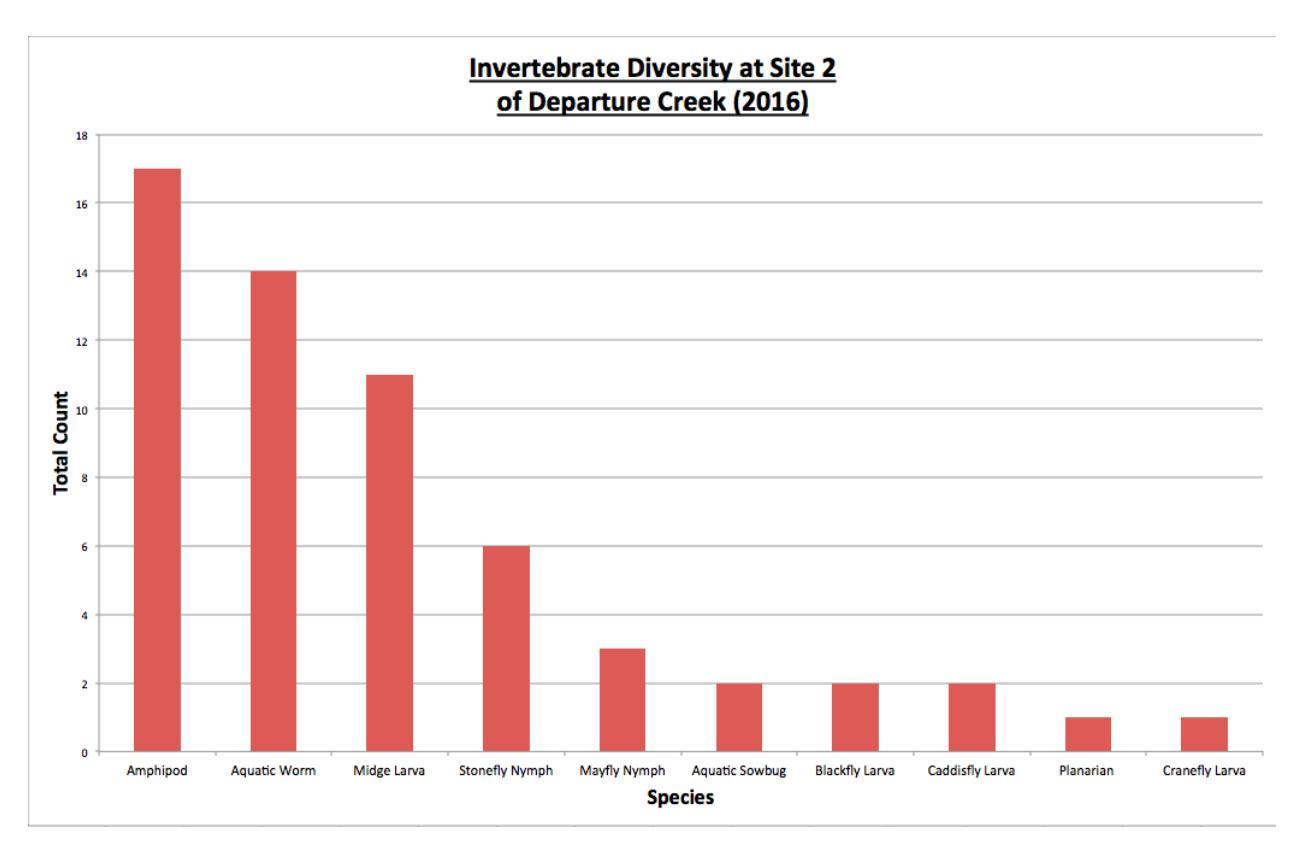
Figure 1. Graph Demonstrating Invertebrate Diversity at Site 2 of Departure Creek

Invertebrate data was collected and examined using the Pacific Streamkeepers guidelines created by the Department of Fisheries and Oceans. The invertebrates were first counted and sorted into categories according to the level of pollution tolerance to estimate the health of the creek (Figure 1). In order to establish the EPT Index, insects within the Ephemeroptera (Mayflies), Plecoptera (Stoneflies), and Trichoptera (Caddisflies) were counted, as the members within these Orders all require clean water. The results of entering the species into the appropriate sections (Figures 14 and 15 in Appendix) showed that the presence of particular invertebrates indicated that Departure Creek has good pollution tolerance level and an acceptable EPT index. The EPT total ratio index is rated as poor due to the small amount of different taxons found; however, there is a good predominant taxon ratio due to the abundance of Amphipods. Departure Creek was given an overall rating of 3 and deemed acceptable for invertebrate life. In order to accurately calculate the species diversity of Departure Creek, the Shannon-Weiner Diversity Index was used. The calculations shown in Table 6 enabled the use of the Shannon-Weiner Diversity Index Formula,  $\{H = -(-1.8788)/\ln(10), H = 0.8150, H = 0.82, H = 82\%\}$  and outline how the creek received an overall species diversity rating of 82%.

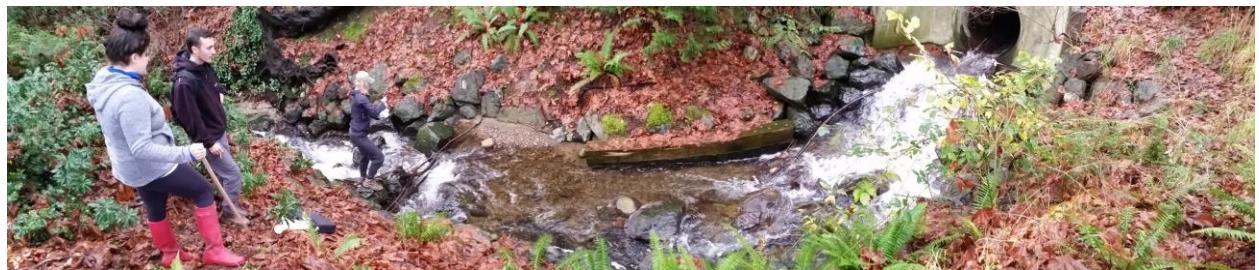
Figure 3. - Site 1 Panorama

The first site, "Site 1", was located at the intersection of Neyland Road at UTM coordinate 10U 0429312 5450829 (see Figure 3 in Appendix). The access to this site was a steep slope beside the downstream end of the Neyland Road culvert. This site was close to the road and simple to access. The site conditions consisted of a slope of 5%, a riparian area featuring 1.5m of stacked boulders lining the bank (man-made) and some overhanging shrubs. The substrate composition was predominantly gravelled, and the creek depth was low with a fast rate of flow. The only safety concern at this site was unstable footing. The surrounding land use was residential. Environmental issues noted at Site 1 included a large road culvert that greatly accelerated flow, causing a fast cascade of water. This may have caused increased erosion immediately downstream of the culvert.

Residence #3038 had PVC pipe extending from their property into the riparian area downstream of Site 1, demonstrating the extent of urban runoff into this creek. Site 1 was also laden with invasive plant species of Daphne (*Daphne laureola*), English Ivy (*Hedera helix*) and Holly (Aquifoliaceae) (E-flora BC 2013). Additionally, there was a storm drain entering the culvert from Neyland Road which could deposit road debris and other sediment. The measurements of Site 1-4 are recorded in Table 1.

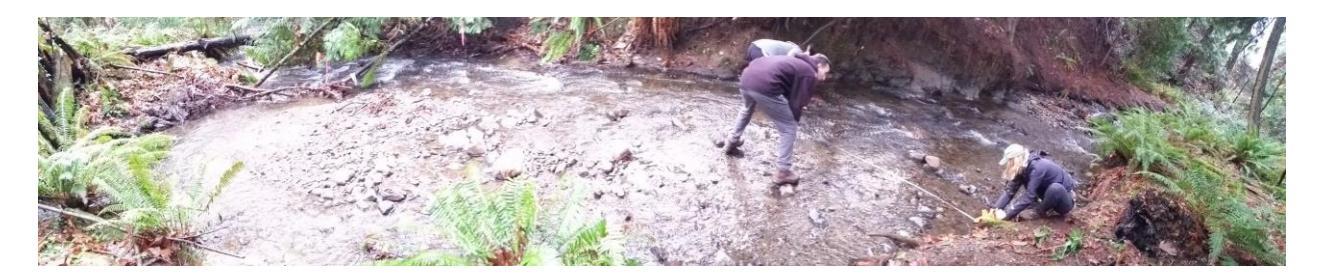
Figure 4. - Site 2 Panorama

"Site 2" on Departure Creek was located downstream of the crossing of Newton Street at UTM coordinate 10U 0428857 5450901 (see Figure 4 in the Appendix). The access to this site was down a steep bank off Newton Street, approximately 50m downstream of the road culvert. The conditions at Site 2 included a slope of 6% and a riparian area consisting of overhanging Sword Ferns (*Polystichum munitum*), Big Leaf Maple (*Acer macrophyllum*), Yellow Cedar (*Cupressus nootkatensis*), and undercut banks. The creek bottom composition was mainly gravel and cobble. Joseph Creek entered Departure Creek at this site, causing a small tributary. The only safety concern at Site 2 was the steep bank used for access. There was an appropriate site for sampling both water quality and aquatic invertebrates upstream from the Joseph Creek confluence. The surrounding land use was residential. Environmental issues discovered included the presence of an illegal urban dumpsite at roadside and invasive species including Daphne, English Ivy, and Yellow Archangel (*Lamium galeobdolon*) in the riparian area. There was also evidence of soil erosion in the riparian area, as indicated in Table 1.

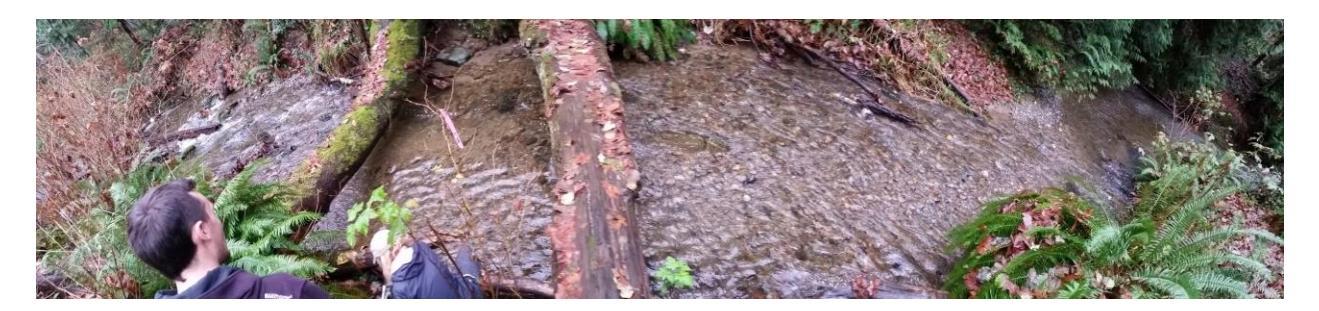
Figure 5. - Site 3 Panorama

"Site 3" on Departure Creek was located in Woodstream Park off of Bay Street at UTM coordinate 10U 0428392 5451129 (see Figure 5 in Appendix). This site was approximately 150m

off of Bay Street, in a large gully accessed through a public-access park trail. The stream runs adjacent to this footpath. Site conditions observed were a slope of 5%, and riparian area including in-stream cover with large woody debris and a deep pool. The substrate composition consisted of fines, gravel, cobble and boulders. The water was fast flowing and shallow. A slippery bank at the sample site was noted to be a potential hazard, as well as signs of recent fallen branches which could be dangerous in high winds. There was an appropriate site for water quality beside a pair of large logs crossing the creek. The land use at Site 3 was a municipal park, immediately backing onto residences. Environmental issues identified included the presence of invasive species of Daphne and English Ivy and Holly. There was also a very popular public trail running parallel to the creek which could contribute to erosion. The site measurements are indicated on Table 1.

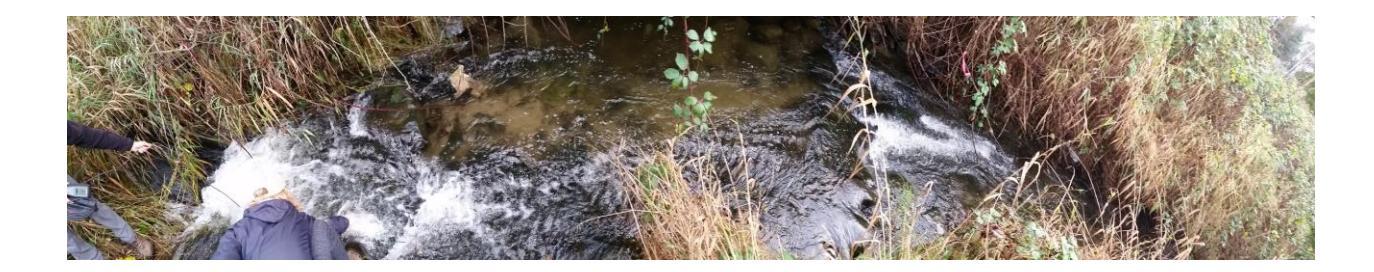
Figure 6. - Site 4 Panorama

"Site 4" on Departure Creek, the final site, was located near the intersection of Bay Street and Departure Bay Road at the downstream end of the Bay Street culvert at UTM 10U 0428075 5451095 (see Figure 6 in Appendix). This site was selected to avoid the tidal zone that introduces salt water into the Departure Bay Road culvert. Site conditions included a 10% slope and riparian zone with bankside shrub cover. The creek bottom composition at Site 4 included fines and boulders. The creek was fast flowing, likely due to the slope, and cascaded over boulders. Again, slippery conditions were a working hazard. There was an appropriate site to sample water quality 5m downstream of the Bay Street culvert. The surrounding land use was both commercial and residential; however, a key environmental concern at Site 4 was the presence of invasive plant species. The site was shrouded by Himalayan Blackberry (*Rubus armeniacus*) and also contains Yellow Flag Iris (*Iris pseudacorus*), and Morning Glory (*Convolvulus arvensis*) (E-Flora BC 2013). Measurements are displayed on Table 1. This site

was characterized by a limited area for vegetation as large portions of the area were characterized by concrete, culvert, grates, bridges, sidewalks and buildings. It is also adjacent to a gas station.

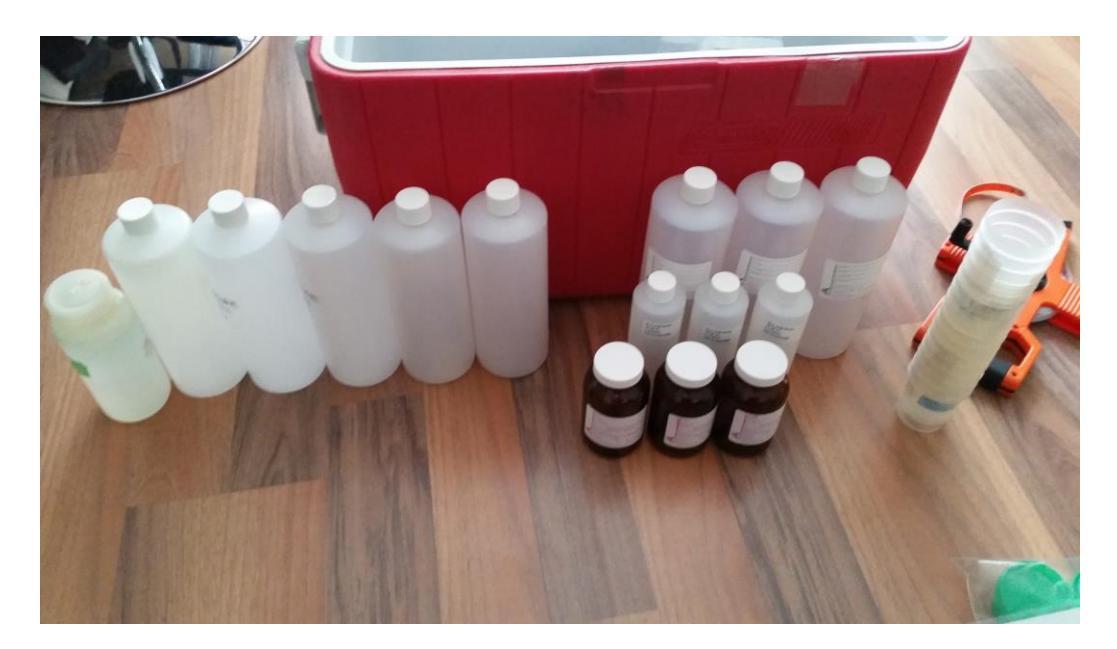
Figure 7. - Sampling Kit

A collection of nine samples, three from Sites 1, 3, and 4, were sent to ALS Labs in Burnaby, BC for analysis. These samples were collected in pre-rinsed and pre-labeled containers for quality assurance (Figure 7 in the Appendix). A 1 litre white plastic bottle obtained from ALS Labs was filled to the shoulder at Sites 1, 3, and 4, with no preservatives added. This sample was sent to test the general water parameters. A 250 ml white plastic bottle obtained from ALS Labs was filled to the shoulder at Sites 1, 3, and 4, and premeasured Nitric Acid (HNO<sub>3</sub>) was added as a preservative. This sample was sent to test for the total metals in the water. A 250 ml amber glass bottle obtained from ALS Labs was filled to the shoulder at Sites 1, 3, and 4, and premeasured Sulphuric Acid (H<sub>2</sub>SO<sub>4</sub>) was added as a preservative. This sample was sent to test for the available nutrient levels. The results of these analyses were compared against the BC Ministry of Environment guidelines for interpreting water quality data.

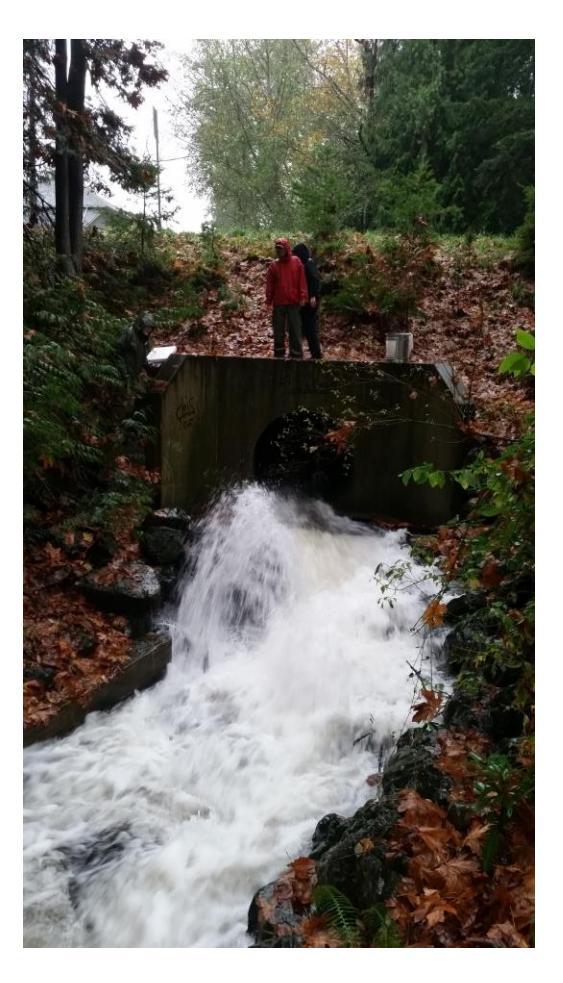
Figure 9. Site 1 Rain Event

The first sampling series took place during a higher than average rainfall event and caused some abnormal fluctuations to the sampling data (Figure 9 in Appendix). There were increased levels of turbidity and soil disruption from the high flow rate. Increased water disturbance was causing additional oxygen to be input into the system. In addition, the increased flow permitted ions to be flushed out of the system, which caused a significant drop in conductivity. Finally, the temperature remained relatively stable during both events.

It was found that there was a significant decrease in water quality during high flow events. This is most noticeable at culverts within the stream system, as noted at Site 1, where a rain event caused acceleration of water flow. A direct correlation could be drawn between increased stream system discharge and an increase in acidification, higher turbidity, and high levels of coliforms within the creek. The phosphorous level was also considered to be eutrophic by the ALS lab (>0.025 mg/L) during the rainfall event.

The final recommendations are to disrupt the heavy flow at locations where culverts enter the creek. This could be made possible by the installation of permanent large woody debris or other structures. The removal of invasive species in the riparian areas and the subsequent planting of native species could improve the areas surrounding the creek as a wildlife corridor. The dumping of garden waste could be monitored and fined by local enforcement agencies to increase the suitability of the area as habitat for local species and to slow the spread of invasive and exotic plants. Further work could be done to determine whether high phosphate and nitrate counts are the direct result of fertilizers from the Nanaimo Golf Club. Any residences with septic tanks in the area could be flagged as possible sources of phosphate and nitrate as well.

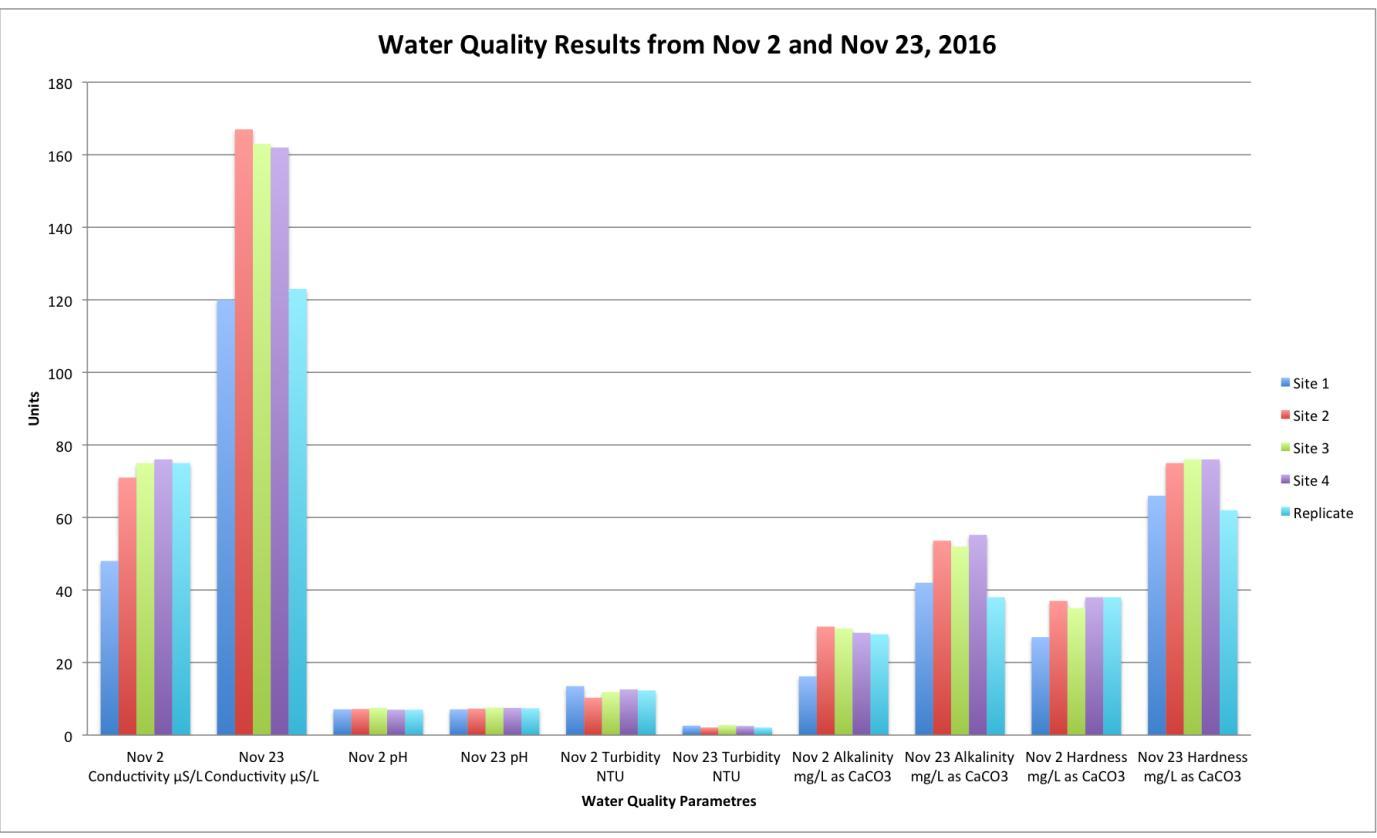
Figure 12. VIU Laboratory Analysis November 2, 2016 vs. November 23, 2016

Unlike the ALS Laboratory results which generally decreased from the first sampling event to second event, the data collected in the Vancouver Island University generally increased between the first and second sampling event. This is because many of the parameters tested for in the Vancouver Island University lab relate closely to the increased calcium levels in the ALS results between the first and second sampling events that increased Departure Creek's ability to neutralize acid in the watercourse. These parameters include: conductivity, alkalinity, and hardness and these three parameters increased along with Calcium. All are known to reduce acidity and it is believed that the increase in calcium is directly related to the increase in the other three parameters. The pH of the system, however, was similar for both sampling events. The turbidity decreased during the second sampling event, which was a result of the heavy rain and flashy, increased flow that was present during the first sampling event. The high rate of flow caused particles in the stream to become stirred up and mobile; this, along with runoff from the vicinity, resulted in a higher level of turbidity. The nitrate and phosphate were compared separately as they were observed to have much lower levels, between 0.04 mg/L and 1.16 mg/L. Phosphate levels decreased between the first and second sampling events across all four sites, directly comparable to the phosphorus levels detected by the ALS sampling. The phosphate levels are connected to the runoff from the rain event and likely came from fertilizers, detergents, and sewage. Nitrate levels decreased at Site 1 and Site 2 between the first and second sampling event following the pattern of the phosphate levels. At Site 3 and Site 4 however, the nitrate levels increased between the first and second sampling events. Reasons for this could be varied: it is possible that nitrate levels were higher at Site 3 and Site 4 because they are further downstream and more nitrate had built up in the water system as it culminates downstream. However, this was not the case for the other parameters so it is more unlikely. It is more likely that there is an influx or source of nitrates closer to sites 3 and 4 that are causing the nitrate to build up when the velocity is lowered. Nitrates come from untreated sewage and are often found in fertilizers. Site 3 is a known spawning location for Pink Salmon (Oncorhynchus gorbuscha) and coho salmon (Oncorhynchus kisutch), as well as a location of dog and black-tailed deer (Odocoileus hemionus) activity, which could increase fecal and urine counts in the water. Site 3 is also the closest site to the Nanaimo Golf Club, which has the potential to leach nitrogen rich fertilizers into the stream. Results of the laboratory analysis completed at Vancouver Island University can be viewed in Figure 12 and Figure 13 located in the Appendix.
