Holland Creek Environmental Monitoring

Water Quality and Invertebrate Population Assessment

December 2012

RMOT 306

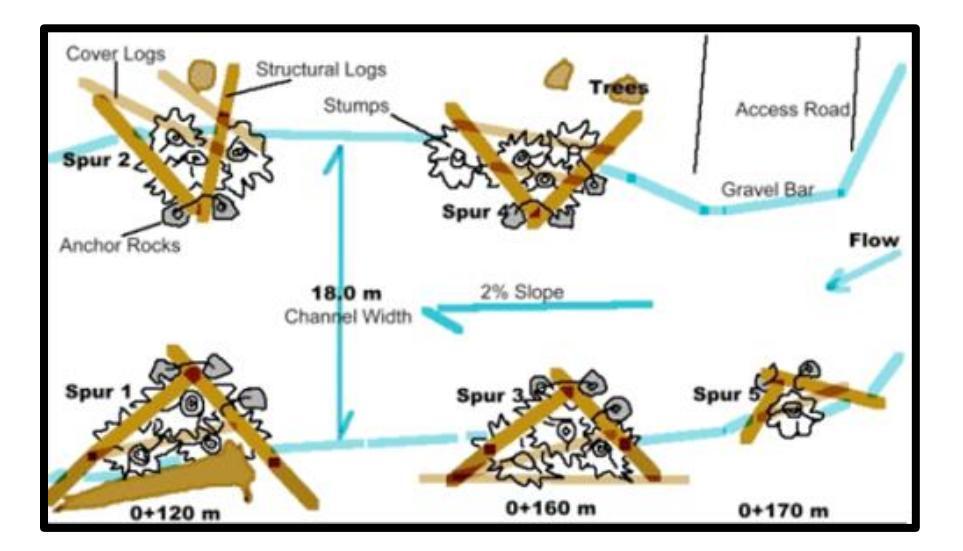
Figure 1. Example of log spur placement used by Dave Clough Consulting to increase fish cover and alter channel bed. (Coastal BC,2004)

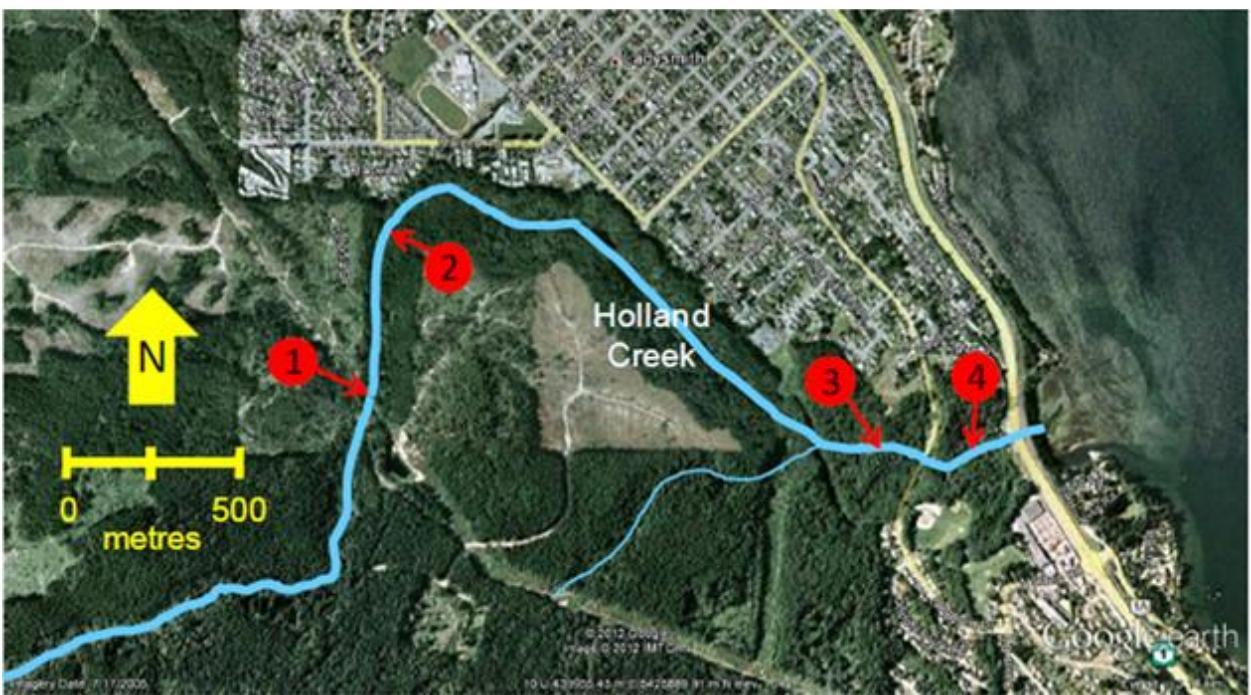
(Figure 3) Approximate location of the sampling stations used for water quality and stream invertebrate assessments on Holland Creek during October-November 2012

Station #	UTM Northing	UTM Easting	Distance (m) Ladysmith <u>Harbour</u>	General Location
1	5425763	439234	2,700	Wooden bridge, 600 m upstream of trail access at Mackie Road
2	5426167	439247	2,300	Between Lower and Upper Colliery Dams, 200 m upstream of trail access at Mackie Road
3	5425625	440718	450	100 m upstream of the Dogwood Drive crossing
4	5425635	440948	210	100 m downstream of the Dogwood Drive crossing

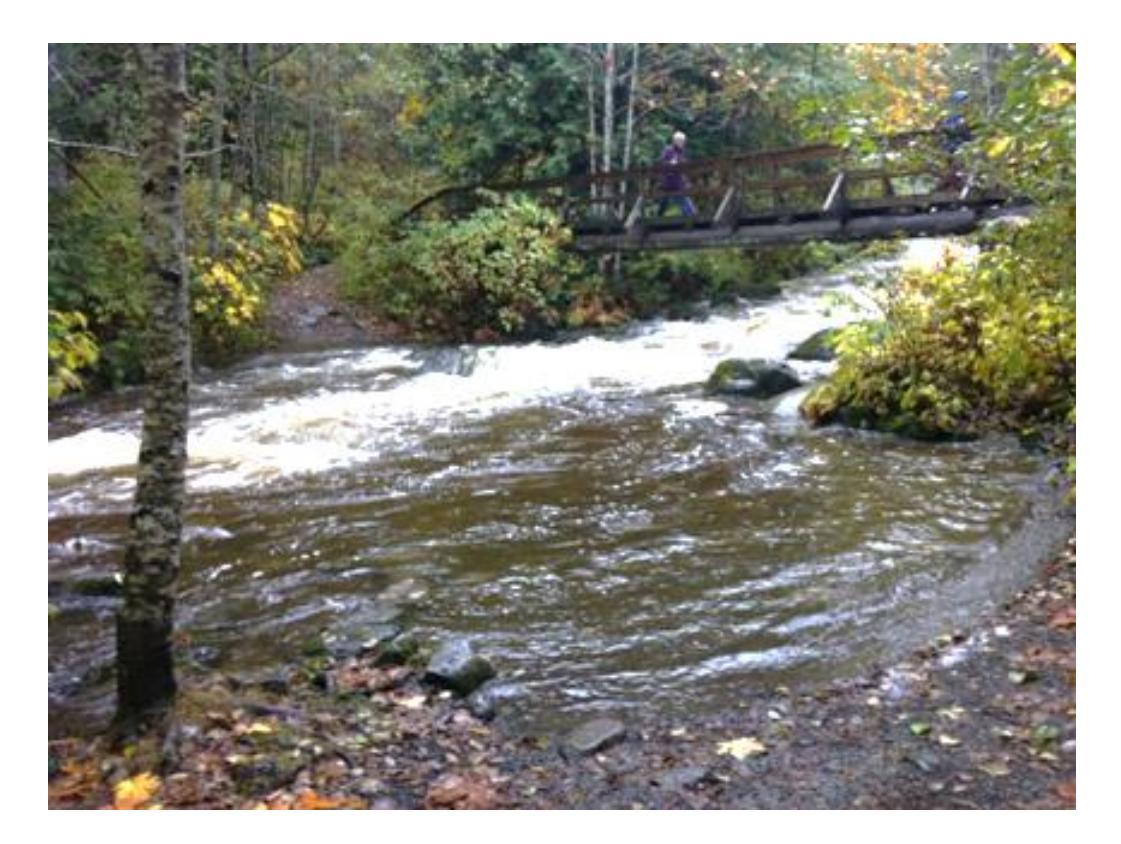
Sample site 1 was located 800m along the Holland Creek walking trail and is accessed from Mackie Road. Samples were collected beside the wooden foot bridge

crossing the creek. Large boulders are present at this site along with cobble-gravel substrates. Vegetation in the surrounding area is dense with both deciduous and non-deciduous tree species, mainly Red Cedar (*Thuja plicata*), Douglas Fir (*Pseudosuga menziesii*), Red Alder (*Alnus rubra*). The total canopy cover over the stream is approximately 35%. (Figure 4)

Figure 4. Sample site 1. Photo taken by Braeden Lattanzi

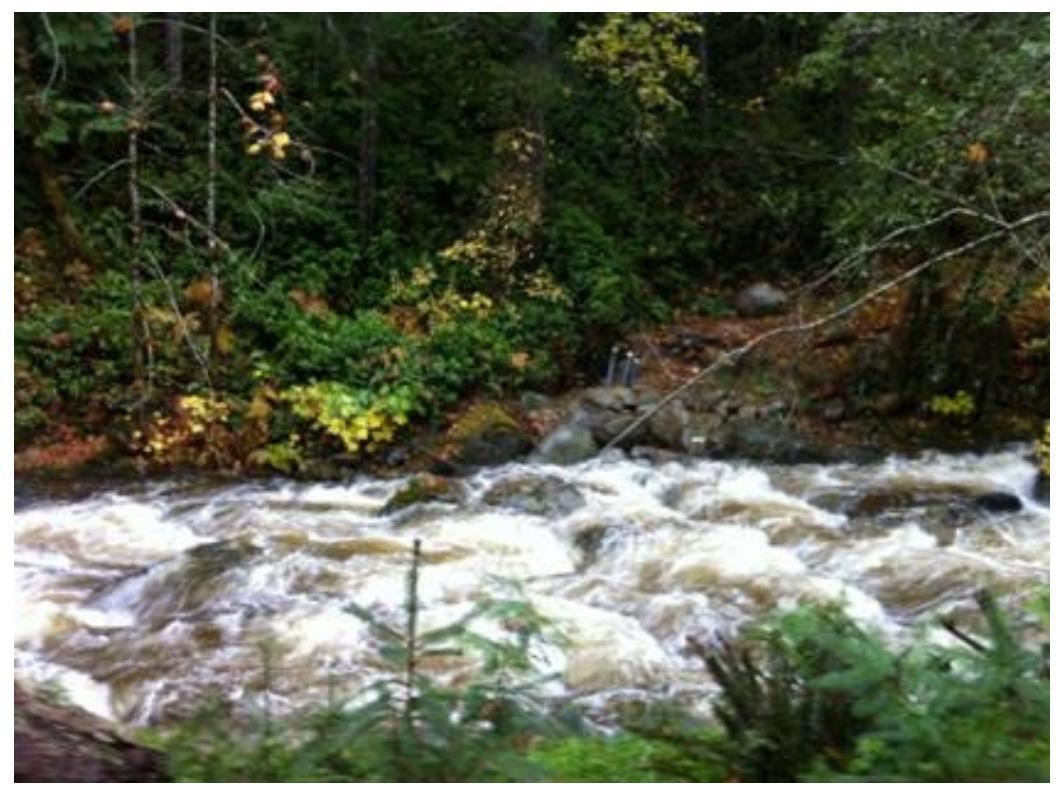
Sample site 2 was located 300m along the Holland Creek walking trail and is accessed from Mackie Road. Samples were collected in lower flow areas near the side of the stream. Recent landscaping by the city has added new fir trees to the bank, while large amounts of Salal, deciduous and non-deciduous trees are also scattered along the river. The canopy cover in this area is approximately 15%. Large boulders are present at this site along with cobble-gravel substrates (Figure 5).

Figure 5. Sample site 2. Photo taken by Braeden Lattanzi

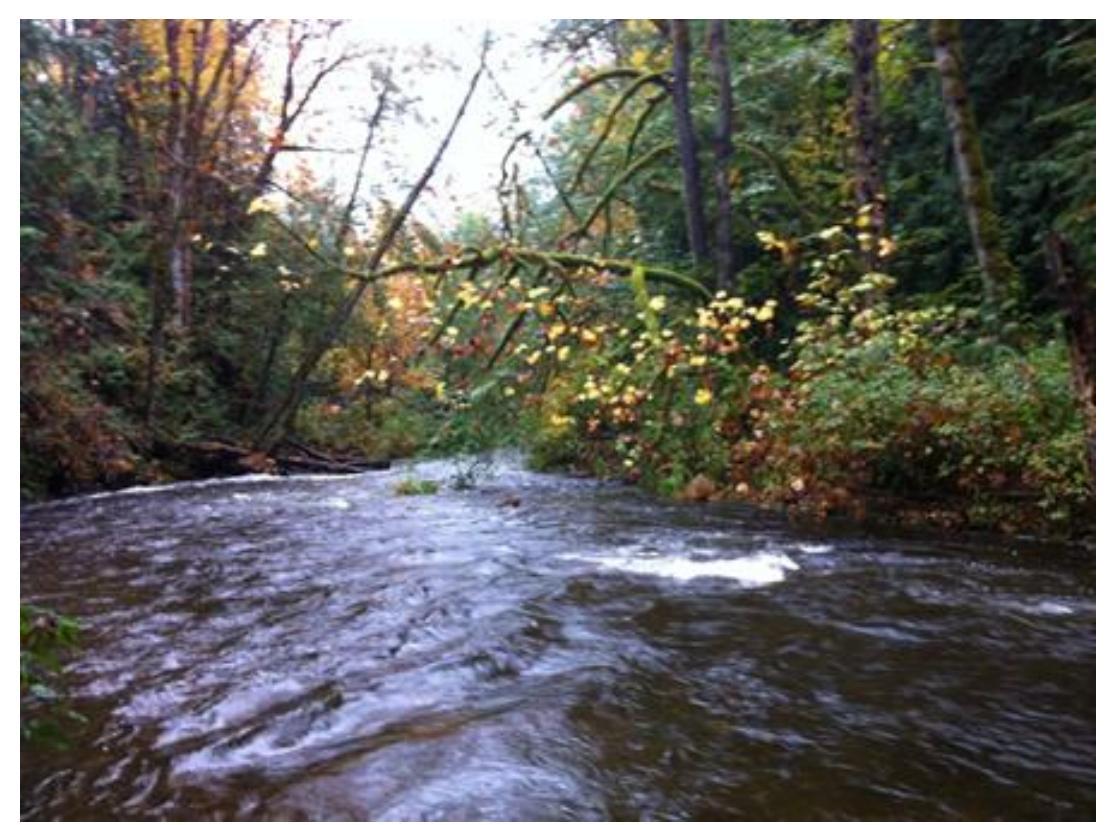
Sample site 3 is located approximately 100m upstream of the overpass and accessible from the parking lot on Dogwood Drive. Approximately 150m along the Holland Creek Lower Loop with large deciduous and non-deciduous growing throughout with approximately 45% canopy cover. There are no large boulders at this site but mostly cobble and small gravel substrates. This site looked to be the most productive area for Chum salmon spawning during water quality monitoring, likely due to its low gradient and optimal substrate size.

Figure 6. Sample site 3. Photo taken by Braeden Lattanzi

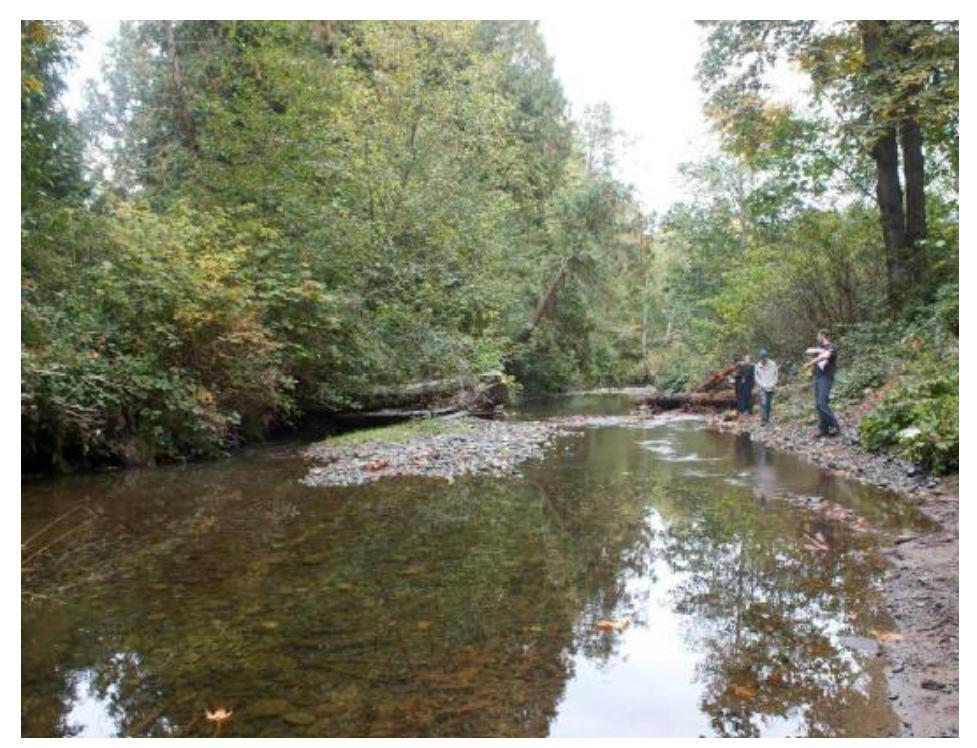
Site 4 is located 200m down the Holland Creek Lower Loop & accessed from the parking lot on Dogwood Drive, roughly 100m downstream of the overpass. Approximately 55% canopy with deciduous and non-deciduous cover the stream has deep undercut banks and large woody debris. This site has many burned in trails leading to the river and it looks like there is a lot of human traffic leading to the streams edge. This part of the creek has large boulders spread throughout the area but is mainly small gravel substrates (Figure 7).

Figure 7. Location of sample site 4. 2011. File corruption prevented use of 2012 photo. Taken by Stephanie Righi.

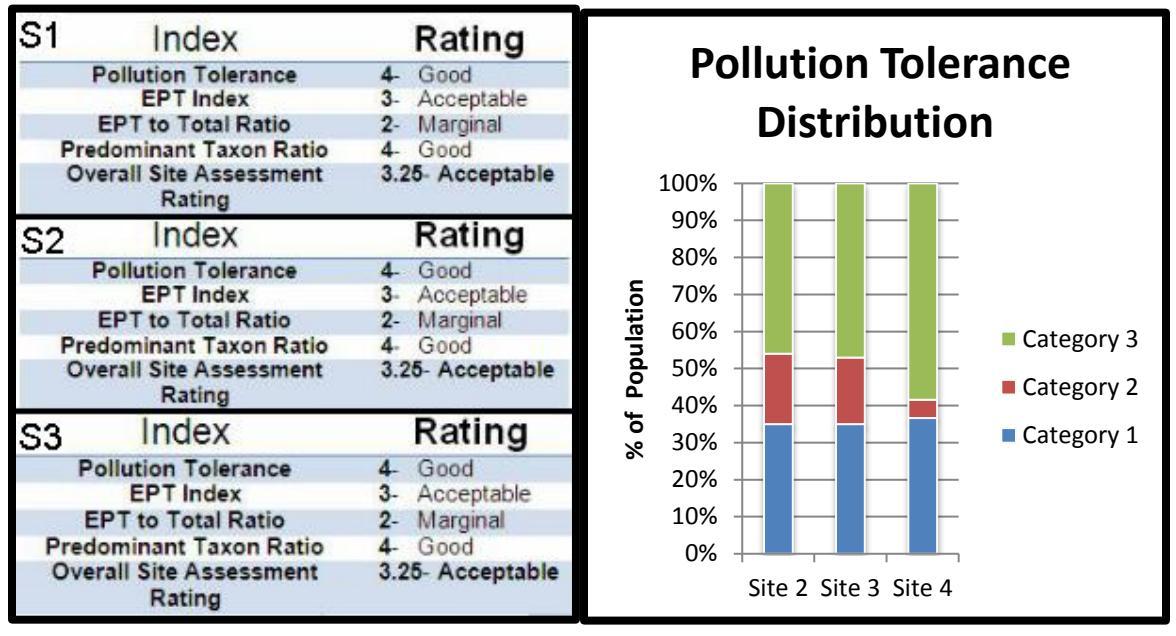
Table 6. EPT Index ratings

Figure 8. Pollution tolerance distribution

Total Population ratio, which was the lowest scoring quality during the site assessment, with a rating of 2 ("marginal")(Figure 8).

The overall site assessment for all 3 was found to be 3.25 (Table 6), with a rating of 4 being the maximum rating ("good") and 3 being "acceptable" using this system. The site assessment rating in 2012 was slightly lower than the previous, but had much less variability overall; in 2011 it ranged from 2.75-3.75 and averaged 3.375 (Demers et al, 2012), while in 2012 it was 3.25 at all sites monitored.
