# **Data Report**

# Water Quality and Stream Invertebrate Assessment for the

# Millstone River, Nanaimo, BC

(Fall 2012)

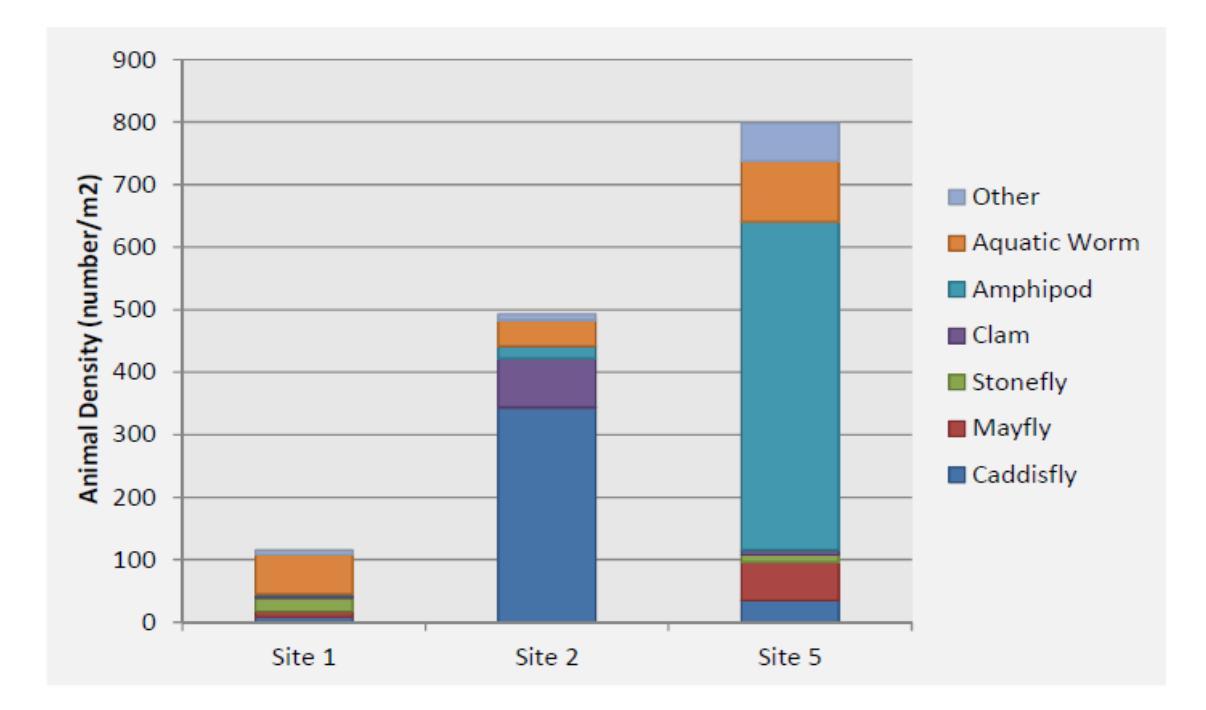
Figure 2: Invertebrate density obtained October 29, 2012 from Benson Cr and the Millstone River. The "other" category represents Damselfly, Water Penny, Dobsonfly, Gilled Snail, Alderfly Larva, Dragonfly Larva, Cranefly Larva, Blackfly Larva, Leeches, Midge Larva, Pouch and Pond Snails, True Bug Adult, and Water Mites. (Appendix 7)

In comparison to samples taken in 2011, the samples collected on October 29, 2012 demonstrated a significant increase in the total abundance of invertebrates collected at all three sites. The total abundance count for the nine samples collected in 2012 was 1,411, while the total for 2011 was 698. The 2012 number represents 19 taxonomic groups of invertebrates. This indicates a significant increase in diversity relative to 2011 when only 9 taxa were represented. The same trend in density in 2011 appears again in 2012. In both sample years, density increased from upstream to downstream. In 2012, site 5 had the highest density among the three sites at 2,967 invertebrates per square metre. The most prominent taxa represented in 2012 were aquatic worms (oligochaete), caddisfly larvae and amphipods, although the numbers of each taxon varied among the three collection sites. These results are similar to the 2011 results, though site 5 experienced a change in dominant taxa collected, from mayflies in 2011 to amphipods one year later (McNeill et al. 2012; Taccogna and Munro, 1995; Figure 2; Table 6; Appendix 7).

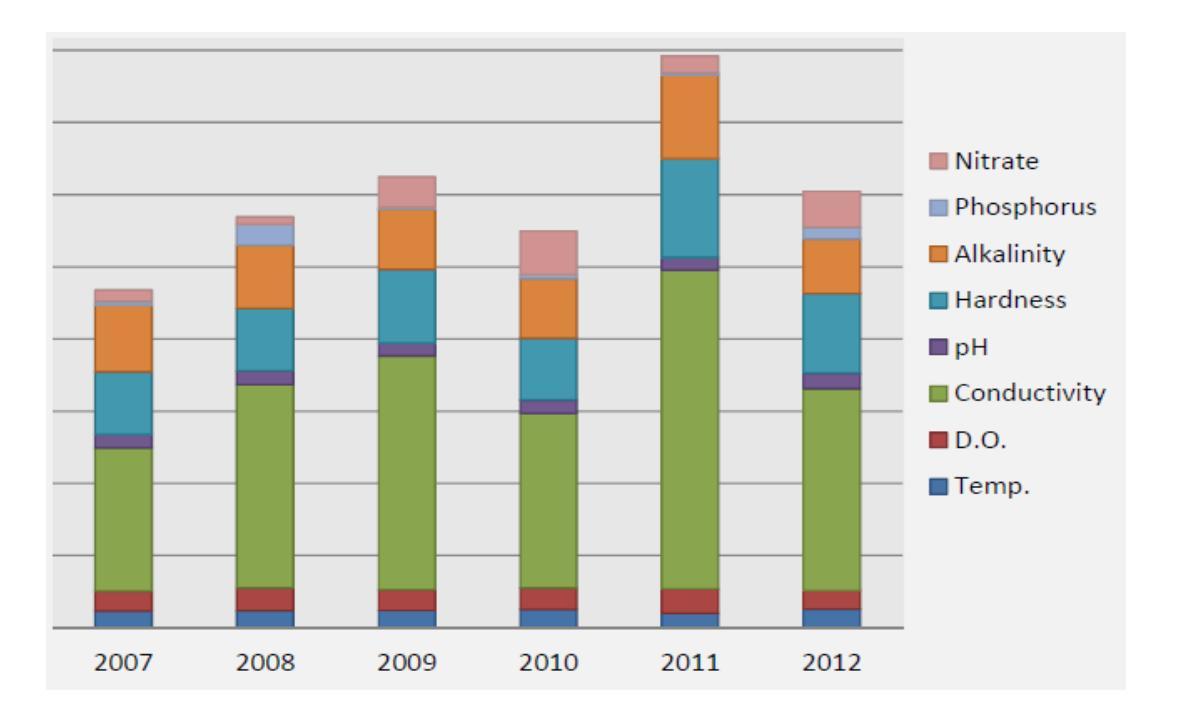
Figure 3: Millstone River water quality representation obtained by VIU 2007-2012 inclusive. (Brooks et al. 2009; Clark et al. 2011; Cox et al. 2008; Goeppel et al. 2010; McNeill et al. 2012)

According to the Pacific Streamkeepers' *Invertebrate Interpretation Sheet*, sites 1 and 2 had overall site assessment ratings of 3 which is within acceptable parameters. However, site 5 showed a decrease from acceptable in 2011 (3.25) to marginal in 2012 (2.5). The decrease in site 5 is due to a reduction in the EPT to Total Ratio Index. This indicates the possibility of the presence of (a) pollutant(s). There was an increase in the abundance of taxonomic groups; however, the decrease in the EPT to Total Ratio Index indicates the possibility of a negative trend becoming established, to the extent that there are more pollution-intolerant taxa than in 2011. This trend seems to be correlated with the increase in conductivity since 2011 (McNeill et al. 2012; Taccogna and Munro, 1995; Figure 3).

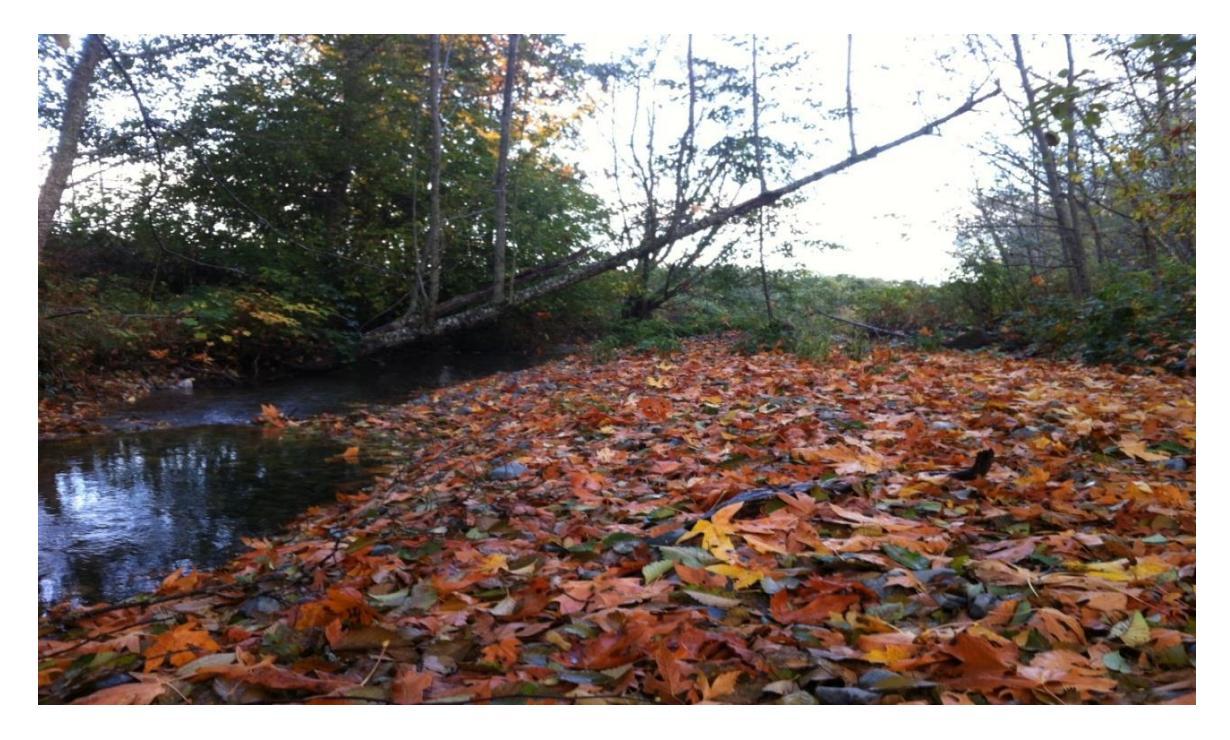
Photo 1 - Downstream view of Site 1 on Benson Creek near Biggs Rd on October 22, 2012.

Site 1 was located on Benson Creek at the Biggs Road Bridge, approximately 500 meters upstream from Brannen Lake. Sampling was done on the downstream side of the bridge, with trail access adjacent to the bridge on the east side. The site is a small, low gradient riffle with a relatively shallow pool directly upstream. The substrate composition was approximately 45% gravel, 45% cobble, and 10% fines. Fines in the stream are in isolated pockets of the riffle and don't deteriorate invertebrate habitat. Benson Creek is located in an agricultural/residential area so nutrient enrichment and coliform presence was a concern. Minimal hazards were encountered at this site with the exception of high water levels during the second sampling event (Figure 1; Table 1; Appendix 1).

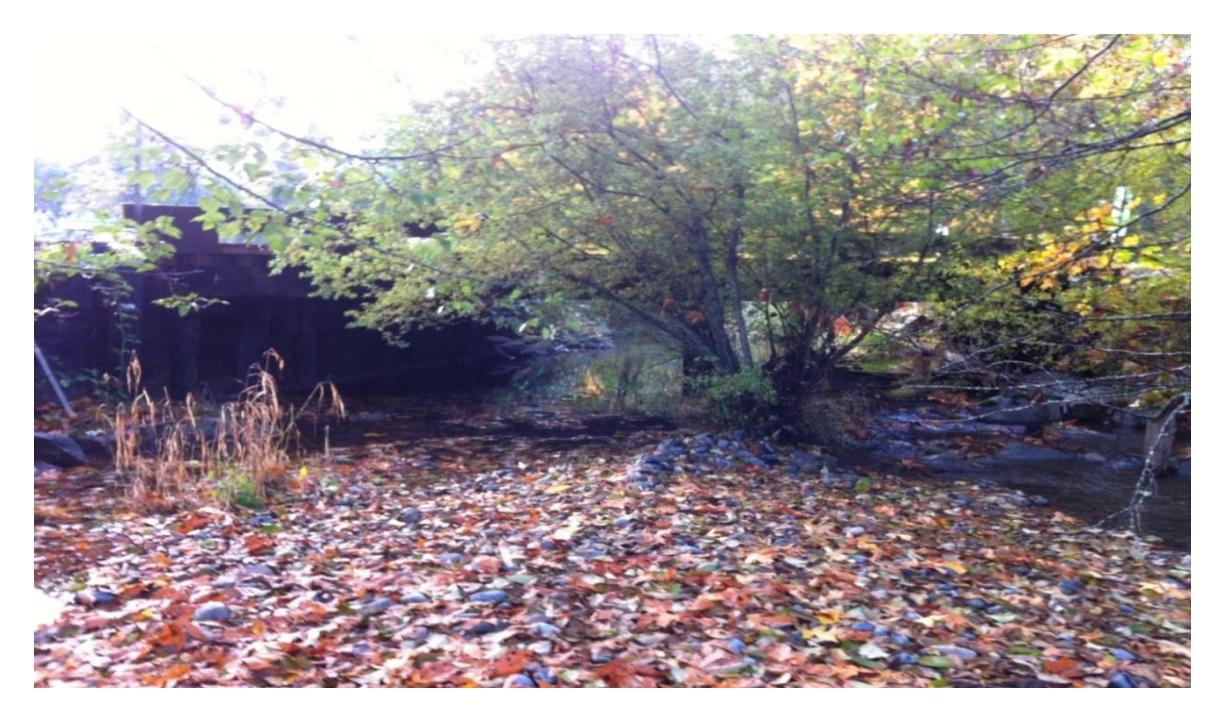
Photo 2 - Upstream view of Site 1 on Benson Creek near Biggs Rd on October 22, 2012.

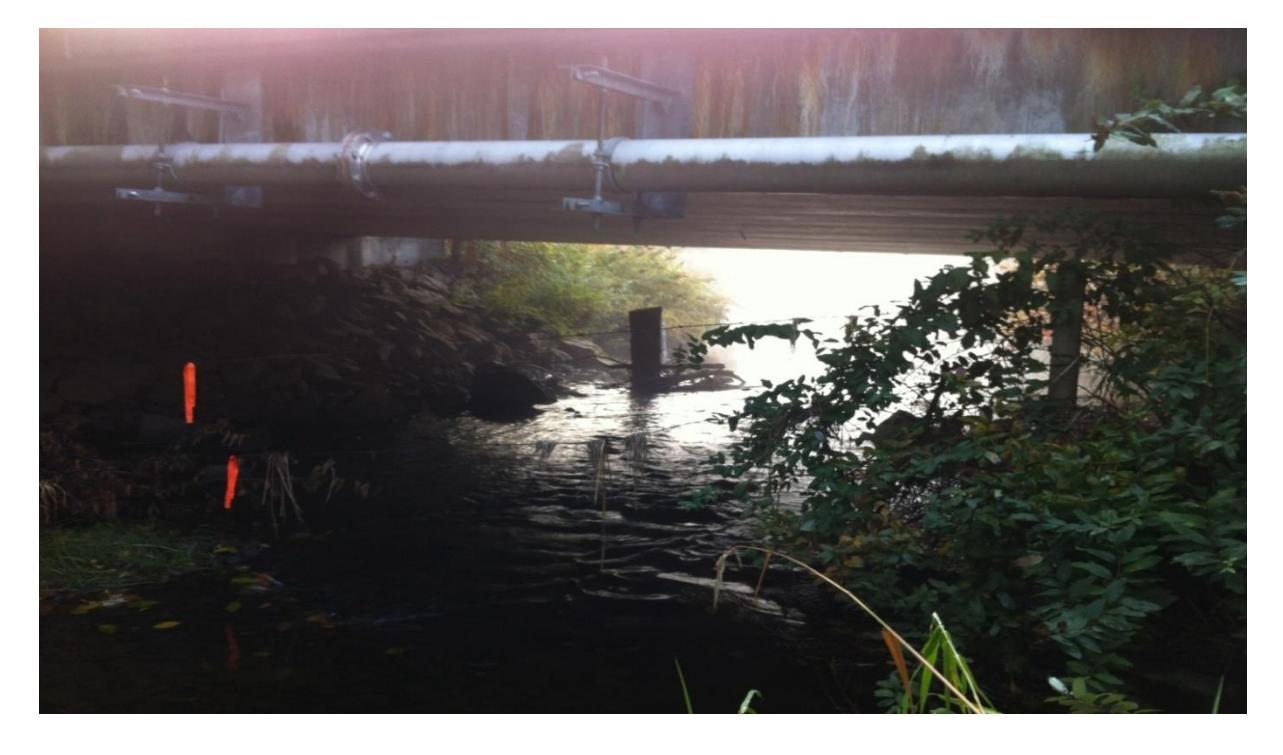
Photo 3 - Downstream view Site 2 on the Millstone River at the Biggs Rd. bridge on October 22, 2012.

Site 2 was the most upstream site on the Millstone River and was located at the bridge crossing also on Biggs road, approximately 500 meters downstream from the outflow of Brannen Lake. Sampling was conducted on the upstream side of the bridge with relatively easy walking access through grasses and small shrubs. There was a barbed wire fence on either side of the bridge that may have been for cattle, although it did not hinder passage of the river and did not catch debris. The fenced off land was public land and the responsibility of the Ministry of Transportation, the area along with the road is patrolled by guards from the prison, who's land borders one bank of the river from the bridge out to the lake. The site is a small, long, and low gradient riffle, where the river substrate is made of 10% fines, 20% cobbles, and 70% gravel. Possible pollution sources where anticipated to be the same as Site 1 as they are located in relatively the same area. Parking was along the roadside next to an agricultural field. Streamside vegetation was fairly thick along the banks, and during the high flow sampling event navigation along the bank was difficult as water was at its absolute capacity at this point of the year. Getting into the site was easy but staging areas were mostly wet (Appendix 2).

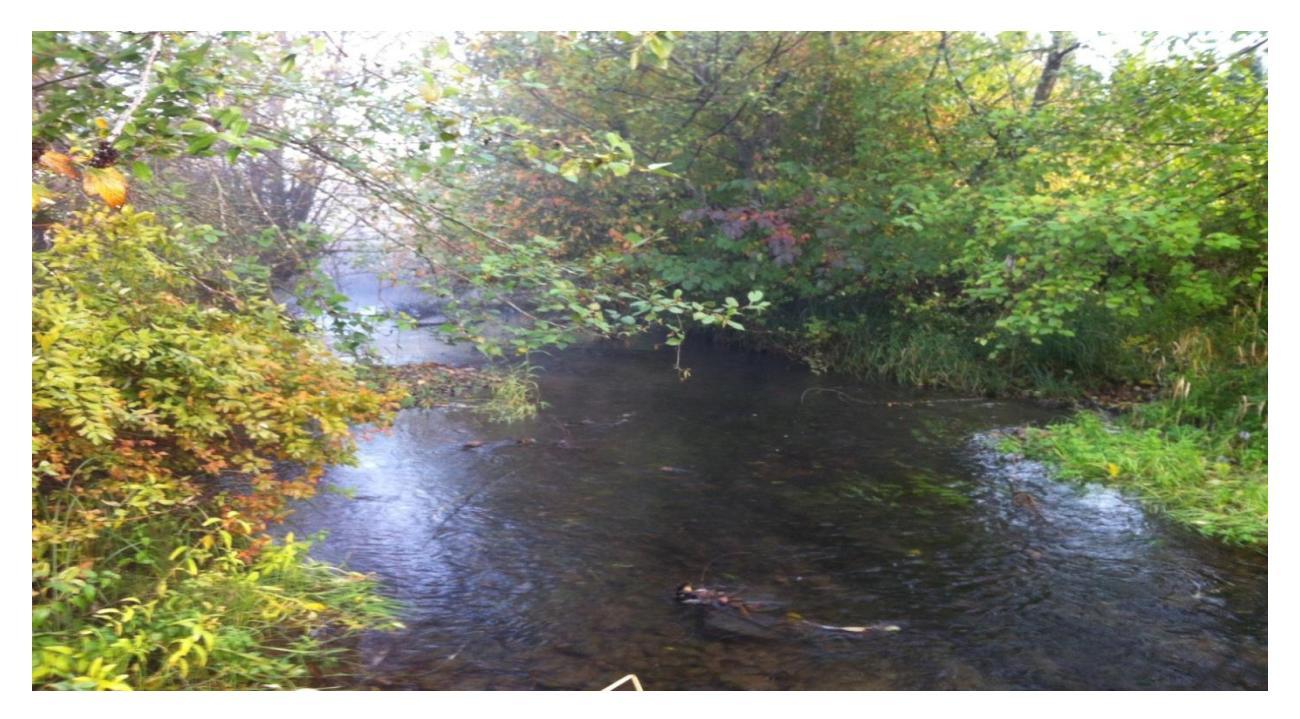
Photo 4 - Upstream view of Site 2 on the Millstone River at Biggs Rd. bridge on October 22, 2012.

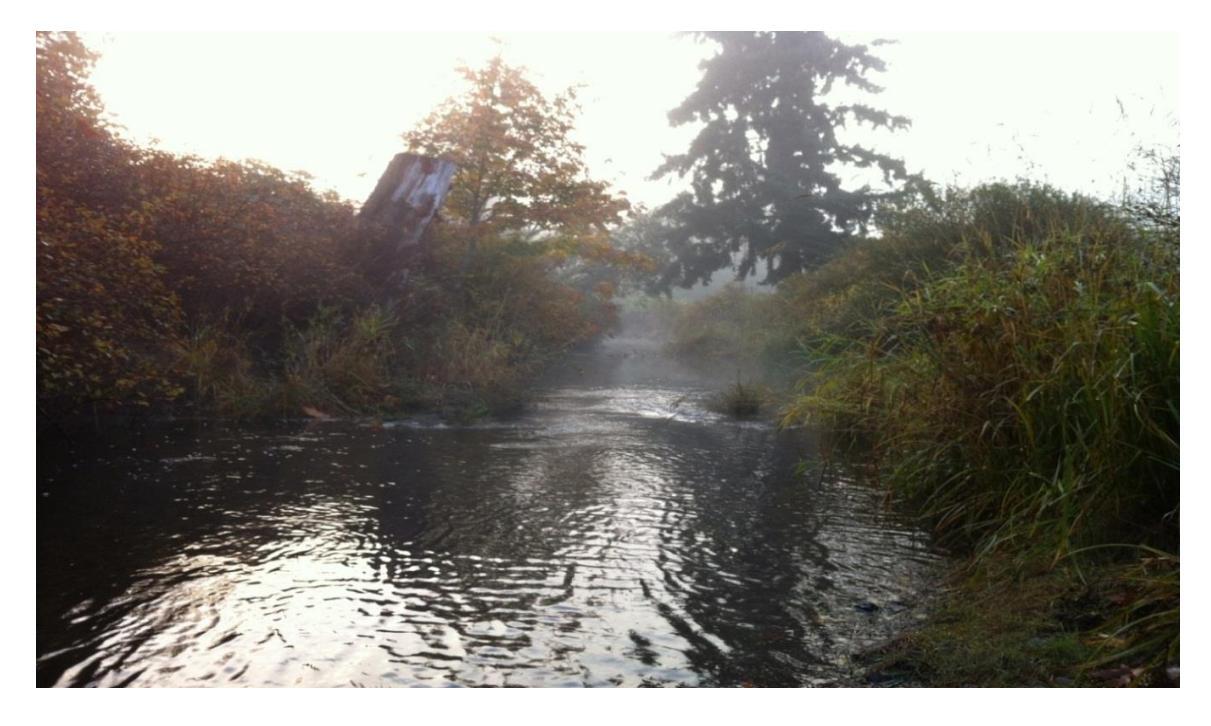
Photo 5 - Downstream view of Site 3 on the Millstone River at Durnin Rd on October 22, 2012.

Site 3 was located on the Millstone River where it crosses Durnin Rd., approximately 3 kilometers (km) downstream from site 2. Sampling was done on the downstream side of the bridge, with a simple trail access from the road. Again this site is a small, low gradient riffle, with a shallow glide directly upstream from the riffle. Substrate is made of both cobble and gravel being 45%, and 10% boulder. Although water depth and flow were acceptable and easily workable at the time of the first sampling event, it was well above safe levels, for working in the water, during the second high flow event. The area is made of residential acreages so agricultural pollution was a possible concern; however storm water effluent was also a likely to have impacts (Appendix 3).

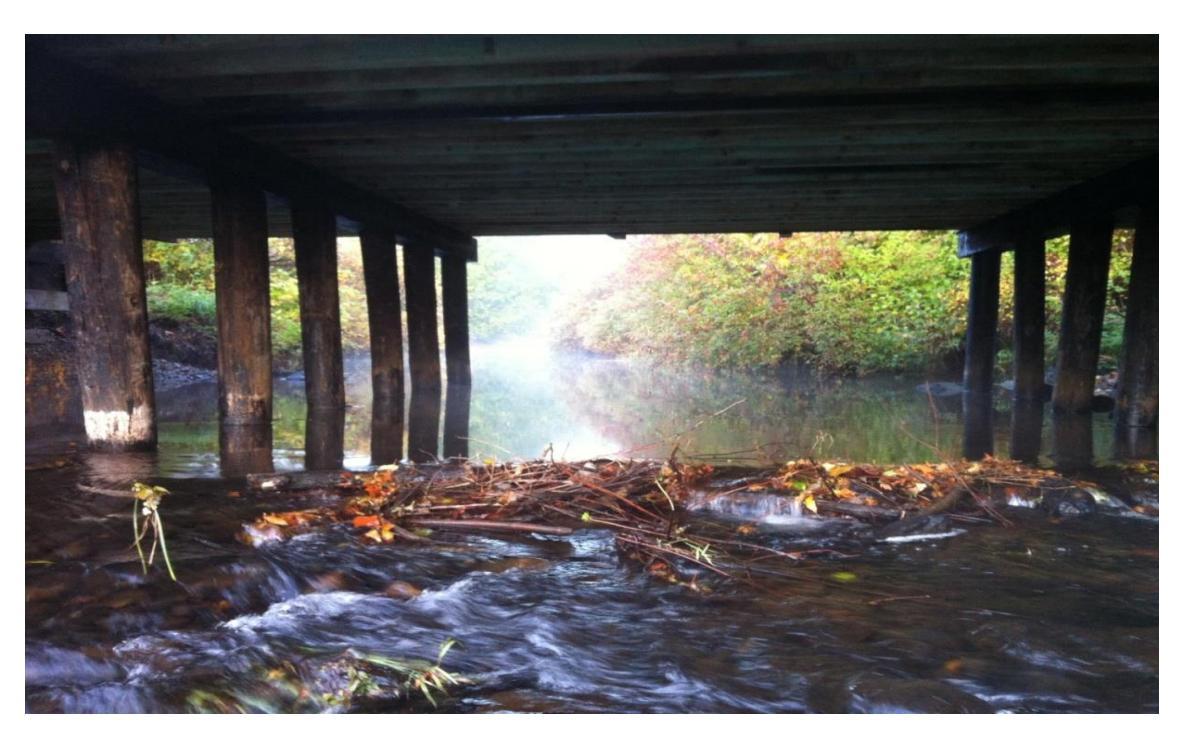
Photo 6 - Upstream view of Site 3 on the Millstone River at Durnin Rd on October 22, 2012.

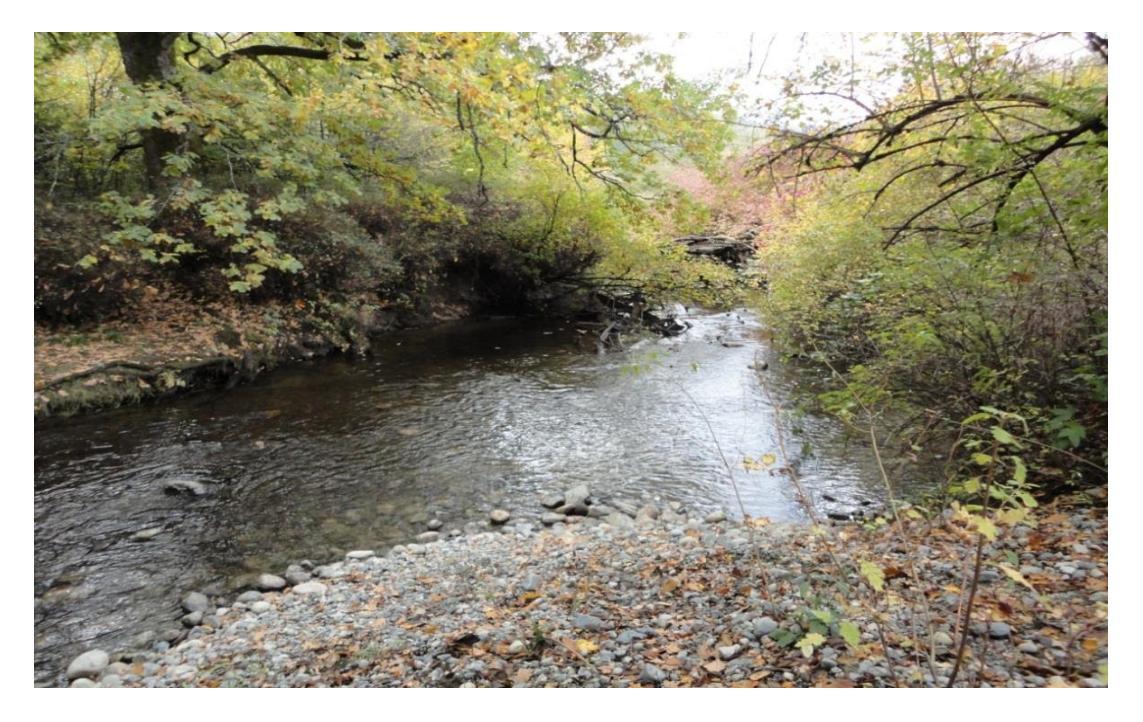
Photo 7 - The upstream channel Millstone River located at site 4 in Nanaimo British Columbia on October 20, 2012.

Invertebrate sampling was not conducted at this site, as it was not completed for the fall 2011 report and water depths even at low flow would have made sampling difficult. Substrate is made of 50% gravel, and 40% cobble and 10% fines. Gravel had been added to the site in previous years in order to enhance Coho spawning habitat. Care was taken during sampling for possible redds, although no spawning salmon were observed. Flow rates were extremely high during the second event and no work was done far into the river. The site was adjacent to the Pryde Vista golf course, with residential housing nearby; HWY 19 is also nearby and directly upstream which all may have potential impacts to the river (Appendix 4).

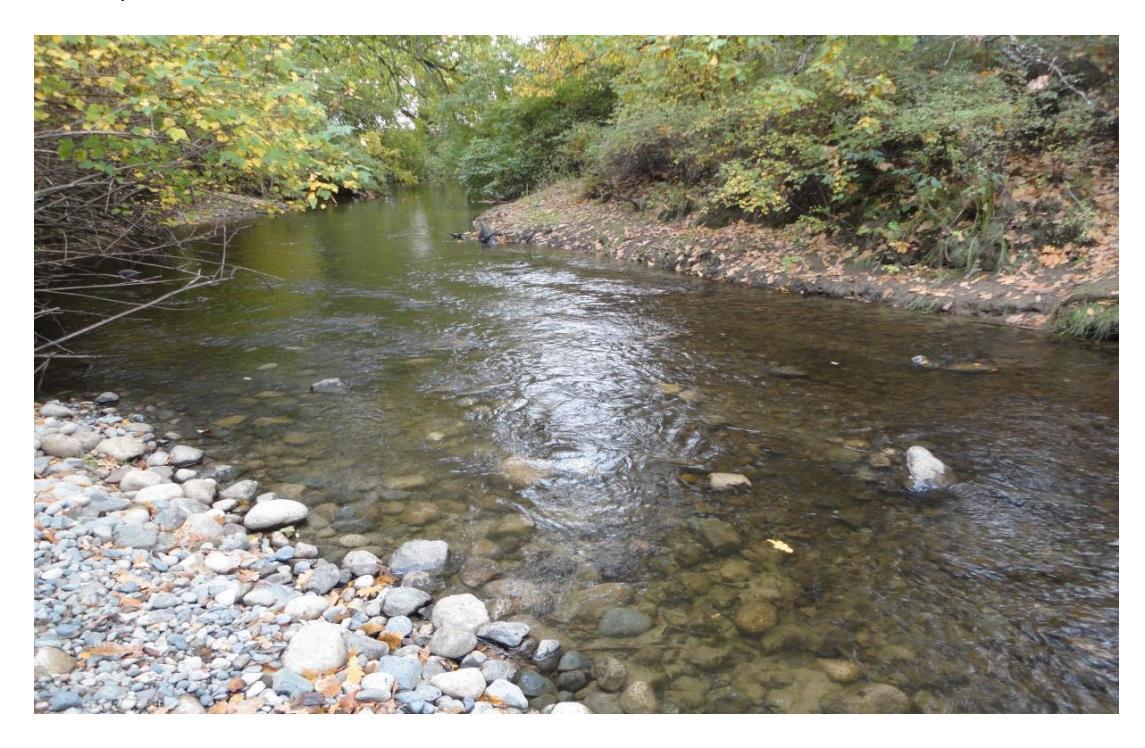
Photo 8 - The downstream channel Millstone River located at site 4 in Nanaimo British Columbia October 20, 2012.

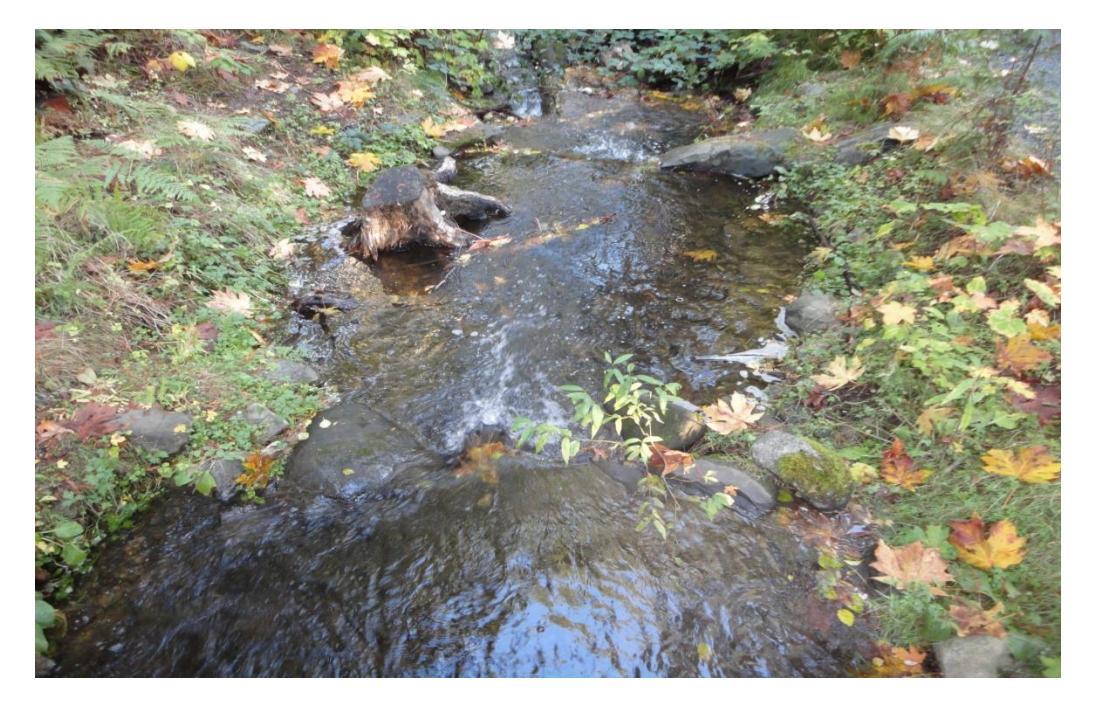
Photo 9 - The downstream channel of the Millstone River located at site 5 in Nanaimo British Columbia on

October 20, 2012.

Site 5 was located in Bowen Park directly below the Duck Pond in the Millstone side channel, approximately 3.5 km from Site 4. The side channel is 800 m in length and was built in 2007 to allow juvenile and adult Coho access to habitat above Deadman Falls. The site was a low gradient riffle, with substrate that shows 50% gravel, 40% cobble, 5% boulders, and 5% fines. This site was sampled for benthic invertebrates to be consistent with previous years sampling, and provide continuing data. The site is located within the municipal park with walking trails surrounding the area. Possible pollution sources could be fecal coliforms, as it is a popular dog walking area and other wildlife are frequently present in and around the pond. There were no hazards at this site because it is in a walking park and the flow of the side channel is controlled (Appendix 5).

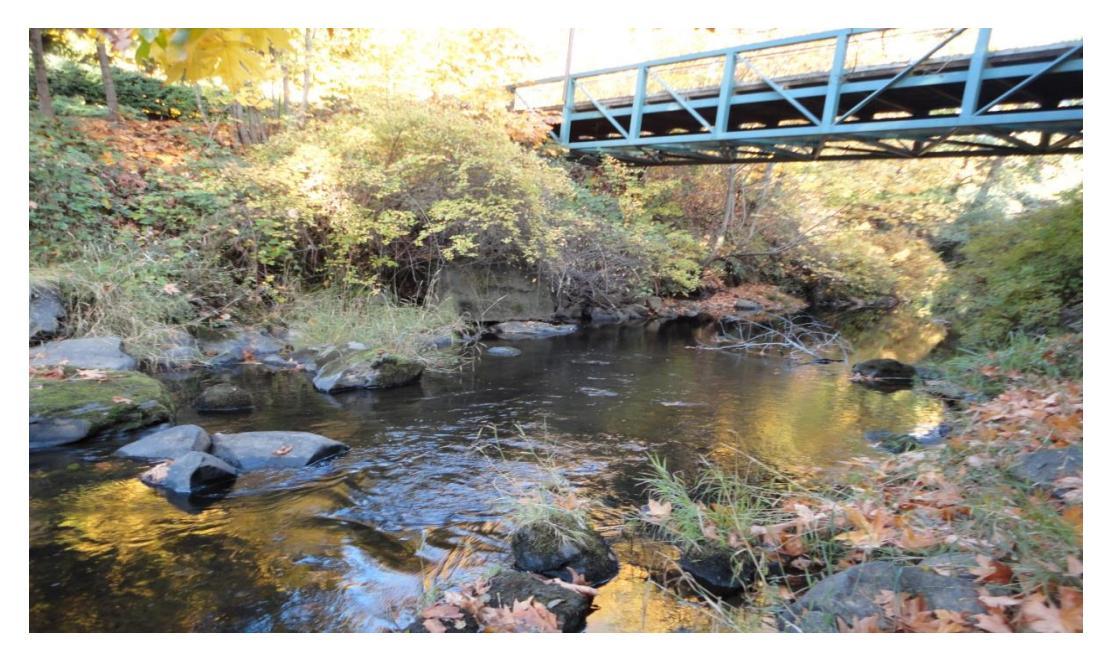
Photo 10 - The downstream channel of the Millstone River located at site 6 in Nanaimo British Columbia on October 20, 2012.

Site 6 was in Barsby Park, which is approximately 170 m upstream from the mouth of the Millstone River which discharges in to Nanaimo harbor. The site is situated at the top end of the park above the staircase (a series of man-made pools in bedrock, allowing anadramous fish access upstream), it is just under the footbridge that crosses over the channel. This site again has easy foot access with a short walk from the Barsby Park parking lot. The area was a faster flowing riffle; at high flow no work was done in mid channel. Even taking flow measurements during the first sampling event was tricky and care was needed to keep steady footing. Substrate was a mixture of cobble, gravel, boulders, and fines however; cobble was the dominant substrate on site. Urban runoffs combined with a significant amount of garbage present on the banks at site 6 are potential pollution source (Appendix 6).

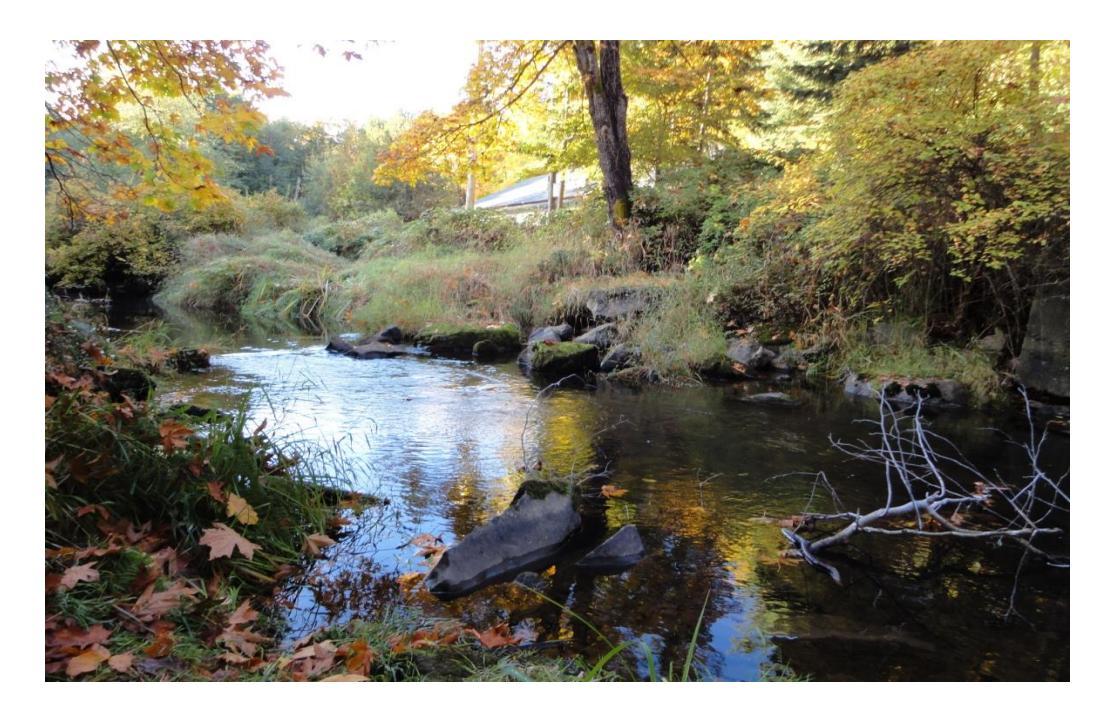
Photo 11 - The upstream channel of the Millstone River located at site 6 in Nanaimo British Columbia on October 20, 2012.
