DATA REPORT

Water Quality and Stream Invertebrate Assessment for the Millstone River, Nanaimo, BC, (Fall 2009)

Students of Vancouver Island University RMOT 306 (Environmental Monitoring)

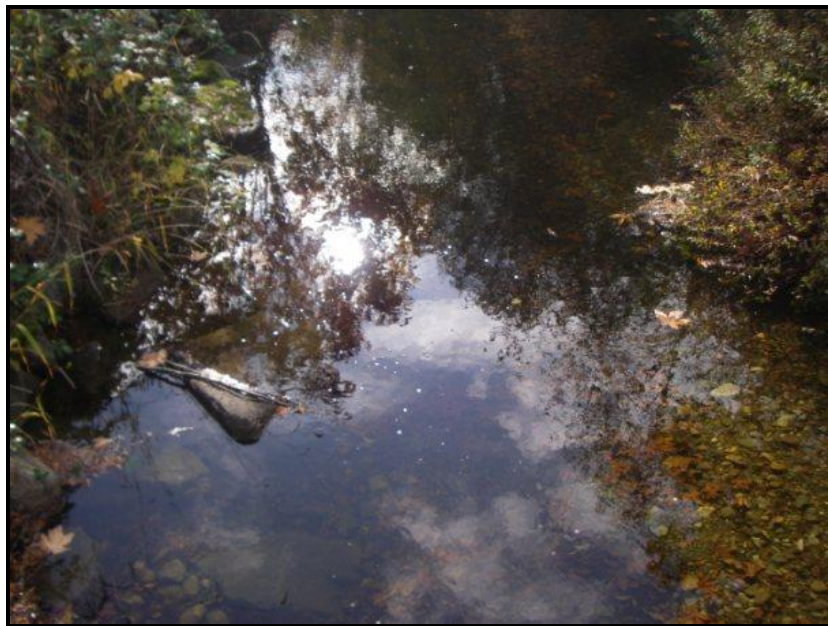
Photo 1. Benson Creek at the Biggs Road crossing (station 1).

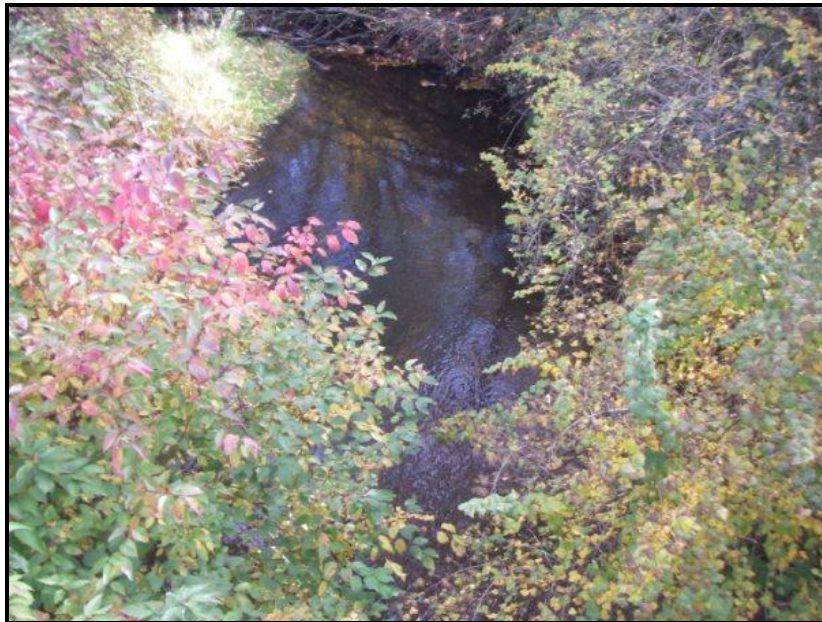
Photo 3. Millstone River at the Jingle Pot Road crossing (station 3).

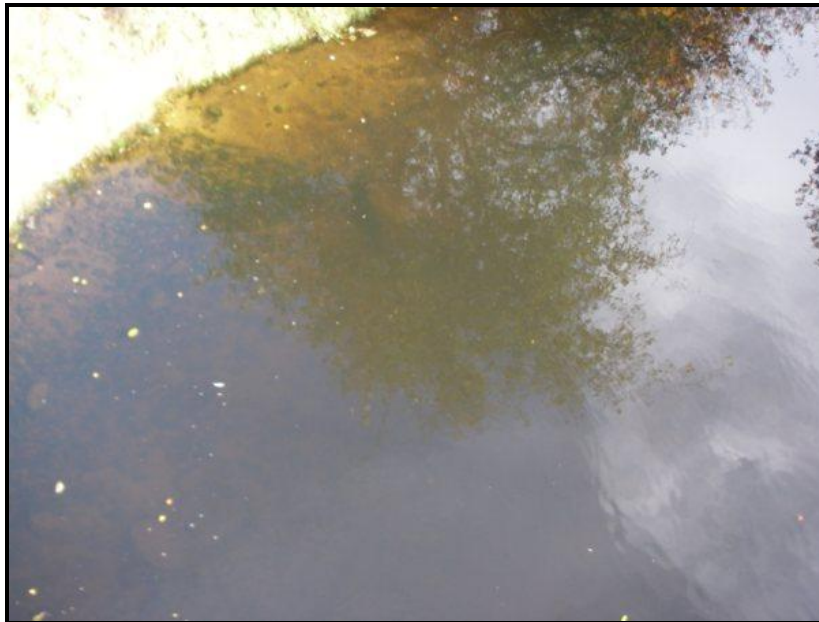
Photo 5. Millstone River at the Westwood Road crossing (station 5).

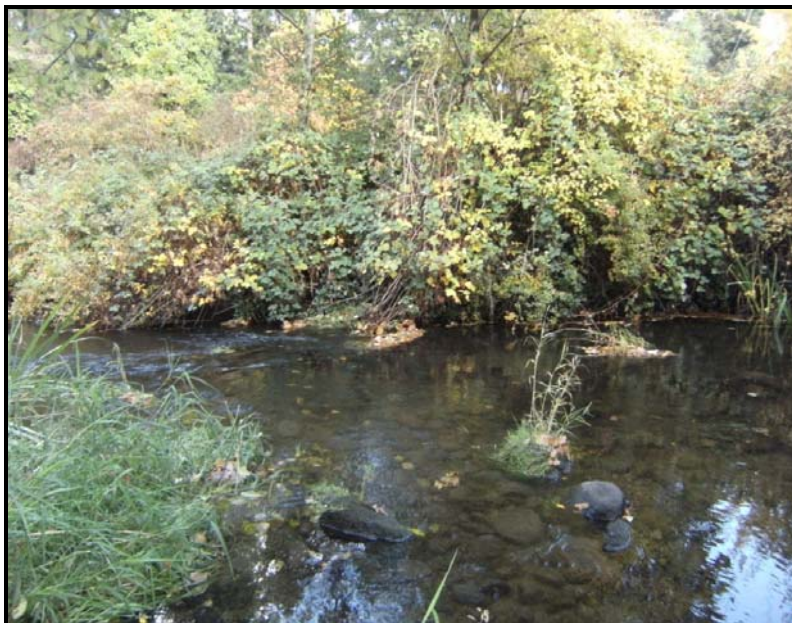
Photo 6. Millstone River at the Bowen Road crossing (station 6).

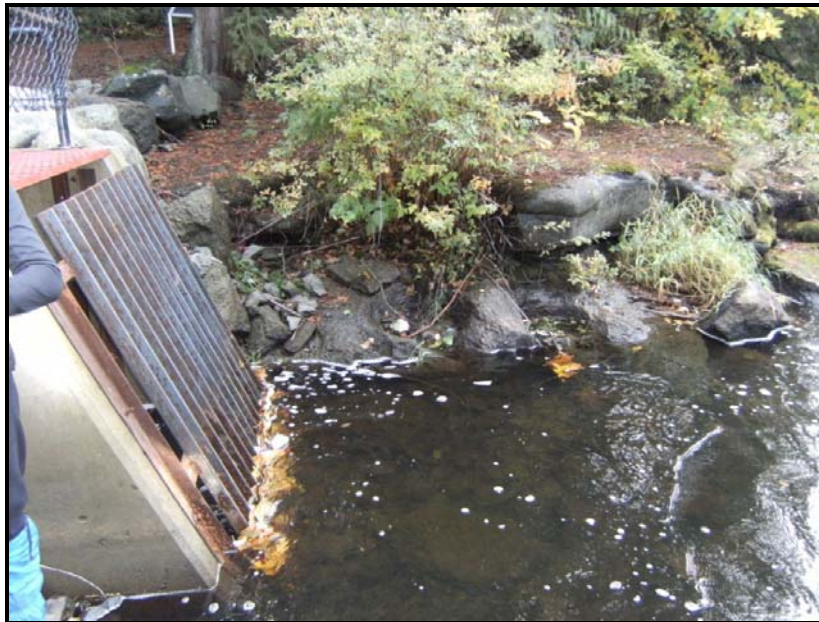
Photo 7. Millstone River at the upstream entrance to the bypass channel (station 7).

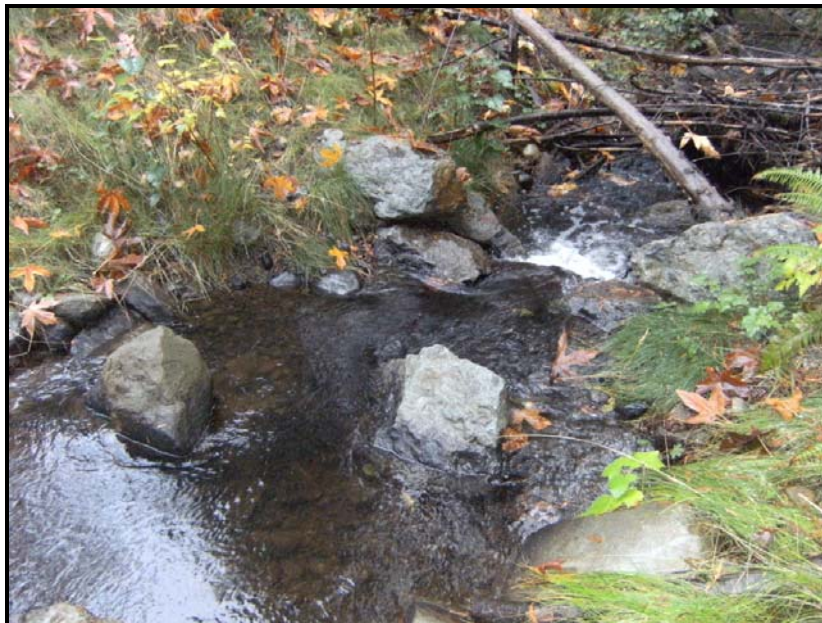
Photo 8. Millstone Bypass Channel, approximately midway along the bypass channel (station 8).

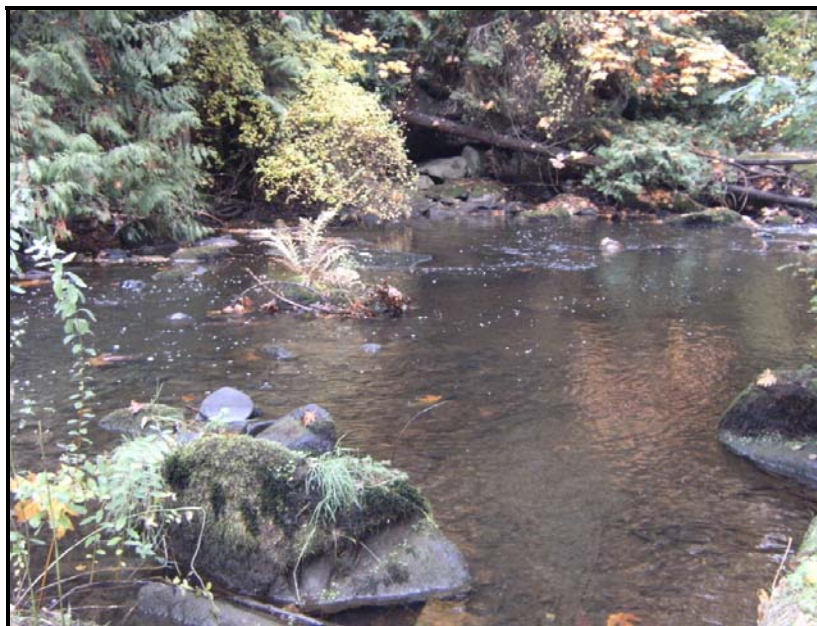
Photo 9. Downstream outlet of the Millstone Bypass Channel into the Millstone River (station 9).

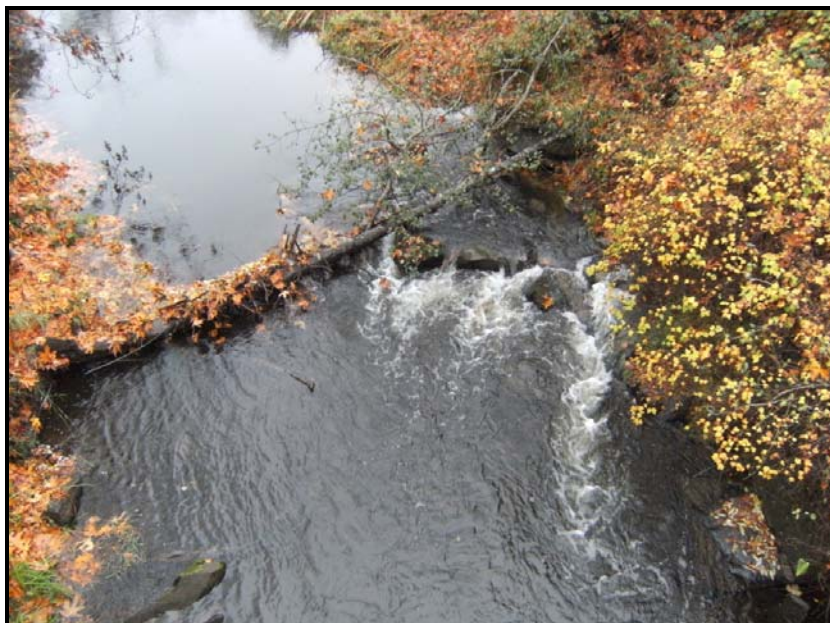
Photo 10. Millstone River in Barsby Park, approximately 10 m upstream of the estuary (station 10).
